Rail Accident Investigation Branch

Rail Accident Report

**Two near misses at Crofton Old Station No.1
Level Crossing, near Wakefield, West Yorkshire
1 and 18 May 2006**

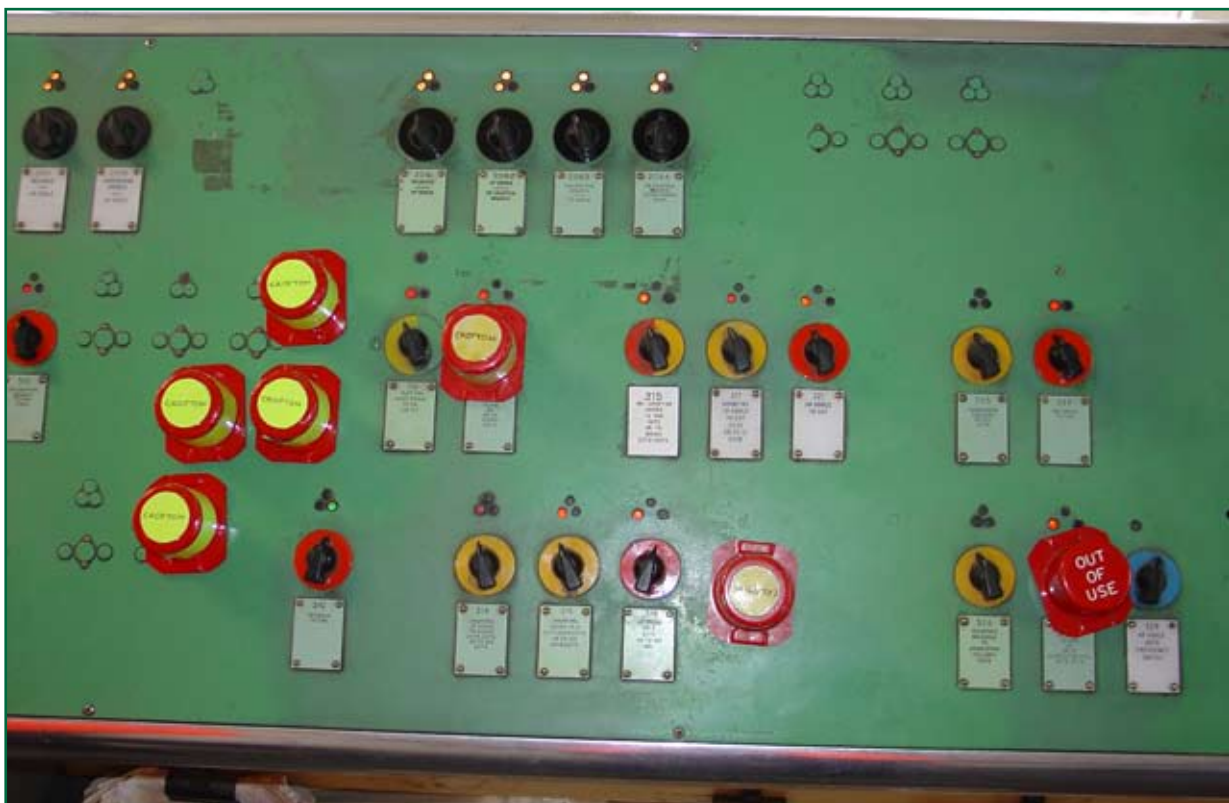
Figure 4: Oakenshaw signal box switch panel showing special crossing reminder appliances

- for incident 2, distraction led to the *special crossing reminder appliance* not being replaced over the switch for Signal O313 the last time it was used.

- 167 The distraction in the duties of Signaller 2 is considered to be contributory to incident 2 in that it led to the omission of the special crossing reminder appliance not being replaced over the switch for Signal O313 following its earlier use.

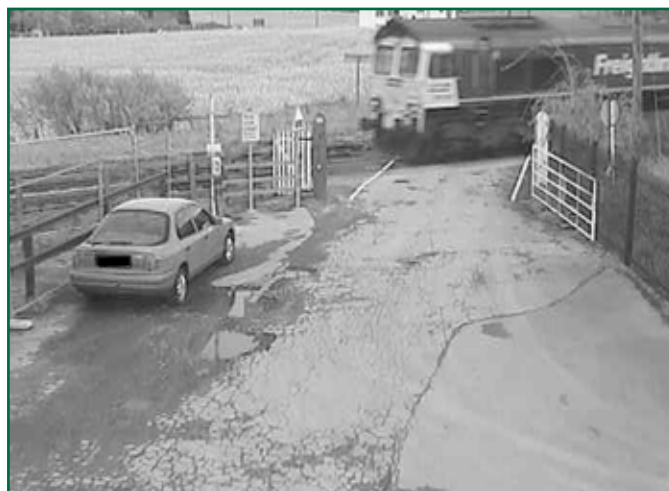
Figure 5: CCTV image of 0D52 passing over the crossing during incident 1

- 45 At around 12:42 hrs, after train 2F71 had passed over the level crossing, Crossing Keeper 1 left the crossing keeper's cabin and opened both level crossing gates to the road.
- 46 Between 12:41 hrs and 12:43 hrs, Signaller 1 cleared Signal O313 for train 0D52 to pass over the crossing on the down line.
- 47 At around 12:44 hrs, a car, driven by Crossing Keeper 2, crossed over the crossing. Crossing Keeper 2, who was about to commence his shift of duty, parked his car close to the cabin and entered the cabin to sign on. The changeover duty occurred and was recorded in the cabin occurrence book.
- 48 At around 12:45 hrs, train 0D52 passed over the crossing with the gates open to the road (Figure 5).

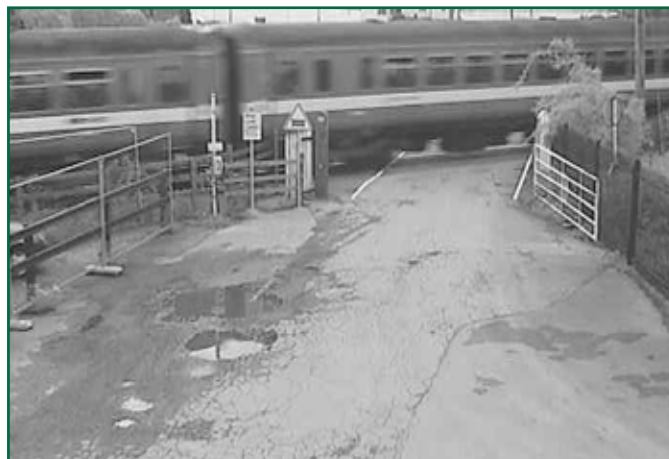
Figure 6: CCTV image of 2F65 passing over the crossing during incident 2

- 69 Train 2F65 passed over the crossing as Crossing Keeper 3 had just locked the up side line gate. He was between the gate and the running lines as the train passed. The gate closest to the down side line was still open to the road (Figure 5).
