# Rail Accident Report

## **Tram collision at Soho Benson Road, Midland Metro 19 December 2006**

# Tram collision at Soho Benson Road, Midland Metro, 19 December 2006

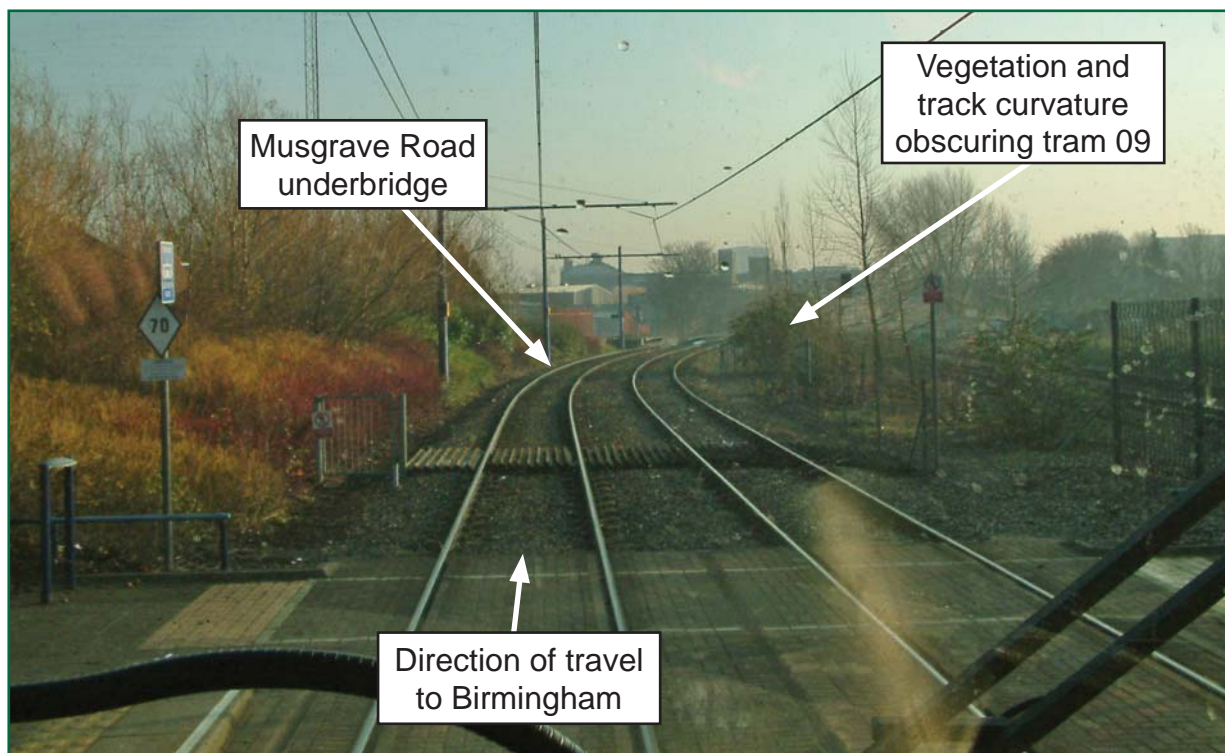
Figure 5: Tram 09 and the collision location obscured from tram at Soho

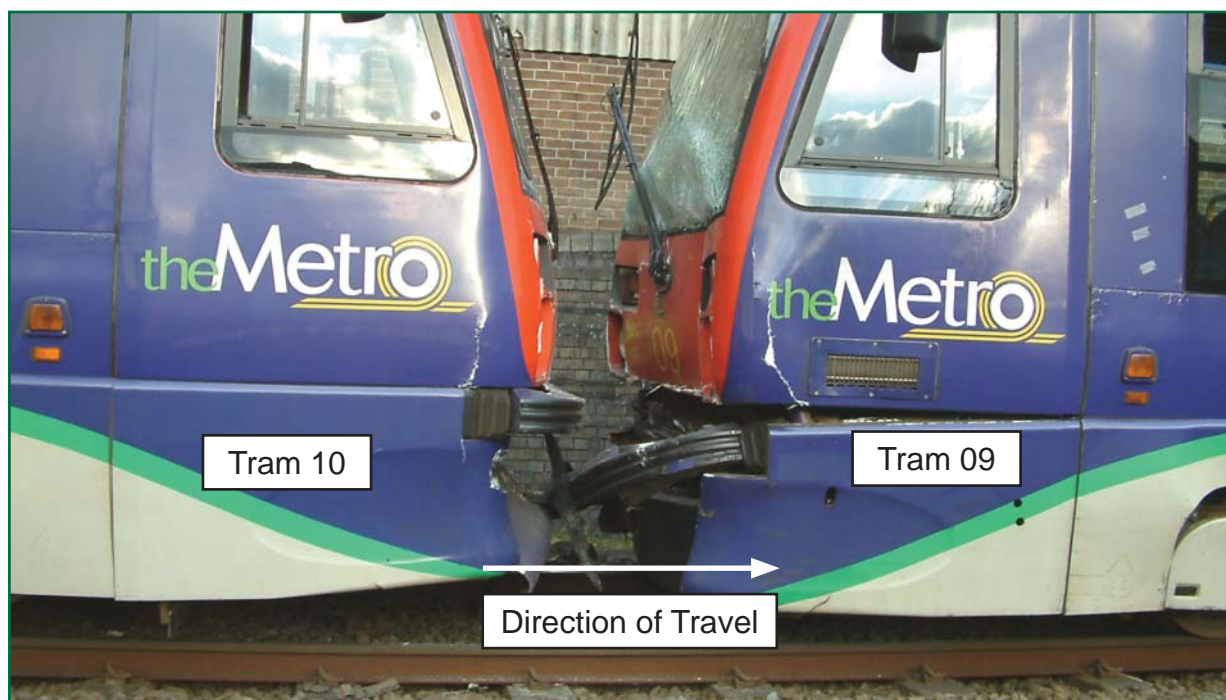
- 38 Passengers and TMM staff sustained minor injuries as a consequence of the collision; 13 passengers were taken by ambulance to three local hospitals. All were discharged the same day.
- 39 Trams 09 and 10 sustained damage to their cabs. See Figures 6 - 9.

Figure 6: Trams 10 and 09 after the collision

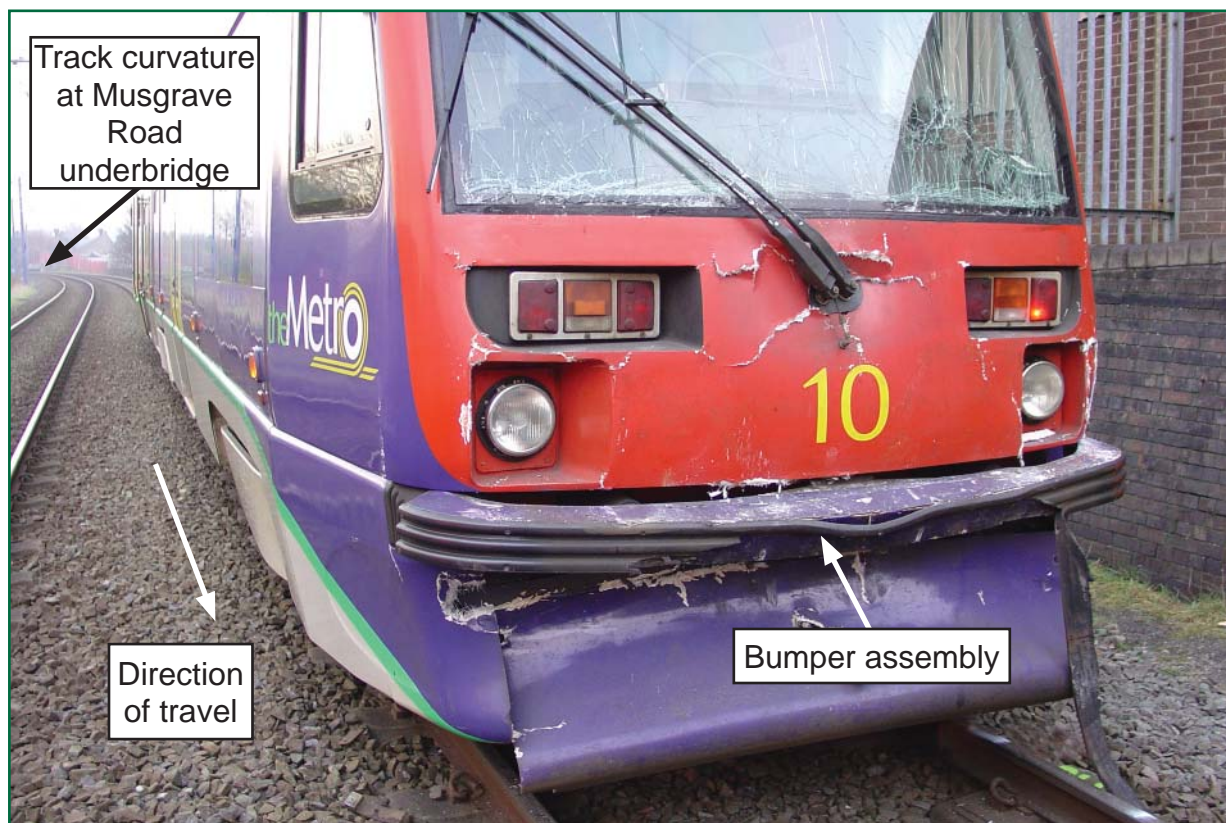
Figure 7: Tram 10 damage to cab

- 89 The accident was not a symmetrical collision of structurally equal trams; differences existed in tram vertical height due to differences in payload, suspension setup, deceleration forces and track gradient. The result of this non-symmetrical collision was that: (i) tram 10's cab structure was undamaged; (ii) tram 09's bumper assembly was deformed vertically down and not longitudinally as predicted by the simulation; (iii) tram 09 sustained permanent deformation to its cab floor and waist rail fabrications although a driver's survival space was maintained; (iv) trams 09 and 10 sustained damage to their windscreens and glass reinforced plastic cab exteriors.

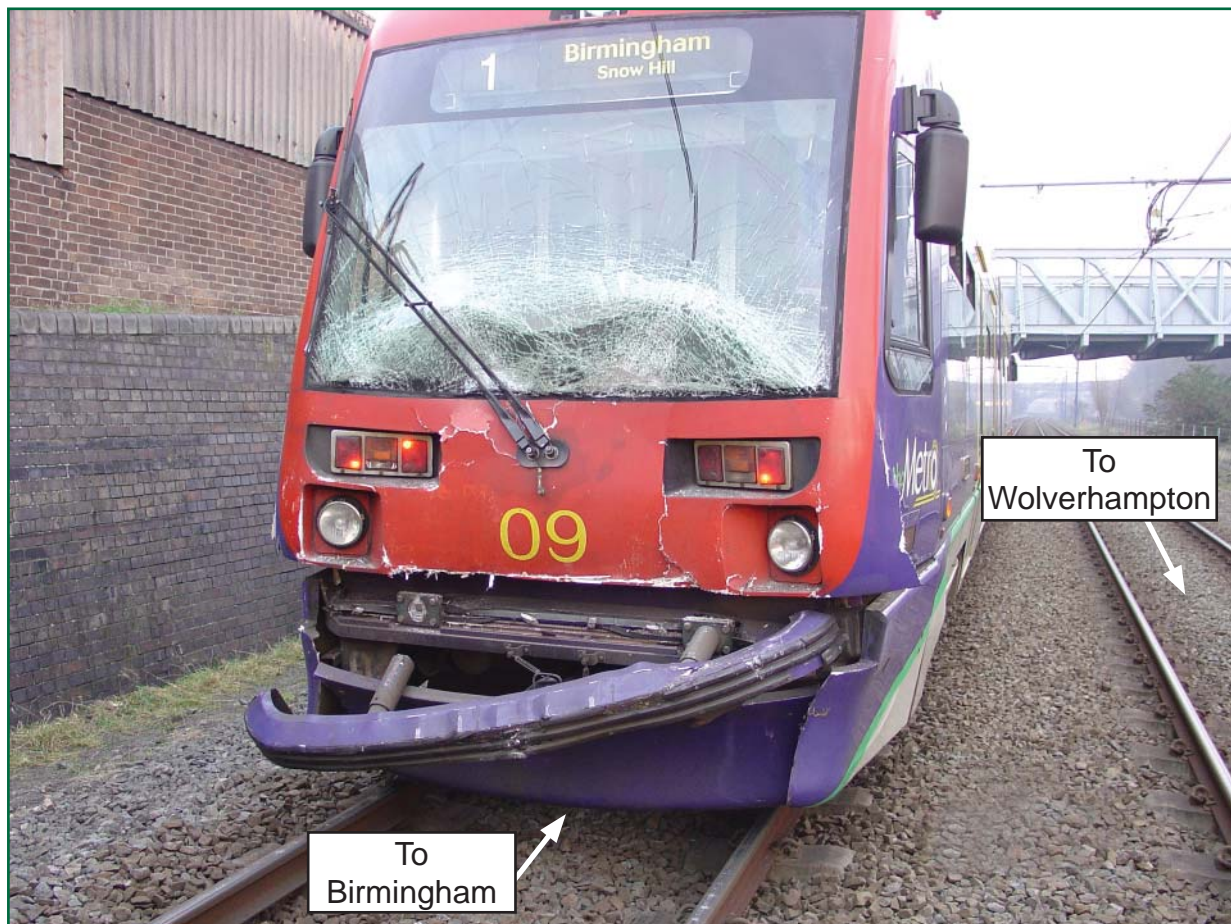
Figure 8: Tram 09 damage to cab

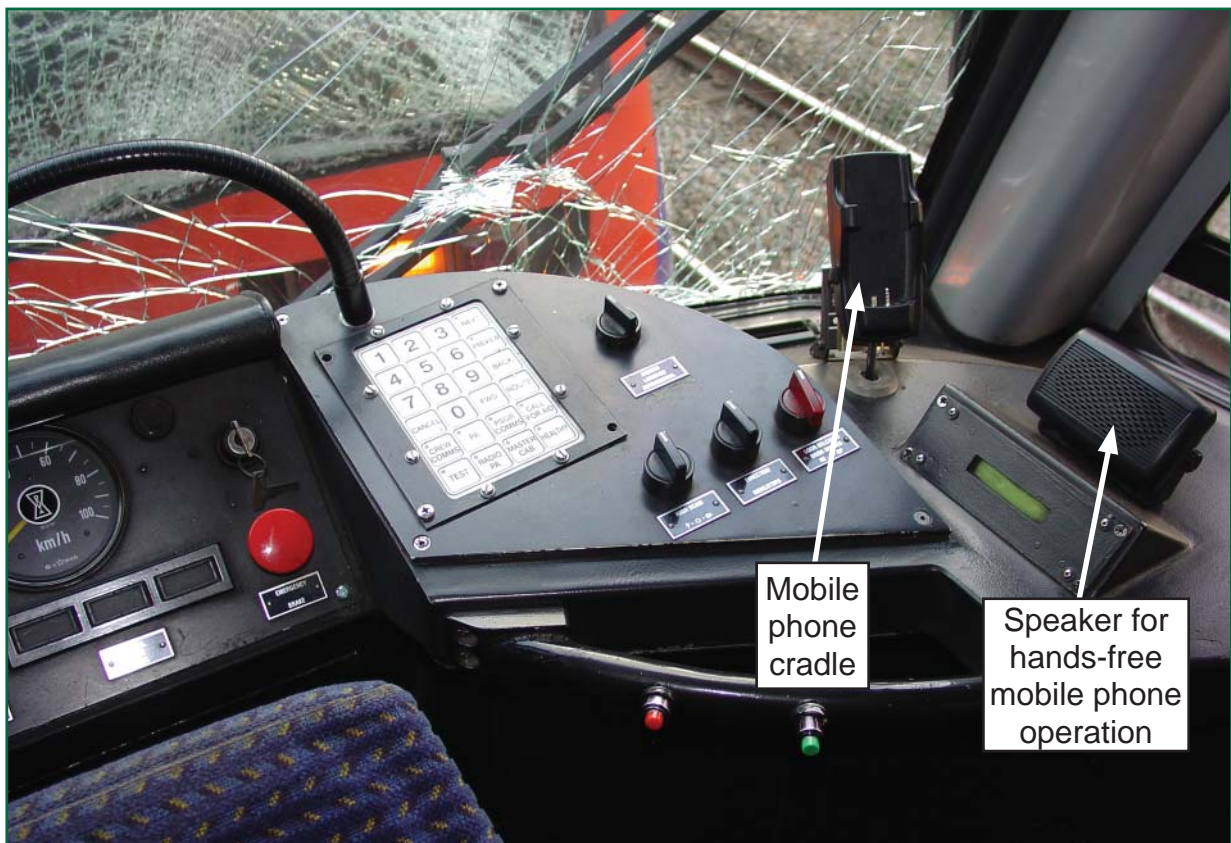
Figure 9: Inside tram 10's cab

- 75 Although TMM installed the cab mobile phone in a desk mounted cradle with a speaker for hands-free use, they did not discourage its hand-held use by retention of the phone to the cradle. See Figure 9.

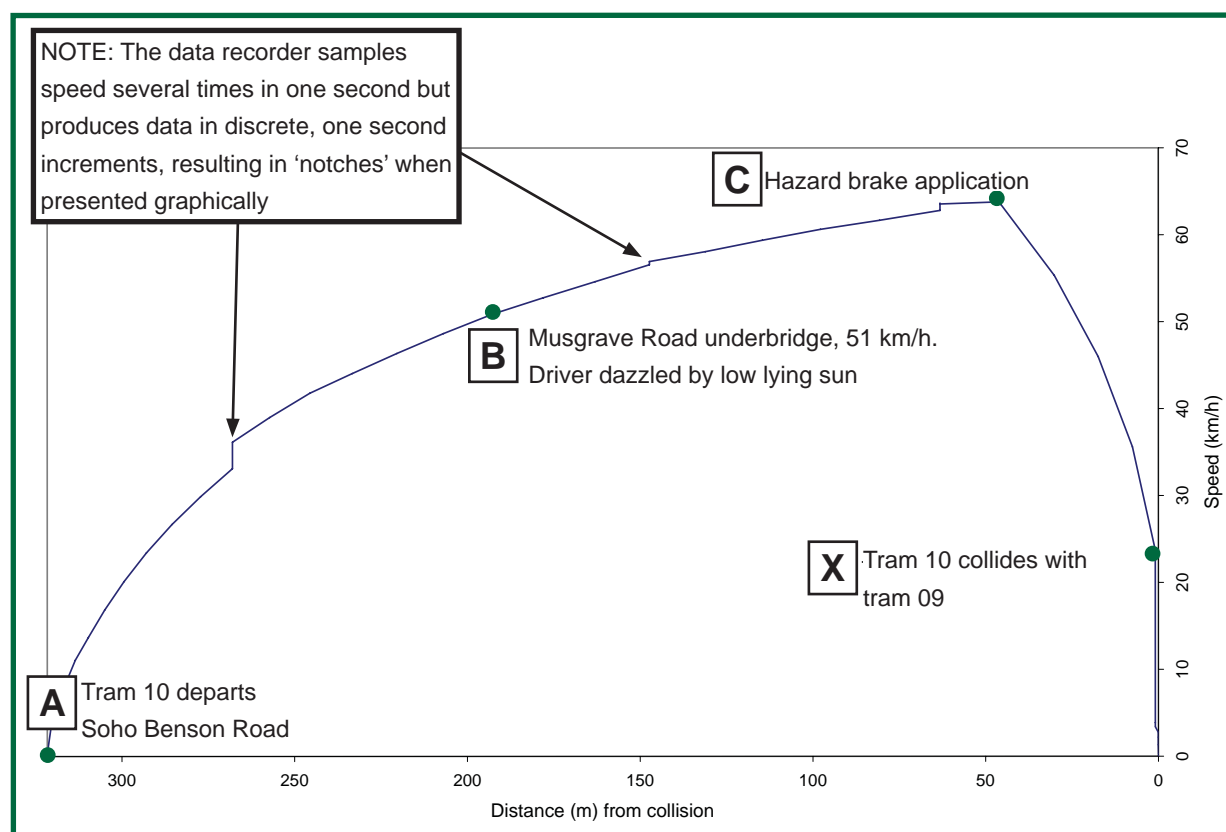
Figure 10: Tram 10 data recorder analysis from Soho Benson Road tram stop to the collision

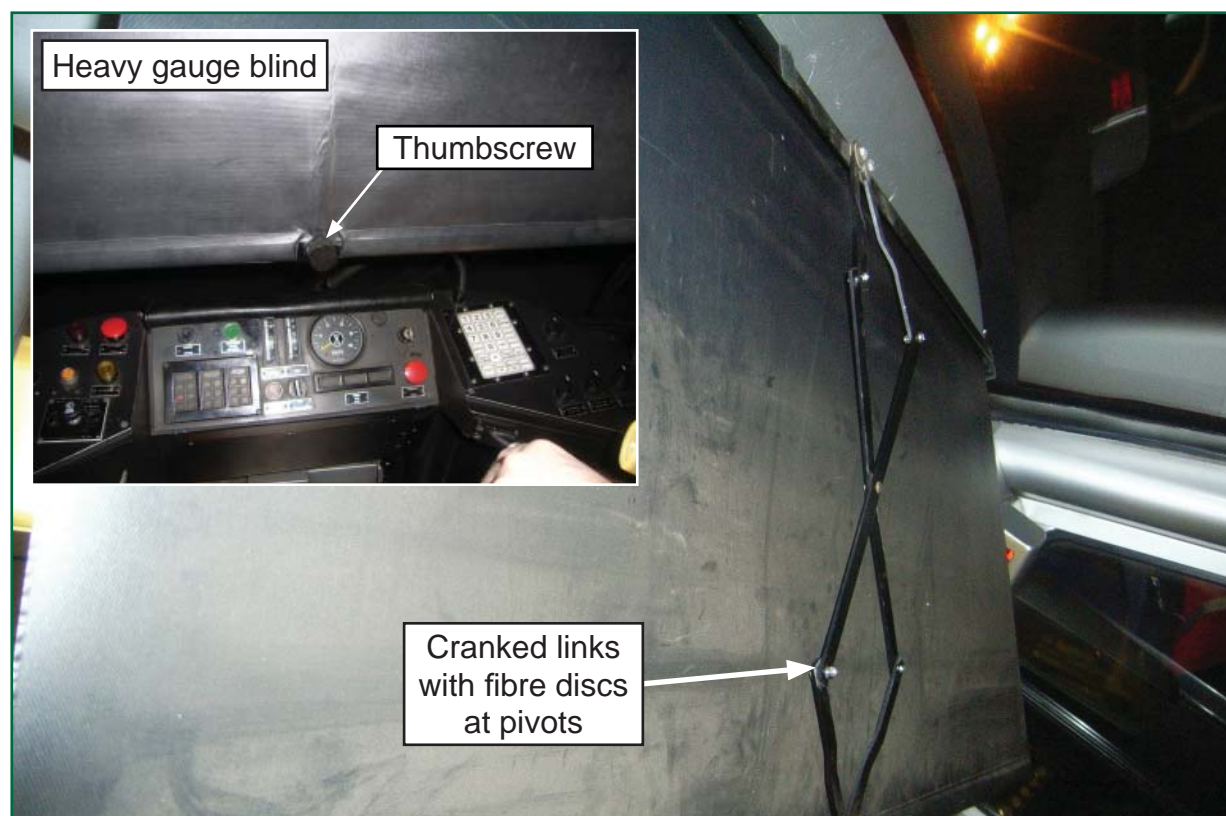
- 59 TMM trams are fitted with two sunblind types identified in this report as types I and II.
- 60 Sunblind type I, the original equipment, has a scissor mechanism with cranked links, fibre discs at its pivots, a heavy gauge blind and a thumbscrew to adjust clamping force and, in turn, the force that is required to deploy or retract the blind. See Figure 11.

Figure 11: Sunblind mechanism - type I

- 1 TMM should:
  - (i) modify the design of the tram sunblinds to ensure that, when deployed, they remain in position during tram operation;
  - (ii) amend the maintenance regime to ensure that sunblind mechanisms remain fit for purpose over their working lives; and
  - (iii) amend their procedures to ensure that fleet checks are carried out to a standard sufficient to correctly identify faults (Paragraph 101b).
- 2 TMM should amend their procedure for tram failure to require the use of hazard warning lights immediately a tram is causing an obstruction (Paragraph 101c).
- 3 TMM should conduct a risk assessment into their off-street operation to identify improvements that could be made in the identification of and response to unexpected hazards, including obstructions on the tramway (Paragraph 74).

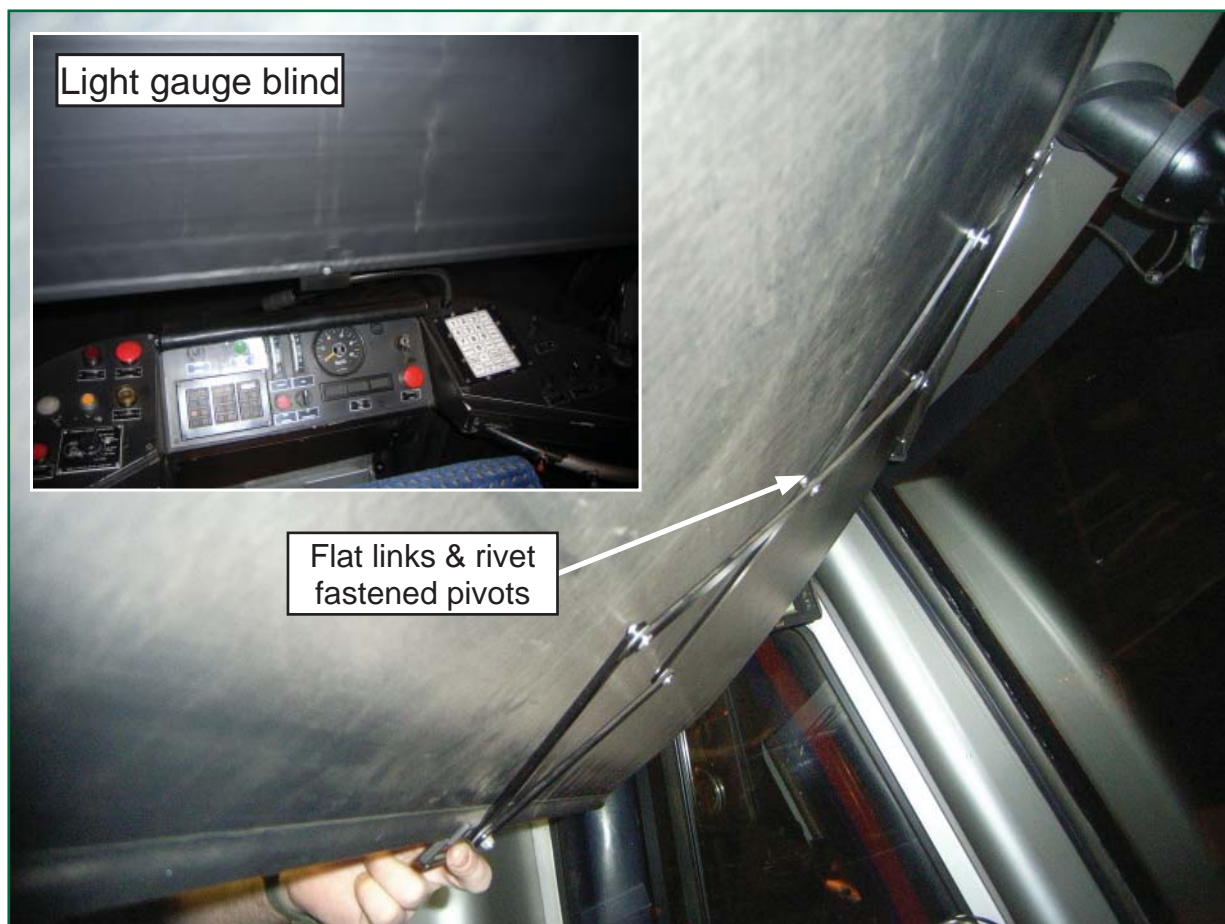
- 61 Sunblind type II is used as a replacement for type I and has a scissor mechanism with flat links, rivet fastened pivots, a thin gauge blind and no device to adjust clamping force; the force that is required to deploy or retract the blind. See Figure 12.

Figure 12: Sunblind mechanism - type II

- 64 When the driver attempted to deploy tram 10's type II sunblind, a 'wedge' made from ticket roll paper fell from the mechanism. The wedge had been used by an earlier driver to prevent the sunblind from involuntary retraction, a commonplace event according to TMM staff and supported by test results.
- 65 The driver released the TBC and attempted to reinsert the wedge into the mechanism with the sunblind at the required position, and stated that this activity took approximately three seconds.
- 66 A contributory factor was that tram 10's driver became occupied with adjusting a sunblind that would not remain in position.

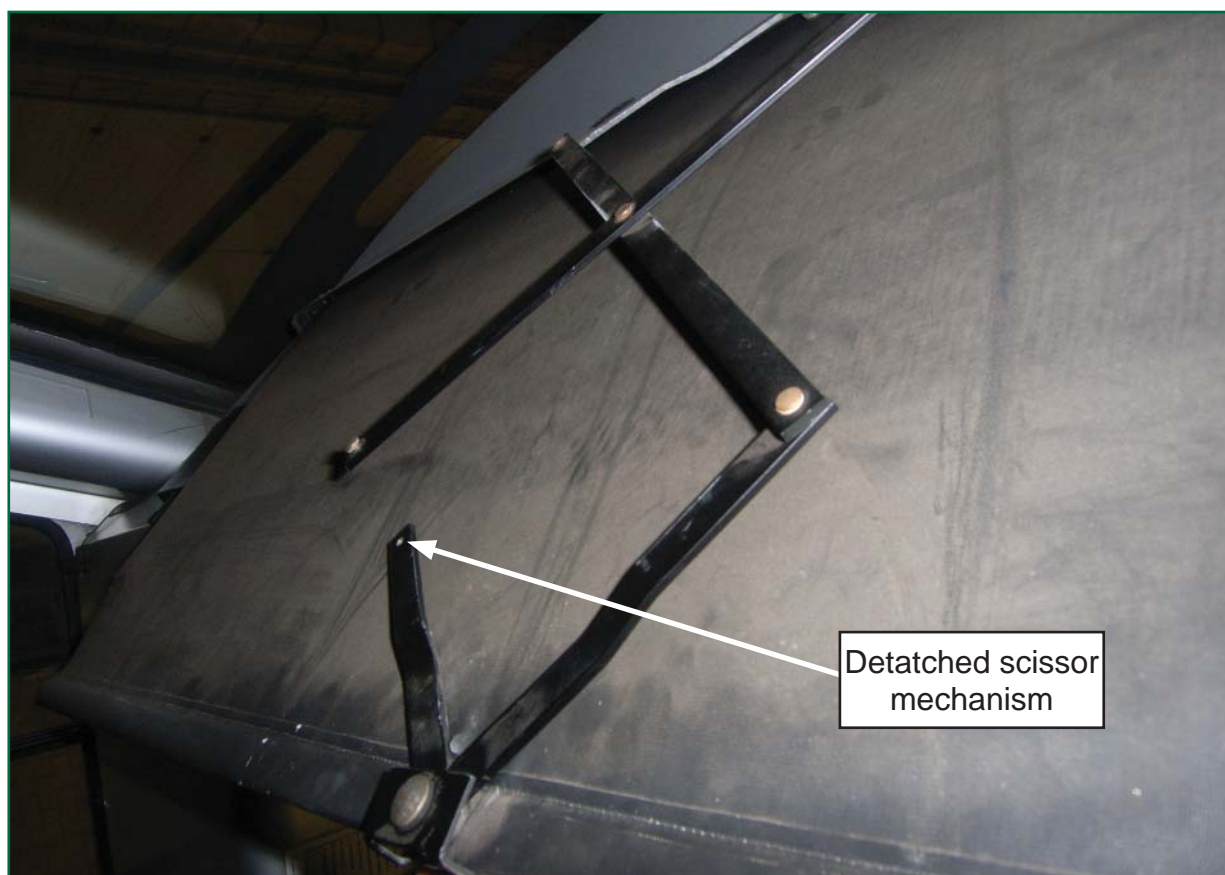
- 62 RAIB testing found 18 sunblinds of 25 that were not fit for purpose, despite the fleet being subjected to a TMM post-accident check of sunblind mechanism performance with no faults reported.
- 63 The sunblinds that were not fit for purpose were either prone to involuntary retraction or not capable of operation (see Figure 13 for an example of the latter). All seven of the satisfactory sunblinds were type I, original equipment. The sunblind test results are summarised in Figure 14.

Figure 13: Sunblind mechanism - type I - not capable of operation

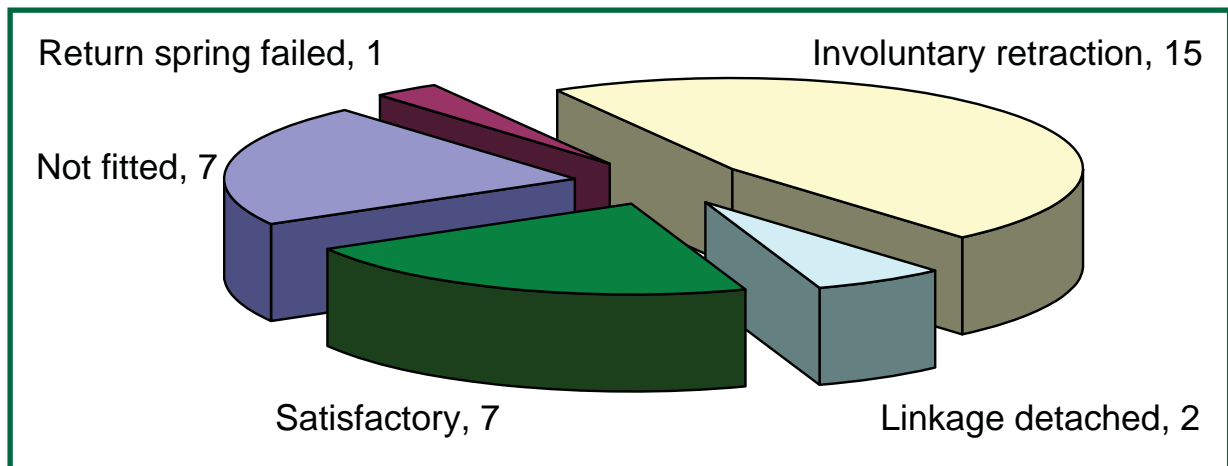
Figure 14: Sunblind test results
