Rail Accident Report

Collision between a tram and road vehicle at New Swan Lane Level Crossing on Midland Metro

8 June 2006

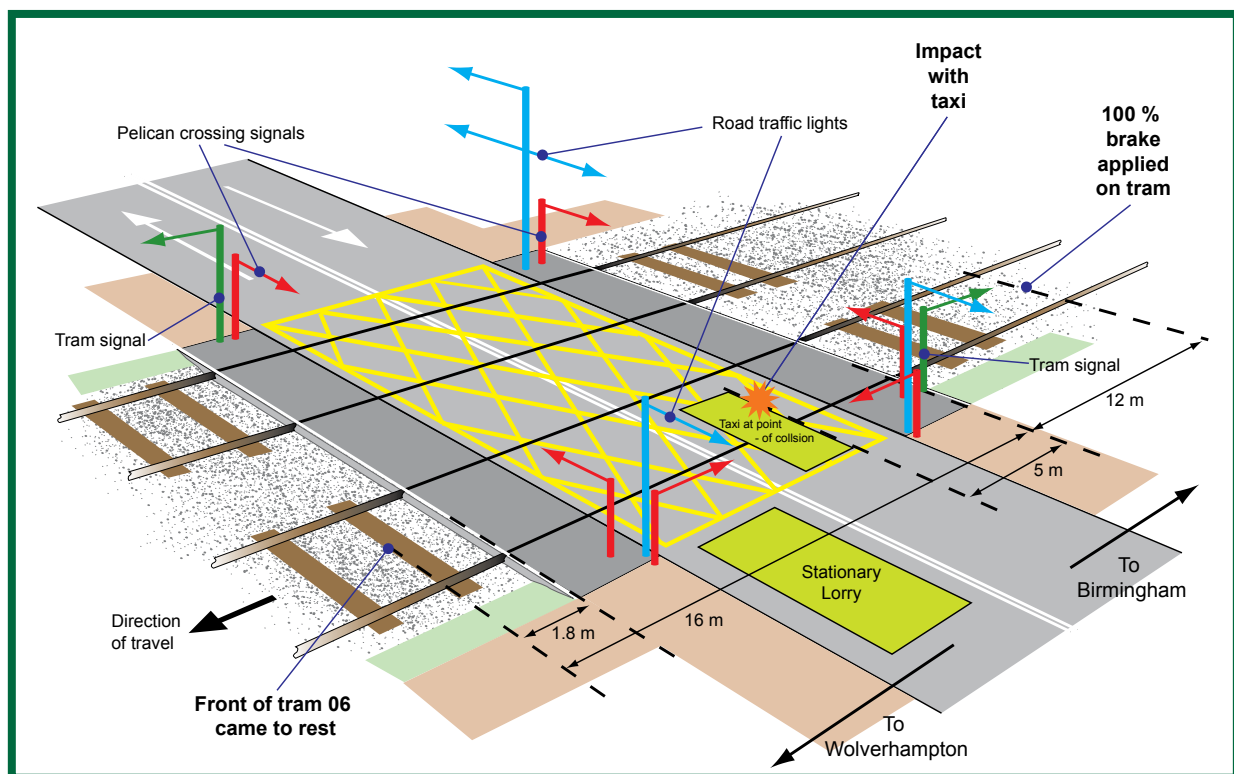
Figure 4: Layout of New Swan Lane Level Crossing.

- 25 At New Swan Lane Level Crossing, the approach of a tram from Birmingham is detected by 'Prepare' and 'Demand' loops located in the track. When these receive a signal from a tram mounted transponder a timed sequence is initiated that results in the road traffic signals showing a stop (red) aspect and the tram signal showing a proceed aspect approximately 10 seconds after demand detection. This arrangement normally results in the tram receiving a proceed aspect before it reaches the crossing. An additional 'Stop' loop is provided immediately before the crossing at which a tram driver may request a manual intervention of the signals using the *Tram Ready To Start* (TRTS) function. A further 'Clear' loop is provided after the crossing indicating that the tram has passed the crossing.

- 29 The location of the New Swan Lane Level Crossing is shown in Figure 1. It is located in the off-street section between Dudley Street Stop and Black Lake Stop. The layout of the crossing and associated signalling system are shown in Figure 4.

- 107 TMM have reviewed the crossing layout arrangements and approach speed signage locations. The road and tram signals at the junction have now been replaced with high intensity signal heads and the Wolverhampton bound speed board for the 30 km/h permanent speed restriction has been moved 25 m further away from the crossing.
