Rail Accident Investigation Branch

# Rail Accident Report

## **Derailment at Ropley (Mid Hants Railway) 25 July 2006**

## **25 July 2006**

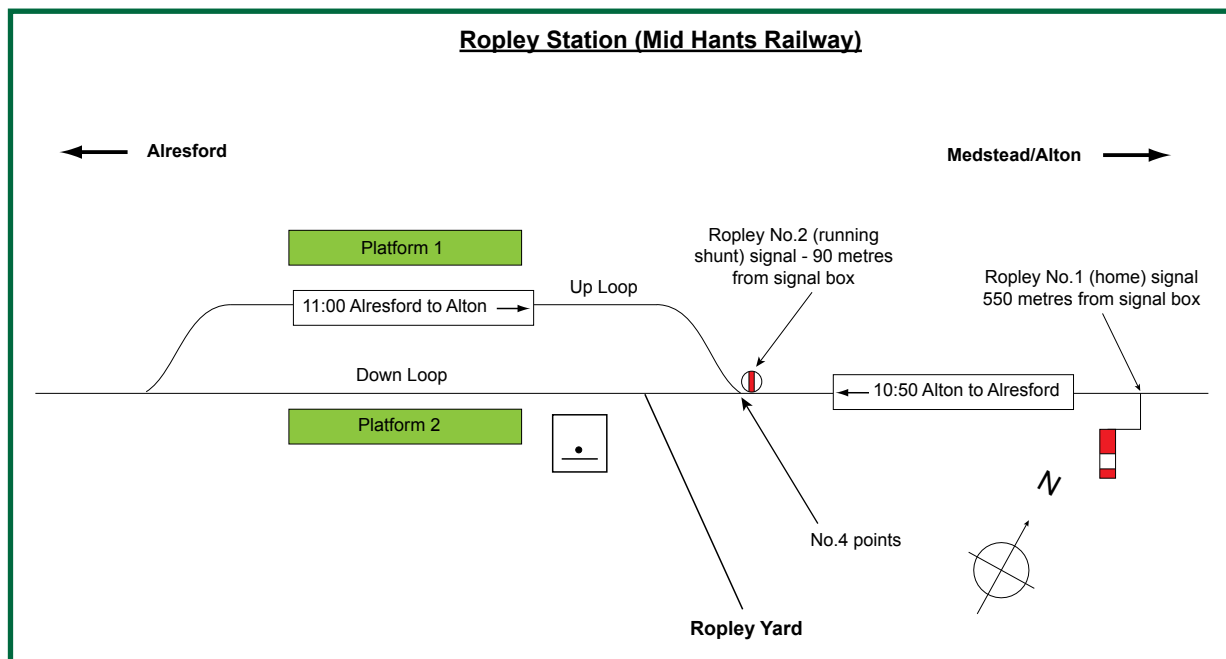
Figure 3: The track layout at Ropley

- 18 At approximately 11:15 hrs on Tuesday 25 July 2006, the leading bogie of the 10:50 hrs MHR service from Alton to Alresford derailed on No.4 points (see Figure 3) approaching Ropley station. There were no injuries to passengers or staff as a result of the accident. The train and track suffered only limited damage. Train services were suspended for the remainder of the day.

- 22 Soon after the leading bogie of the train passed the *switch toes* of No.4 points, it derailed. The derailed bogie followed a path midway between the routes to platforms 1 and 2, while the second bogie remained on the track, but followed the route towards platform 1.
- 23 The derailment became apparent to the trainee driver and instructor almost immediately because of the severe jolting that occurred as the leading bogie left the rails and ran over sleepers. The instructor applied the emergency brake and the train stopped within 20 metres of the point where the front bogie derailed.

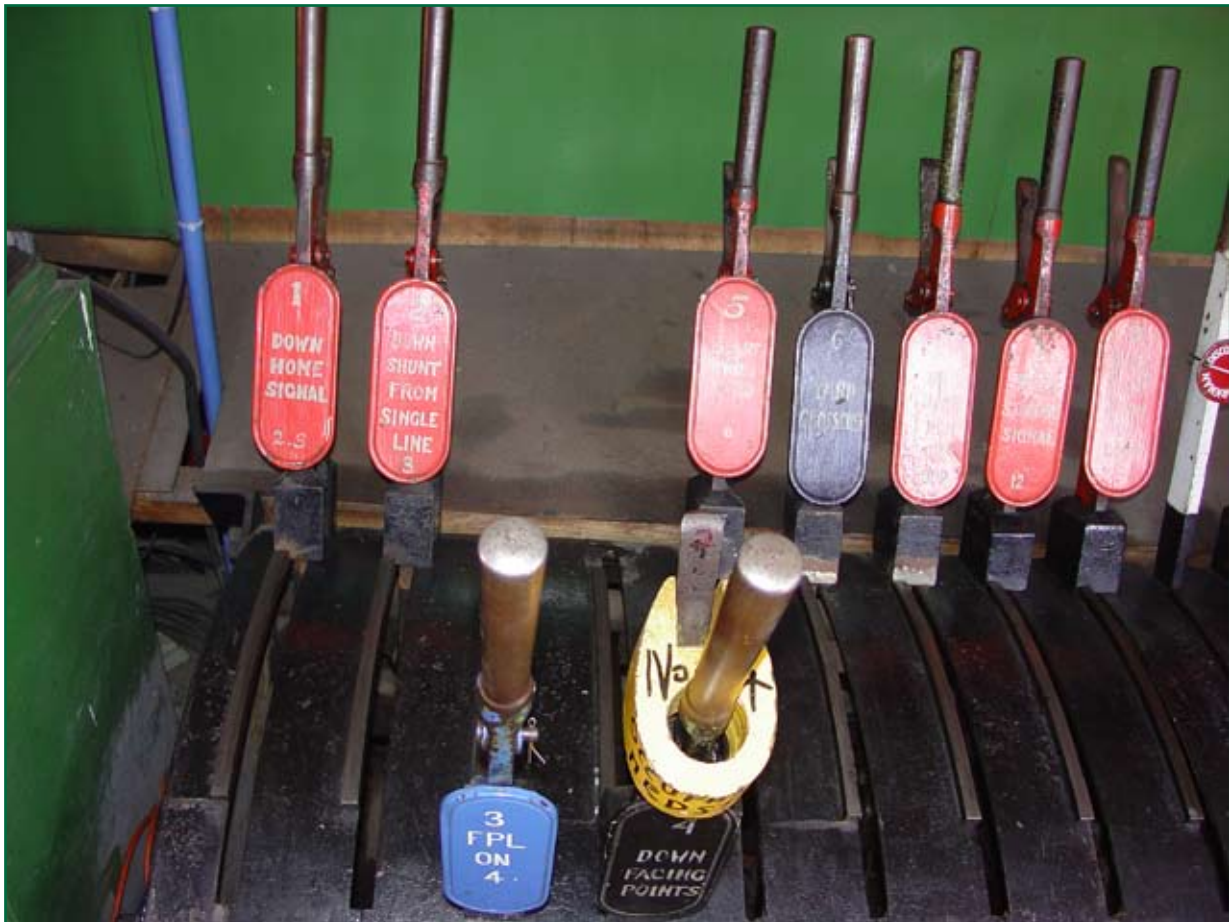
Figure 4: The lever frame in Ropley Signal Box

- the signalman was able to move the points under the train and did so.
- 82 The only source of power used to move the points is human; the points therefore could not have moved as a result of spurious operation of a motor. At an early stage in the investigation, the signalman accepted that he had caused the points to move under the train. For this reason, testing of the points for faults was not undertaken. The action of the signalman is the immediate cause of the derailment.

- 90 Another possible explanation is that having replaced signal No.1 and signal No.2 to danger and unlocked the facing point lock, the signaller realised that the down train had not arrived and, being concerned about the passage of the train over unlocked points, returned to the frame to lock the points again. The levers for the facing point lock and No.4 points are adjacent (see Figure 4). If the signaller accidentally pulled the lever for the points instead of that for the facing point lock, the fact that the facing point lock was already unlocked would allow No.4 points to be moved.
