# Rail Accident Report

## **Derailment of a tram on the Seaton Tramway 18 March 2007**

# **Derailment of a tram on the Seaton Tramway**

## **18 March 2007**

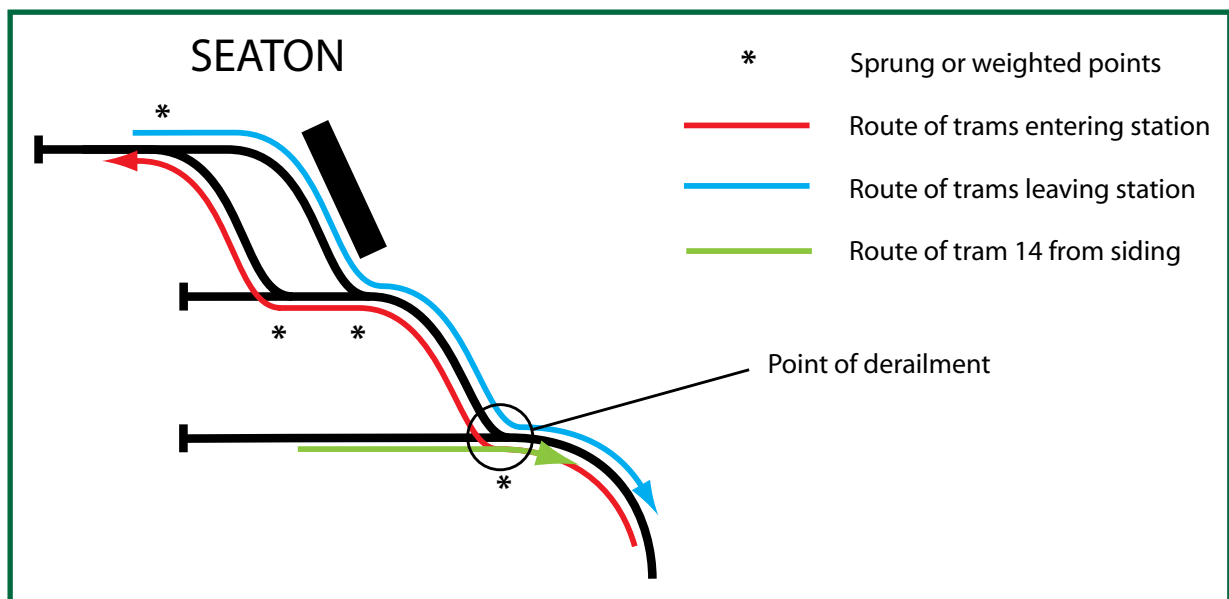
Figure 3: Track layout at Seaton

10. Located at the entry to Seaton station is a pair of points, leading to a siding (Figure 3). These points are normally set so that trams run into the station platform. The points are operated by a weighted lever, which is secured by a pin; the pin, in turn, is padlocked in position, and are not *detected*. A tram can only enter the siding if the pin is removed and the points fully thrown to *reverse*. However, the pin allows sufficient movement of the lever for trams to *trail* the point when leaving the siding; the weight of the lever then ensures that the points then return to their normal position. As a result the lever can be manually lifted sufficiently that the *switches* partially open (Figure 4).

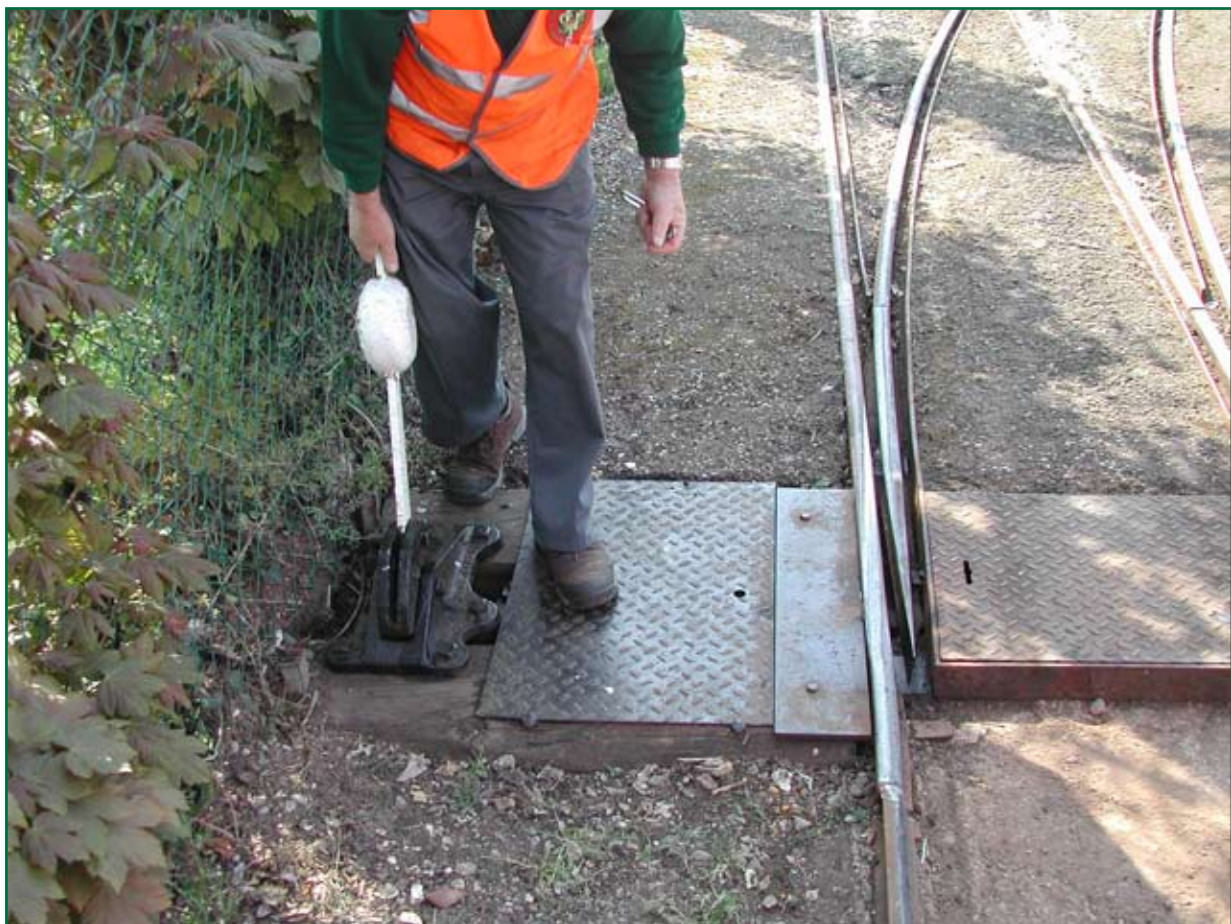
Figure 4: Points lever lifted and switch open with locking pin in position

1. The Seaton Tramway should replace the weighted lever at the entry to Seaton station with a point lever that is capable of being locked when not in use, in order to prevent it from being used to move the points without authority. The points could be operated from the lever via a slotted joint, and be spring loaded, so that operational flexibility is not lost.
2. The Seaton Tramway should implement, so far as is reasonably practicable, the provision of visual indicators that show to drivers whether sprung and weighted points on the system that are used by trams carrying passengers are correctly set for the normal route.

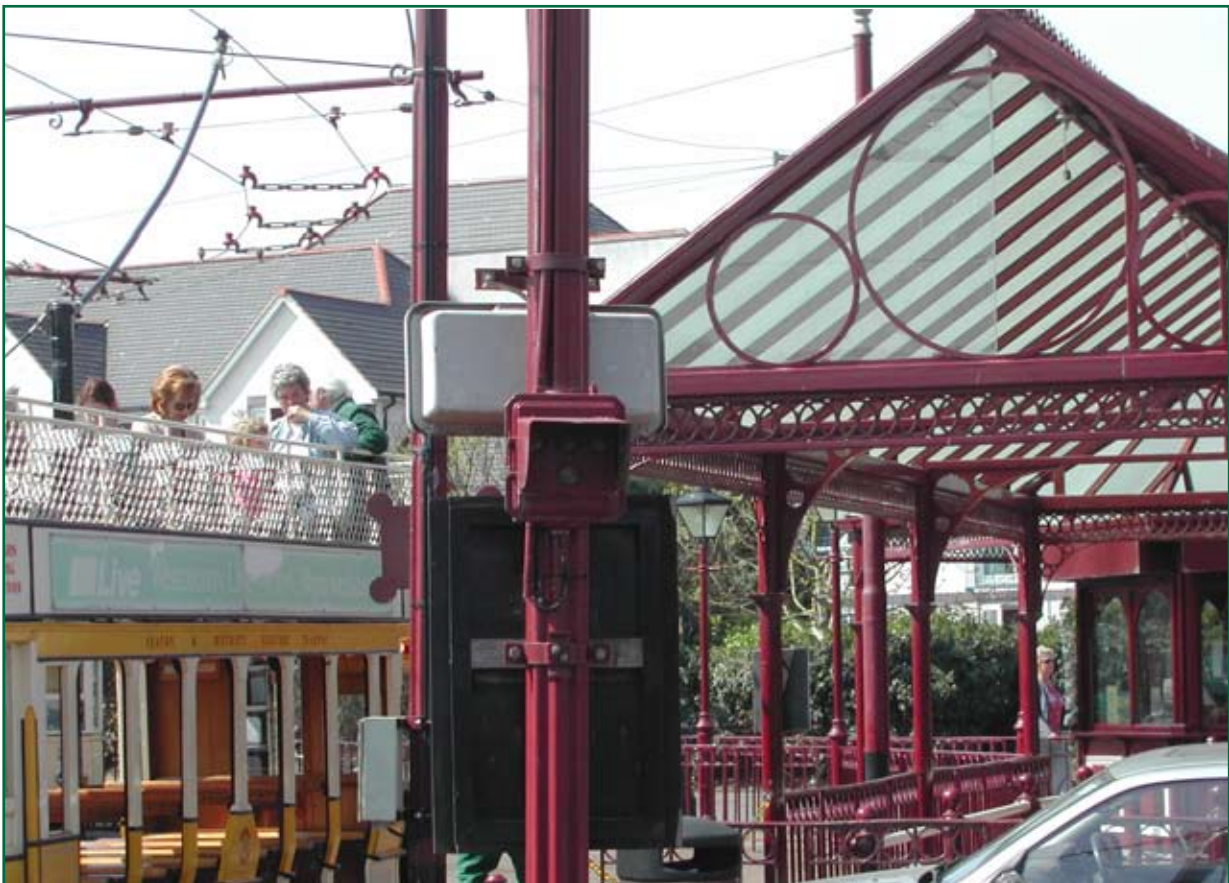
*Figure 5: Trolley indicator*

24. The trolley indicator is situated 22 metres after the points, and is over to the right relative to the approaching tram; it illuminates when the driver has travelled only 8.8 metres past the points. The requirement of Rule 81 to look at the indicator means that the driver of a tram may tend to look at the points, in accordance with Rule 60, some distance before arriving at them, and then look up for the indicator. If viewed from a distance, and in the absence of any other indication of the lie of the points it is possible that the driver may not notice if the points are slightly open.

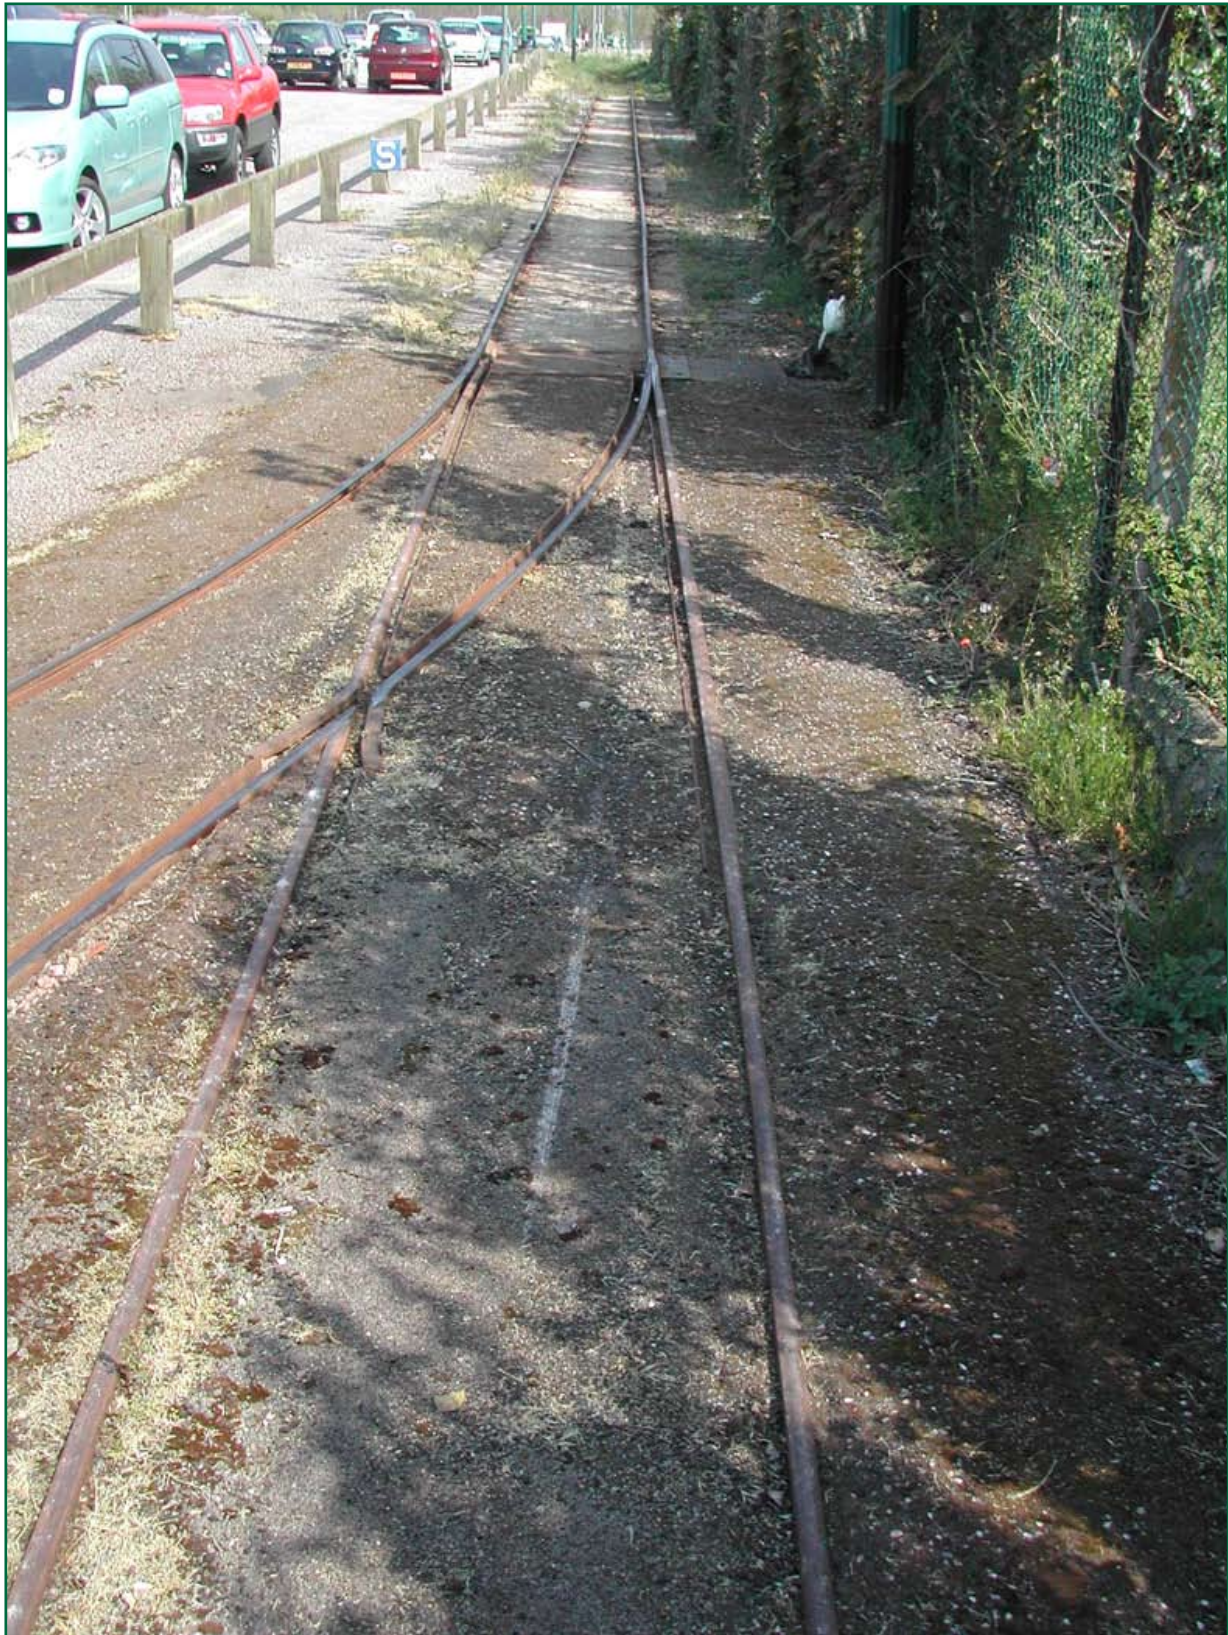
*Figure 6: Marks from derailment*

17. The incident was not immediately reported to the RAIB (paragraph 28). After the derailment the tramway company found marks between the switch and stock rails of the points. They concluded that these marks indicated that there was an obstruction between the two rails, such that the switch rail was held slightly open. There were several incidents of vandalism around Seaton station at the time of the derailment, and the tramway company concluded that the derailment was caused by someone placing a stone in between the switch and stock rail, with the switches being just sufficiently open to lead to the derailment, but not so far open that the driver could see the risk.

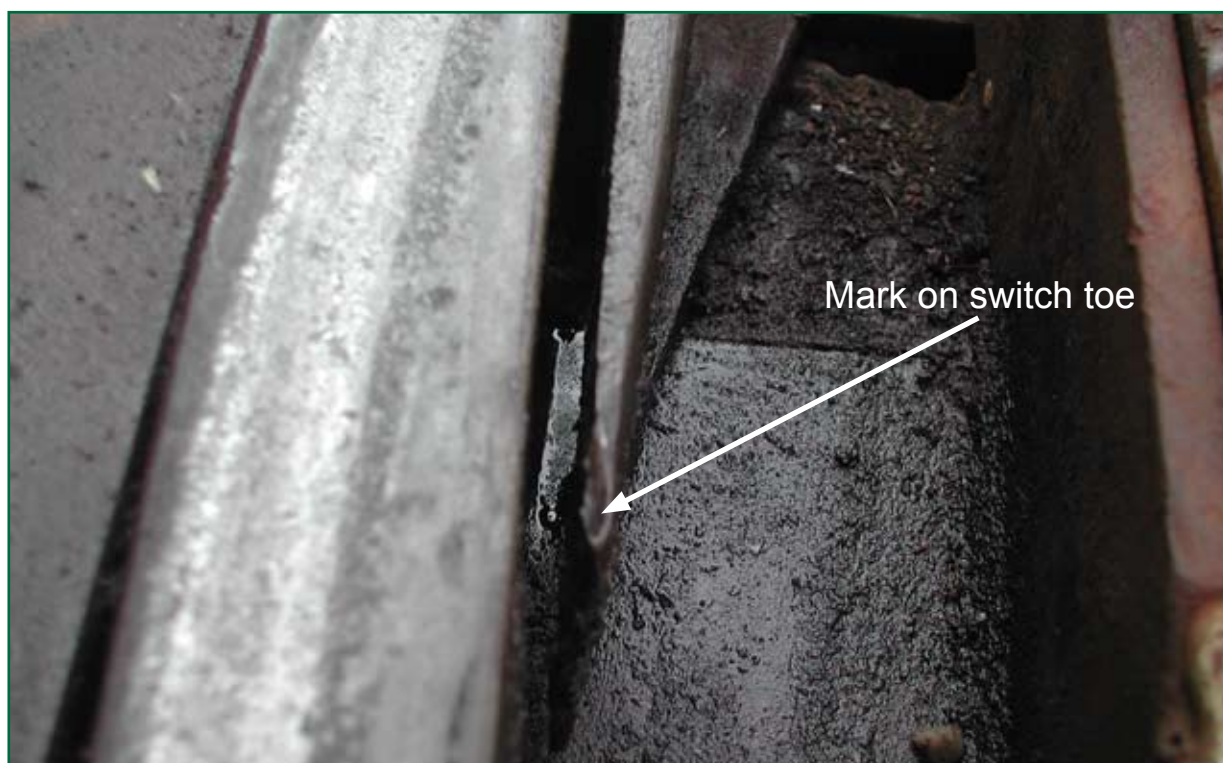
19. Subsequent examination of the switches by RAIB showed a small mark on the switch toe, on the stock rail side, such as would have been made by a wheel striking the switch toe and going between the switch and the stock rails (Figure 7). The derailment marks on the switch toe, and on the ground, accord with the points lying very slightly open, so that they were struck by the tram's wheel, which went to the wrong side of the switch rail. The design of the point lever (paragraph 10) would allow the points to be opened sufficiently to let an object be placed between the switch and stock rails.

*Figure 7: Mark on switch toe*

20. There have been no previous derailments at these points caused by the switches lying open, and they have functioned satisfactorily since the derailment, although no further maintenance has been carried out. The points operated satisfactorily when demonstrated to the RAIB in mid April. In view of these, and the relatively fresh state of the mark on the switch toes, the RAIB is satisfied that it is associated with the derailment on 18 March 2007.

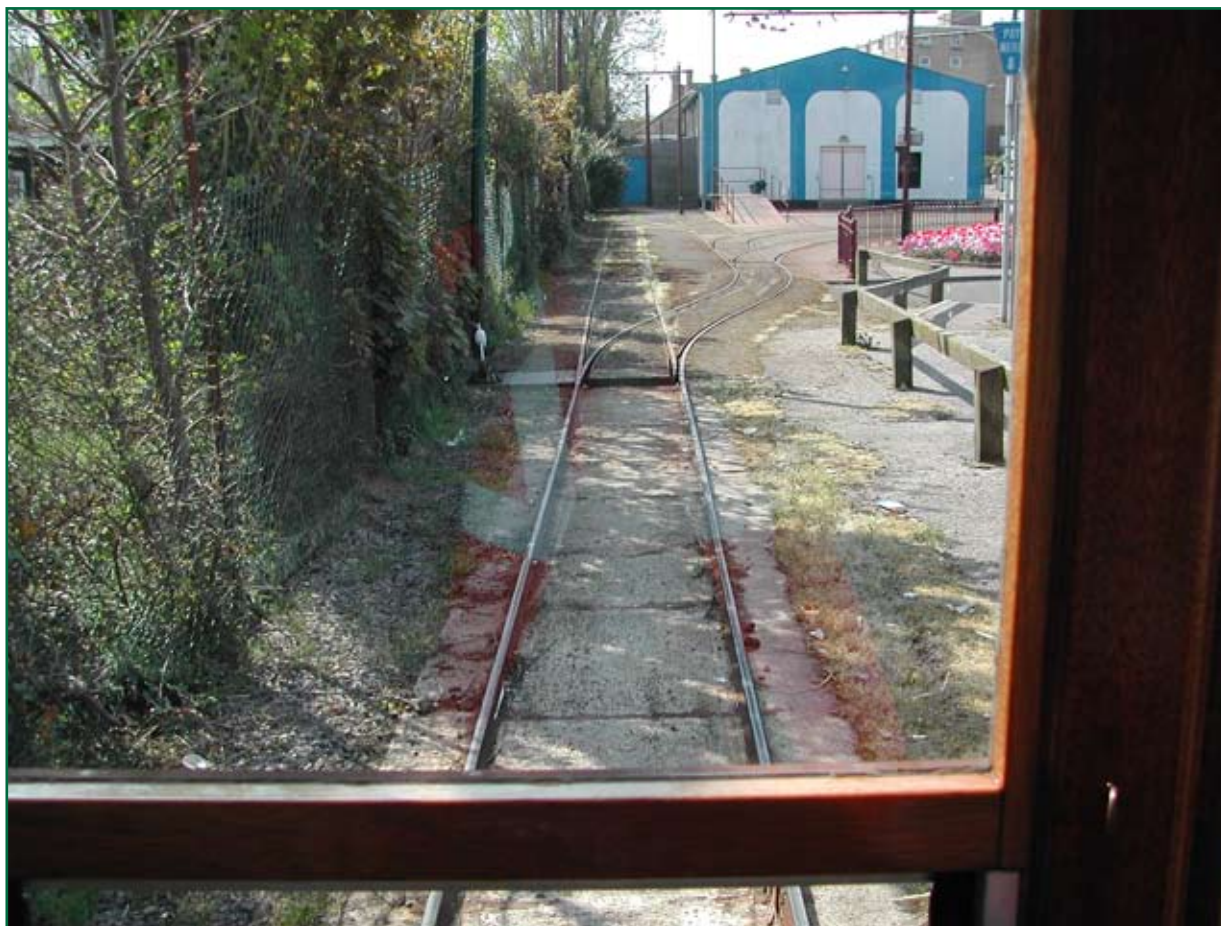
22. The safe operation of the points depends on the driver, as he approaches the points, being able to see whether they are set correctly (Figure 8). In this case the driver did not see the small opening of the points.

*Figure 8: Driver's view approaching Seaton station*
