Rail Accident Investigation Branch

Rail Accident Report

**Fatal accident at Bronwydd Arms station,
Gwili Railway
19 July 2006**

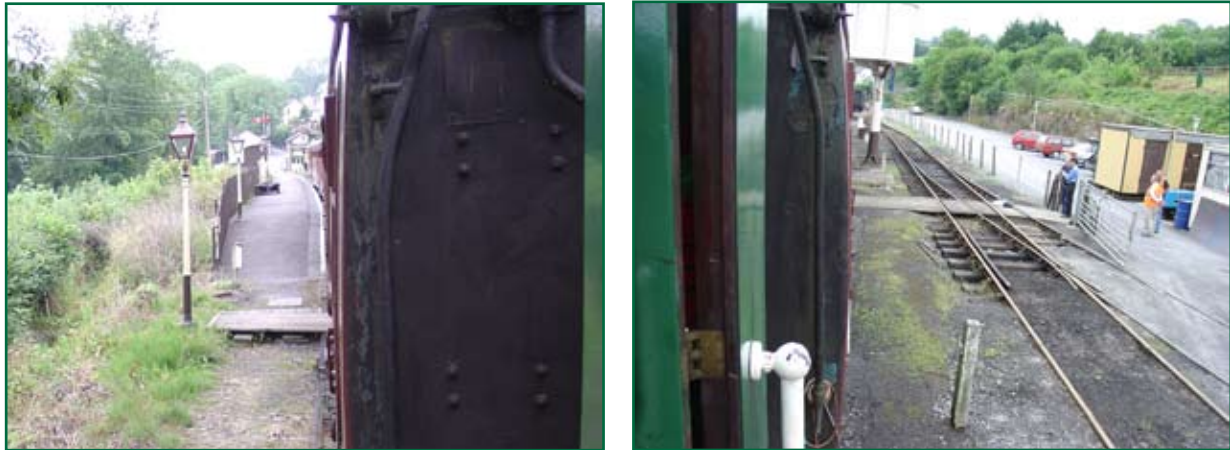
- 18 The platform is on a very slight curve from west to east as a train approaches the station from the north. This curve is visible in the photographs in Figure 4.
- 19 The station area is fully signalled with semaphore signalling, typical of that found in the 1960s at a country station. The signal box is opposite the platform, adjacent to the level crossing. The fixed signalling system played no part in the accident.
- 20 The Gwili Railway is operated by volunteer staff.

Figure 4: The views from the locomotive cab windows showing the slight curvature of the track at the north end of the station

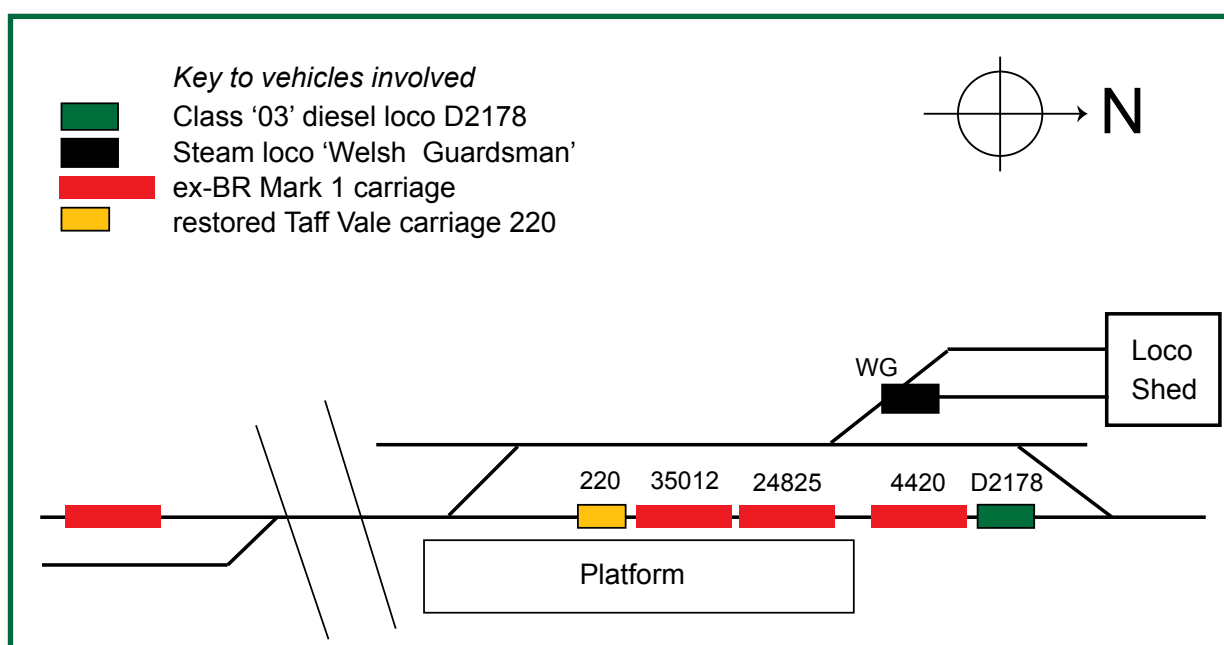
- 40 When the locomotive and carriage had passed the points at the north end of the station, the signaller set the route and cleared the signal for the vehicles to propel back towards the platform line. The driver then commenced the propelling move (Figure 6).

Figure 6: Location of relevant rail vehicles during the shunting manoeuvre, immediately prior to the accident occurring

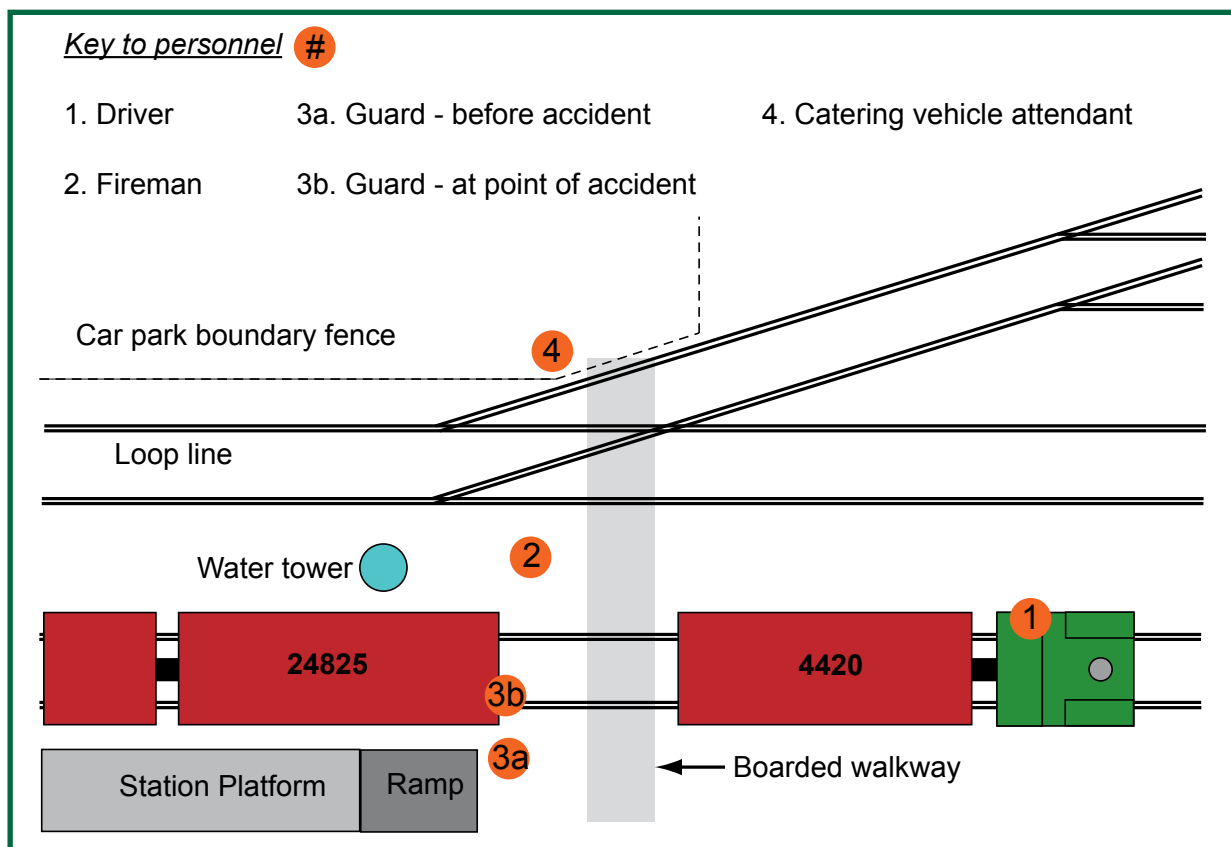
Figure 7: Location of relevant staff during the shunting manoeuvre, immediately prior to and at the time of the accident

- 64 A reconstruction was undertaken to determine the viewing lines of the driver, the fireman and the guard, based on their positions as denoted in Figure 7. The results of this were:

- the driver could clearly see the fireman in position 2;
 - the driver could not see the guard in either of positions 3a or 3b;
 - the fireman, when looking towards the carriages could see the guard clearly in positions 3a and 3b;

- when the fireman turned to face the driver he was no longer able to see the guard in either position 3a or 3b;
 - the guard could not see the driver from either of his positions;

- the guard could see the fireman from position 3a, but not from position 3b because he was facing the stationary carriage. From position 3b he would not be able to see the carriage moving towards him as it was directly behind him; and

- the guard would be able to see the catering vehicle attendant only when in position 3a.

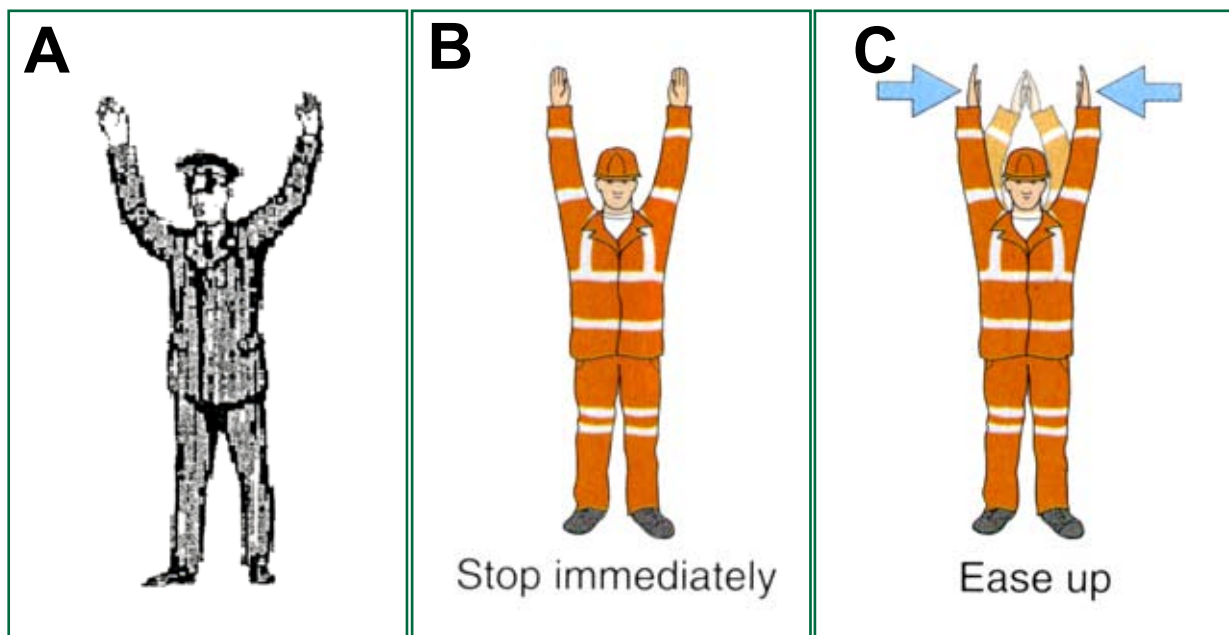
- 74 The hand signals applicable on the Gwili Railway are defined in its 1992 rule book amendment No.2, section J4. There is reference to the 'move away', 'move towards', 'slow down' and 'stop immediately' hand signals, with accompanying pictures. That for 'stop immediately' is shown here in figure 8 as 'A'. For comparison with GE/RT8000 module SS2 4.2a the 'stop immediately' hand signal is referred to in Figure 8 picture as 'B'.

- 75 Nowhere in the Gwili Railway documentation is there any reference to the 'ease-up' / 'couple-up' hand signal. However, both the driver and fireman, and other operations staff interviewed were aware of and demonstrated such a signal. 'Ease-up' is an action generally undertaken before physically coupling vehicles in order to close the gap. 'Couple-up' is pushing the vehicles closer together in order to get the coupling made. The hand signal for both actions requires the same response from the driver. This hand signal is described as both hands raised above the head and palms clapped together two or three times, and is the same signal found in GE/RT8000 module SS2 4.2a. It is referred to there as the 'ease-up' signal. The accompanying picture is shown in figure 8 as 'C'.

Figure 8: Relevant shunting hand signals described in the Gwili Railway rule book and national rail network rule book GE/RT 8000

- 86 The Gwili Railway Rule Book is incomplete in its description of permissible hand signals and also on the restriction on starting or continuing when a hand signal is incorrectly given or not understood. Drivers and shunters routinely use a hand signal that is found on the national rail network but not in the Gwili Railway rule book (paragraphs 73 to 76). **Recommendation 4 refers.**

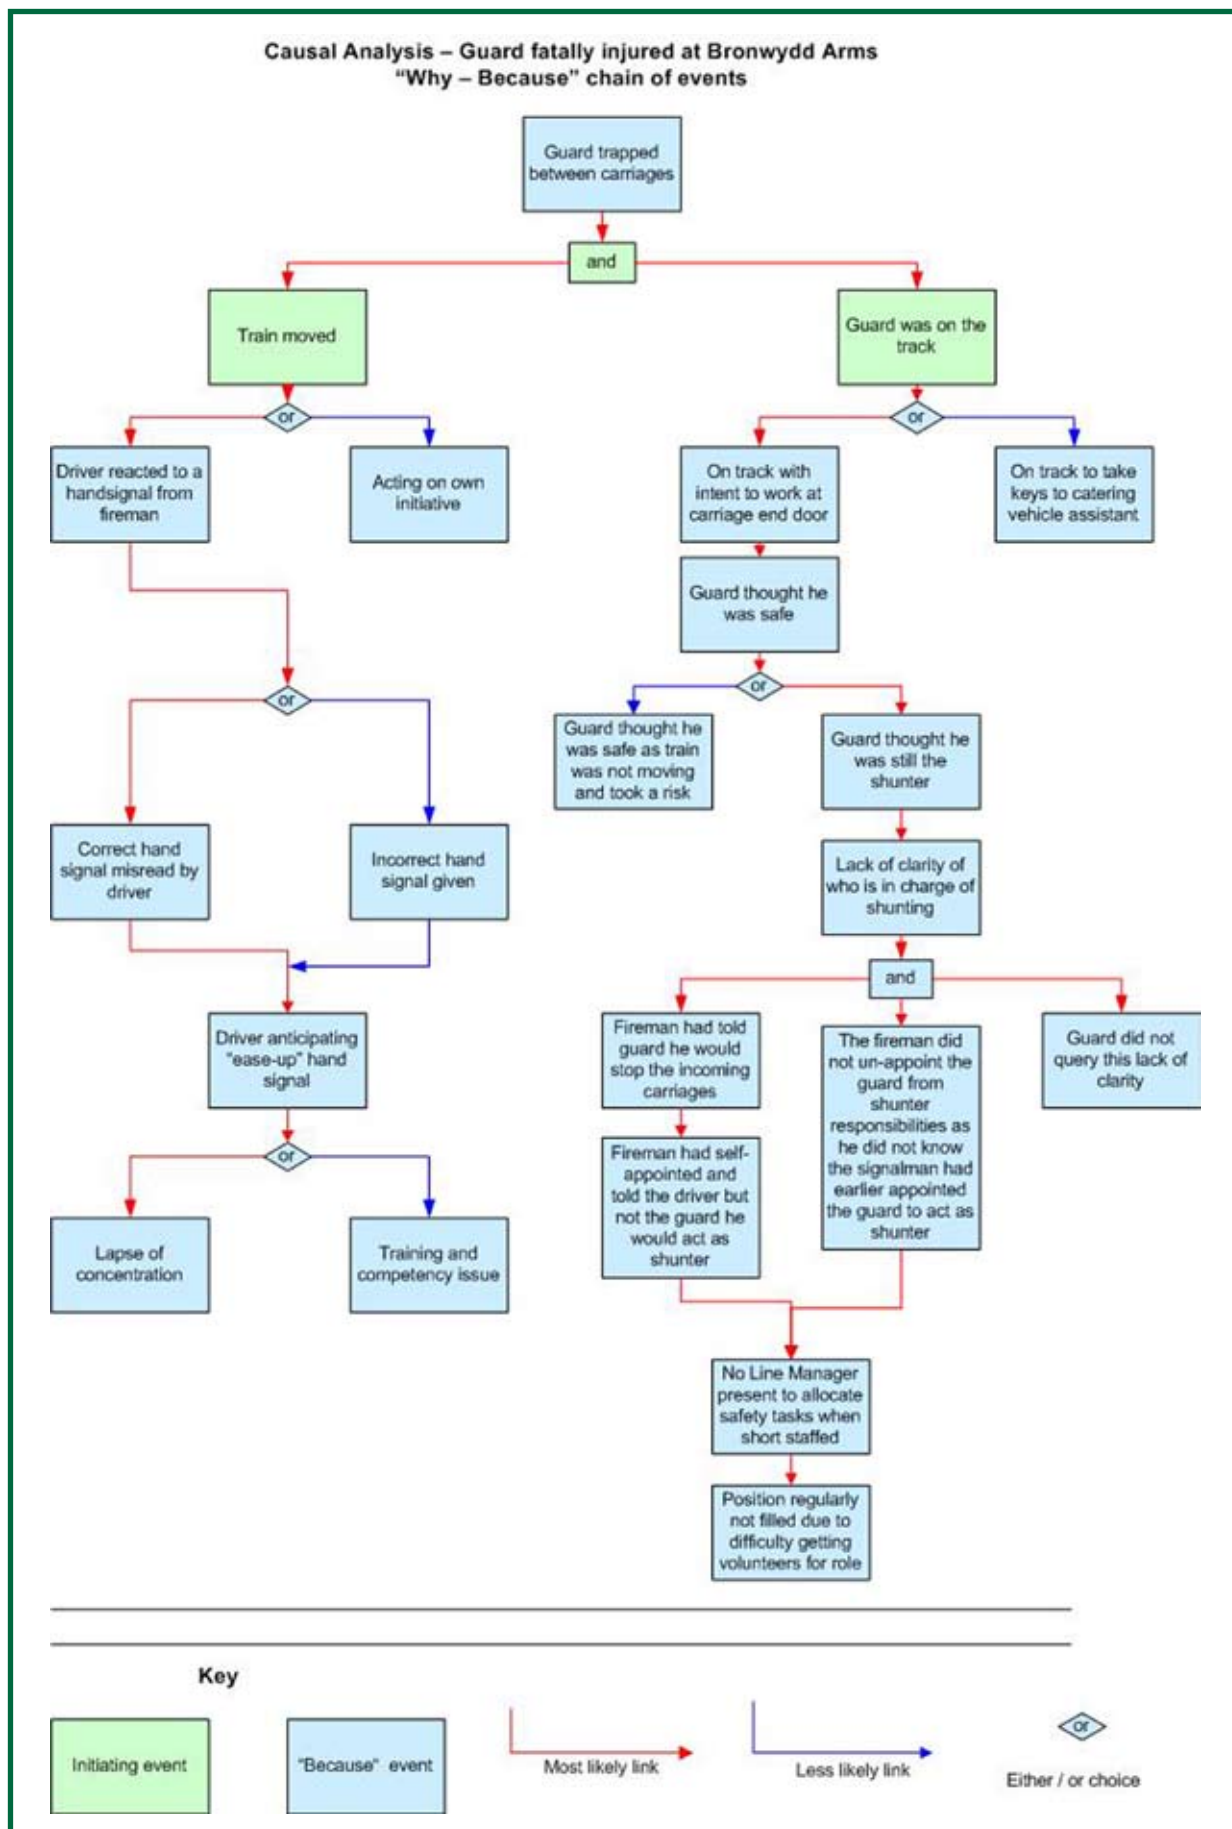
- 106 The chart in Figure 9 shows the causal analysis of the accident on a 'why - because' chain of events, starting from the accident event and working backwards. The two initiating events are highlighted, both of which had to happen at the same time for the accident to have the consequence of the guard being trapped between the carriages.

Figure 9: Causal analysis diagram

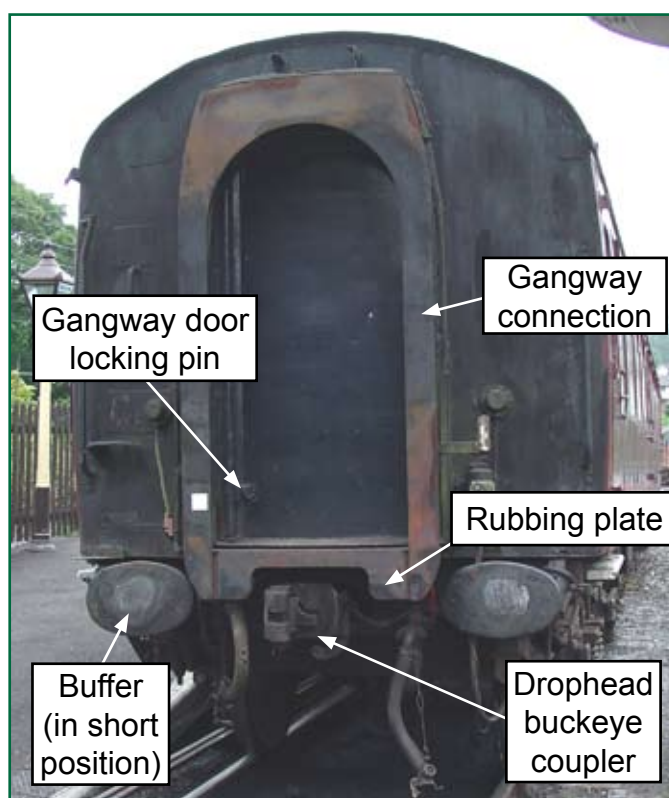
There are several actions required to convert a stationary Mark 1 carriage from the configuration of being attached to a locomotive, to that of attaching to another carriage. A typical sequence of preparation is as follows:

- ensure that the vehicle will not be moved and that it is safe to go onto the track;
- raise the drophead buckeye coupler and insert the locking pin;
- retract the buffers to the short position;
- open the buckeye horizontal hook;
- remove the retaining pin from the external gangway door lock;
- remove vacuum or air brake pipes from dummy housings / receptors;
- remove train heat connectors pipes / cables from receptors;
- check there is no equipment or foreign object present that would prevent a coupling being made;
- return to a position of safety.

Figure 10: The carriage end showing the external features

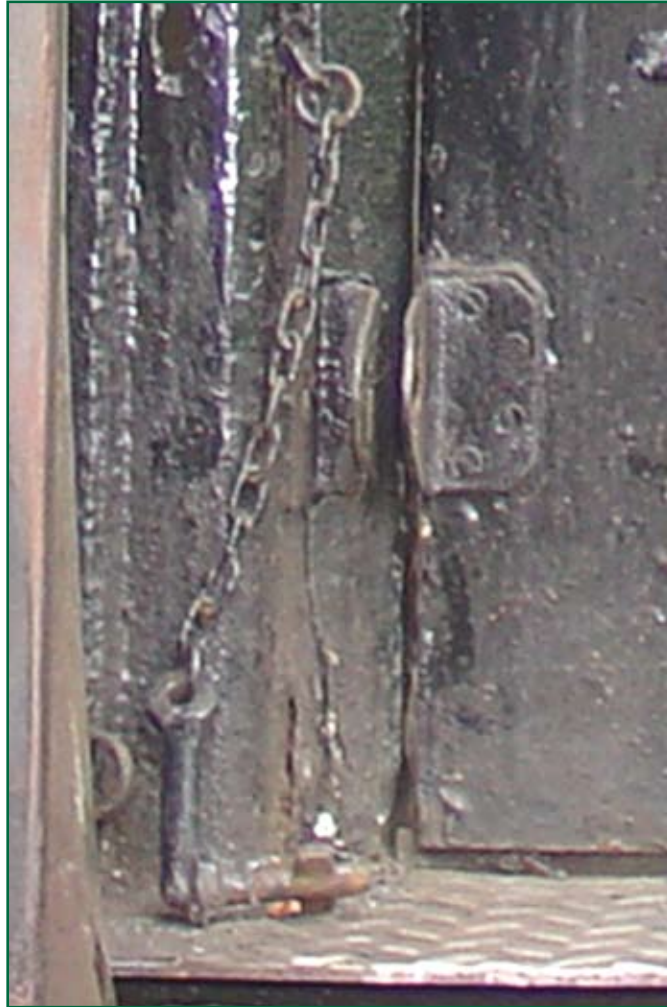
Figure 11: the carriage end door locking pin in the unlocked position
