Rail Accident Report

Fatal accident to Shunter, Dagenham Dock 17 July 2006

Fatal accident to shunter at Dagenham Dock

17 July 2006

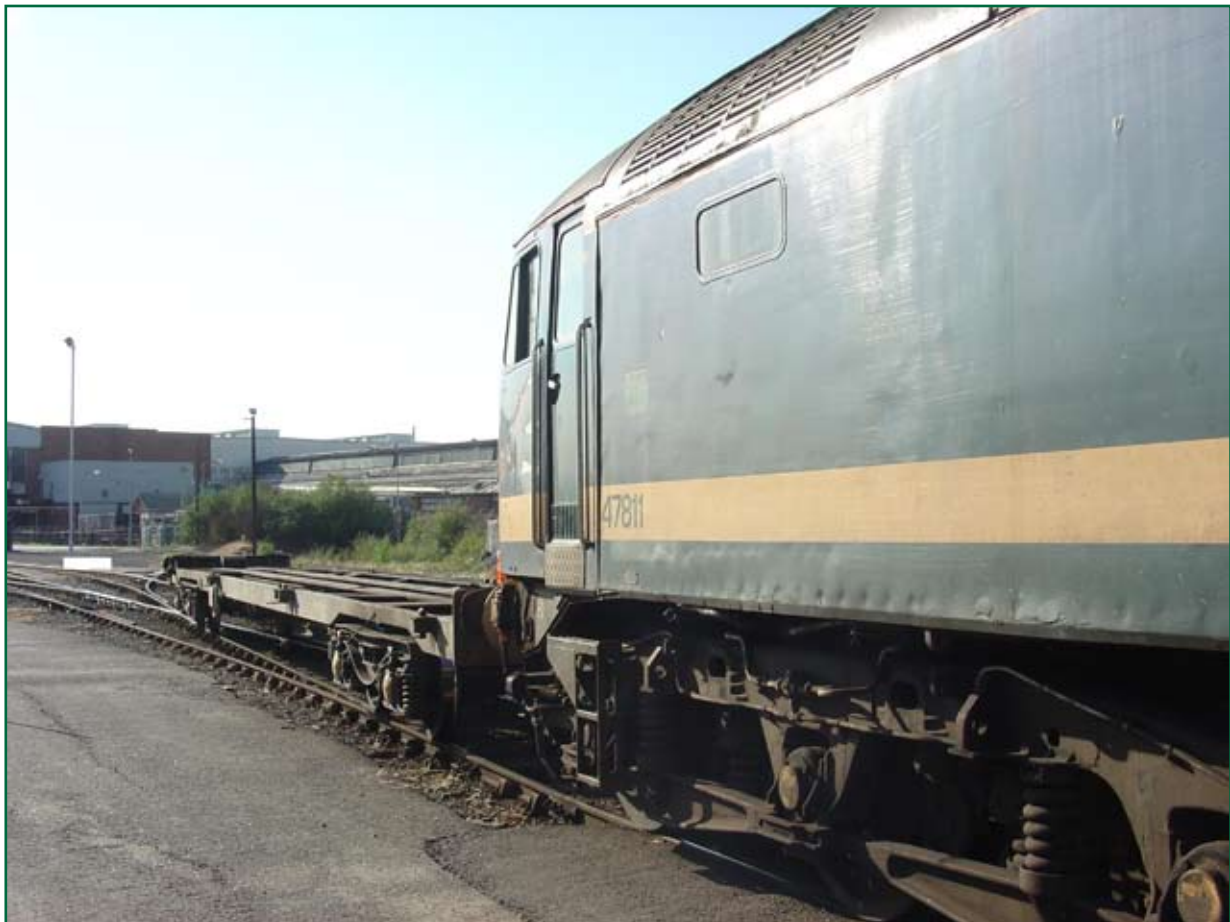
- 14 The shunter was found beside the track, between the position where the locomotive and the wagon had been coupled together and a set of *hand-points* controlling access between the sidings. The shunter had sustained injuries consistent with his having been trapped between the buffers of the locomotive and the wagon.

Figure 2: Locomotive 47 811 and wagon FRA 613035 following the accident. The shunter was found adjacent to the lamp-post in the left hand edge

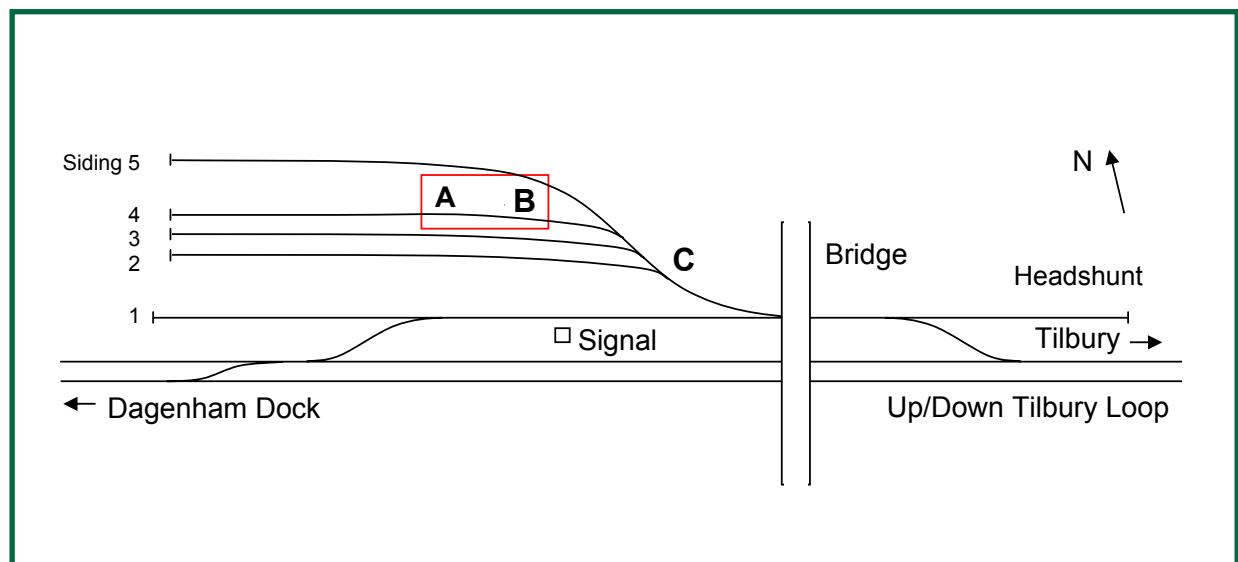
Figure 3: Schematic layout of Dagenham Dock down yard showing the area of accident. Reference is made to positions A, B and C throughout the remainder of this report

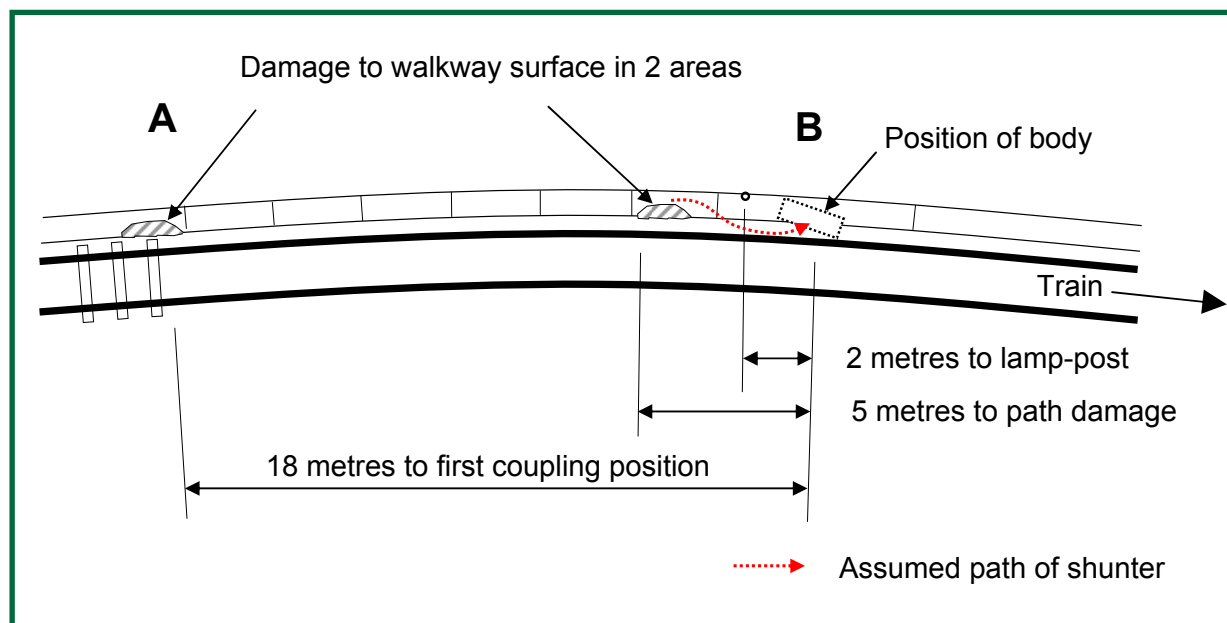
- 38 Finally, locomotive 47 811 returned to siding 4 to collect wagon FRA 613035 to move it to siding 5, ready for loading when the next delivery of loaded waste containers arrived by road. As the westward movement was made, the shunter walked beside the track, ahead of the locomotive and in contact with the driver by radio, counting down the distance to go which allowed the locomotive to reverse up to the wagon as a continuous movement. The driver made this move from the eastern cab nearer the headshunt end of the yard, which was the trailing cab for this movement. The shunter exchanged a few words with the visiting manager, who was once again passing the sidings, but their exchange did not interrupt the shunting movement. The visiting manager then saw the shunter standing beside the stationary locomotive and wagon, preparing to stoop between the buffers to couple the two vehicles together (position *A* in Figures 3 and 4).

Figure 4: Dagenham Dock down yard siding 4. Position A (coupling position) and B are as indicated in Figure 3

- 42 When the driver did not receive a further instruction, he attempted to contact the shunter by radio to determine the cause of the delay. He looked out of both sides of the cab but was unable to see anything, owing to the curve of the track and the height of the wagon. He left the cab to seek the shunter, and saw an orange high-visibility vest on the ground beside siding 4 (denoted position *B* in Figures 3 and 4) and realised that the shunter had collapsed.

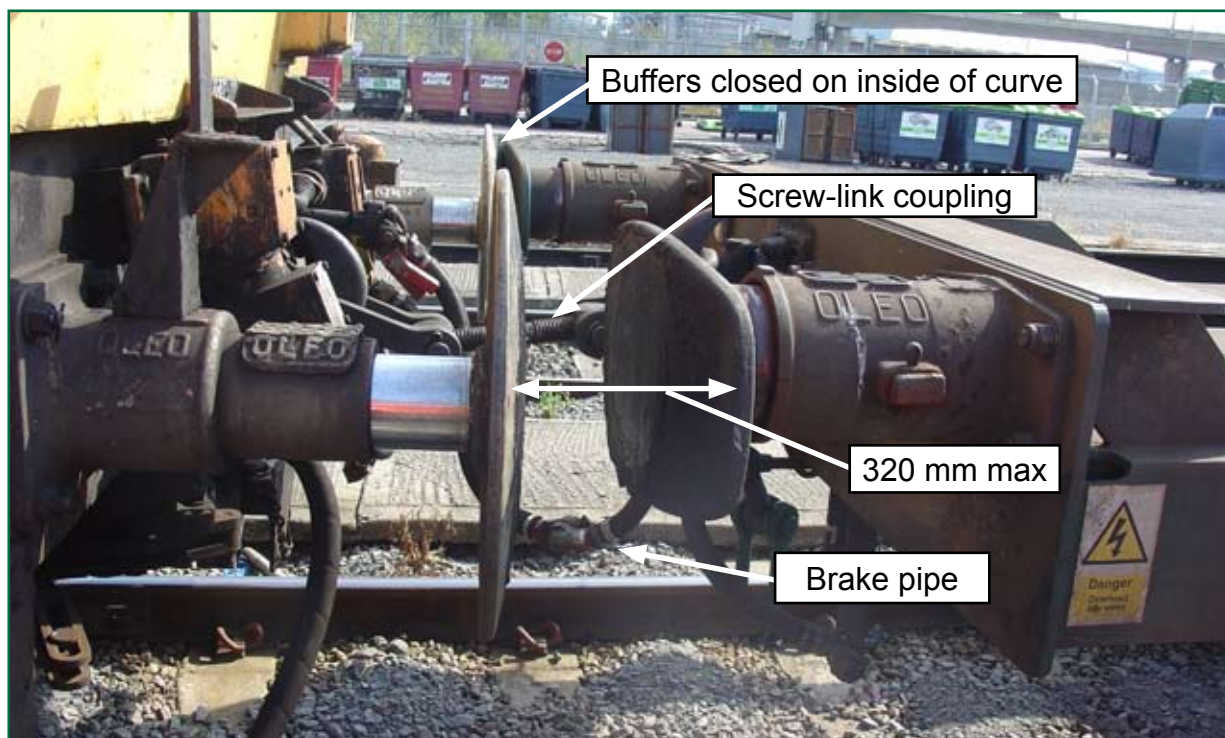
| Recommendations | 29 |

Figure 5: Class 47 locomotive and FRA wagon coupled on curve close to position B, viewed from north side

- 111 The curved alignment of the track at the eastern end of siding 4 is a contributory factor. It leads to a widening of the gap between the buffers on the north side (Figure 5), which makes coupling and uncoupling vehicles difficult and presents an additional hazard to staff close to a train, in that the buffers are far enough apart at this point for a person to become trapped between the buffer faces. The gap between the buffers of the vehicles involved, at the time and place of the accident, was 320 mm, but was liable to change as the train moved.

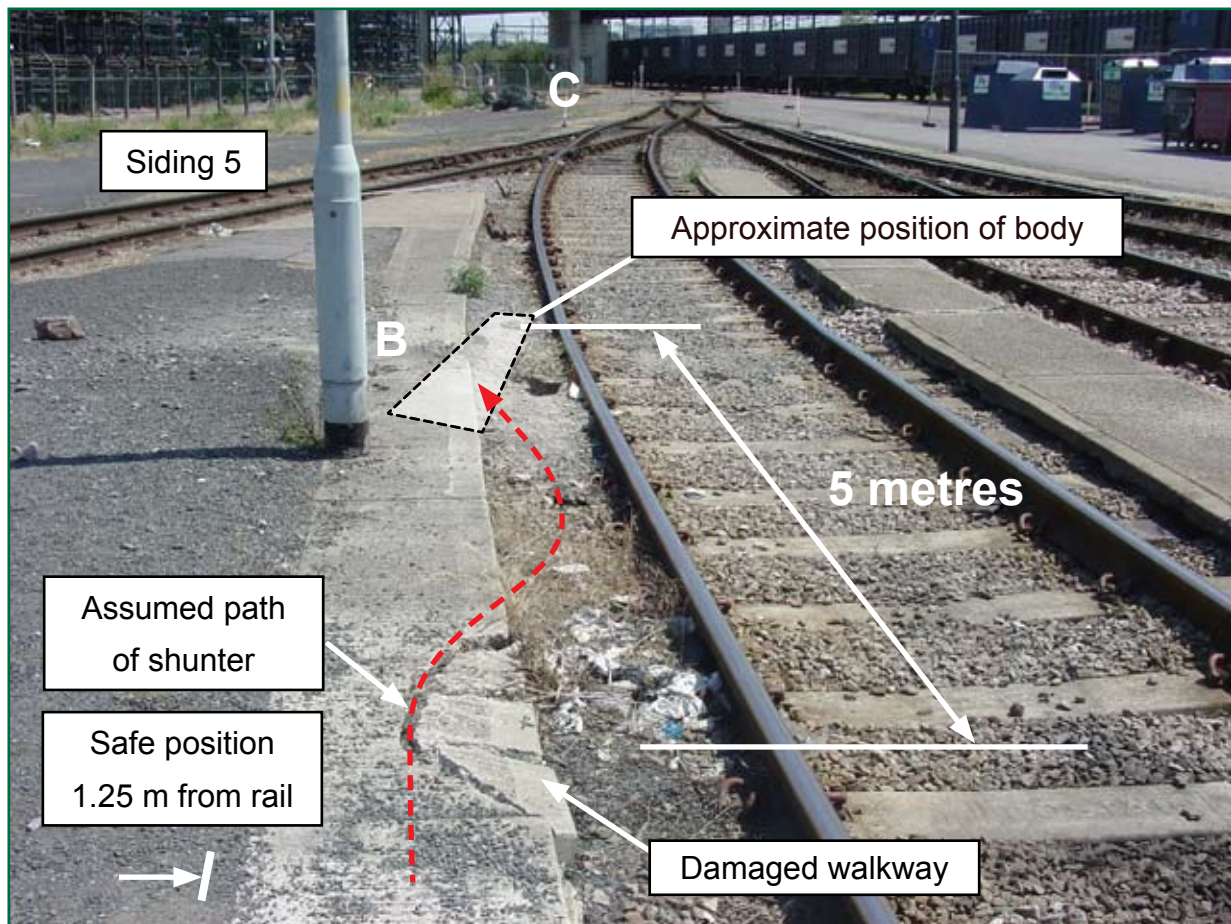
- 51 The concrete walkway 5 metres west of position B was found to be damaged and sloping towards the track.
- 52 The surface of the lamp-post was examined from pathway level to a height of 2.2 metres. It bore no signs to suggest that the shunter had collided with the lamp-post.

Figure 6: Accident scene showing damaged trackside walkway and lamp-post towards east end of siding 4

- 53 The shunter was found lying clear of the track, 2 metres beyond the easternmost lamp-post of siding 4 at position B (Figures 3, 4 and 6). There was no indication of major trauma or amputation and no evidence that he had been dragged for more than a very short distance.
- 54 The pathologist subsequently reported that the shunter had suffered multiple injuries, particularly to the abdomen. The injuries were consistent with being crushed between two flat surfaces at chest height.

- 100 A damaged section of path, 3 metres west of the lamp-post, presents a tripping hazard (Figure 6).
- 101 There was no evidence of physical disturbance of the ballast, litter or dry grass in the ballast between the trackside walkway and the rails before a point 4 metres west of the lamp-post.

- 110 The position of the lamp-post at the eastern end of siding 4 may have been a contributory factor. This lamp-post is within one metre of the track, giving very limited clearance (Figure 6). Other lamp-posts in the yard are positioned behind the walkway rather than set into it. The risks associated with the position of this post are not mentioned in the local working instructions. The shunter had not been made aware of the risk, and although he would have been able to walk on the far side of this post, keeping it between himself and the train, the position of his body when found suggests that he did not do so.

- g. Improvements in the process of obtaining previous employment records; and
- h. Repair or removal of trackside walkways in response to an Improvement Notice served by the Office of Rail Regulation on 20 July 2006. This was to address the foreseeable risk of persons tripping or stumbling and being injured.

- 3 Freightliner should designate safe walking routes between frequently used parts of its yards. This includes marking or signing any hazards, and should include an instruction not to use walkways with substandard clearances where moving trains are present (paragraph 120a).

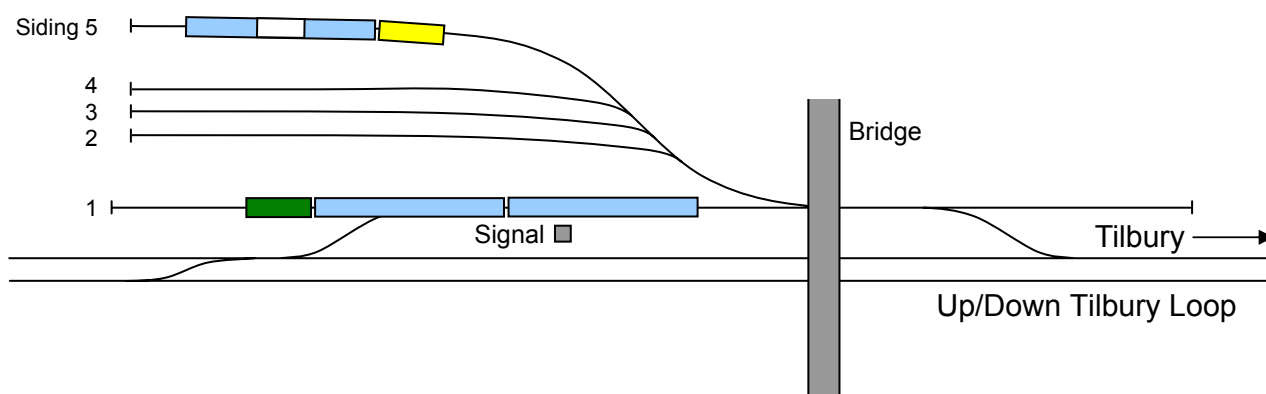
1. Waste container train loaded in sections in siding 5.
Rear section of train contains empty wagon due to late arrival of lorry.

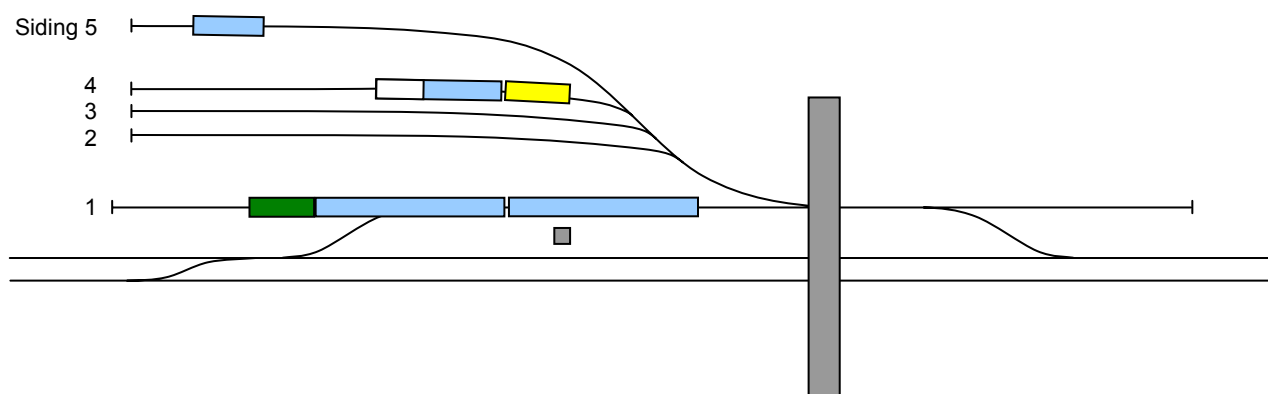
2. Unloaded wagon dropped off in siding 4.

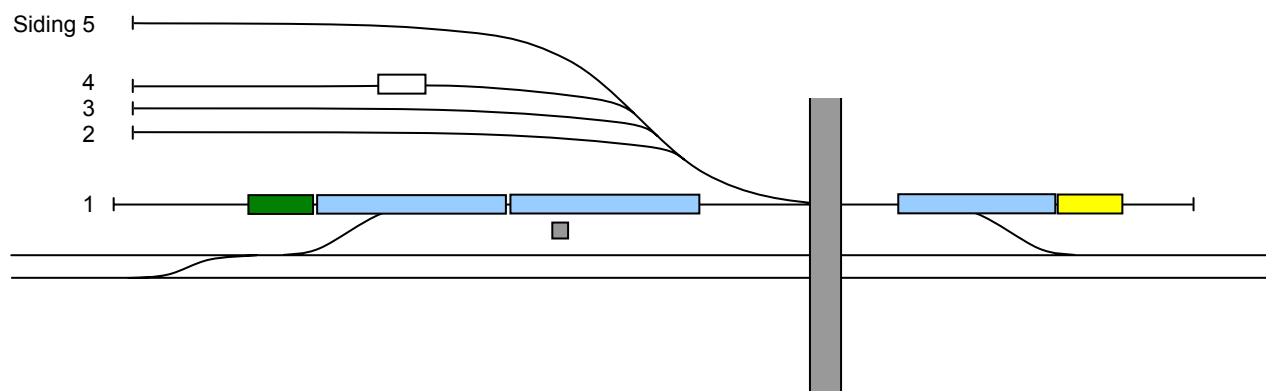
3. Rear section of train moved to siding 1 to complete outgoing train

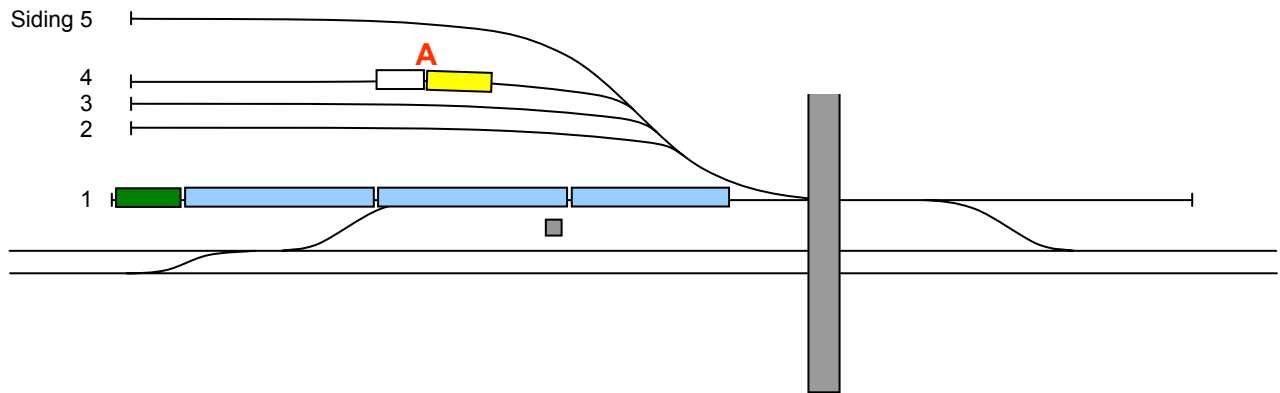
4. Class 47 locomotive returns to empty wagon on siding 4 to position it in number 5 siding in preparation for loading.
Shunter observed next to stationary train at position **A**.

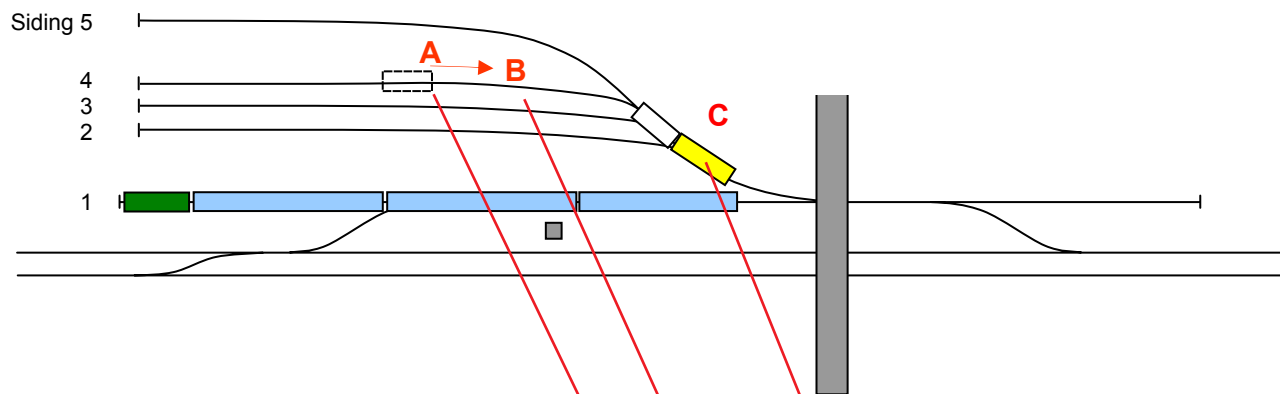
5. Class 47 locomotive moves eastwards to position **C** to clear points.
Shunter is found at position **B**.
