Rail Accident Investigation Branch

# Rail Accident Report

## **Derailment of a freight train at Maltby North 28 June 2006**

## **28 June 2006**

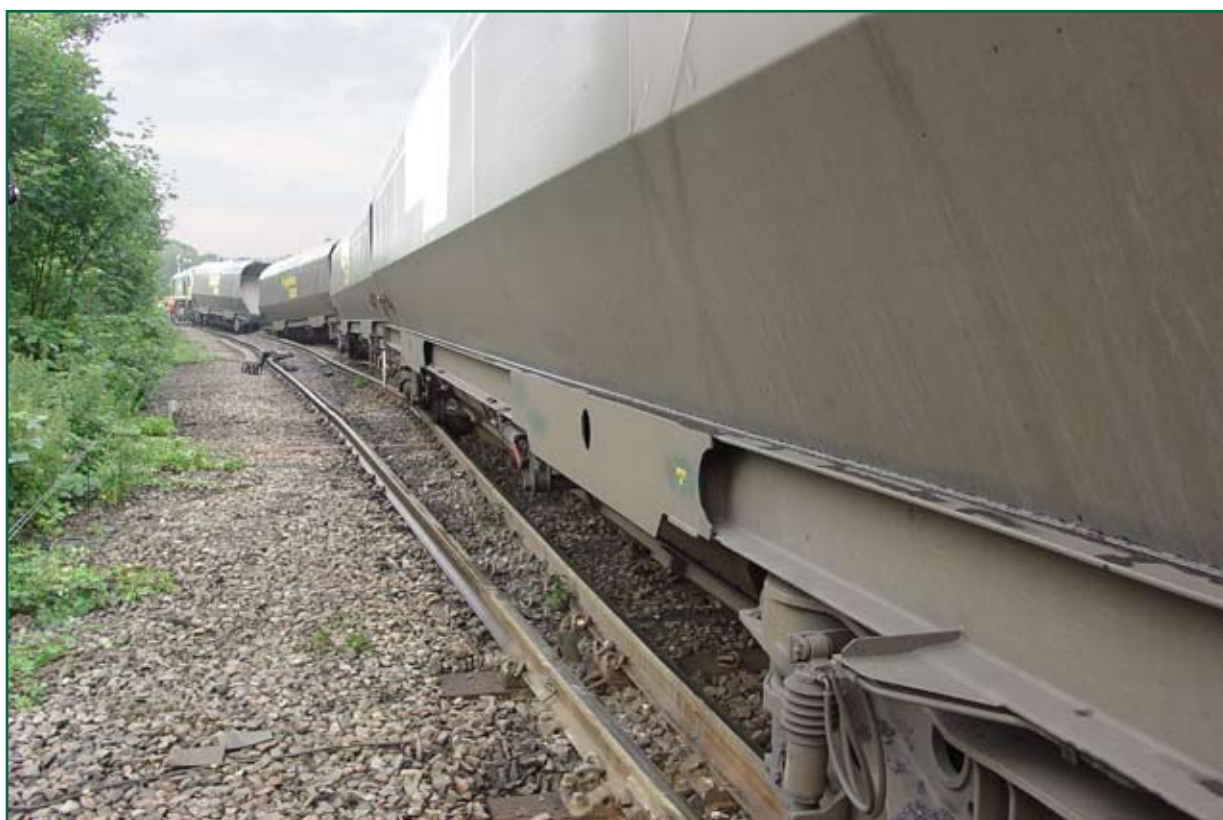
- 15 On 28 June 2006 train 6C51, a freight train operated by Freightliner Heavy Haul, was conveying coal from Redcar, near Middlesbrough, to West Burton power station, near Gainsborough. The train was travelling along the South Yorkshire Joint line between Doncaster and Worksop when it approached Maltby from the north at 03:00 hrs. The line is single track but there are two loops at Maltby which allow trains to pass. The train was being routed from the main line into one of these loops when it became derailed. Figure 2 shows the scene following the derailment.

Figure 2: Front part of train looking from 31B points towards locomotive

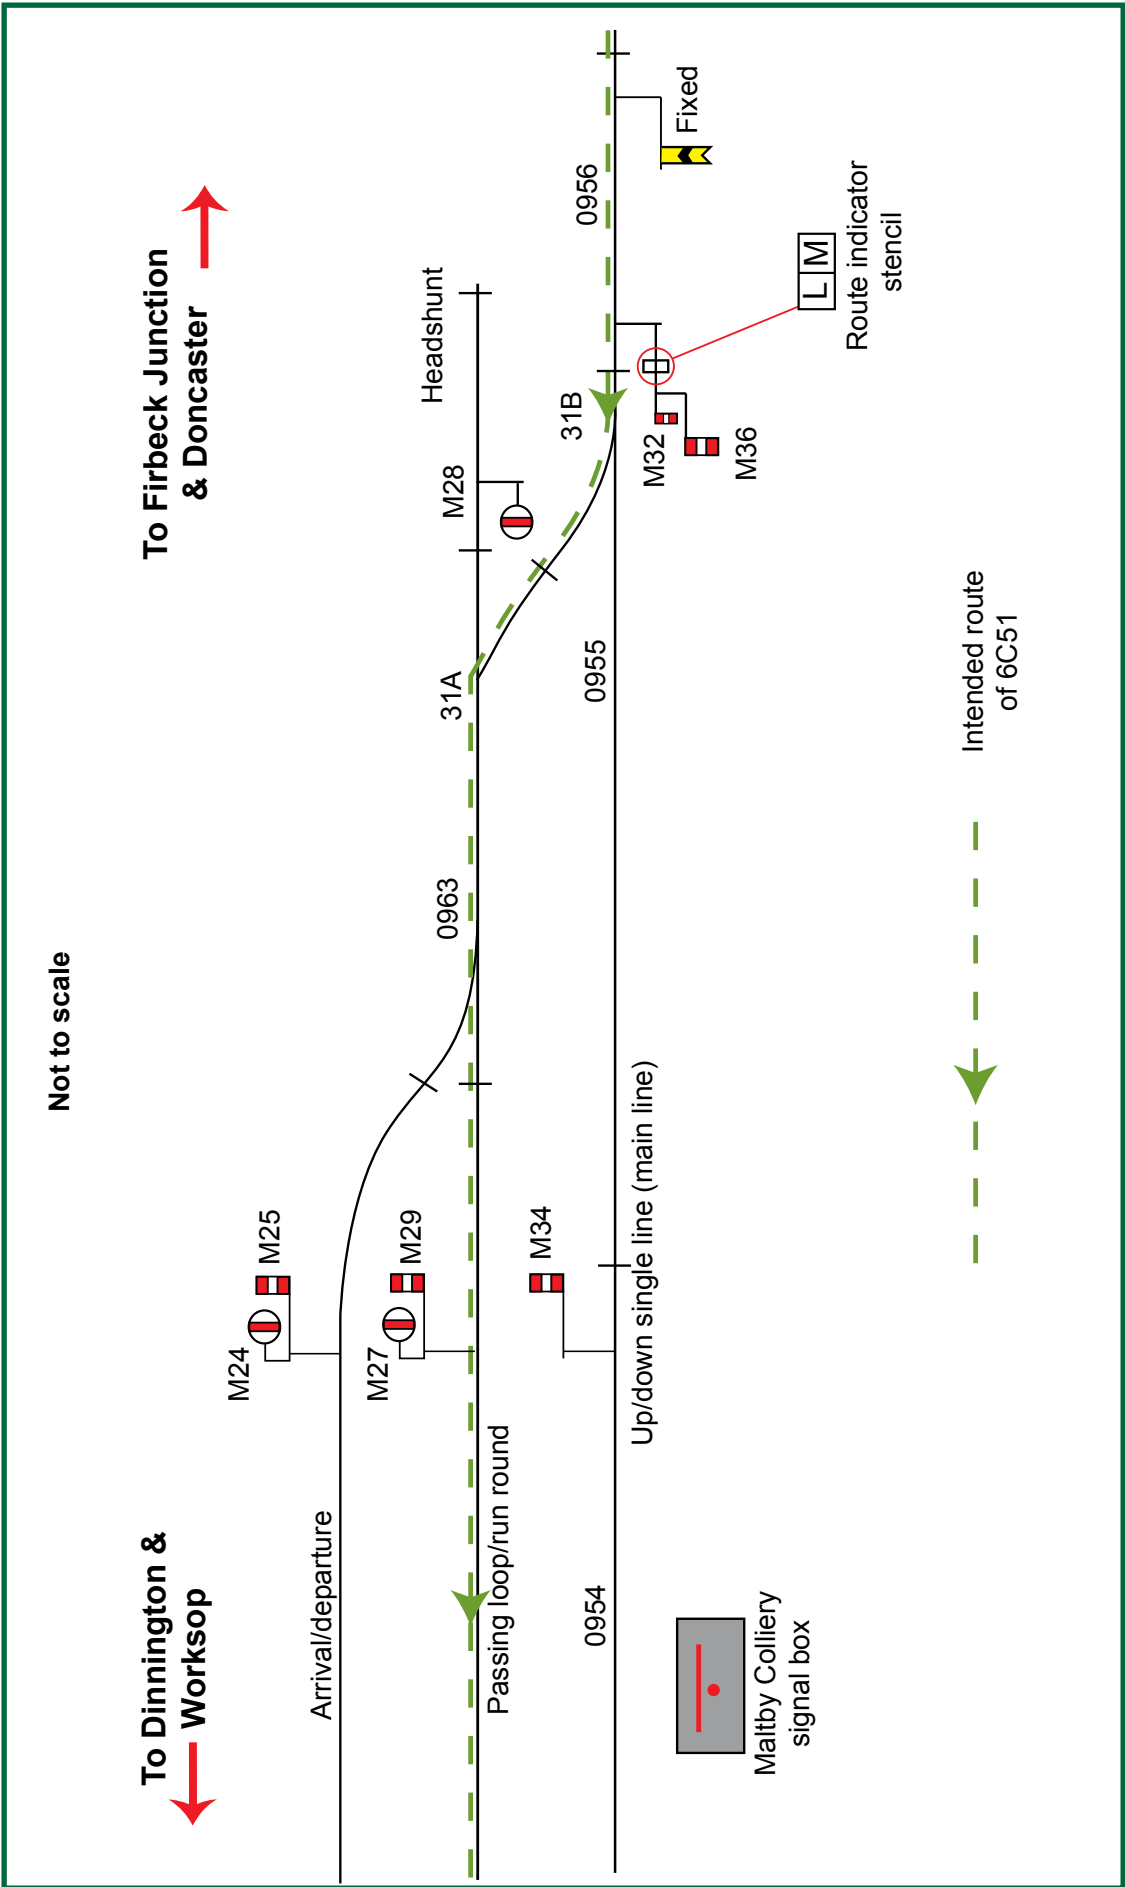
- 17 The train was traversing number 31 crossover at the time of the derailment. The crossover is made up of two points numbered 31A and 31B (see Figure 3). The train was traversing 31B points in the facing direction when it derailed. The locomotive and leading bogie of the first wagon took the *normal* route through 31B points towards the *up* and *down* main line. The points then motored to the *reverse* route whilst the first wagon was passing. All four wheels of the rear bogie of the first wagon passed between the open *switch rails* and the *stock rails* and ran along the stock rails until the widening gauge caused them to drop between the rails into derailment.

Figure 3: Plan of signalling at Malby North

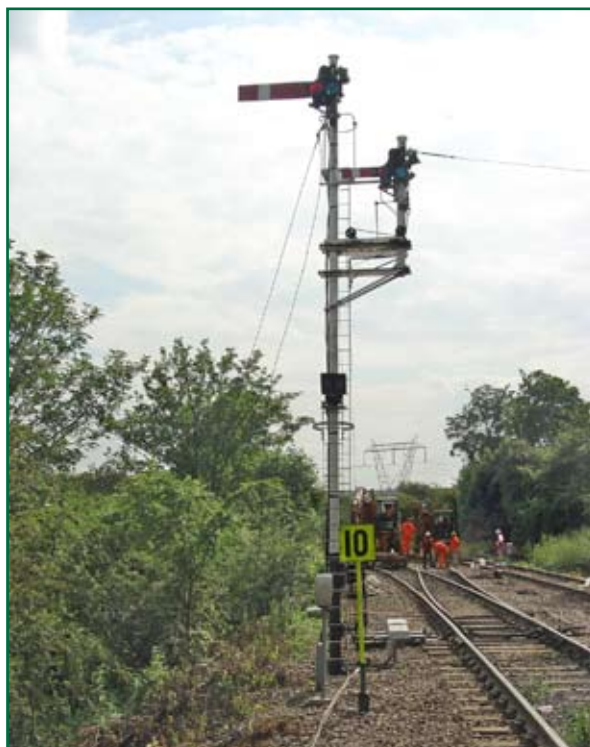
- 27 The Maltby up home signal ('up' at Maltby is from Doncaster towards Worksop) is a semaphore bracket signal with a main arm and a subsidiary arm. The main arm, signal M36, signals routes onto both the up and down main line and the passing loop. A stencil indicator shows 'M' or 'L' to indicate which route is set but both routes are set with the same lever in the box; the relay logic determines which letter to show according to the setting of the points. The subsidiary arm, signal M32, controls access to the arrival/departure line. Figure 4 shows the signals M32 and M36 along with the stencil route indicator box.

*Figure 4: Signals M32 (right) and M36 (left)*

- 120 Signal M36 is poorly sited with a distance of only 3 m between it and 31B points (paragraphs 75 and 29).
- 121 The length of the shifts being worked by the signallers at Maltby may have made them prone to fatigue (paragraph 109, **Recommendation 3**).
- 122 The driver of train 6C51 may have been suffering the effects of fatigue following events associated with the locomotive failure earlier in his shift (paragraph 113).

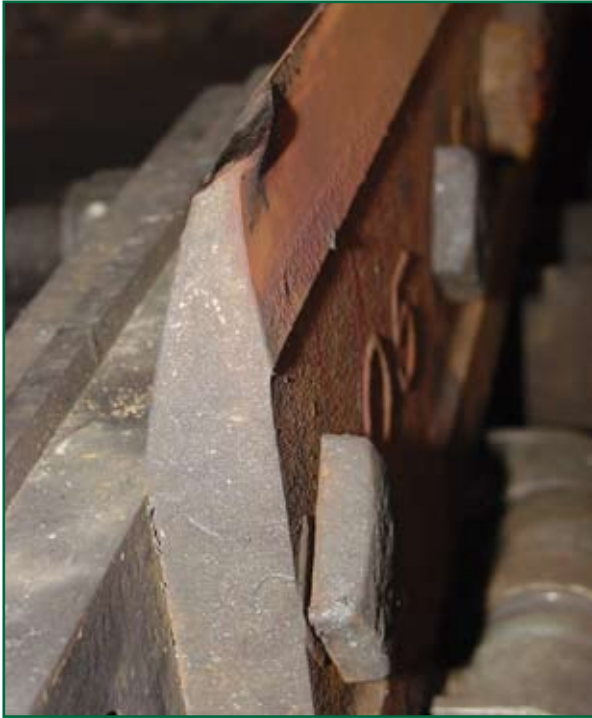
Figure 5: Damage to right hand switch tip of 31B points      Figure 6: Bent stretcher bar

- 67 The marks on the rails around 31B points and the turnout itself consisted of a dent on the right hand side switch tip (Figure 5), drop in marks at the point where the distance between the diverging stock rails became greater than the distance over the wheel treads and wheel flange marks on the spacer blocks within the turnout (Figure 7). There was no evidence of flange climb on the switches which would have occurred if the switch profile had been worn. The switch rails were quite new and unworn, having been manufactured in 2005.

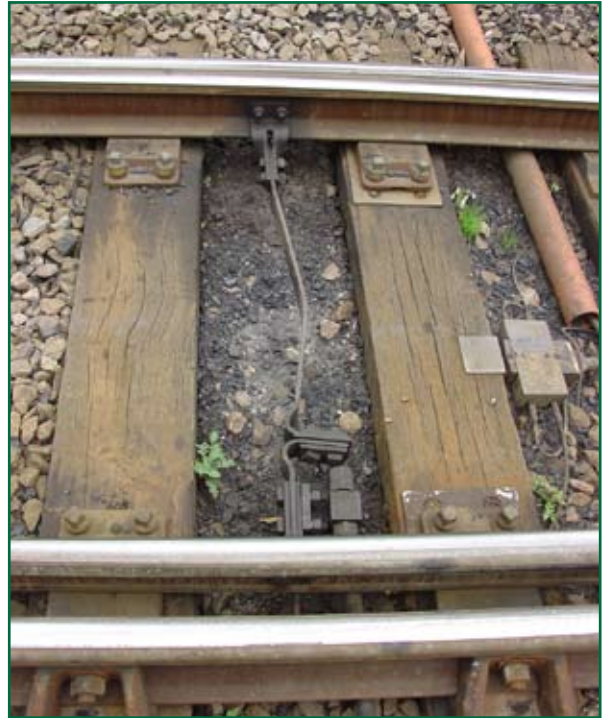
- 41 The locomotive and first bogie of the first wagon passed over the points normally and ran onto the up/down single line. The second bogie of the first wagon ran between the stock and switch rails on both sides of 31B points. This is consistent with the points motoring across to the reverse position as the inter-bogie gap of the first wagon was passing. The right hand side switch tip was struck by a wheel flange (Figure 5).
- 42 The wheelsets of the second bogie of the first wagon ran along the stock rails of 31B points forcing the switch rails together which caused one of the stretcher bars to bend (Figure 6).

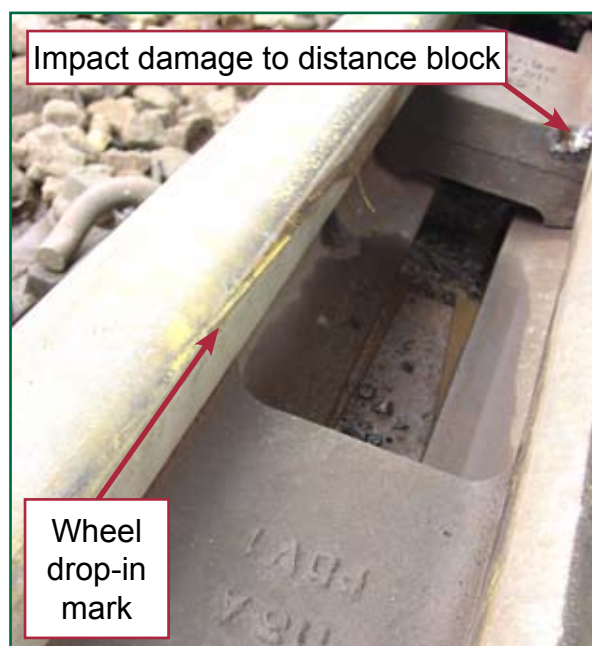
- 43 As the stock rails diverged the gap between them became large enough for the wheelsets to drop into and they then struck the distance blocks and sleepers (Figure 7).

Figure 7: Point where wheelsets derailed

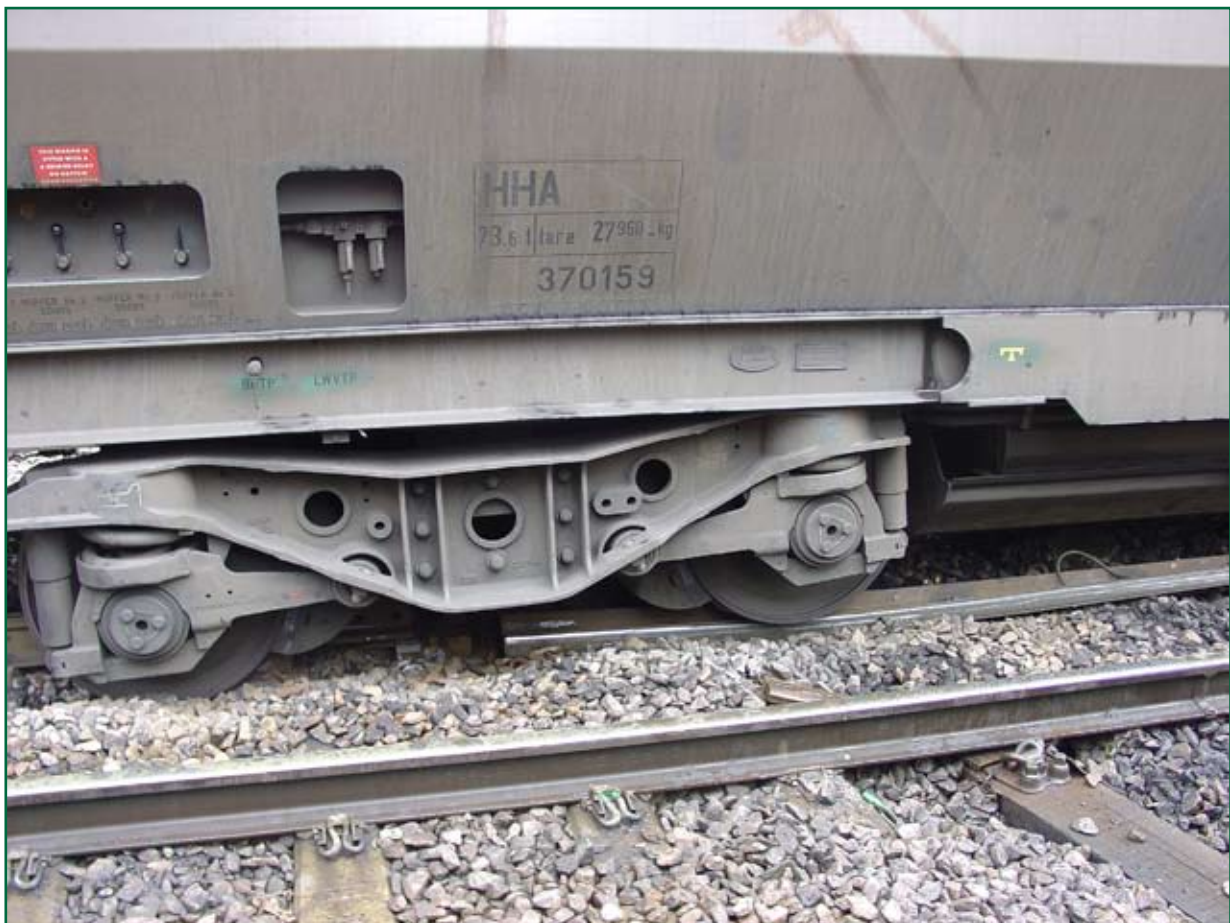
- 46 This rail, having broken free of its fastenings and its neighbour, was able to rotate and this allowed the leading bogie of the second wagon to derail to the sixfoot. The rail then sprung back sufficiently to allow the second bogie of the second wagon to pass without derailling, as evidenced by the fact that this bogie did not derail. The leading bogie of the third wagon had started to derail on passing the rail joint but the train came to rest before the second axle of this bogie had left contact with the rail (Figure 8).

Figure 8: Partially derailed bogie at front of 3rd wagon

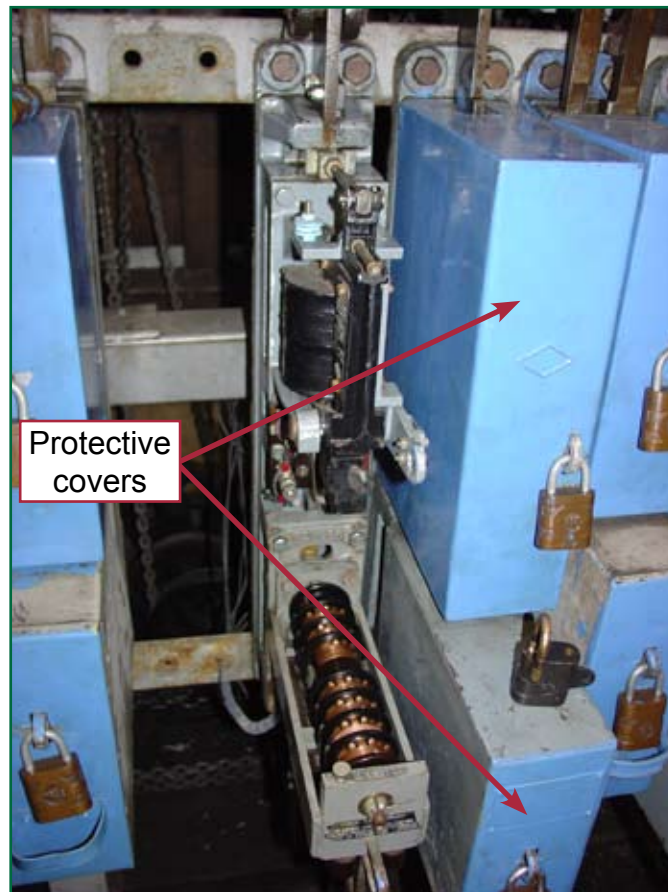
- 81 Where a lever works an electrical unit, such as a point machine, the electric circuit is made or broken via contacts which are driven by the lever. Levers which only operate electrical units do not require as much effort to move them as levers that work mechanical signals and points and these levers have had the handle section cut down to remind the signaller of this fact. Figure 9 shows the electrical lock and the lever contact bands that make up the electrical switch on number 31 lever. Figure 10 shows the operating floor of the box and lever frame with lever 31 in reverse and lever 36 normal.

*Figure 9: Lever lock (top) and lever bands (beneath) on lever 31 in Maltby Colliery signal box (protective covers removed from lever 31 units)*

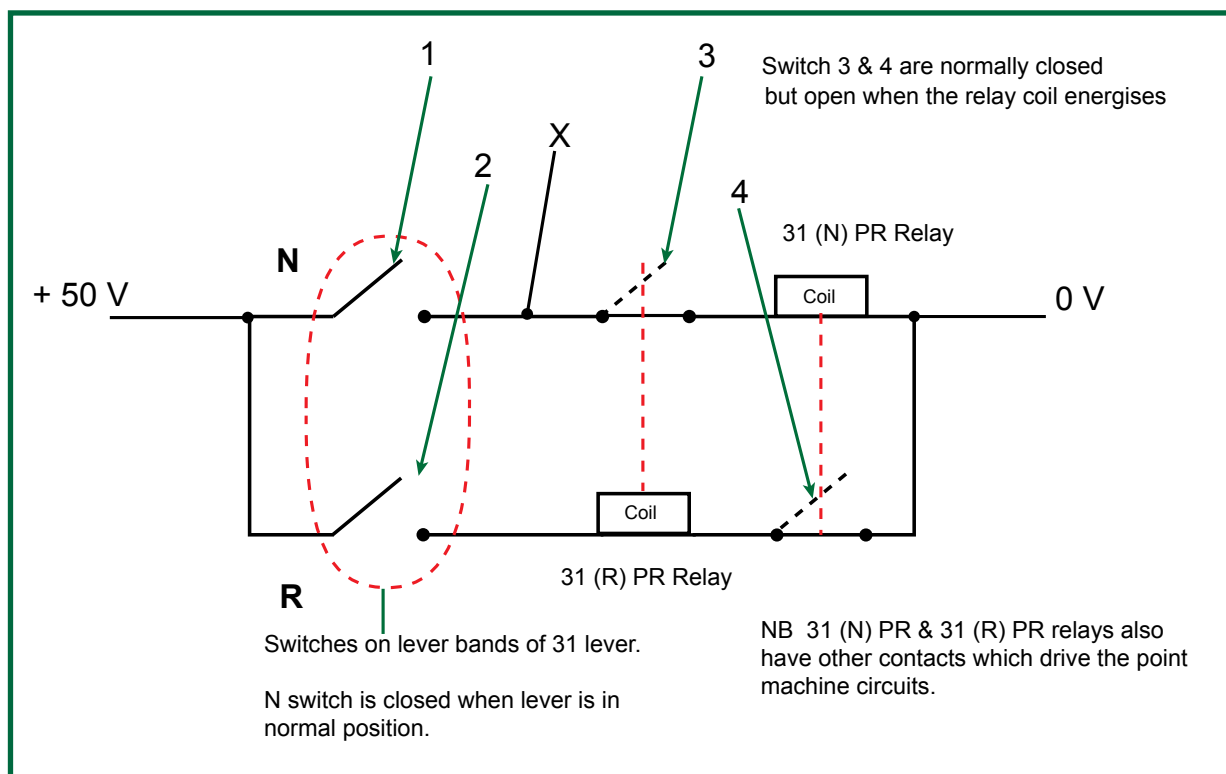
- 84 Figure 11 shows the circuit which is operated by the switch on 31 lever. In normal operation, moving the lever from normal to reverse will cause switch 1 to open and switch 2 to close. The arrangement of the switches in this circuit ensures that only one of the relay coils can be energised at any one time. Other contacts on these relays (not shown in Figure 11) are used to operate the circuits which actually drive the point machines and cause the points to move.

Figure 11: Lever band circuit on lever 36

- 85 The contacts which form switches 1 and 2 in Figure 11 are the only contacts connected to lever 31. This means that any part of the electrical interlocking which needs to know the position of lever 31 is reliant on contacts on relays 31 (N) PR and 31 (R) PR to do this. If there is a defect in one of these relays causing it to stick in the energised position, or there is a spurious electrical feed to wire 'X' in Figure 11, relay 31 (N) PR will remain in the energised position and prevent relay 31 (R) PR from operating, even though the lever has been moved and switches 1 and 2 have operated. In this state, the relay interlocking which displays the point position will continue to believe that lever 31 is in the normal position and will show normal detection for the points.

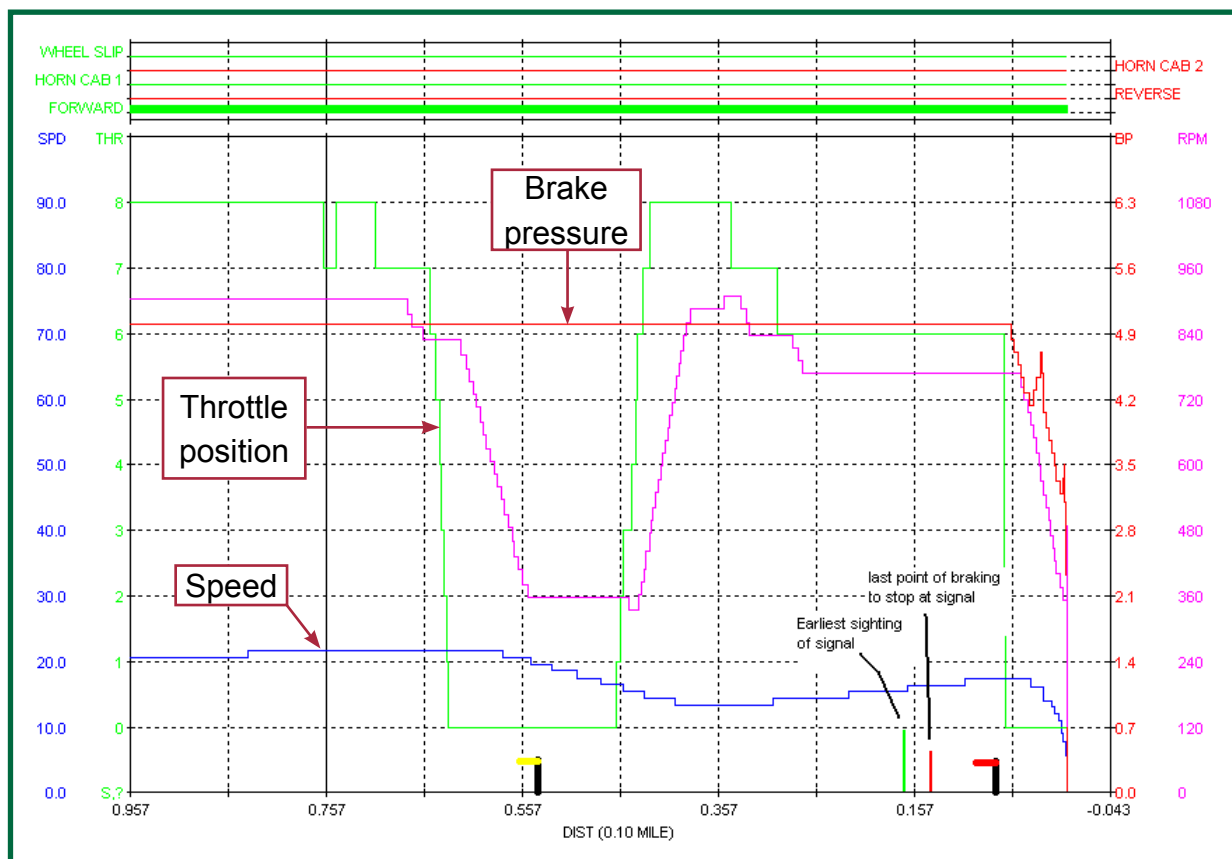
- 100 The OTMR data showing the final approach to the stop at the derailment is shown in Figure 12. The data channels shown in Figure 12 are the train speed, brake pressure and throttle setting (shown as analogue traces) and the driver's brake handle (shown as digital indication at the bottom of the figure). The data has been plotted with distance as the horizontal axis. The distance from the locomotive to points 31B and signal M36 was measured on site and the signal and point location is indicated in Figure 12.

- 101 Figure 12 shows the train approaching signal M36 with the throttle in step 6 and the speed gradually rising. Driver 2 does not alter any control positions until a point 3.3m past the signal when he closes the throttle completely and applies the brakes. This throttle movement is very rapid, taking less than 0.5 seconds to accomplish. Previous instances in the shift when driver 2 had closed the throttle involved a gradual closure, typically 6 steps in 3 seconds. The fastest throttle closure on the OTMR prior to reaching Maltby was shortly into the journey over the South Yorkshire Joint Line when the throttle was moved from step 8 to step 4 in 1.0 second in response to the train reaching linespeed.

Figure 12: Annotated display from the OTMR

- 102 There was no positive evidence as to why driver 2 had shut the throttle so quickly. He stated that he had seen signal M36 at clear when he approached and passed it but he could not recall seeing the route indicator stencil. Analysis of the OTMR data suggests that either driver 2 did not notice signal M36 until after he had passed it or that he suddenly noticed that the speed of the train had risen too high for the turnout route and shut off to reduce it.
