Rail Accident Report

**Derailment at Trooperslane near Carrickfergus,
Northern Ireland
23 April 2006**

Derailment at Trooperslane near Carrickfergus, Northern Ireland 23 April 2006

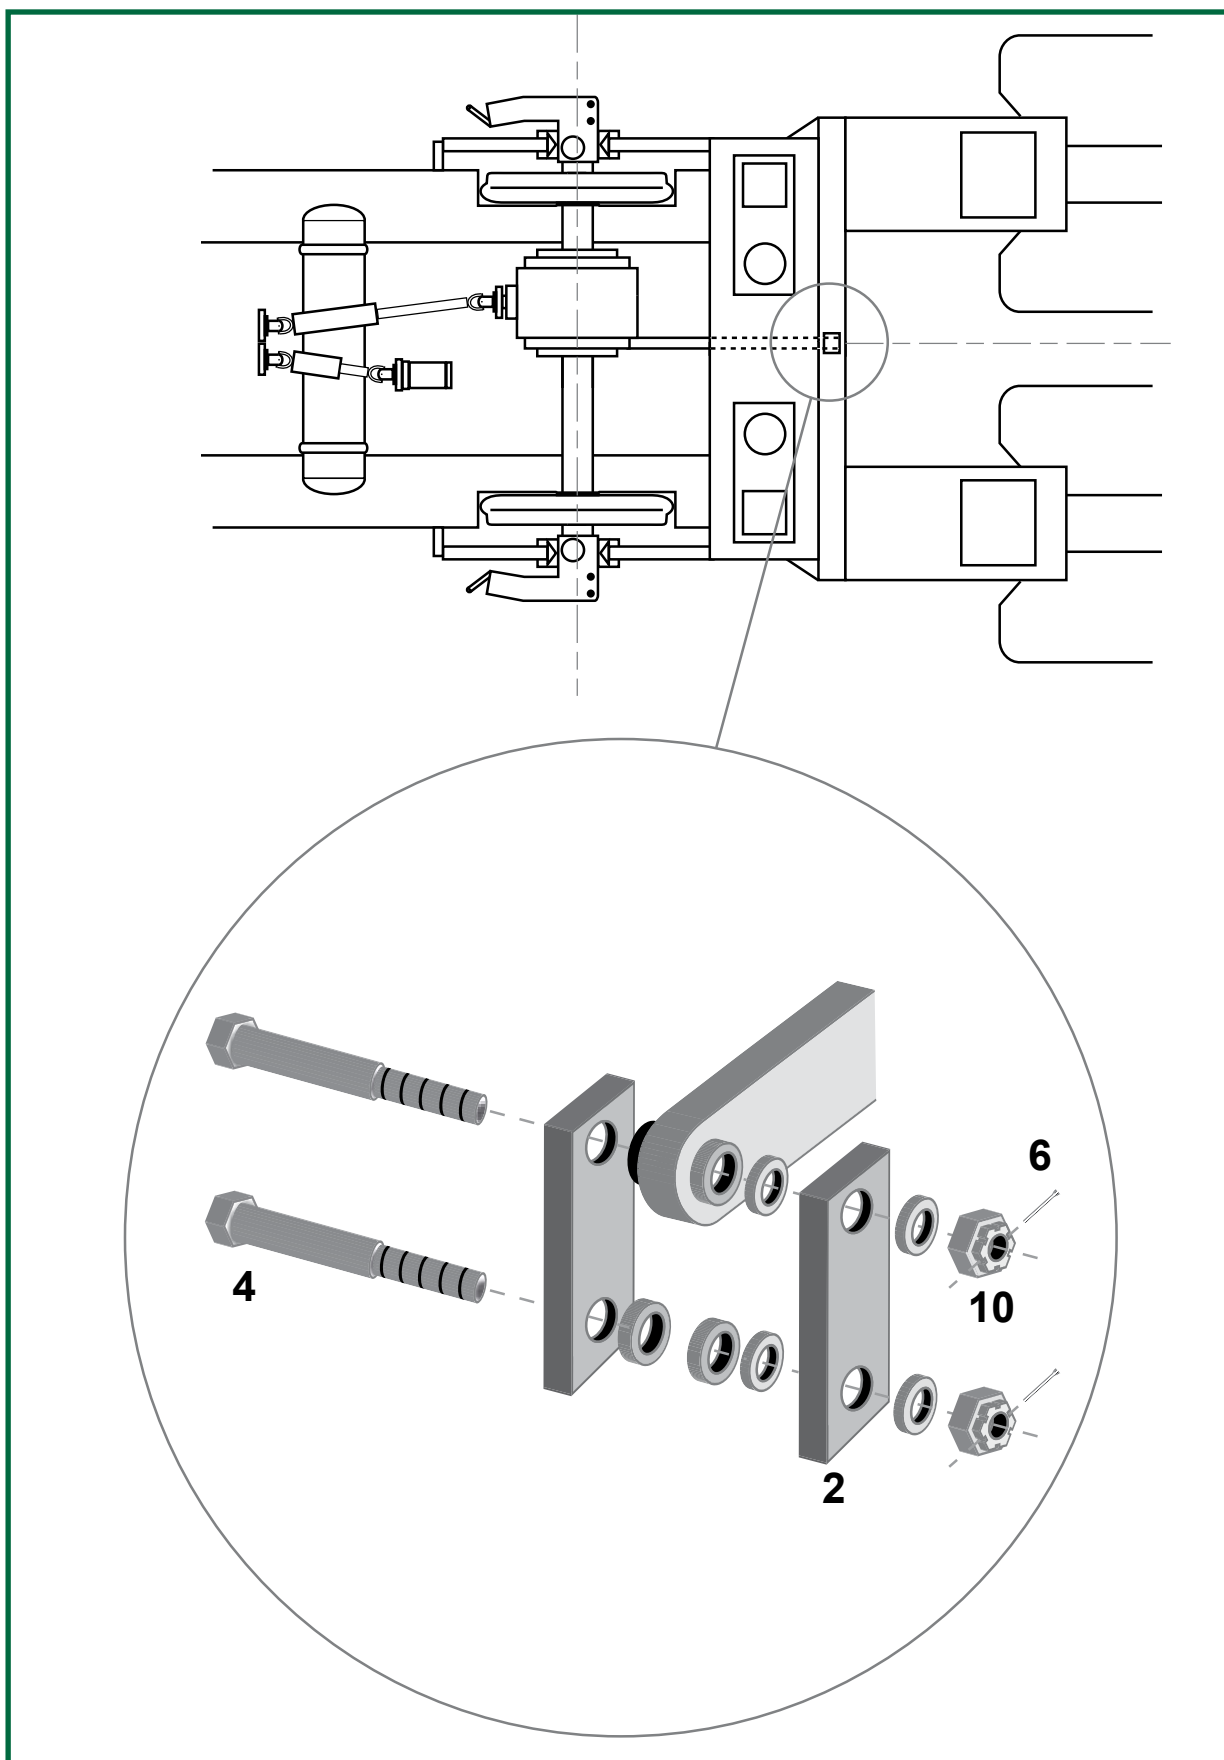
Figure 3a (above): plan view of underside of ballast regulator showing the torque reaction arm assembly attached to the front axle and headstock bracket

Figure 3b (below): Assembly diagram of torque reaction arm anchor fixings. The pin (4), castellated nut (10) and split pin (6) arrangement is duplicated at the top and bottom of the fishplates (2)

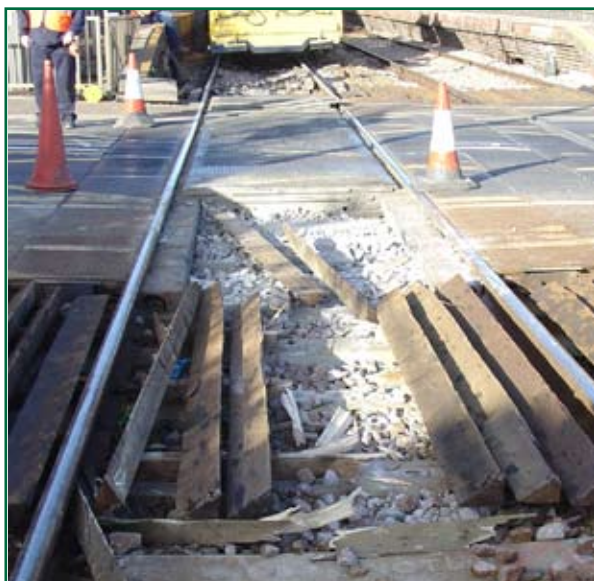
Figure 4: Trooperslane crossing with rear aspect of ballast regulator 7003

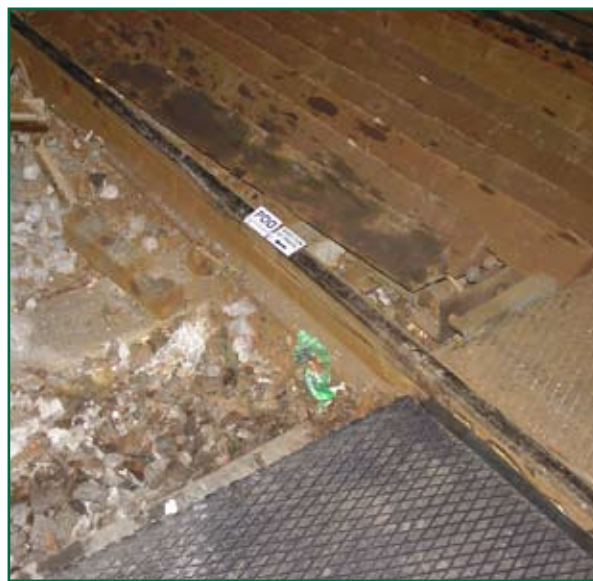
Figure 4a: Point of Derailment (POD) showing sleeper zero

- 121 The point of derailment was taken as a mark when the wheel dropped into the five foot. This was defined as sleeper '0'. This was preceded by a climb mark on the six foot rail at sleeper 2, followed by grooves on the sleeper caused by the derailed wheel flanges from sleeper -2 onwards (Figure 4a). Damage to the *Pandrol clips*, *rail pads* and sleeper damage into the six foot was also visible.

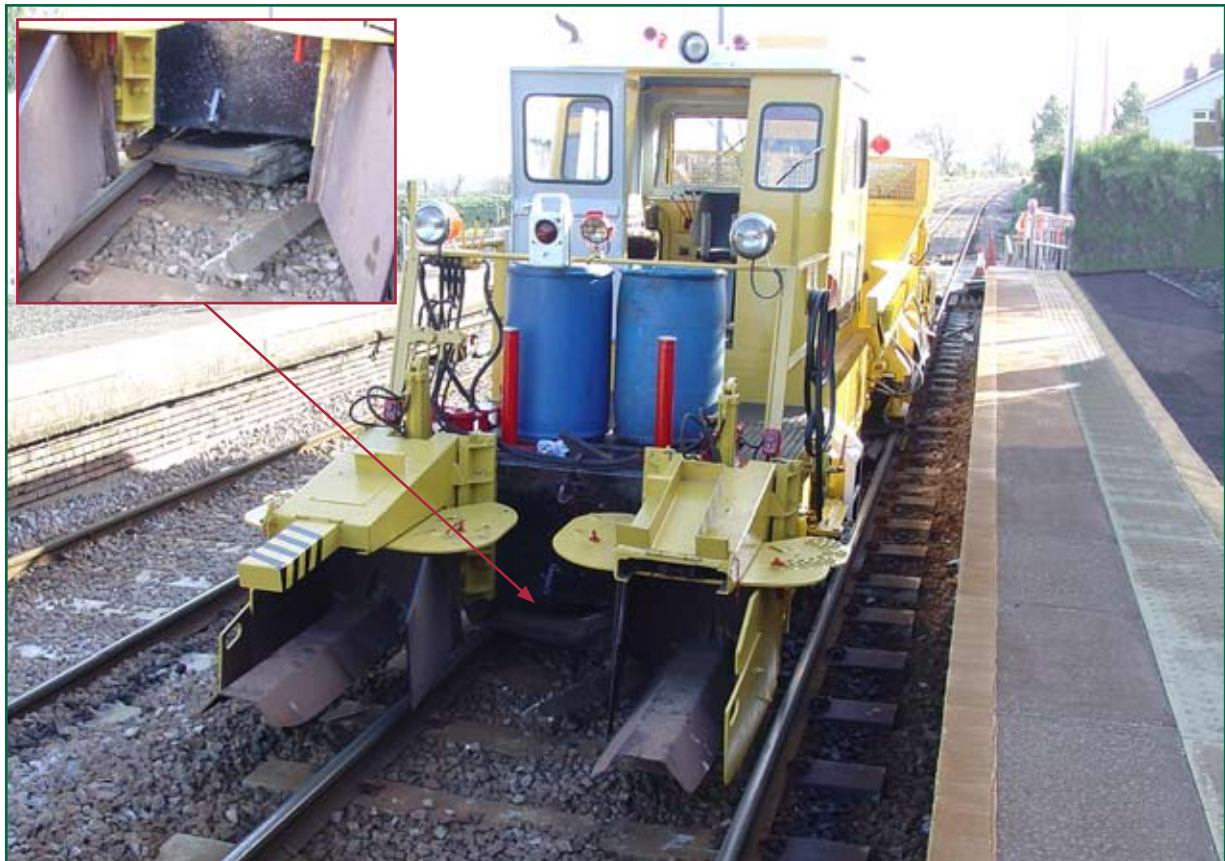
Figure 5: Ballast regulator 315 at Trooperslane station following derailment. The headstock on which both the towing brackets and anchor bracket are mounted is painted black (insert). A displaced road crossing block originating from the level crossing is shown in the background wedged beneath the vehicle

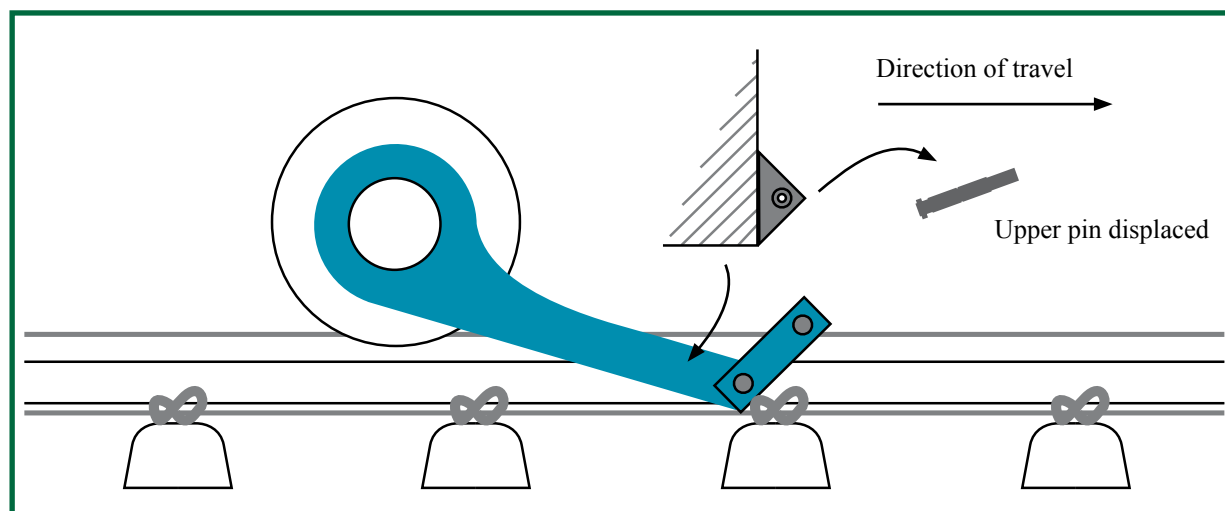
Figure 9: Schematic cross-section through regulator viewed from right in direction of travel showing torque reaction arm impacting on a sleeper following loss of the upper pin.

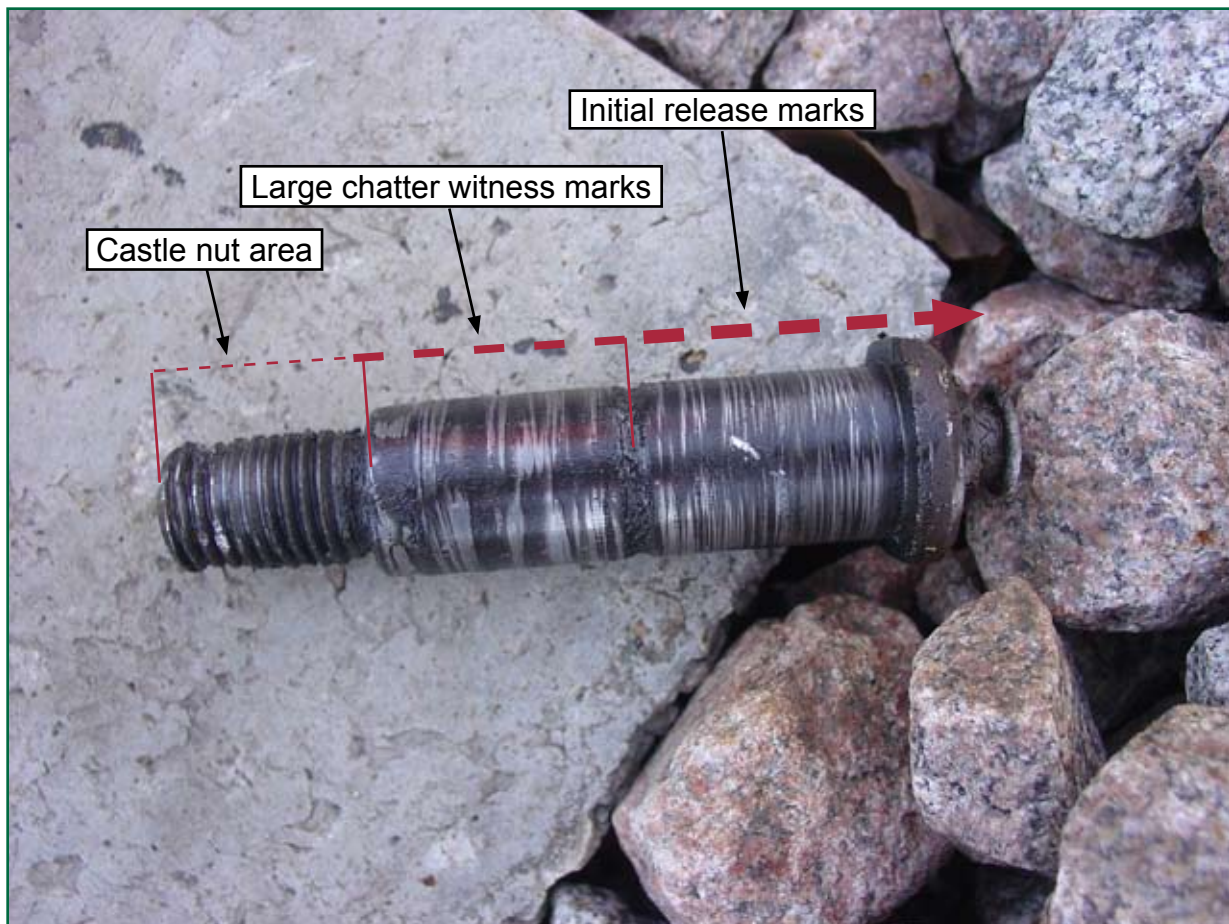
106 The recovered pin was to specification and identified as the correct type for the torque arm assembly. Forensic examination of the site debris, the pin and the evidence recovered from the damaged torque arm found similar materials in all three, and indicated that this was the missing upper securing pin (Figure 10).

110 The recovered upper securing pin has a thread diameter of 20 mm and was to specification. Visible 'chatter and rocking' witness marks in grease were present in the 'as found' condition. The varying frequency of the witness marks on the shaft of the bolt indicate an initial slow release and 'rocking' motion between the torque arm and the headstock. This is likely to have occurred at low speed as the train left the depot.

Figure 10: Image of securing pin found on site

- 111 There is evidence of rotation as well as wider ‘chatter / rocking’ marks along the shaft of the pin indicating a quicker release as the train increased its speed en route to Whitehead. Vibration between the arm and the headstock bracket caused greater movement to take place and the dimensions between the pin and the headstock bracket increased. The top pin eventually came apart from the bracket and the torque arm dropped hitting the track.

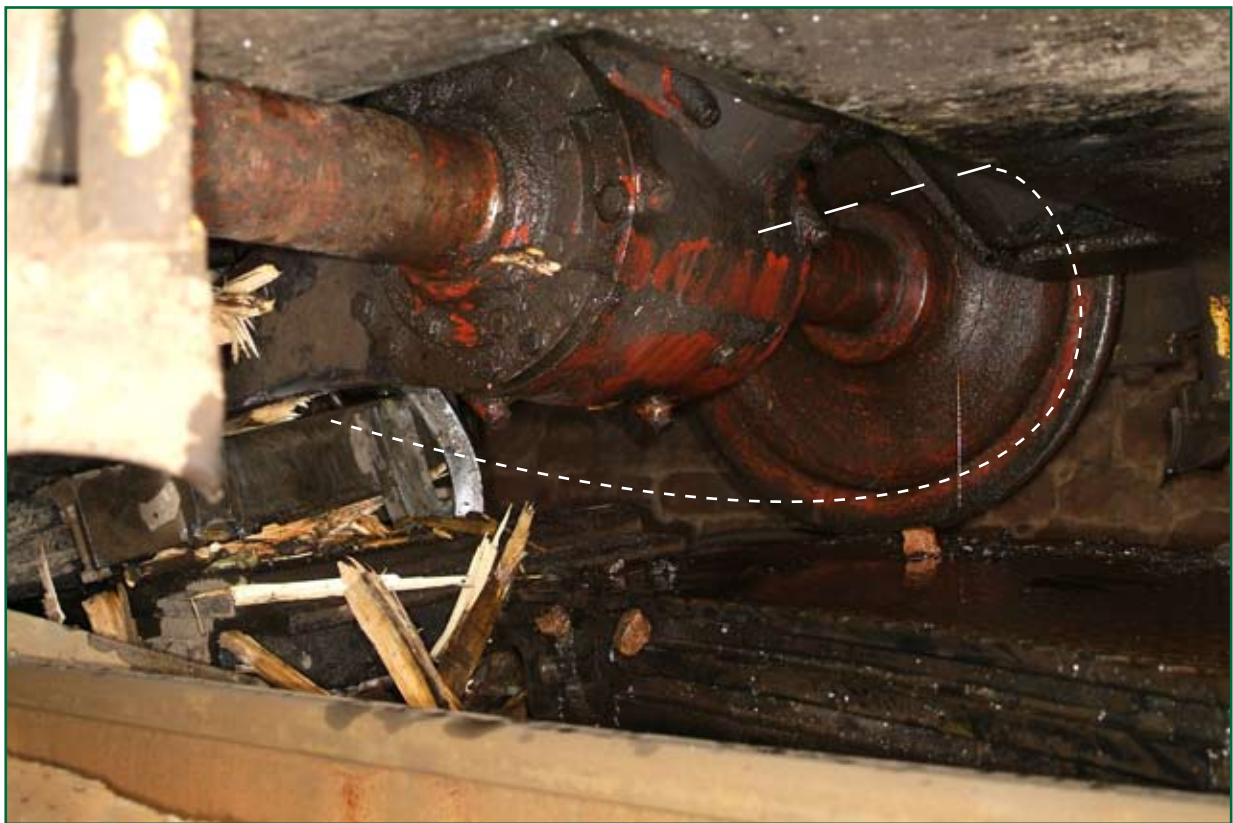
Figure 11: Torque arm damage seen when regulator lifted on site

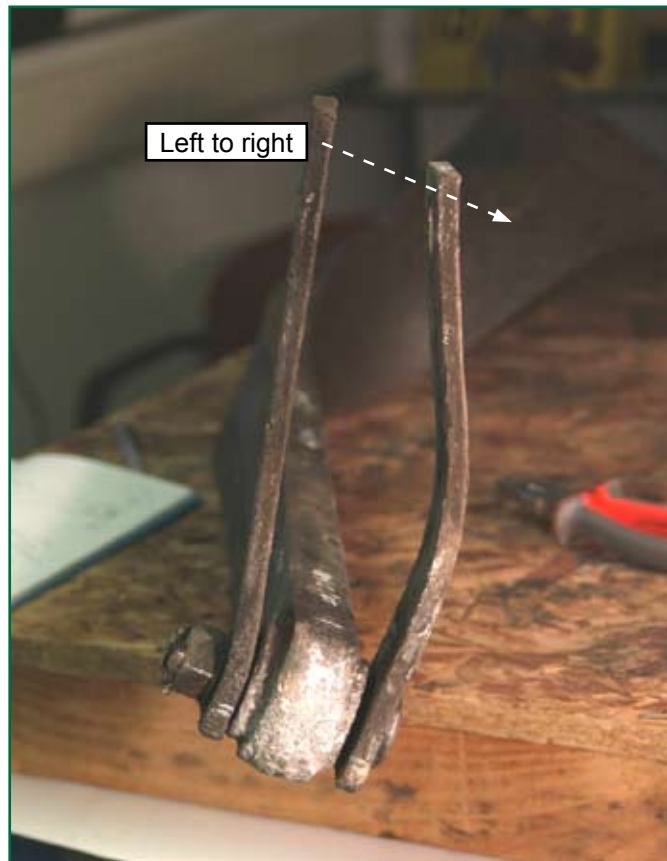
Figure 12: Incident torque bracket

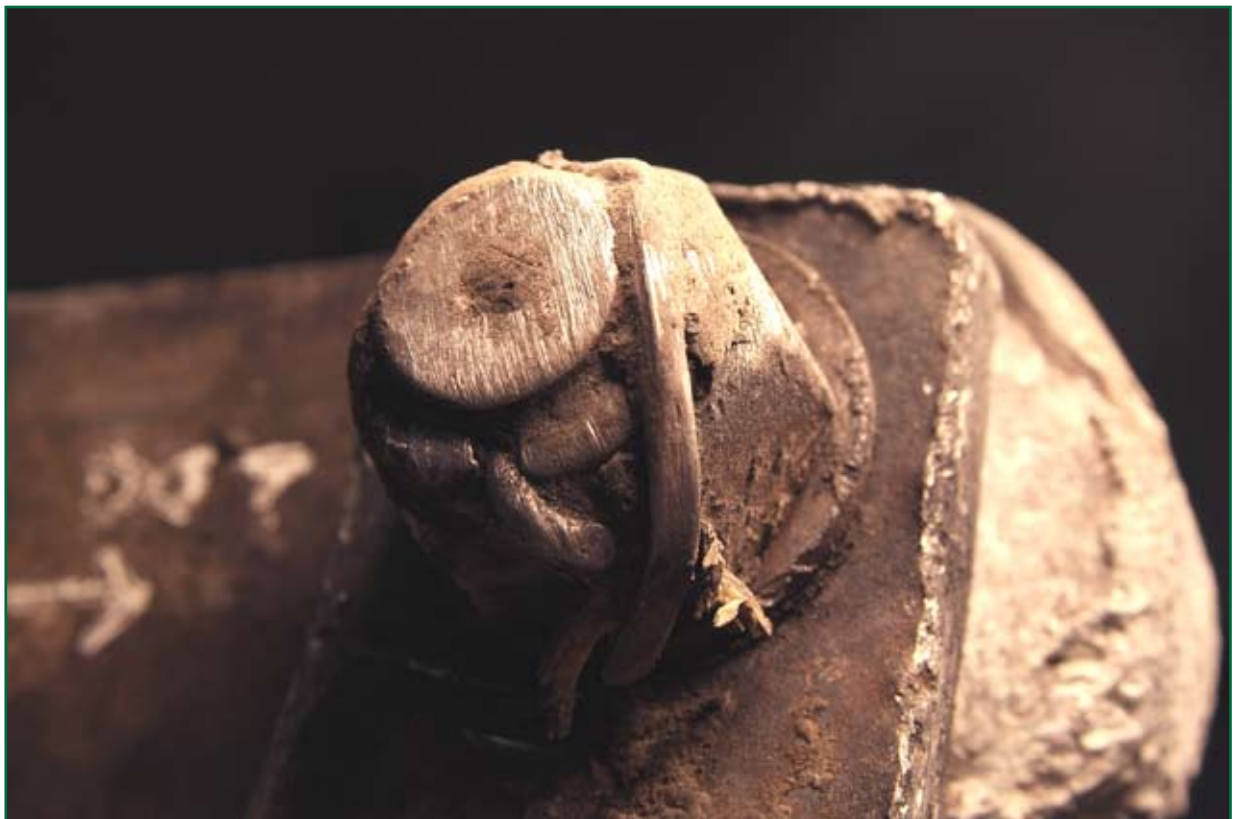
108 The torque arm and the lower securing pin were heavily damaged, with ballast, wood, grease and concrete debris visible on the end of the arm. The lower securing pin and castellated nut were damaged but secure and were to the correct specification. The split pin was in place and visible; it had been spilt in the correct fashion around the castellated nut.

109 Wood debris from the cattle grid stakes was visible in the crown of the lower castle nut. Fresh marks were visible around the mating surface of the holes of the upper bracket. The securing pin is slotted through the bracket and the headstock to secure the torque arm. The marks (Figure 10) indicated that the mating surfaces of the pin and castle nut had been in position for sometime before the incident and corroborate the pin being released just prior to UWC crossing X 301.

Figure 13: Lower torque arm fixing bolt with post incident damaged castle nut and split pin. Wooden debris from a cattle grid stake is also visible

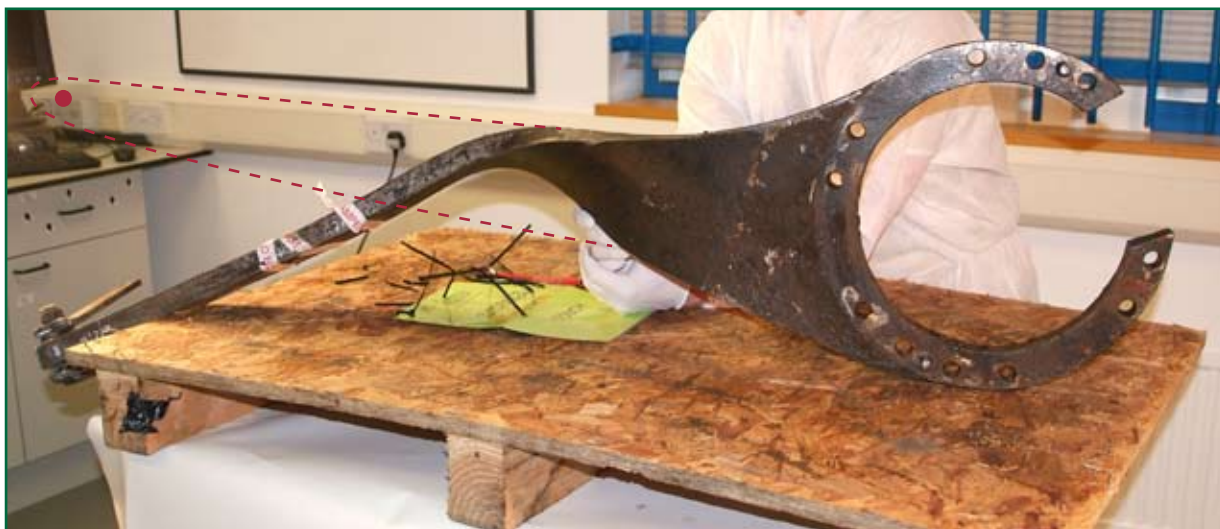
Figure 14: Damaged lower torque arm

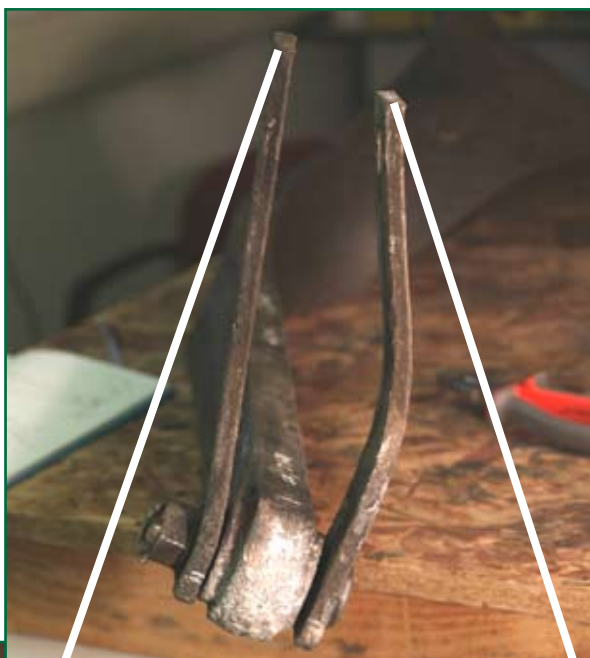
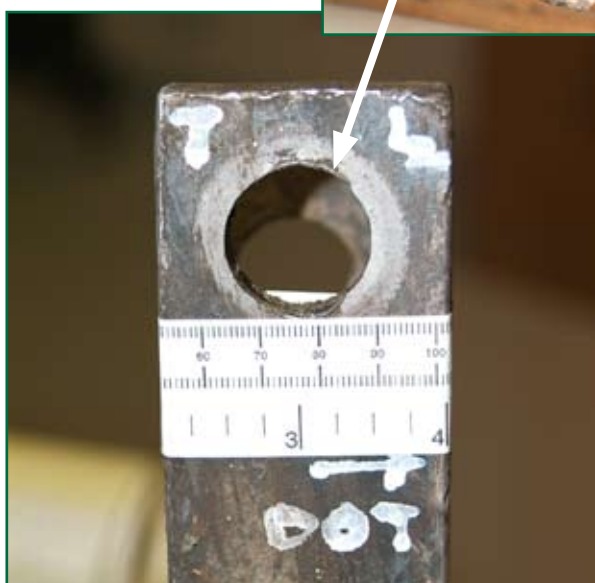
Figure 15: Torque support left side arm bracket (castle nut side)

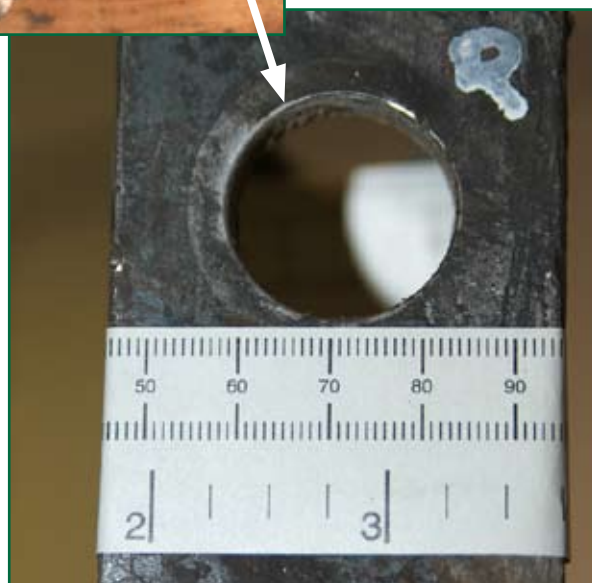
Figure 16: Torque support left side arm bracket (securing pin side)

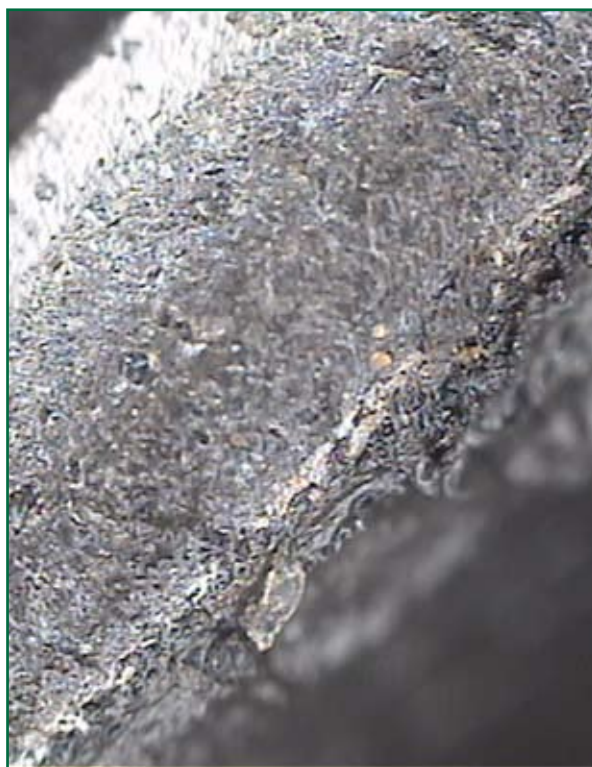
- 189 The lack of thread wear and deformity to the pin indicate the pre-incident state of the nut and pin would have allowed the rapid release of the nut through vibration. There is no visual evidence on the thread or shaft of the securing pin recovered from the scene which supports a hypothesis that the bolt spent any significant period of time in one position prior to its release. This would indicate the securing pin and castellated nut vibrated loose over a short period of time and distance (Figures 13, 16 and 18).

Figure 18: Image of clean tip and root of incident thread indicating contact with tip and root of internal threads of a nut
