Rail Accident Investigation Branch

# Rail Accident Report

**Fatal collision between a Super Voyager train  
and a car on the line at Copmanthorpe  
25 September 2006**

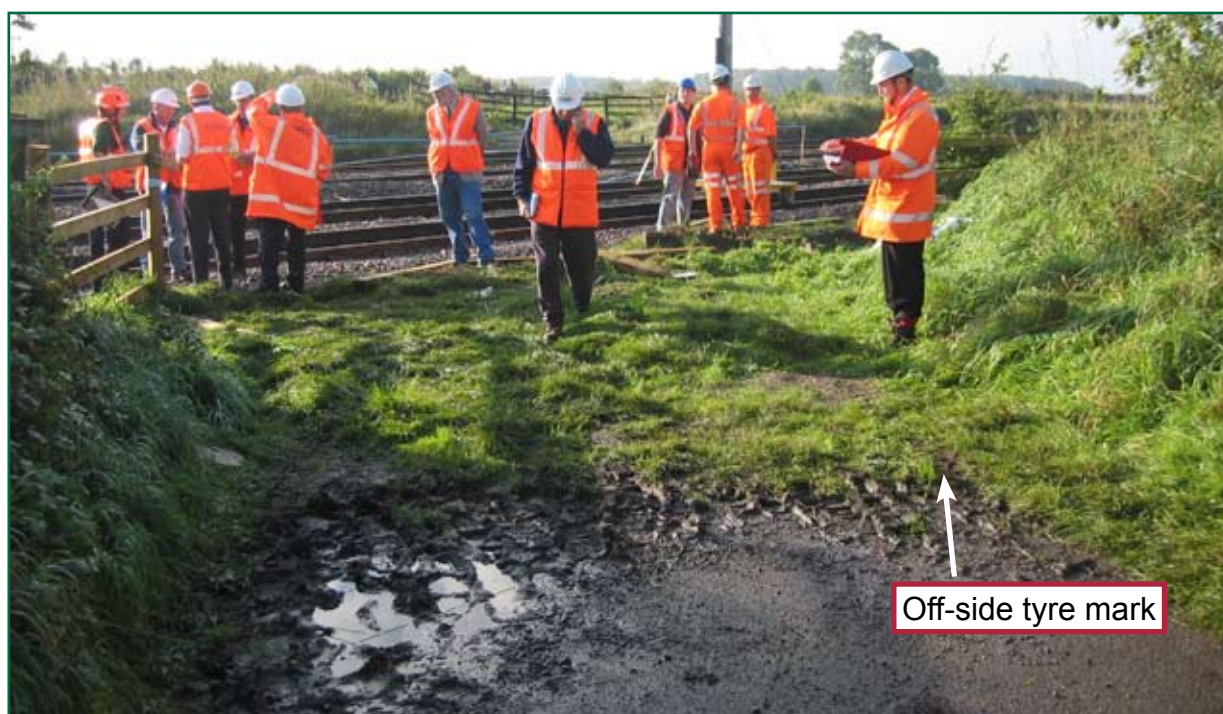
Figure 2: The site of the damaged fence

- 32 Shortly before 21:00 hrs the car collided with and broke through the fence at the end of Moor Lane, and ran onto the railway (see Figure 2 and Diagram 1). The front wheels of the car came to rest in the four foot of the down Leeds line.

- 56 No measures over and above a wooden fence were in place at the end of Moor Lane to protect the railway from road vehicle incursion. A fence of this design adequately marks the boundary of the railway, and will prevent trespass and large animal incursion, but is not capable of stopping a car which hits it.
- 57 The fence was substantially damaged by the collision with the car. However, the fence had been removed and reinstalled in August 2006 and was in a good condition.

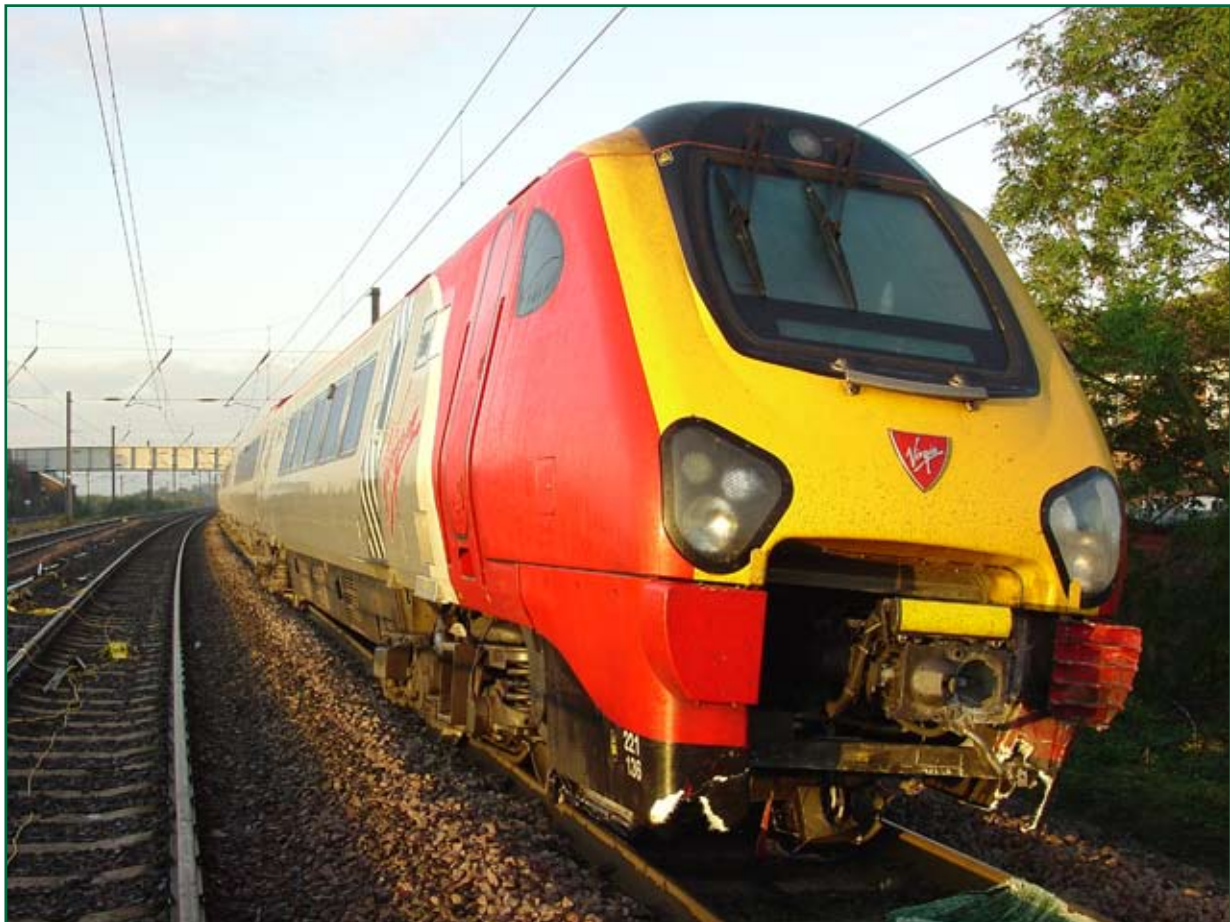
*Figure 3: The derailed train - front view*

- 35 The leading wheels of the train remained on the track, but the second, third and fourth wheelsets of the train were derailed (Figures 3 and 4). All other wheels remained on the track, and the train decelerated to a halt 907 metres north of the point of collision. The train remained upright and inline on or close to the track throughout its deceleration.
- 36 At the time of the collision the car driver was still in the driving position of the car with his seat belt fastened.

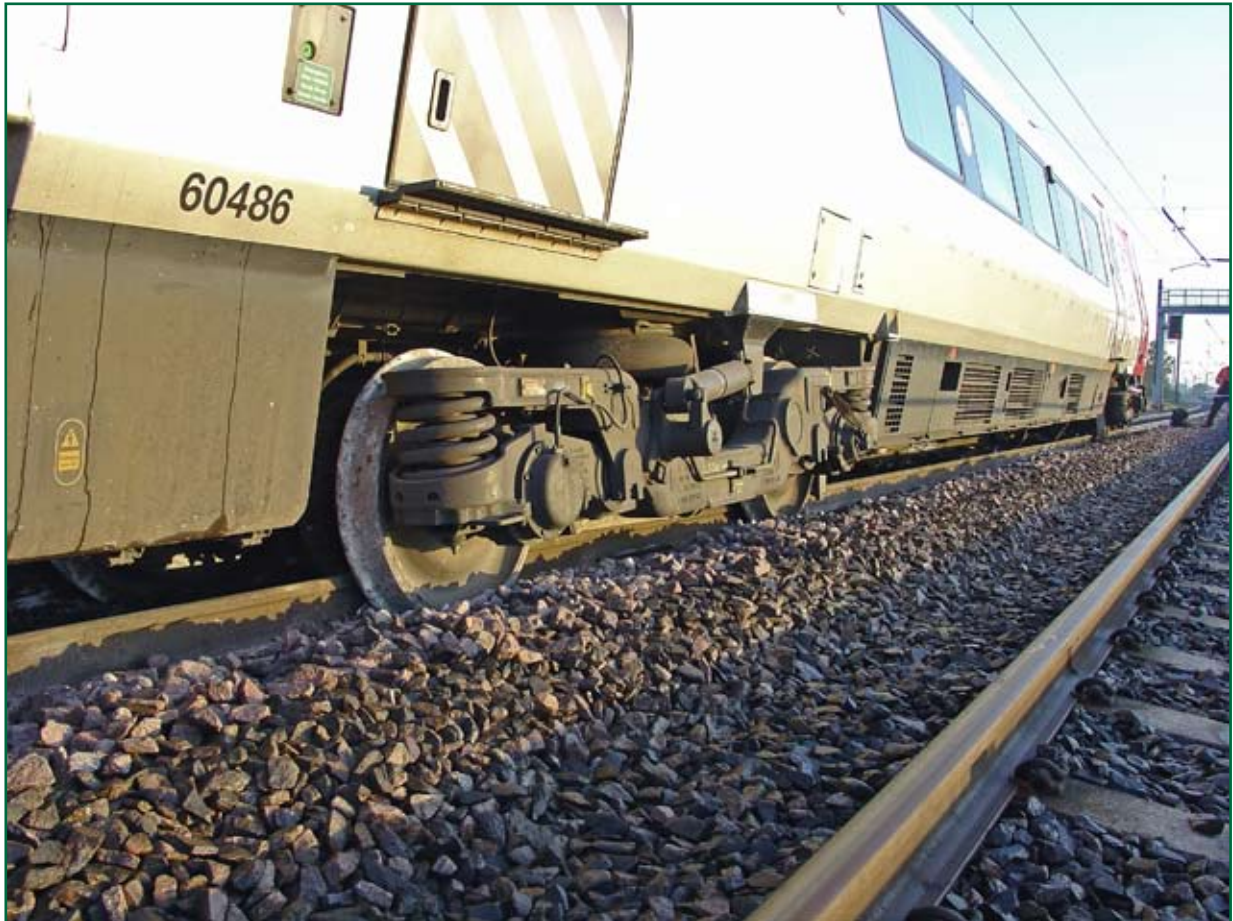
*Figure 4: The derailed wheelsets, 2, 3 and 4 from the front, on the leading vehicle*

- 52 Wheelsets two, three, and four of the leading vehicle became derailed and sustained damage by running on *track fasteners* and over collision debris. Marks on the derailed wheel flange crowns support this.
- 53 There was extensive, but not major, damage to the train underframe area:
- the obstacle deflector was tilted back and superficially deformed in the collision (paragraph 83 et seq);
  - three of five fuel tanks leaked fuel from damaged valves into the track ballast;
  - the bogie-mounted *stone guards*, designed to protect the tilt system were damaged and hydraulic hoses were knocked off the tilt cylinders.
- 54 However, no major system or component came loose from the train, and there was no interior damage as a result of the accident.

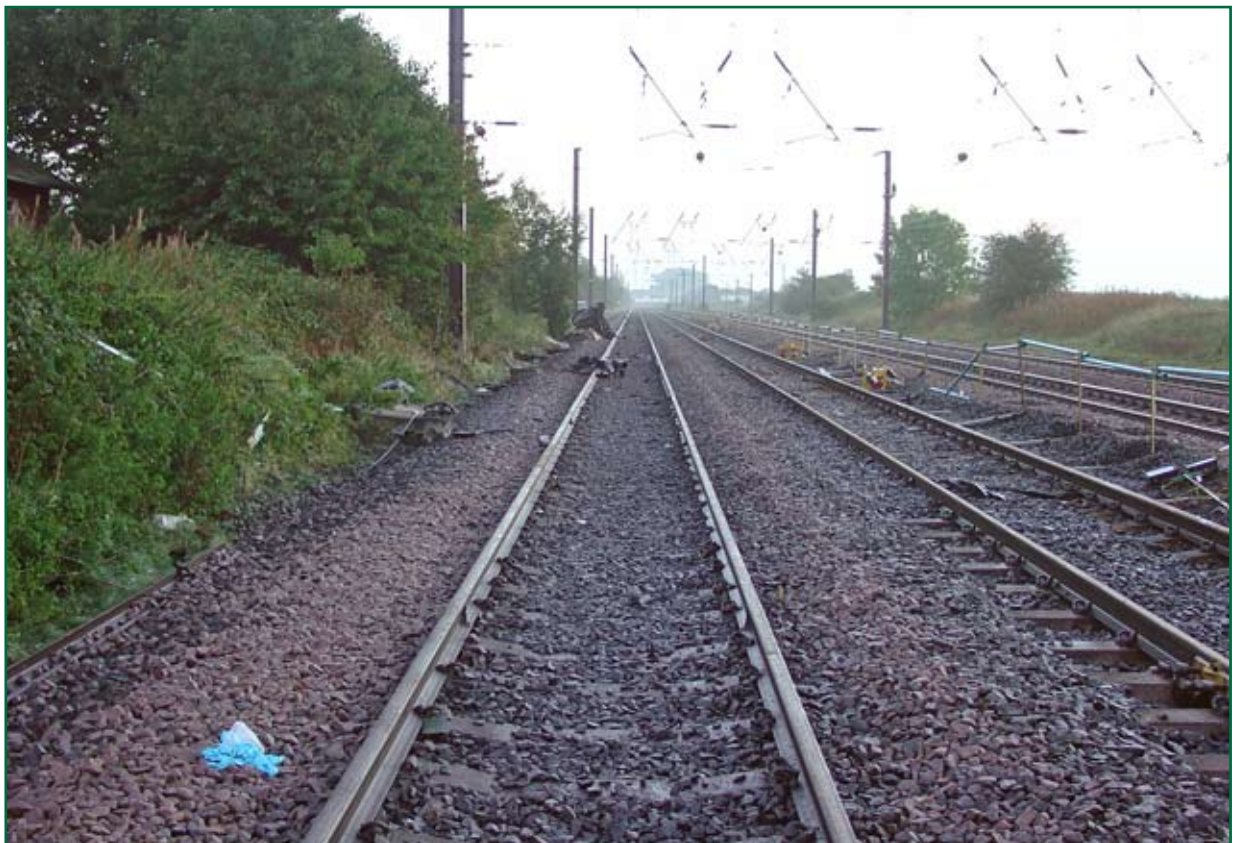
*Figure 5: Debris from the car after the collision*

- 37 The car driver received fatal injuries from the collision. No one was injured on the train. The car broke into many parts and was scattered by the impact (see Figure 5).
- 38 The derailed train did not obstruct the adjacent line. There was considerable damage on the underside of the vehicles (see paragraphs 90 to 96); as a result fuel leaked into the track ballast from three of the train's fuel tanks and the *tilt system* became completely unlocked on two of its five vehicles.
- 39 The railway track and signalling were damaged.

- 51 This breaking up of the car left debris scattered into the cess and across all four tracks throughout the 907 metres that the train ran after the collision.

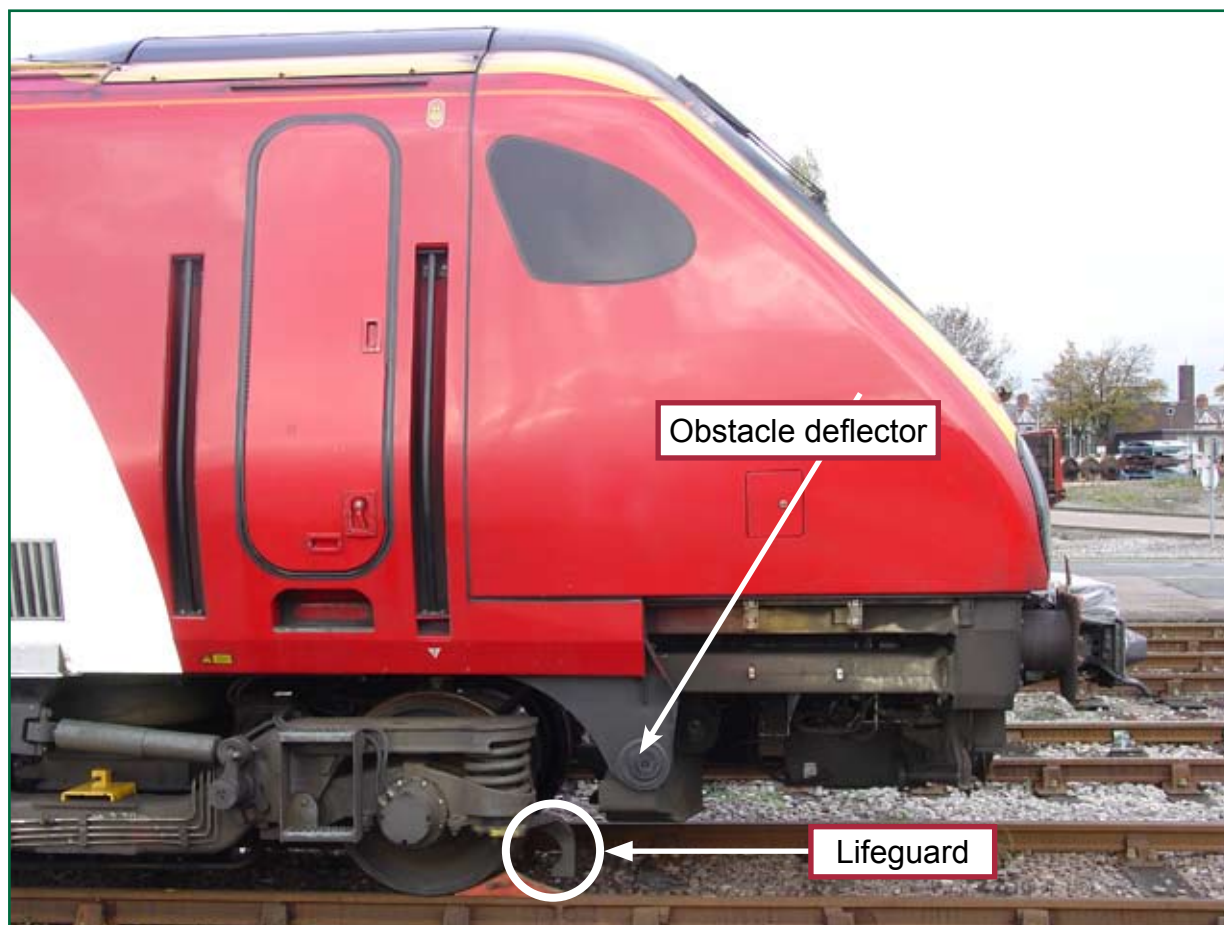
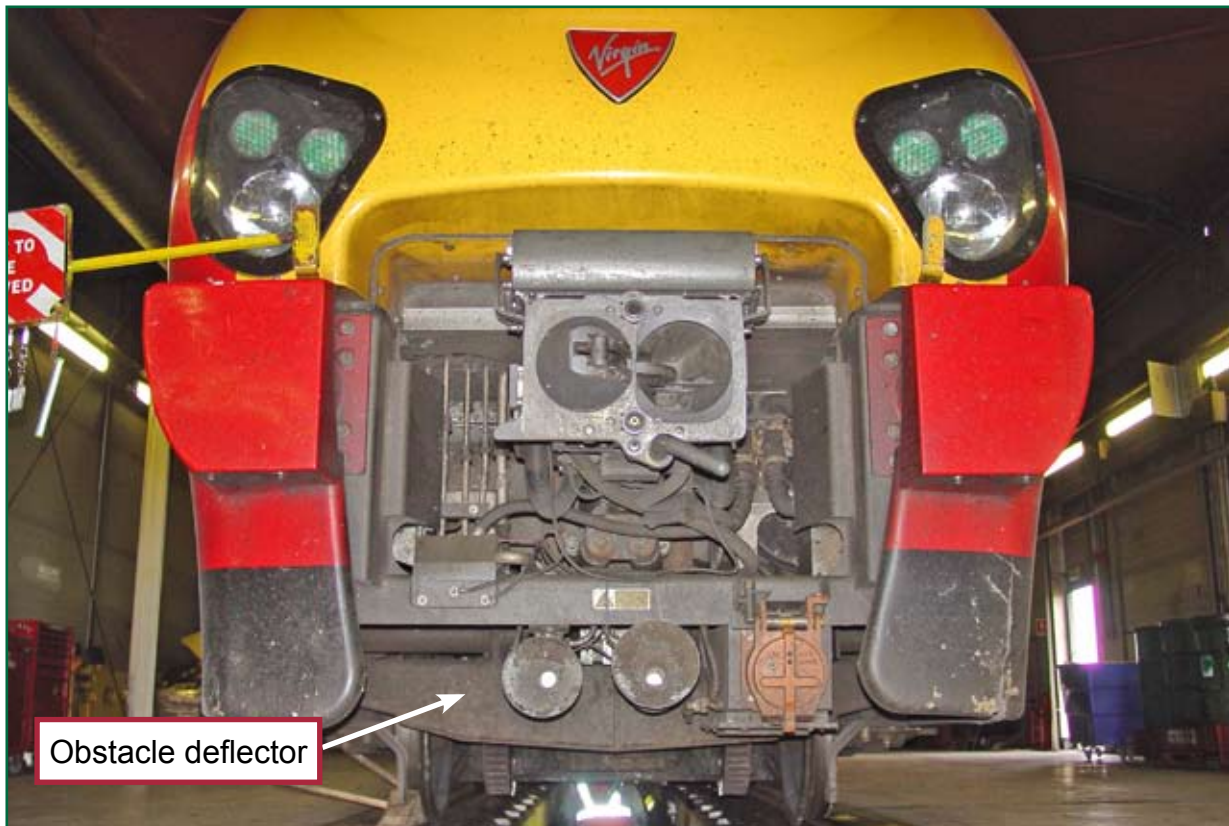
- 83 Trains that are built to current *Railway Group Standards*, which include class 221 trains, are fitted with an obstacle deflector at the leading end. This is a steel structure, usually attached to the underside of the leading body shell in front of the first bogie, which is designed to prevent large objects from entering under the train (Figures 6 and 7).

Figure 6: Location of obstacle detector seen from side of train

Figure 7: Undamaged obstacle detector at the rear of the train (note that horn covers are missing)

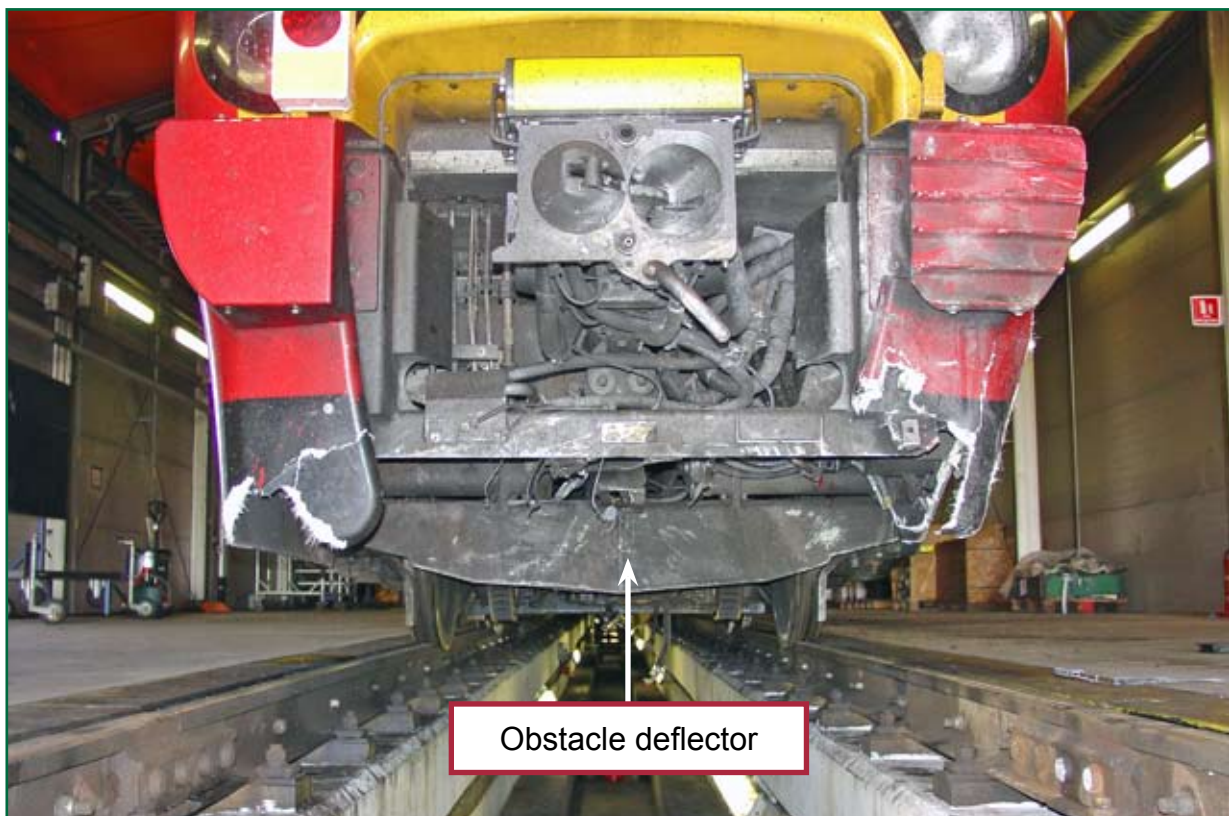
Figure 8: Obstacle deflector at the front of the train after the accident

- 84 The performance of the obstacle deflector was contributory to the train remaining in-line and upright after striking the car as it prevented the leading wheelset from derailing and also ensured that only relatively small bits of the car passed under the train (see Figure 8).

- 85 The obstacle deflector performed structurally in accordance with its design purpose. The obstacle deflector withstood the loading imposed by the collision with the car and remained attached to the train. There were no signs of distress at any of the attachment points. The deflector had rotated backwards before returning to a permanent plastic deflection on its mounts of seven to seven-and-a-half degrees.

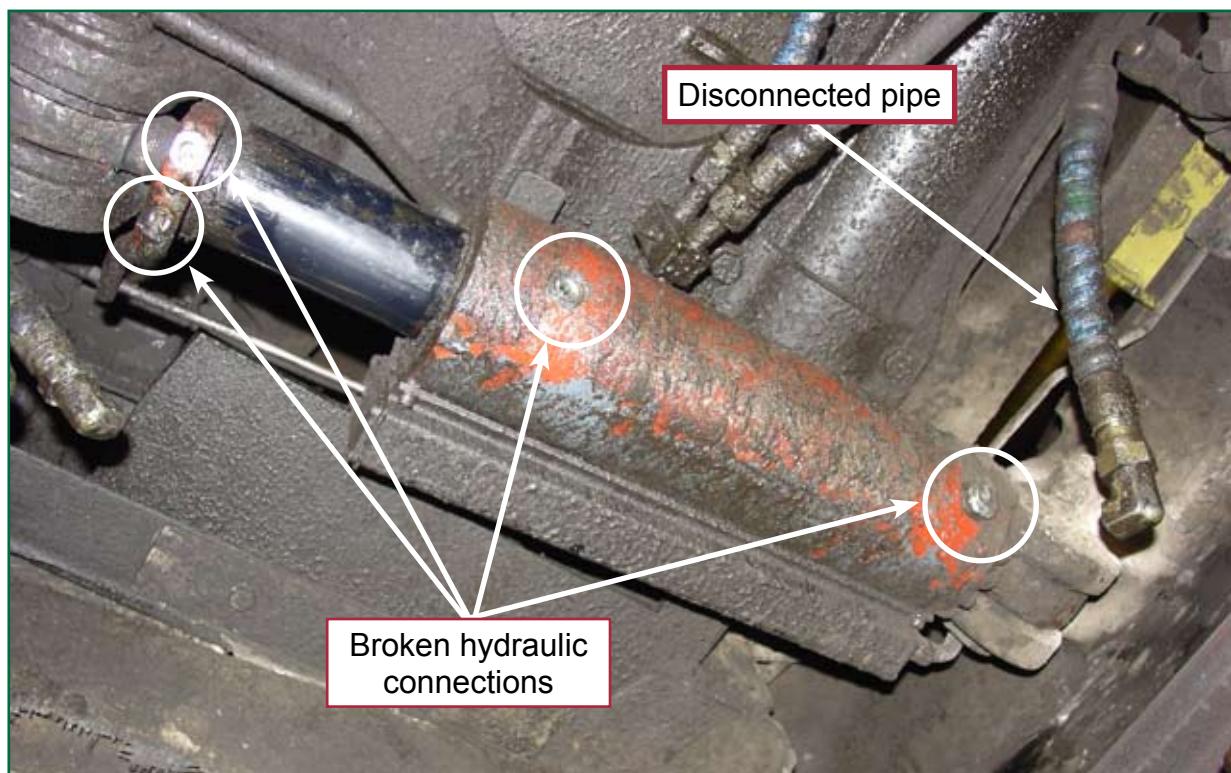
Figure 9: Tilt actuator showing all four hydraulic connections knocked off

- 90 The debris from the car hit several elements of the train's tilt system. In particular it knocked two hydraulic connectors off the *tilt actuators* located on the trailing bogie of the leading vehicle, and 60 % of the *locking actuators'* hydraulic connections (see Figure 9) The removal of the connectors from the tilt actuators caused a loss of system pressure which was detected by the *tilt control system's* pressure monitors. In accordance with its programming, the tilt control system then commanded the locking actuators to centre the tilt system, and to lock it in that position. However, due to the damage to the locking actuators' hydraulic connectors, the locking system failed completely on two vehicles (the leading and the third vehicle from the front) and partially on the other three. This left the leading and third vehicles free to tilt in a passive mode as dictated by the kinematics of the unlocked tilt pendulum system interacting with the vehicle body's centre of gravity.

- 91 The tilt control system is designed to monitor the operation and condition of the tilt system's constituent parts. When the tilt control system detects problems it instructs the tilt system to deactivate, and the tilt and locking actuators to power to the centre position and lock the tilt system. The probability of a wrong-way tilt being commanded or experienced for trains operating in normal conditions is thus very low. If a train loses hydraulic connectors, whether to the tilt actuators, the locking actuators, or both, as happened at Copmanthorpe, the train will not tilt beyond the permitted *kinematic envelope*, even at maximum permitted cant deficiencies. This is because the design of the mechanical components of the tilt system, when it is acting un-powered and free, is stable and moves the vehicle body to a position at or very close ( $\pm 1.5^\circ$ ) to the vertical relative to the bogie.

- 92 Concurrent loss of tilt actuation and total loss of locking, as occurred on two vehicles at Copmanthorpe, is still a safe condition that does not put the vehicle at risk of passively tilting 'out of gauge'.

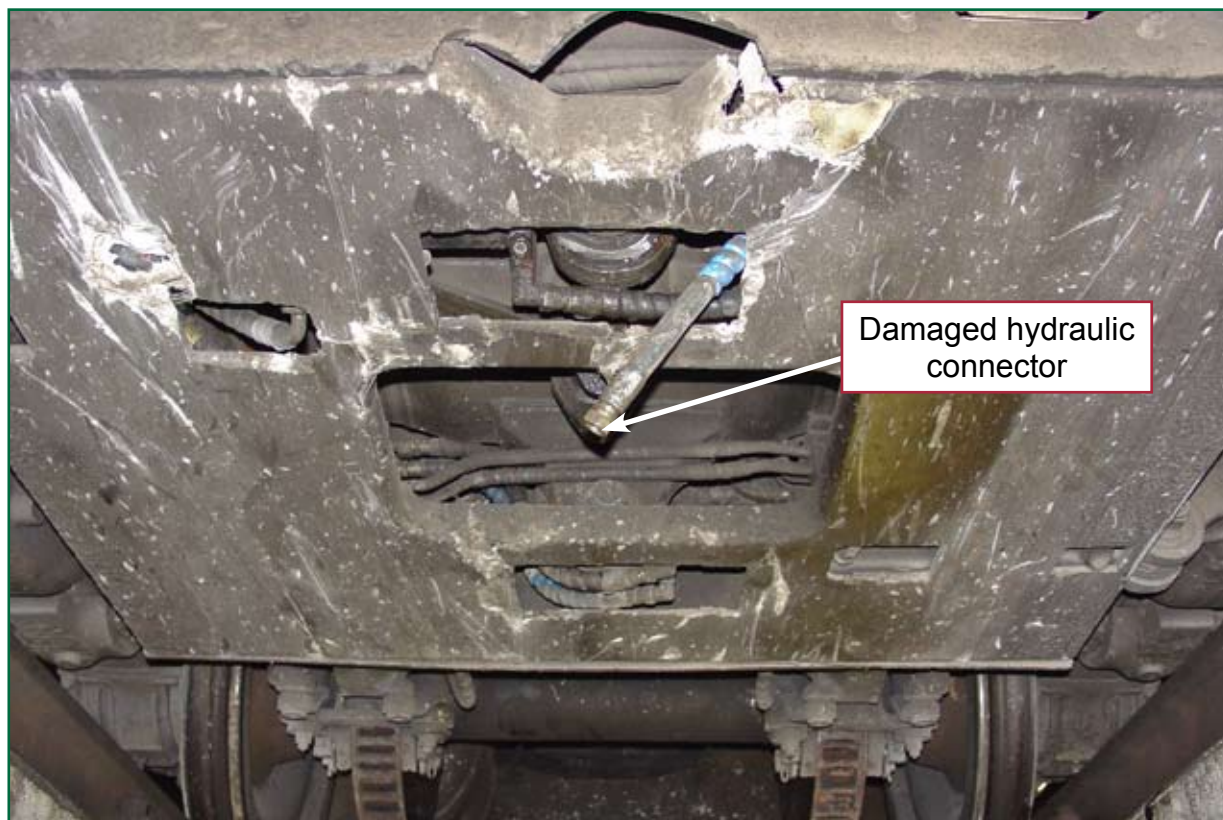
Figure 10: Stone guard showing openings and damaged hydraulic connector

- 93 More locking connectors were knocked off than tilt connectors as the former are close to the longitudinal centre-line of the bogie, where the stone guard's design contains significant openings to facilitate access to the tilt pipe work, which expose the locking connectors (Figure 10). The tilt actuator connectors are off-set to either side and are better protected by the stone guard.

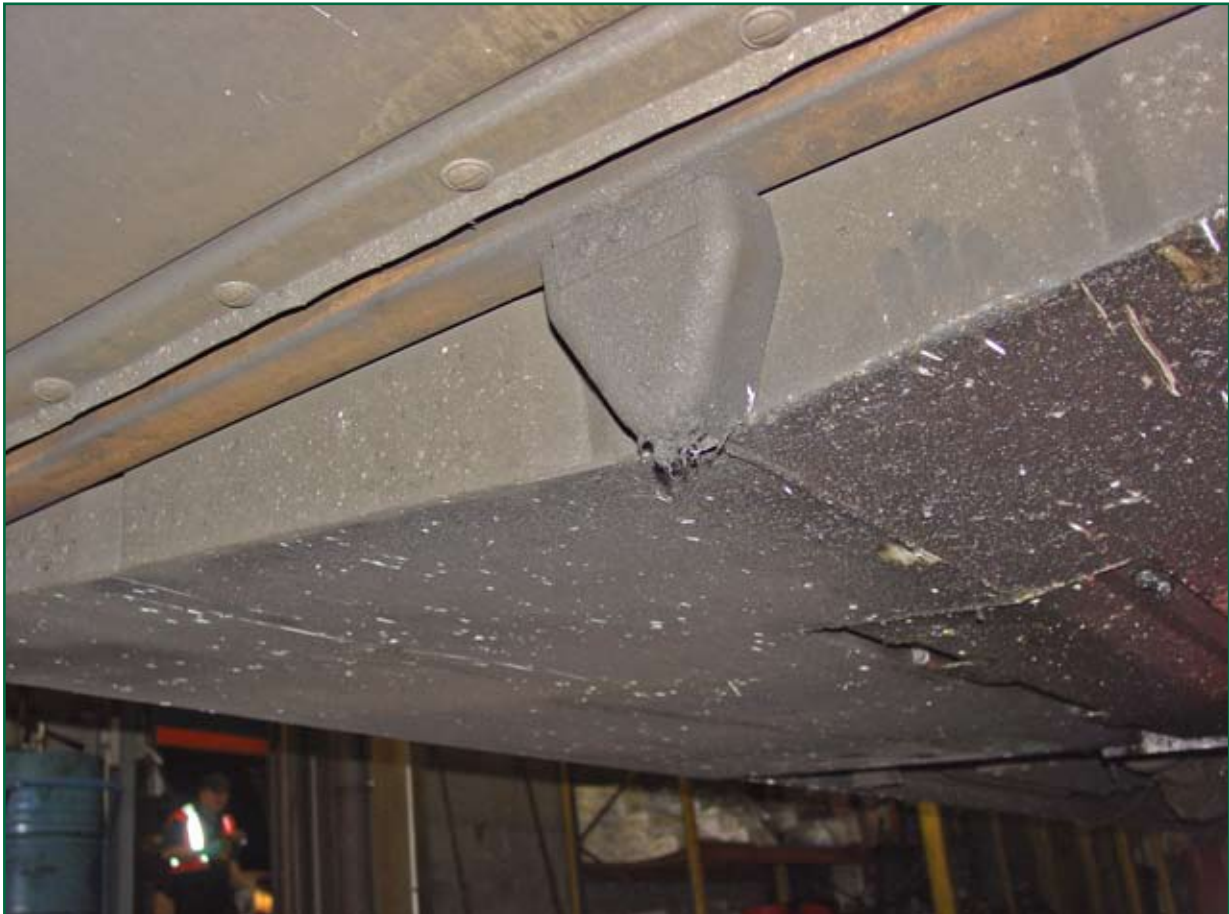
*Figure 11: Plastic cover over fuel tank 'dead-space' drain valve*

- 94 Debris from the car smashed the plastic protective cover on four of the five diesel tanks' 'dead-space' drain valves, and damaged the valves and their protective brass covers to such an extent that a large quantity of diesel fuel, possibly up to 1,500 litres from each of the four vehicles affected, leaked out into the ballast (see Figures 11 and 12).
- 95 The plastic cover, which was designed to protect against small objects such as pieces of track ballast, was not strong enough to withstand the impact with the collision debris at 100 mph (161 km/h) and therefore did not protect the valves or their protective brass covers.
