Rail Accident Report

Derailment at Epsom 12 September 2006

Derailment at Epsom, 12 September 2006

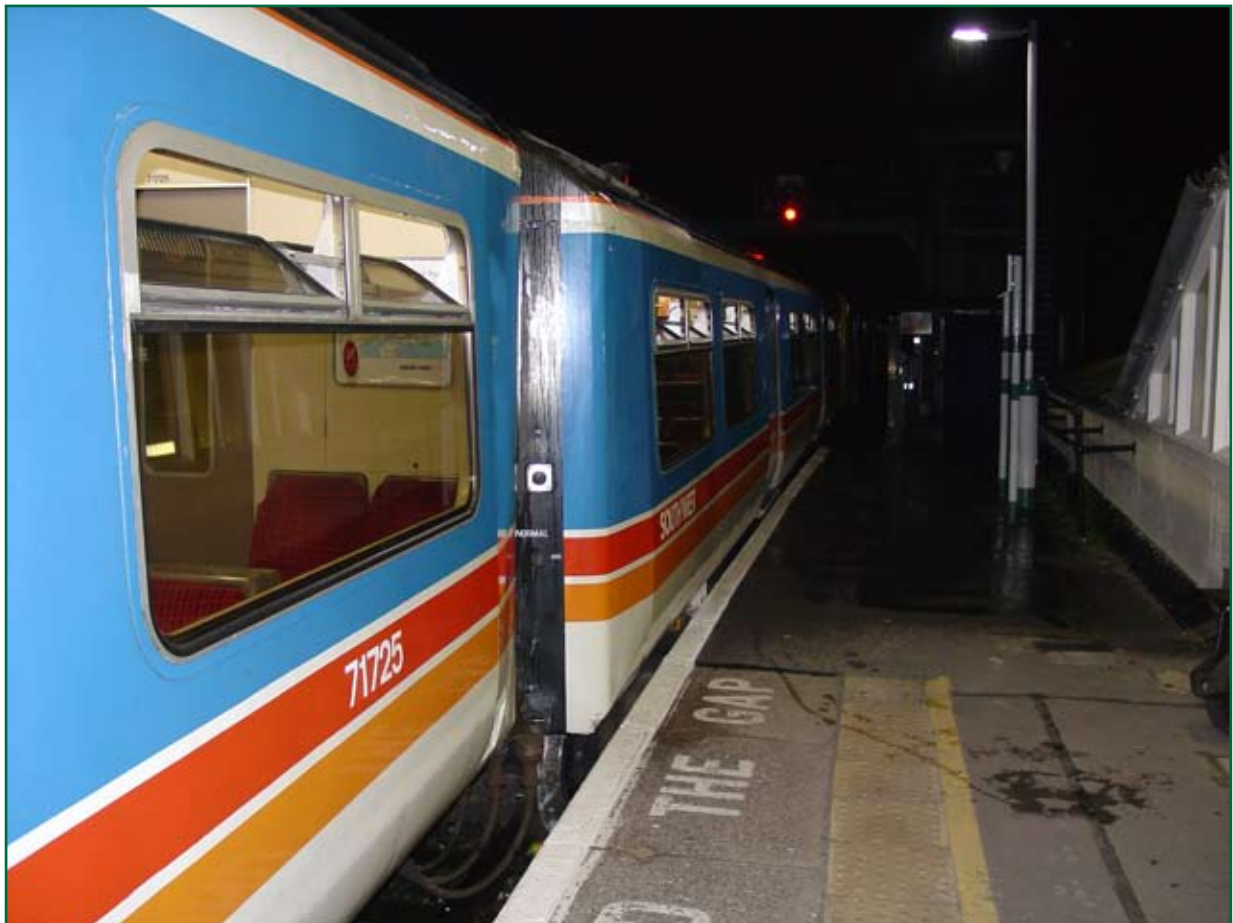
Figure 2: Third and fourth carriages of train, showing fourth carriage derailed and in contact with station platform

- 32 There was slight damage to the train where it contacted the platform edge, and distortion to the damper brackets of the derailed bogie caused by the excessive bogie rotation which occurred during the derailment. One ‘hopper’ ventilator window was dislodged when its stay bracket was broken, and fell into the passenger saloon, but it did not shatter and there was no other interior damage or displacement of internal fittings.
- 33 There was some track damage beyond the point of derailment, with minor damage to 840B points, the *diamond crossing* and some track fastenings and sleepers, but superficial damage only to the edge of the station platform.

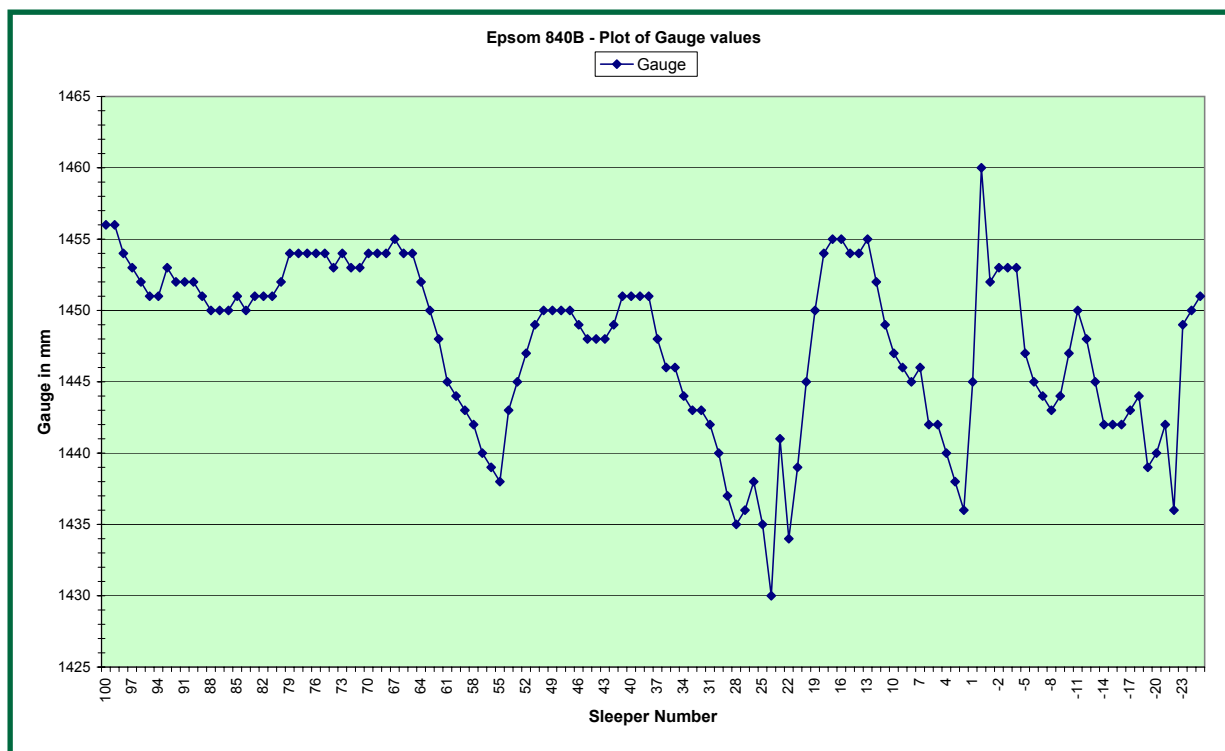
Figure 4: Track gauge at derailment site

- 117 The TISE noted the wide gauge (1460 mm) at the point of derailment on several occasions during the facing point inspections (paragraph 83). In April 2006 he recommended fitting tie bars to correct the gauge, pending replacement of the switches, but this was not done.

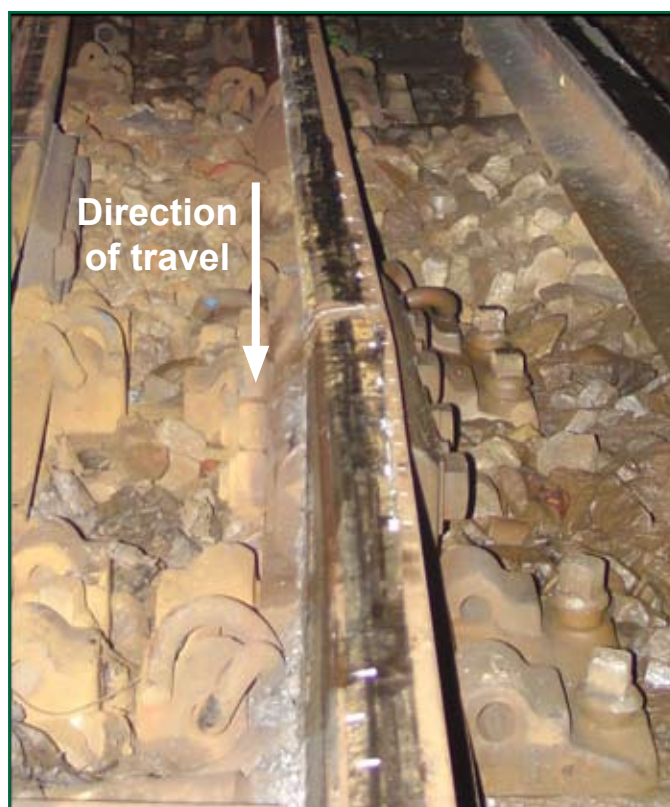
Figure 5: Outer rail at point of derailment, showing misalignment

- 102 The sidewear and misalignment had developed over a number of years, and had been identified by the patrol staff and the asset inspection team and recorded in their reports. Remedial work to realign the track and replace the rails had been planned, but had not taken place. The vertical misalignment was in the form of a step created by the head of the stock rail, worn down some 6 mm over the 22 years it had been in place, being adjacent to the rail on the curve which was relatively new, having been replaced in July 2005 (although it was already becoming sideworn to the point where it was proposed for re-railing in July 2006 (paragraph 123)). When this was done, the existing straight fishplates were used to form the joint. The use of stepped fishplates to bring the running surfaces into the same plane (in accordance with the relevant standard (paragraph 104)) would have reduced the impact loading on the end of the stock rail, and might have reduced the spalling which took place (paragraph 59).

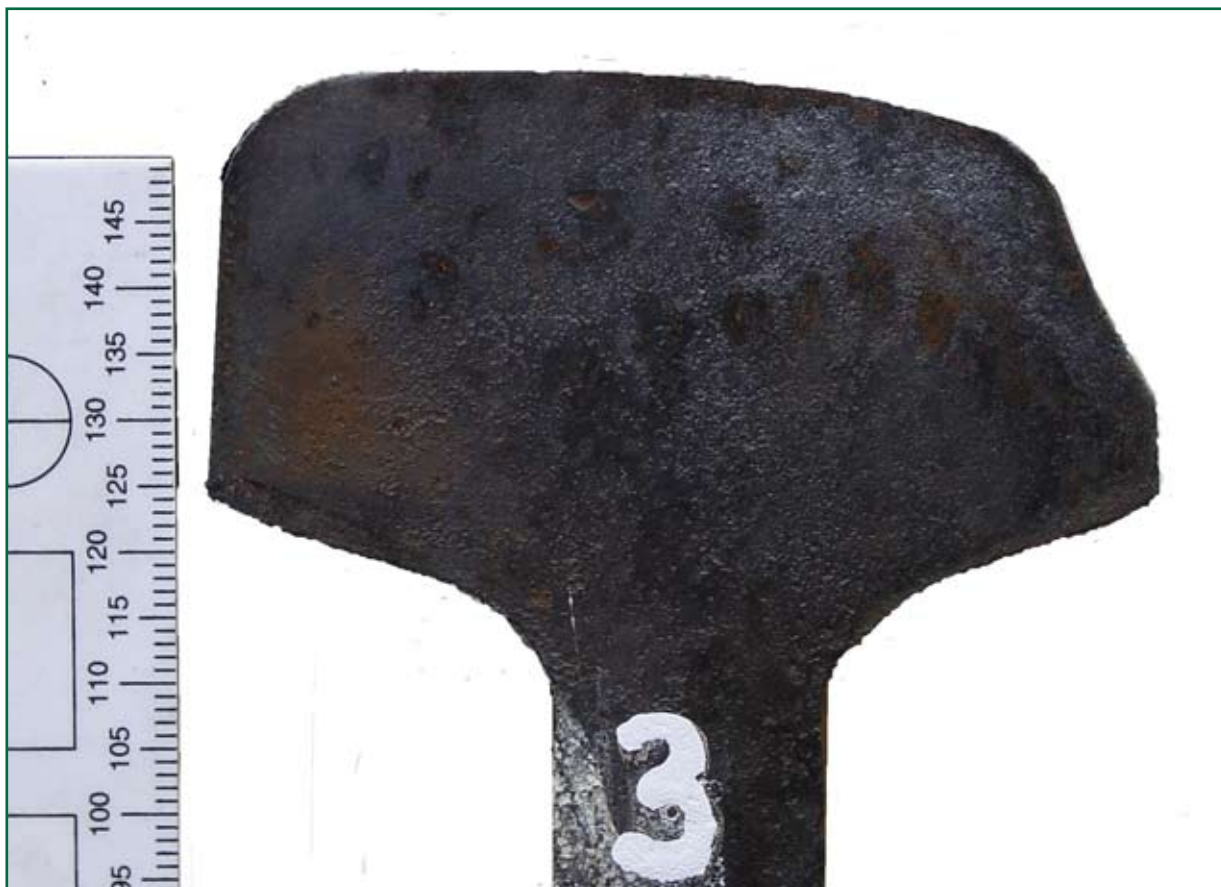
- 55 The running-on rail was marked as being made of austenitic manganese steel (AMS), and was magnetically verified as such. AMS is used for point components because of its greater wear resistance. Both the rail head and foot were approximately 3 mm wider than specified. Other dimensions were within the tolerances for BS 113A rail, although the rail height was reduced from the nominal size by about 6 mm by wear.
- 56 The effect of the wear on the head of the running-on rail was to produce a step of approximately 5 mm between the two rails when they were connected together with *fishplates*. This rail was also sideworn at the running-on end (Figure 6). There were heavy deposits of powdered metal on the gauge face and on the foot of the rail: these deposits were fresh and had not oxidised (Figure 7).

Figure 6: Section of end of running-on rail

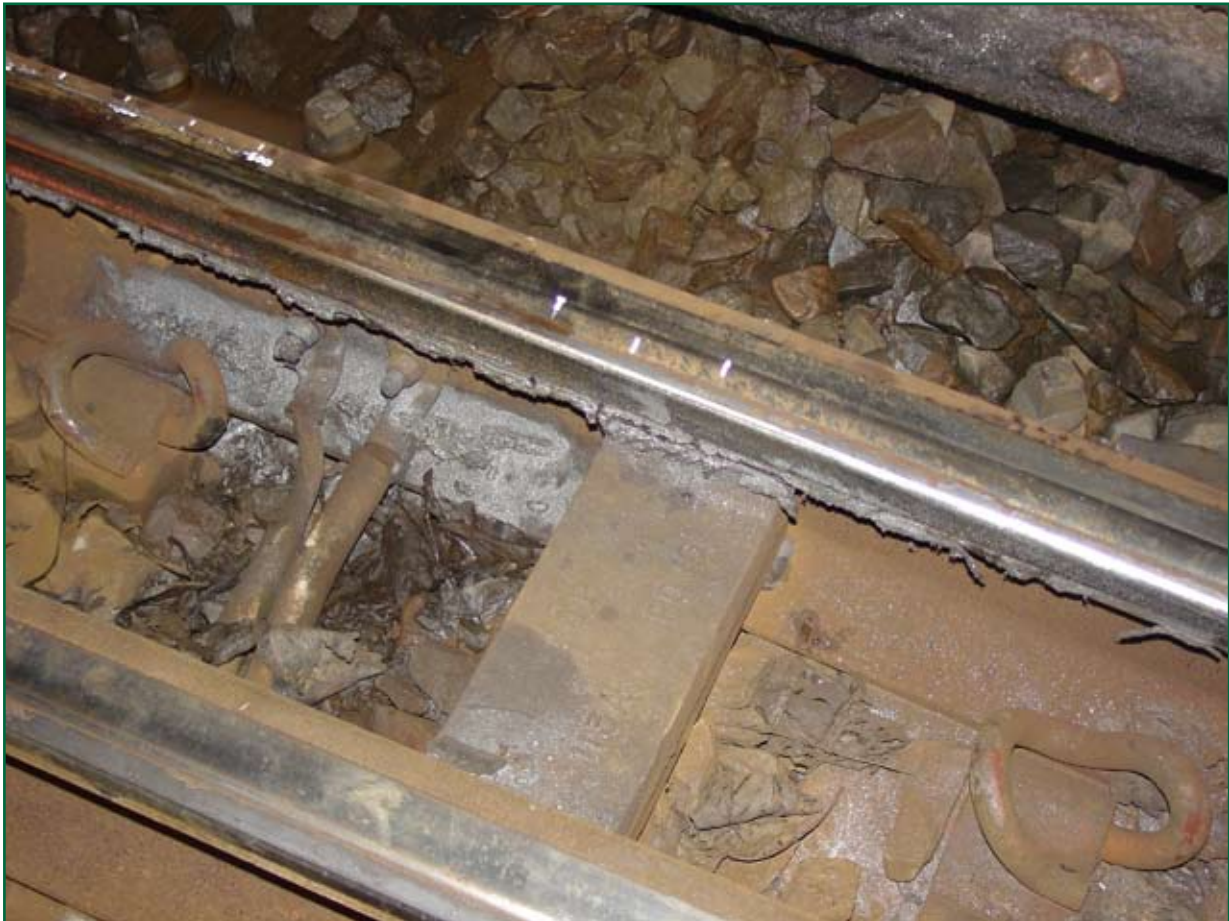
Figure 7: Stock rail near point of derailment, showing sidewear and deposits of powder worn away from rail head

- 110 Because of the lack of lubrication, the rate of sidewear on the curve had increased, and after the derailment a large quantity of metal particles was found on the rail head and spread over the rail foot immediately beyond the heel joint.

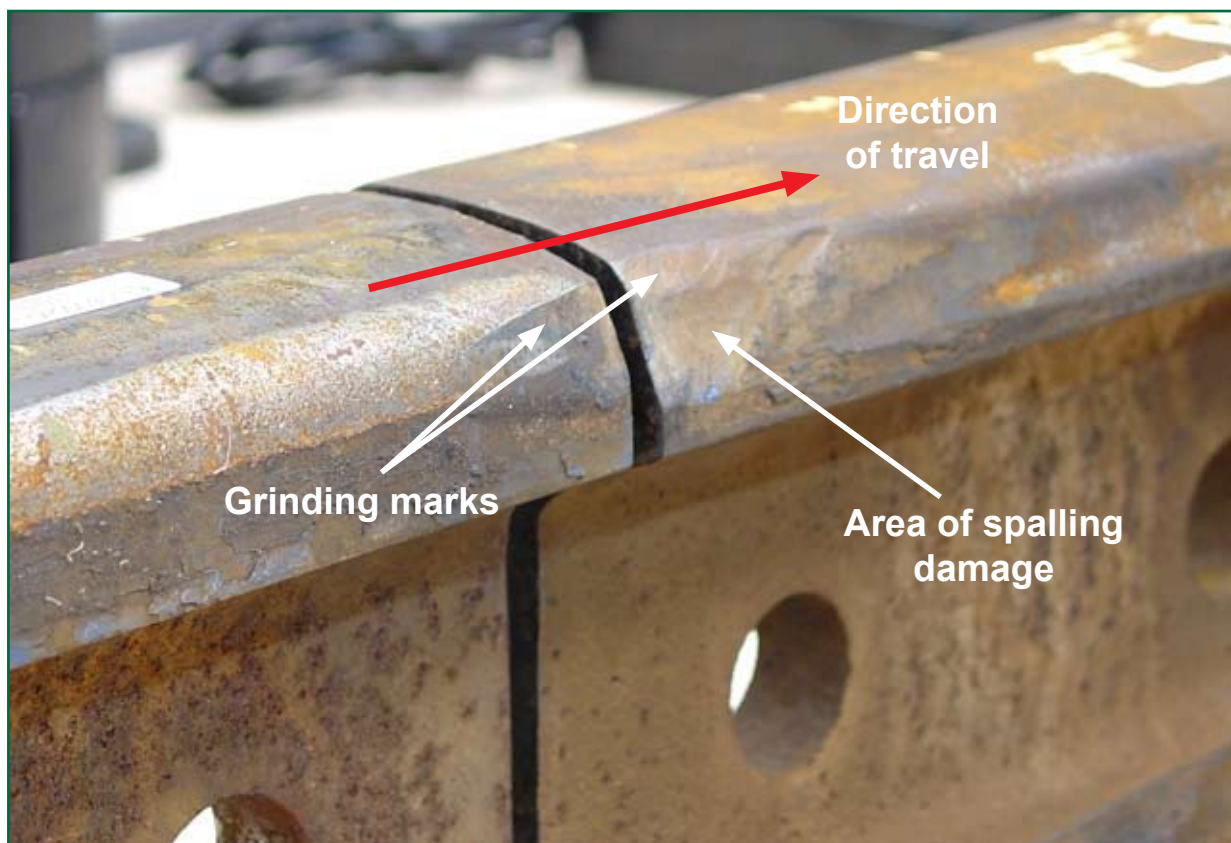
- 57 On the running-on rail, there was evidence of ‘batter’ damage (localised plastic deformation generated by wheels passing over the stepped joint) to the top of the rail head. Damage to the top of the rail extended approximately 530 mm from the joint.
- 58 There was an area of damage to the head of the running-on rail, approximately 55 mm long extending from the rail end, consistent with the application of a rotary abrasive disc grinder (Figure 8).
- 59 There was also damage to the gauge face immediately below the grinding marks that appears to have been caused by ‘spalling’ of the surface, a phenomenon in which repeated impact loading of the surface material of the rail causes it to become work hardened and embrittled to the point where it breaks off (Figure 8).

Figure 8: Wear and grinding damage on rail head adjacent to joint (photographed in laboratory)

- 99 The dynamic predictions are consistent with the derailment being caused by low speed flange climbing arising from the combination of high friction conditions and the local geometry of the heel joint at points 840B. The reason why this particular set of wheels derailed cannot be positively identified, but it is likely to have been related to interaction between a single flange and the 'ramp' produced on the gauge face by the grinding marks (paragraph 58) (Figure 8).

- On completion of any joint the running surfaces, both rail head and running edge, shall be coplanar.’
- 105 The grinding carried out in this case did not meet any of these requirements. It is possible that this particular piece of grinding was carried out with the intention merely to remove an obvious sharp edge that would have been battered over by wheel flanges and might have caused failure of the IBJ.
