Rail Accident Investigation Branch

# Rail Accident Report

## Collision at Swanage station 16 November 2006

## 16 November 2006

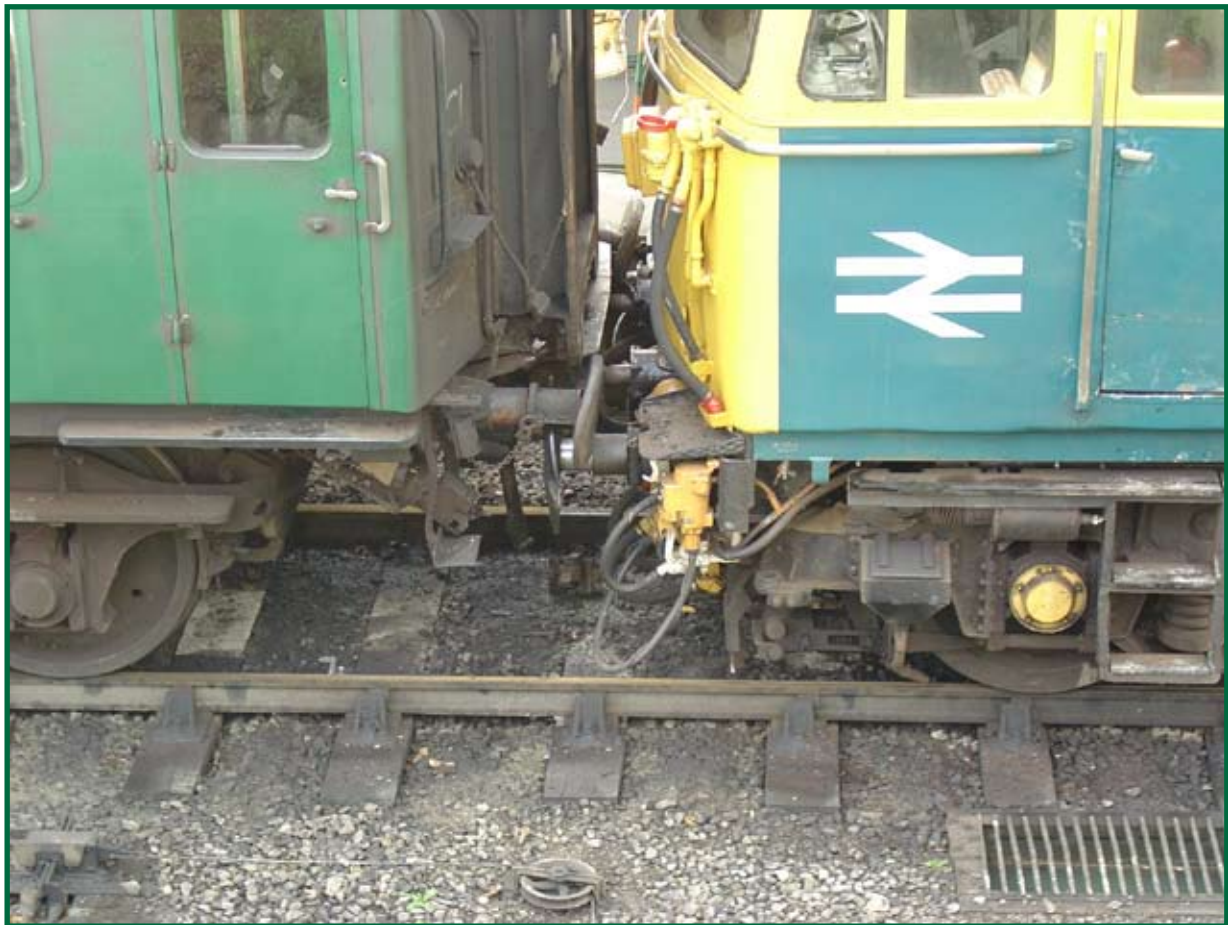
Figure 2: Damage sustained to the locomotive and carriage

- 46 The driver and one of the staff members working in the carriages were slightly injured.
- 47 The carriages were moved 0.6 m towards the buffer stops as a result of the collision. Locomotive 33 108 and the westernmost carriage became buffer-locked (Figure 2).
- 48 Locomotive 33 108 suffered damage to its buffers, buffer beam and body panels at the eastern end.
- 49 The westernmost carriage suffered damage to its buffers and a bogie centre casting.

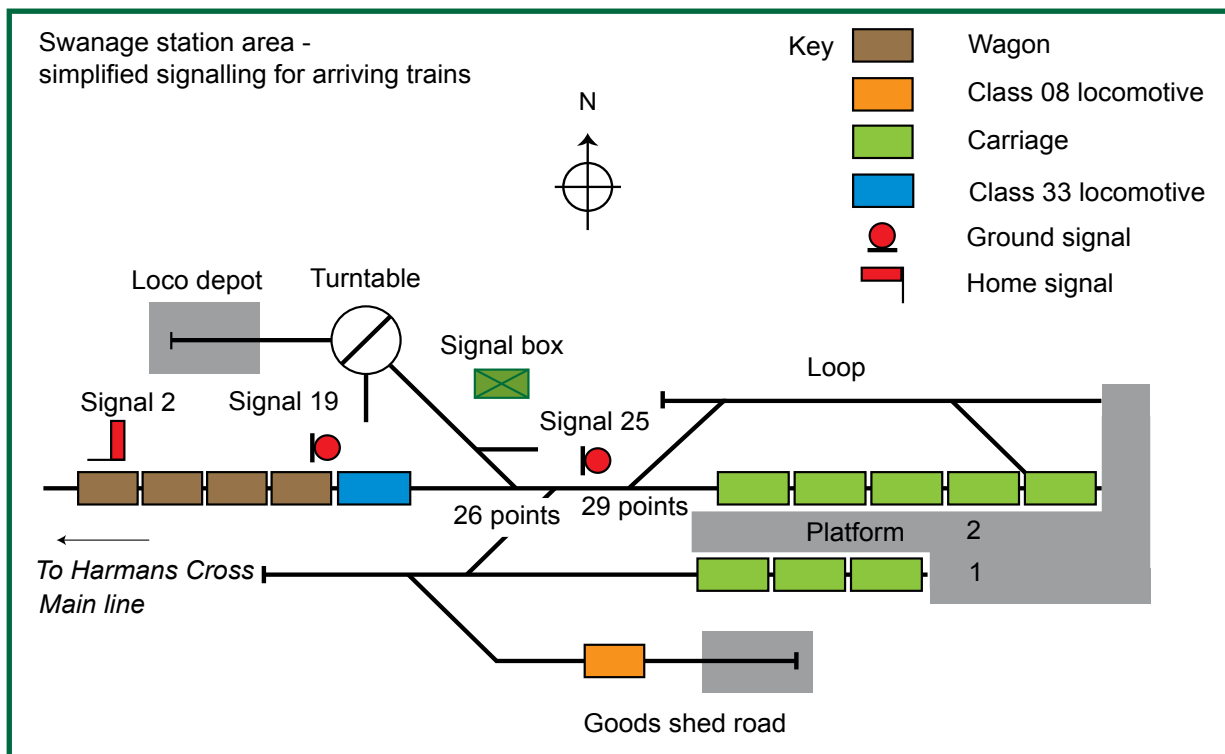
Figure 4: Layout of track at Swanage station, showing signals applicable to an arriving train

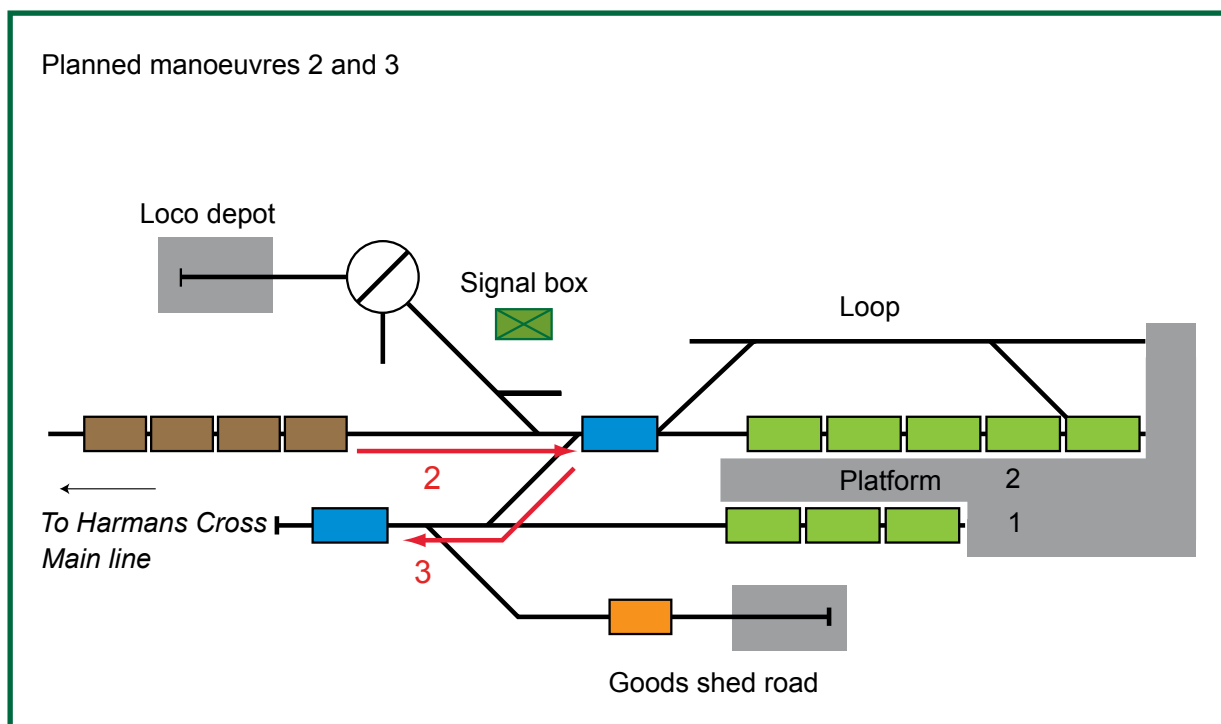
Figure 7: Sketch showing the intentions of steps 2 and 3 of the manoeuvre described in paragraph 34

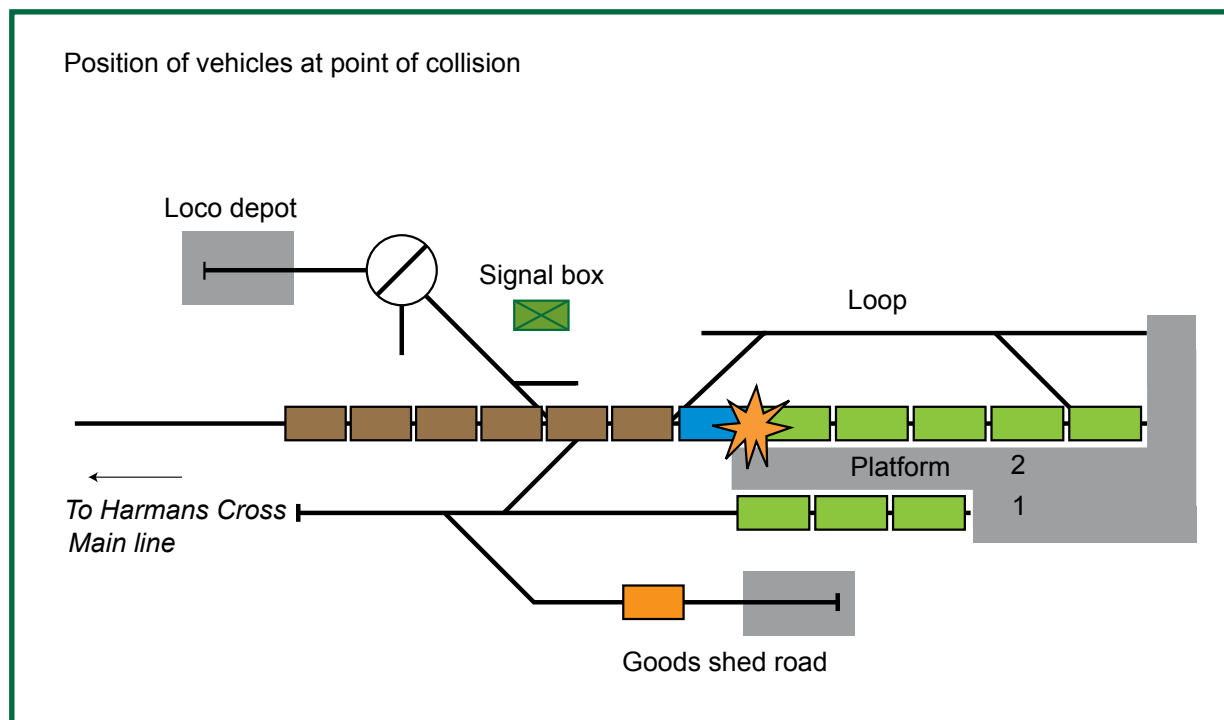
- 44 The operations manager, who was in the cab of the class 08 locomotive, realised that the whole train was moving, contrary to his instructions, and tried to phone the driver by using a speed dial function on his mobile phone. The phone had not rung by the time the collision occurred. The operations manager could not see from his position whether the train was heading for platform 2 or the loop.
- 45 When the driver realised that he was moving into platform 2 he applied emergency braking but this was too late to prevent the train colliding with the stationary carriages (Figure 8).

Figure 8: Sketch showing the actual move of the train up to the point of collision

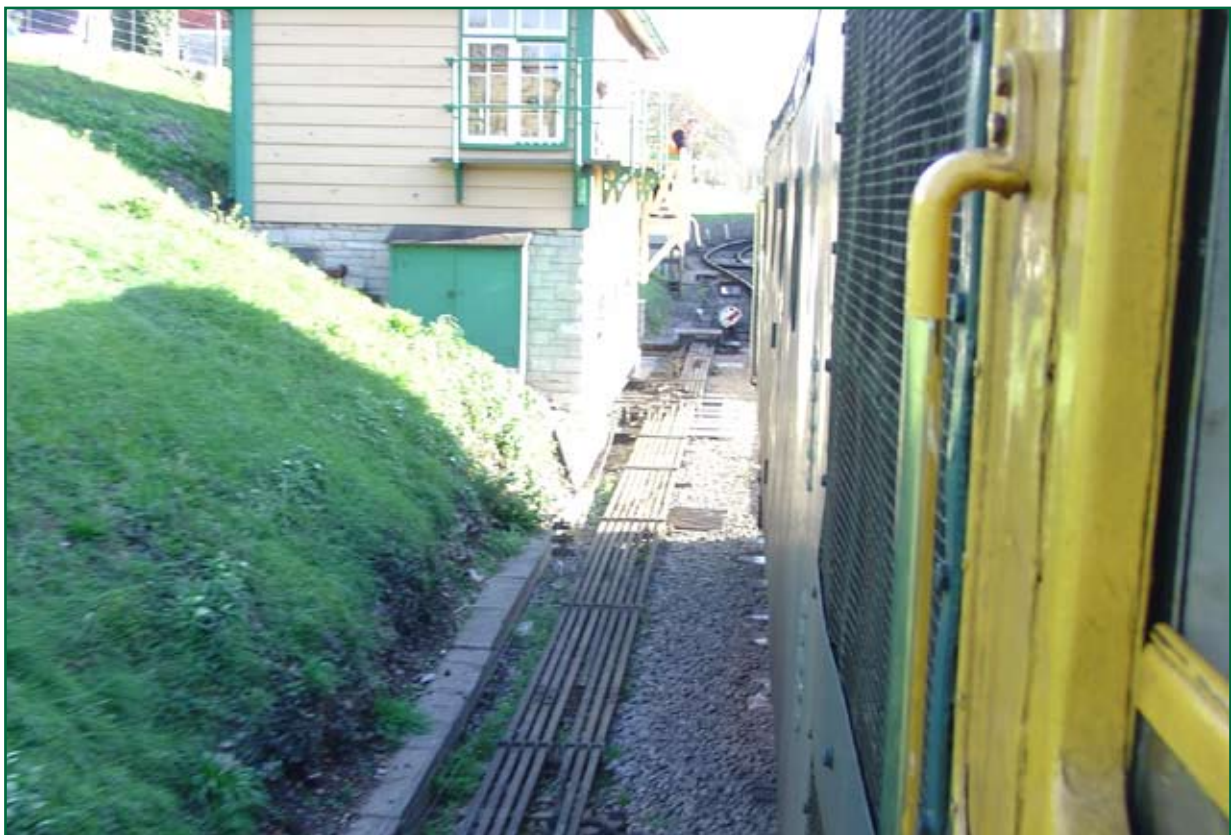
- 66 The driver's perception of the shunting movement (paragraph 57) may have led him to anticipate that signal no.25 would be set for the loop, and hence only to look at it for permission to start forward, and not to check the route indicator aspect.
- 67 The driver of locomotive 33 108 chose to drive it from the rear, western, cab. Had he been in the leading, eastern, cab he would have had much better visibility of signal no.25 (Figure 9), been able to see the lie of the points, and would have realised earlier that the train was heading into platform 2. It is likely that had anyone been in the leading cab the collision would have been avoided.

Figure 9: View of signal no 25 from rear cab of locomotive 33 108, showing 'L' aspect

- 1 The Swanage Railway should amend their Rule Book to:
  - ensure that shunting movements are made by the safest possible route; and
  - ensure that whenever possible shunting moves are driven from the leading cab of the locomotive.(paragraphs 79 & 80(a), 84)
- 2 The Swanage Railway should review its implementation and monitoring of the rule book requirements for safety critical communication to ensure that the requirements are being complied with, and implement such changes as are found necessary (paragraph 80(b)).
