# Rail Accident Report

## Fire on HGV shuttle in the Channel Tunnel 21 August 2006

This report is published by the Rail Accident Investigation Branch, Department for Transport.

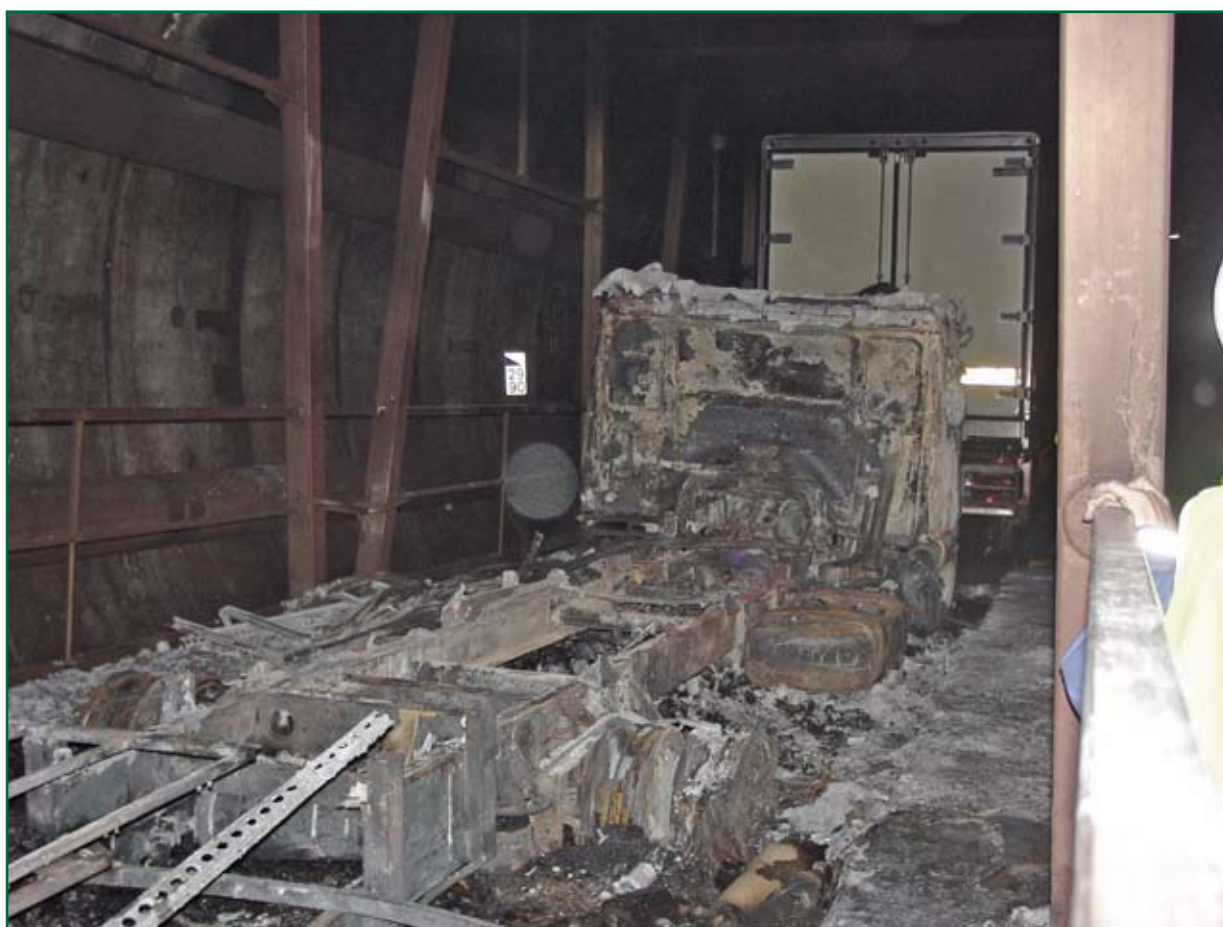
- 46 No passengers or staff were injured during the incident.
- 47 Damage to the tunnel infrastructure was confined to the immediate area of the fire over a length of approximately 12 metres. Cables running along the tunnel wall were damaged. The overhead catenary sustained damage as the copper *contact wire* parted. The tunnel lining immediately above the fire was penetrated to a depth of 30 mm, which was just sufficient to expose the steel reinforcements, but did not cause the dislodgement of large concrete sections.
- 48 The lorry concerned was destroyed by the fire (Figure 4). The lorry immediately behind it suffered destructive damage to the plastic covering over the refrigeration unit (Figure 5); the lorry ahead sustained light damage to the rear involving distortion to the registration plate, rear lights and mud flap (Figure 6).

*Figure 4: Burnt out HGV (at original site)*

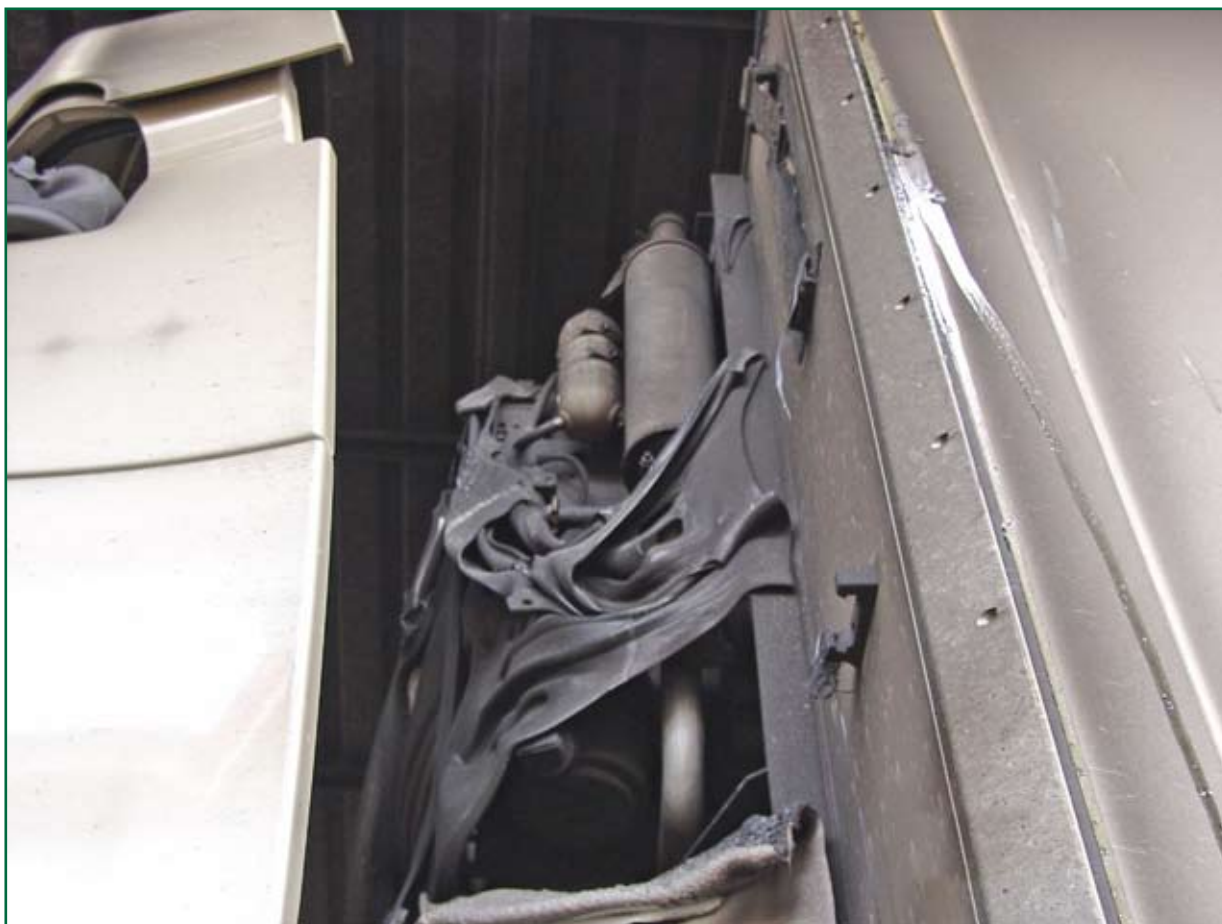
*Figure 5: Damage to refrigeration unit of HGV behind incident wagon*

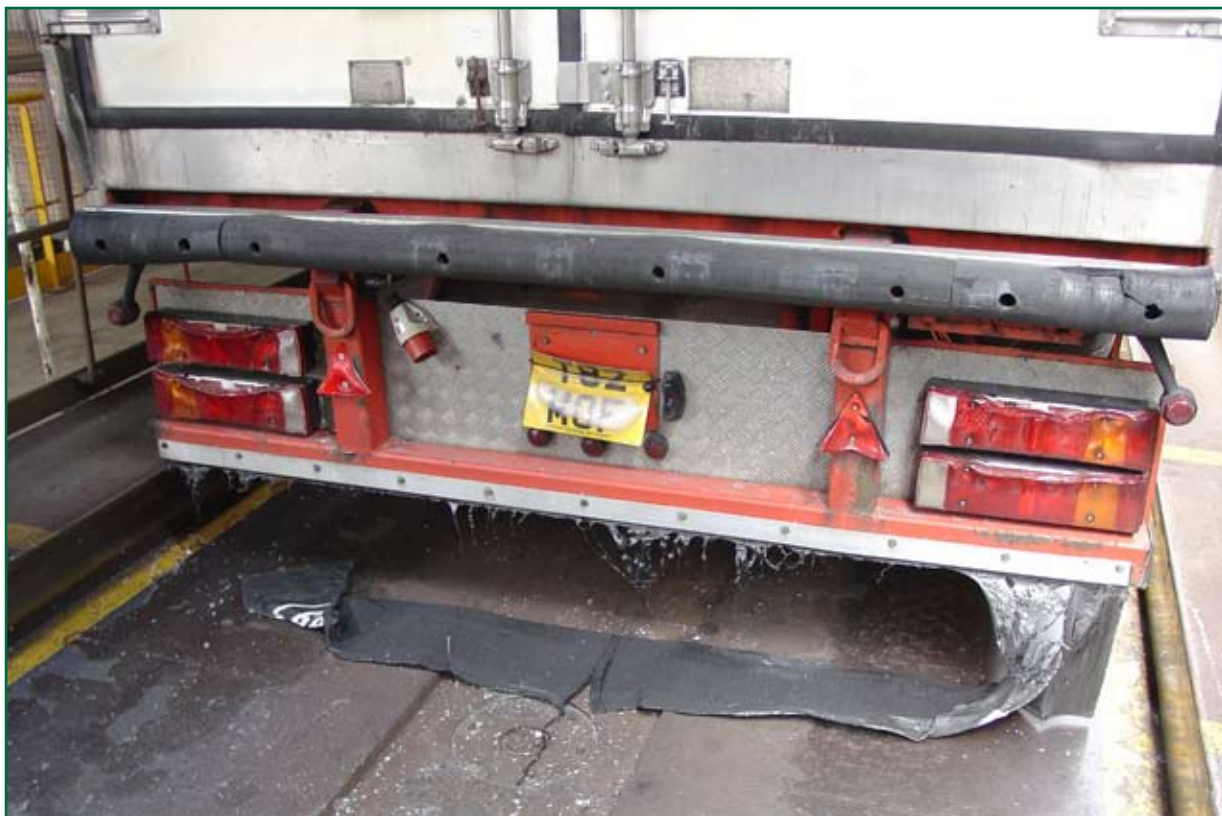
*Figure 6: Damage to rear of HGV ahead of incident wagon*

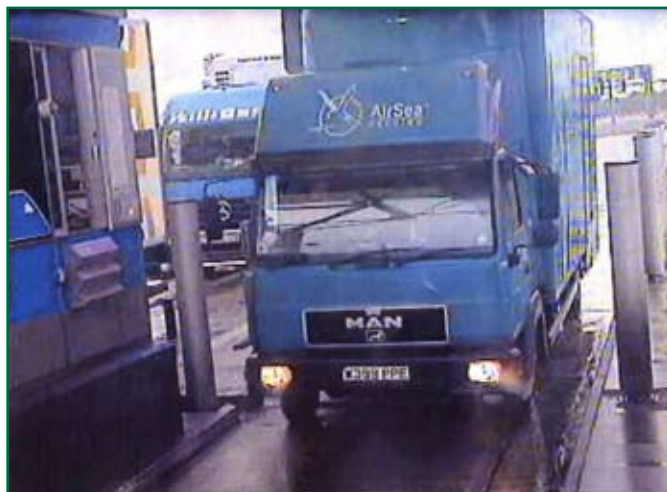
- 121 The lorry involved in the fire was owned and operated by AirSea Packing Group Ltd of Twickenham, Middlesex (Figure 9). It was a rigid chassis vehicle with separate cab and load compartment. The latter comprised an alloy and steel frame to which was attached the aluminium side panels and the roof. A side door to the rear of the near side and a full height rear tailgate gave access to the interior.

*Figure 9: Incident HGV before the fire (photograph courtesy of Kent Police)*
