Rail Accident Report

**Derailment at Birmingham Snow Hill,
Midland Metro
29 January 2007**

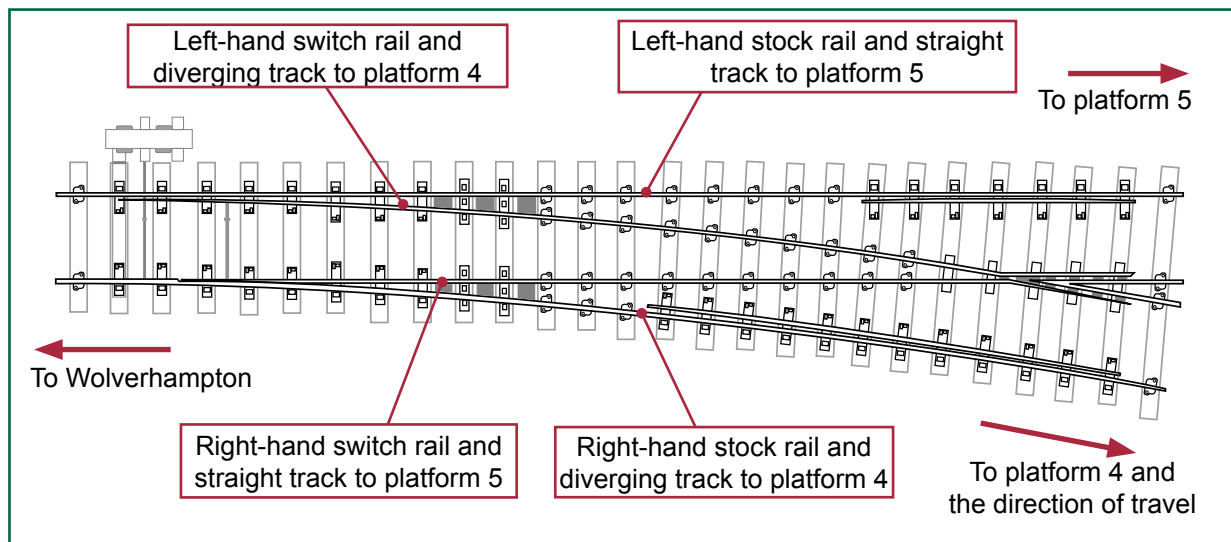
Figure 5: The S&C layout at Birmingham Snow Hill

- 15 S&C *sidewear* is caused by interaction between the rail and wheel *flanges* and is most pronounced on the *switch rail* that causes a tram to change from the straight to the diverging track. A sidworn switch rail can usually be repaired, with lost material built up by welding and its as-designed geometry restored by grinding.
- 16 Travelling into Birmingham Snow Hill, the S&C diverging track is formed by the left hand switch and right hand *stock rails*. See Figure 5 for its layout. Between the Midland Metro commencing operation in May 1999 and December 2006, the left hand switch rail had been weld repaired on at least three known occasions. The dates of these repairs were November 1999, July 2001 and March 2004.

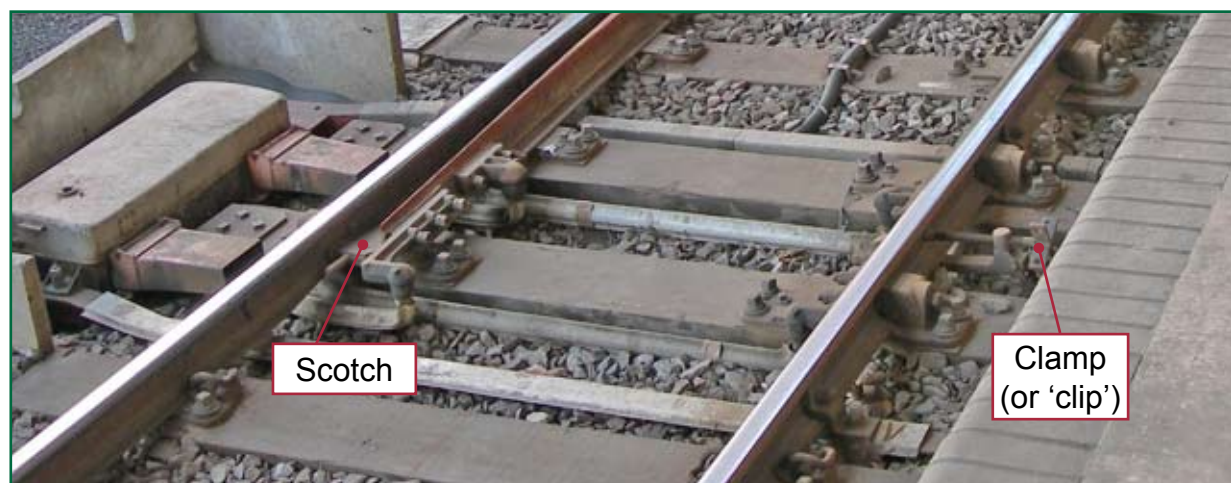
Figure 6: The S&C clipped and scotched out of use

- 17 In summer 2006, Carillion informed TMM that the left hand switch rail of the Birmingham Snow Hill S&C had failed its sidewear inspection; it was then *clipped and scotched* to take the diverging track, and thus Birmingham Snow Hill platform four, out of use. Soon afterwards, a TMM manager decided to reinstate the S&C without rectification, increased inspection or any other measure put in place to take account of its condition.
- 18 On 21 December 2006 a Carillion track worker again found that the left hand switch rail failed its sidewear inspection, clipped and scotched it out of use and advised Midland Metro in writing of this course of action. See Figure 6.

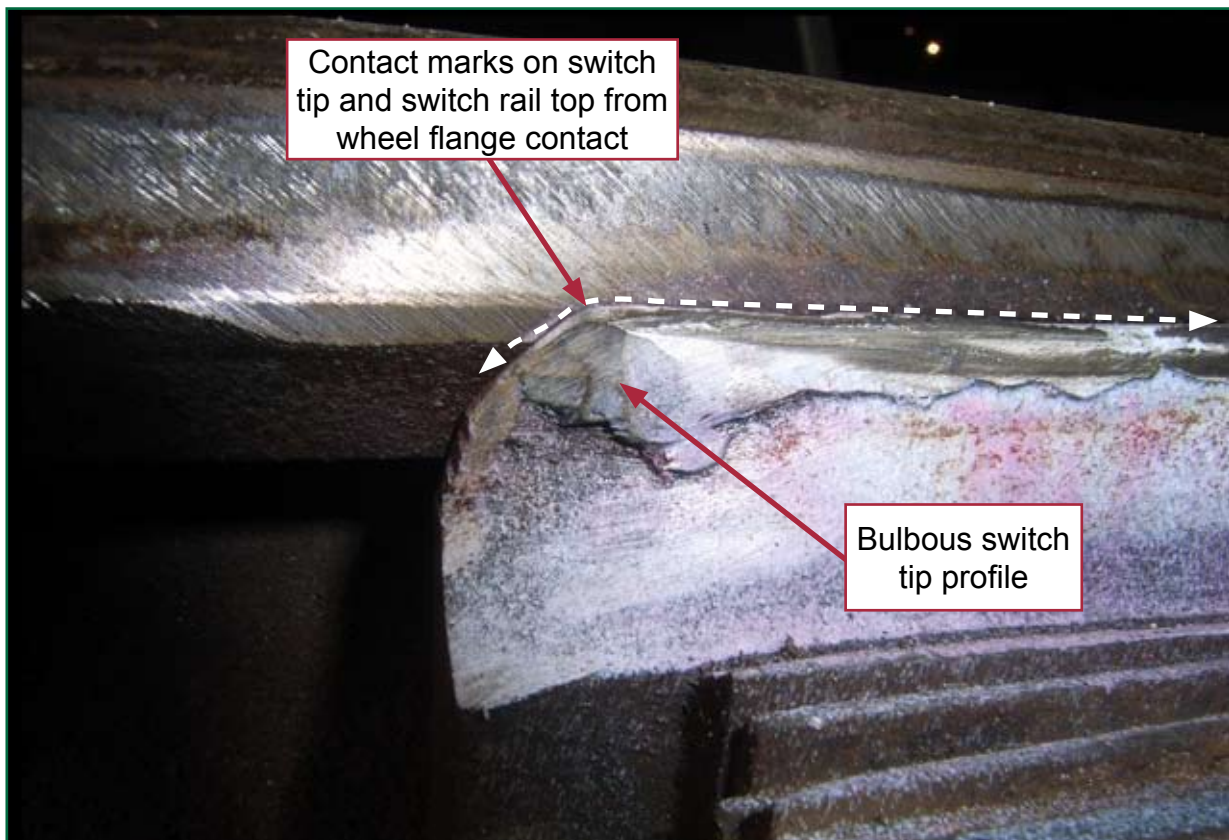
Figure 7: Left hand switch tip

- 29 As tram 06 traversed the S&C, the centre bogie's leading left hand wheel struck and climbed the left hand switch tip and ran along the switch rail. Figures 7 and 8 show wheel flange contact marks on the switch tip and switch rail top respectively.
- 30 The wheel flange travelled 2.6 metres along the switch rail top then dropped into the widening gap between switch and stock rails. The centre bogie trailing wheel derailed in the same manner, resulting in the derailment of all wheels. See Figure 9.

- 31 The immediate cause of the derailment was the interaction between the wheel and the switch tip, causing the wheel to climb onto the top of the switch rail.

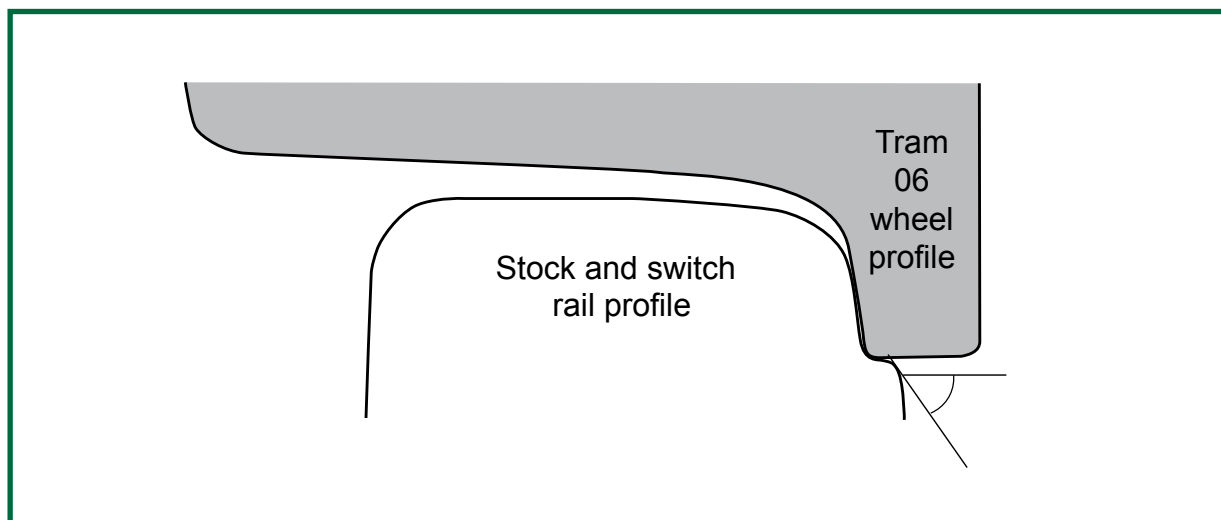
Figure 11: As repaired switch tip and tram 06 centre bogie leading left hand wheel

- 38 The repaired switch tip had a rounded and bulbous profile, was not chamfered to a 'knife edge' and did not undercut the stock rail. It was a derailment hazard as its profile was flatter than that of the stock rail and had an angle of less than 60° where indicated. See Figures 7 and 11. Contact marks from the passage of a number of wheels from trams 02, 12 and 06 can be seen in the *dye penetrant testing* material left from the welding repair. See Figure 12.

- 40 A causal factor was that the left hand switch rail had not been restored to its as-designed geometry following weld repair.

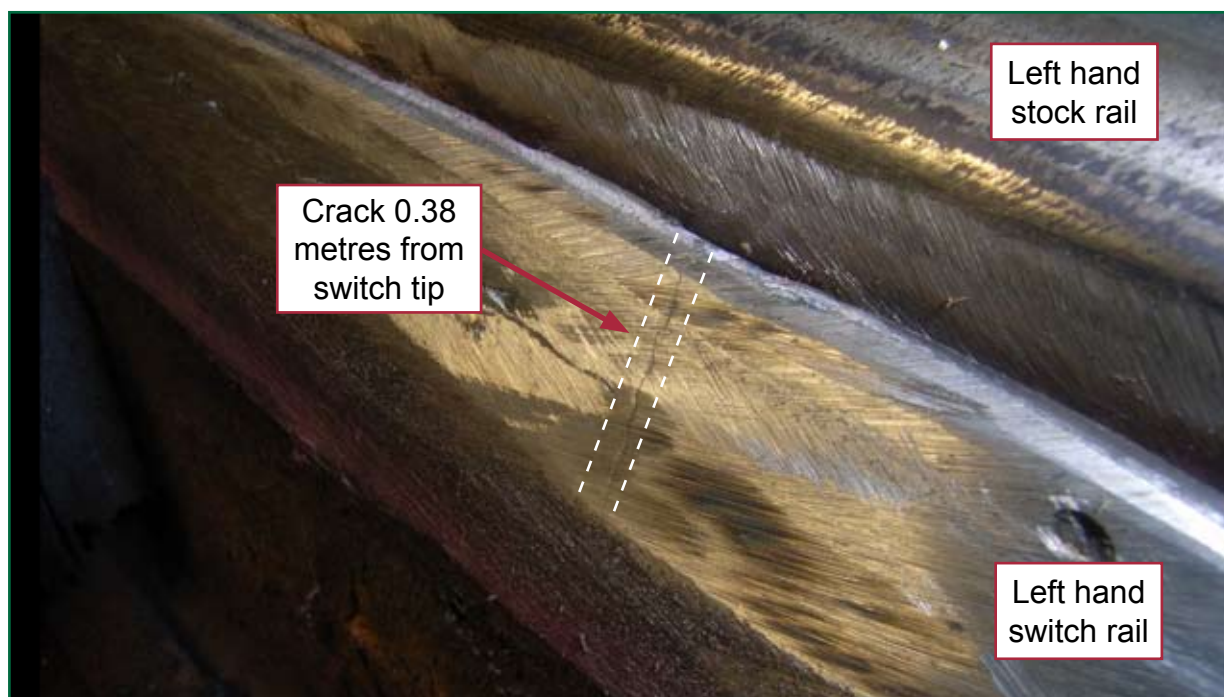
Figure 13: Left hand switch rail fracture

- 39 Impact forces from a number of wheels from trams 02, 12 and 06 were sufficient to crack the switch rail 0.38 metres from the switch tip. The crack was not present before or during the weld repair as it contains no dye. See Figure 13.
