# Rail Accident Report

## The derailment of a freight train at Washwood Heath 8 September 2006

This report is published by the Rail Accident Investigation Branch, Department for Transport.

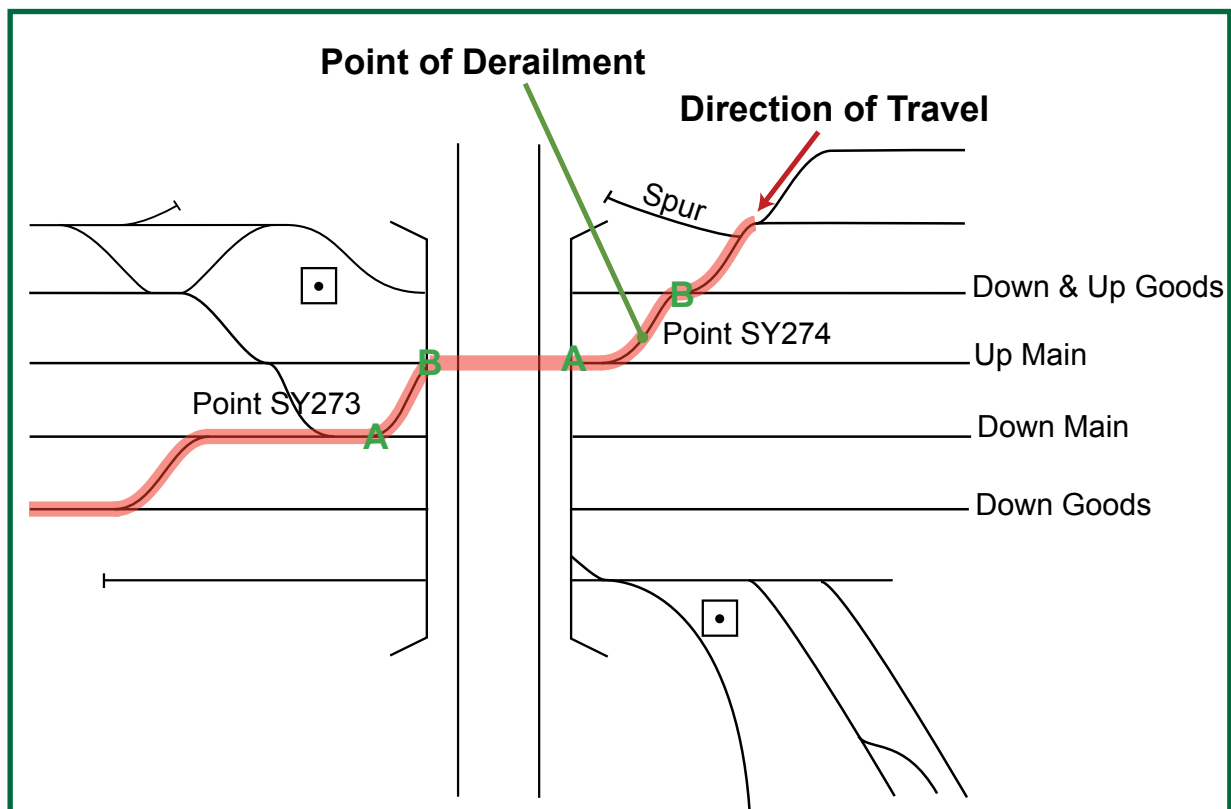
Figure 2: Diagram of SY274 crossover showing point of derailment

- 28 As the train passed over the crossover between the Down & Up Goods line and the Up Main line the leading bogie of the 13<sup>th</sup> wagon derailed to the left-hand side.

- 29 The derailed bogie was dragged through SY274A, SY273B and SY273A points (see Figure 2) causing damage to each. At some position, shortly after passing over point SY273A, the derailed bogie rerailed and continued to run normally.

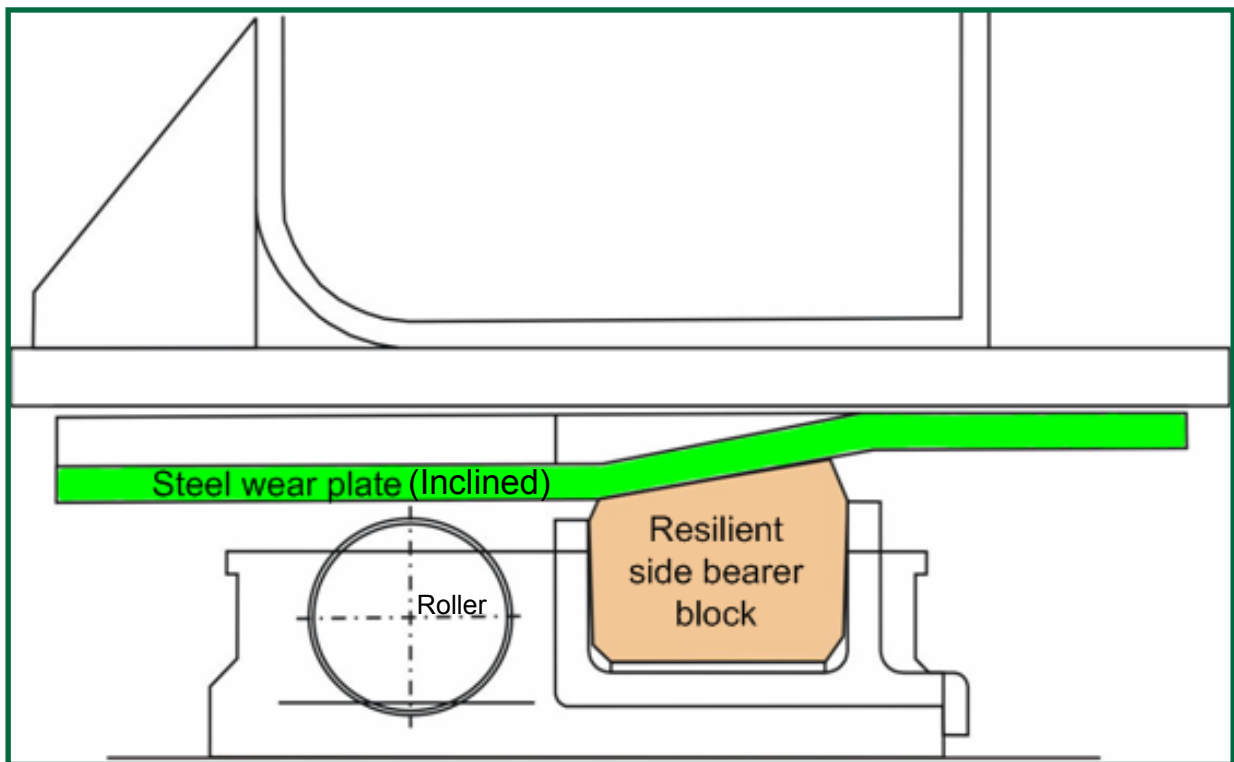
Figure 5: Diagram of the original side bearer assembly with inclined wear plate

- 45 When delivered to EWS in 1999 the FAA wagon's side bearer assembly incorporated:
- an inclined *underframe wear plate*; and
  - a resilient *side bearer block* and roller (see also Figure 5).

- 48 EWS concluded that the propensity to derail was linked to the inclined underframe wear plates on the wagon. They reasoned that when these wagons traversed reverse curves these plates caused the two ends of the wagon to tilt in opposite directions (so generating a twist force). EWS considered that this twist force at the wagon ends, combined with the wagon's structural stiffness, would be sufficient to cause one or more wheels to become unloaded so increasing the risk of derailment.

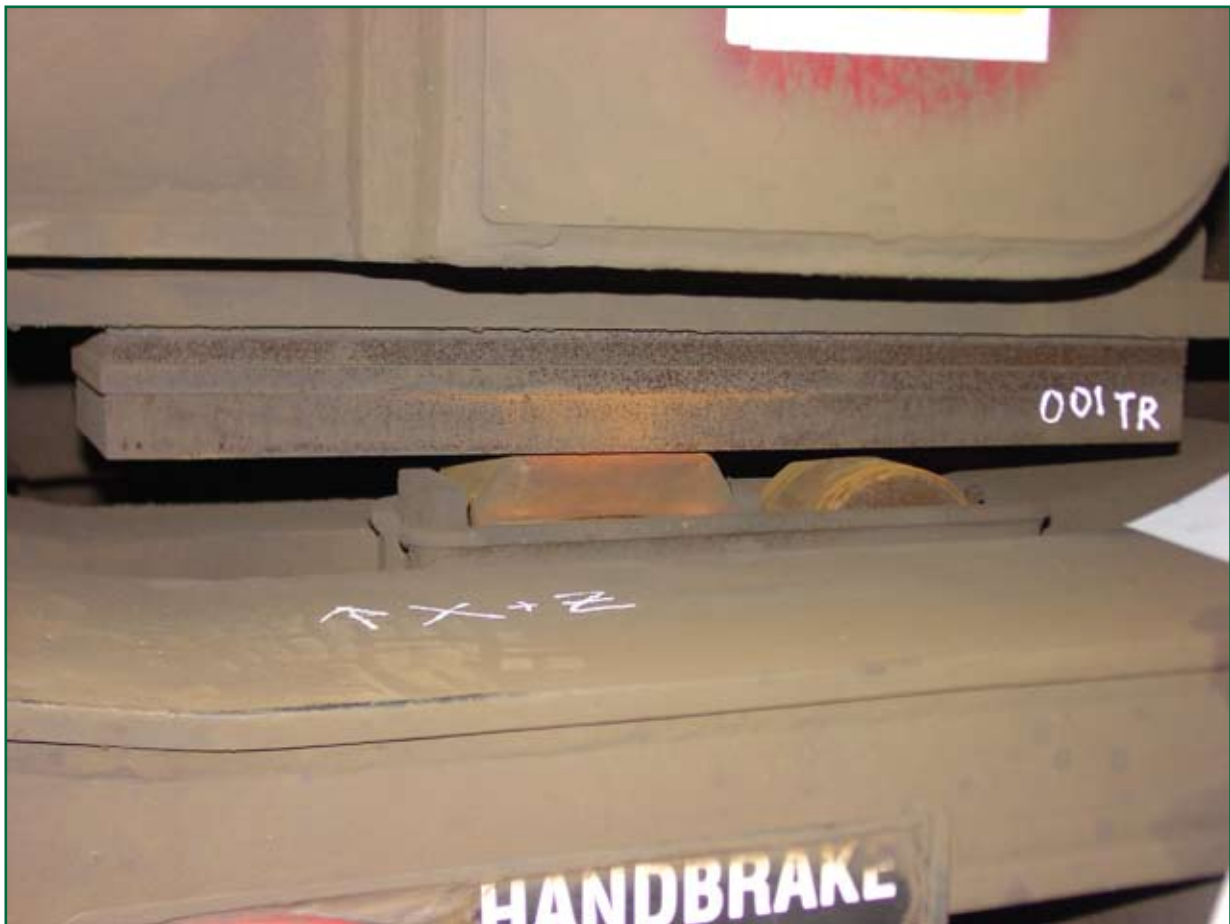
Figure 7: Photograph showing condition of a side bearer assembly

- 58 Some days later the vehicle was subjected to further visual examination at a Bombardier facility. During this further examination it was noted that the outer surfaces of the four steel underframe wear plates on both bogies were showing signs of corrosion, as shown in Figure 7.

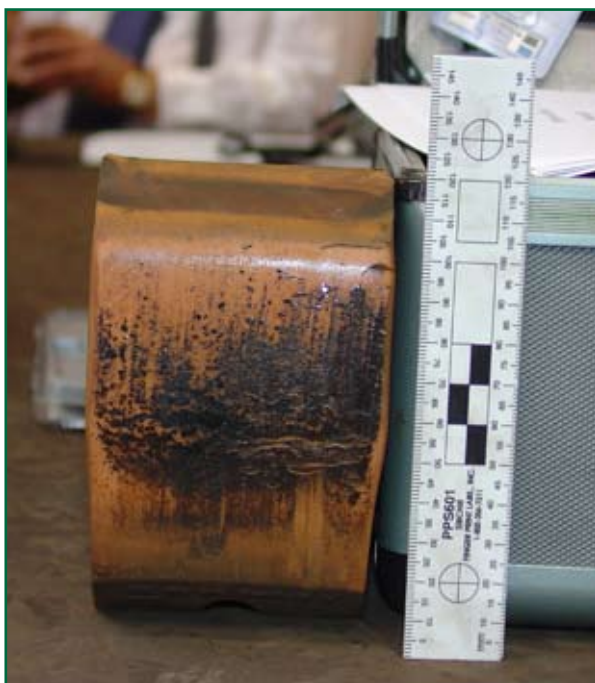
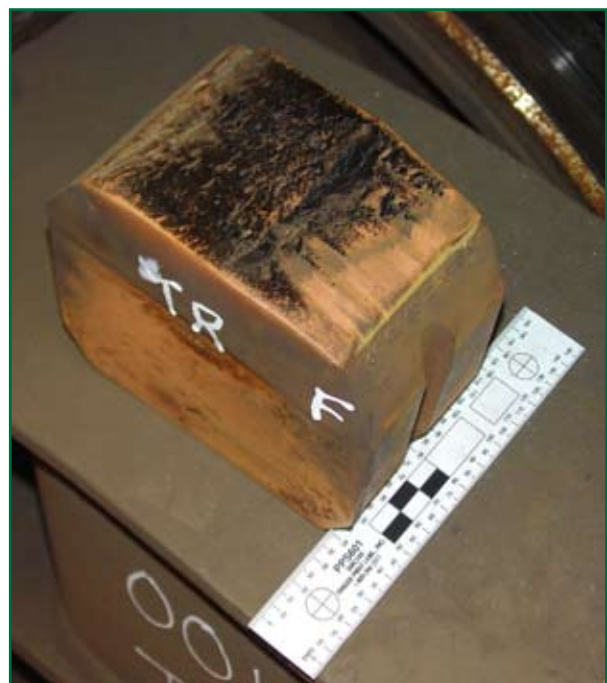
Figure 8: Condition of leading and trailing side bearer blocks

- 59 On lifting the wagon body the side bearer blocks, for both the leading and trailing bogies, were showing signs of surface abrasion and lateral cracking/tearing. The condition of the leading and trailing side bearer blocks can be seen in Figure 8. The surfaces of the trailing bogie's side bearer blocks showed indications of more abrasion and damage than those on the leading bogie.

- 61 In addition to the above, it was found that the side bearer blocks had been compressed by 4.5 mm which indicated that a significant proportion of the vehicle body weight had been carried by the four side bearer blocks.

- 1 EWS should complete its programme for installing UIC sprung side bearers in FAA wagons in order to overcome the known deficiencies with the existing arrangement (paragraph 90).
- 2 EWS, pending the replacement of all existing side bearers, should test a representative sample of the unmodified fleet of FAA wagons in order to confirm that the values obtained for bogie rotational resistance and torsional stiffness remain acceptable once the central pivot and side bearer components have been subject to wear and to measure any change in the performance of the side bearer lubrication between PPM (paragraphs 90 and 91).

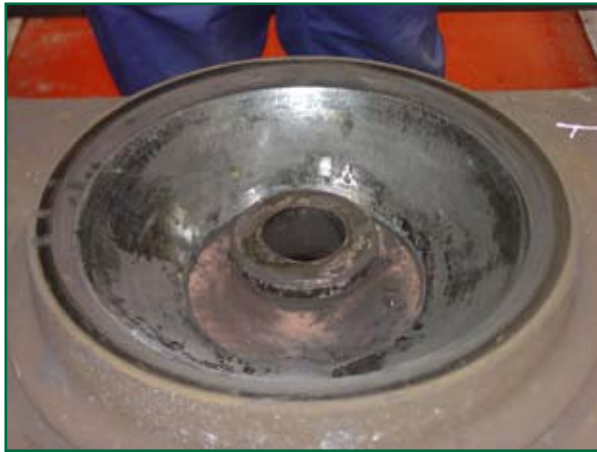
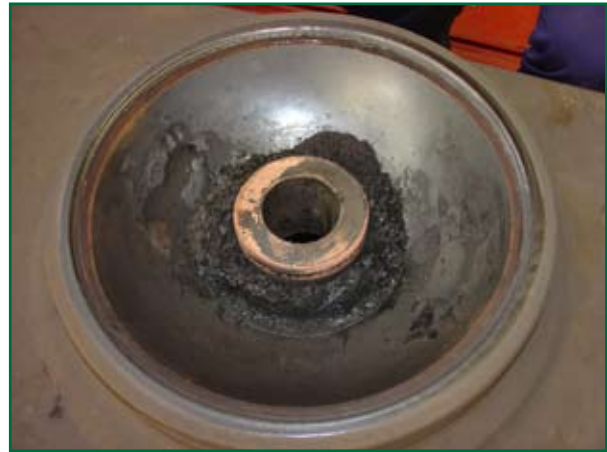
Figure 9: Condition of leading and trailing centre pivot socket liners

- 60 The centre pivot concave bearing surfaces on both bogies were also examined. Both showed signs of wear with the trailing bearing having shaved off an appreciable amount of material (see Figure 9). The surfaces of the centre pins were scored but did not show signs of significant damage (see Figure 10).

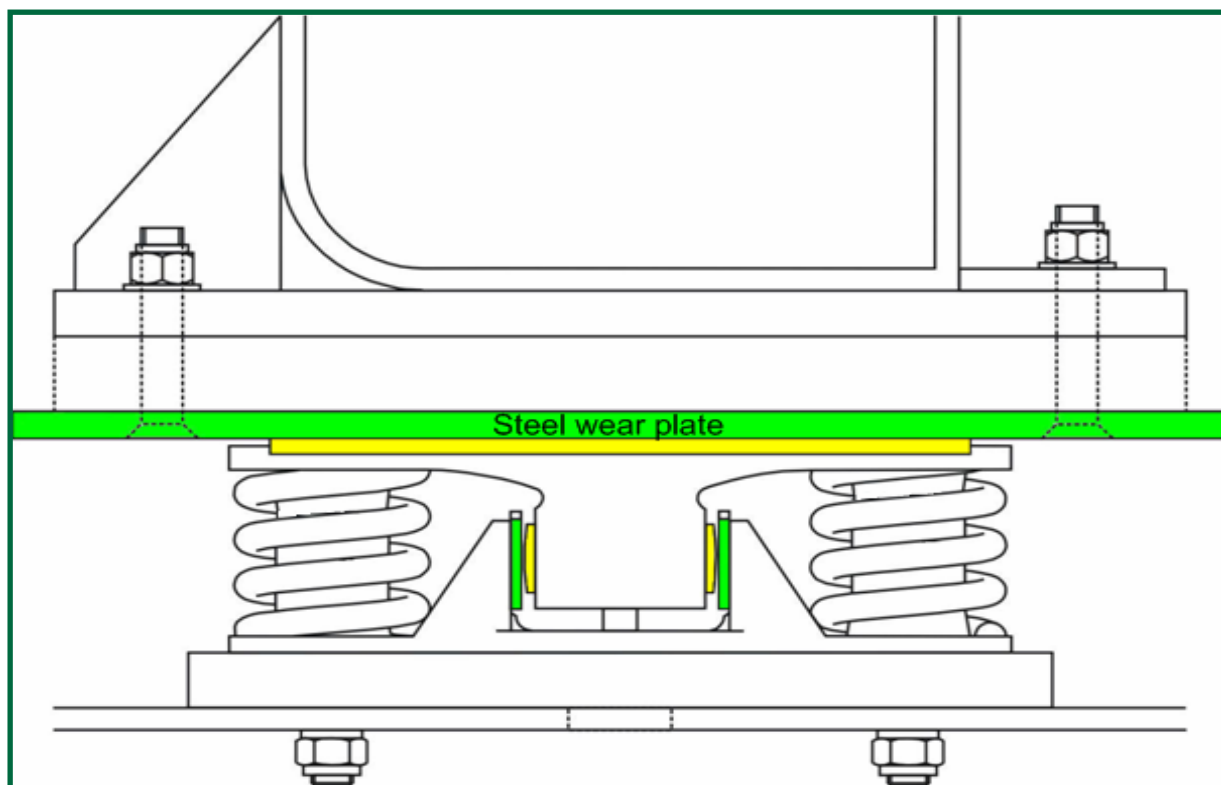
*Figure 11: UIC design of side bearer*

70 On a sixth FAA wagon, 609052, the existing side bearer block/roller was replaced by a UIC sprung bearer (Figure 11). The values obtained for this modified configuration of side bearer was as follows:

- bogie rotational stiffness = 0.104 (the original approved value was 0.119)
- average wheel unloading = 45 % (as compared to the specified limit of 60 %)

- 82 Tests carried out on wagon 609052 showed that both bogie rotational stiffness and wheel unloading would be comparable with the original values measured with the approved design if the resilient block was replaced by a UIC standard sprung side bearer (see Figure 11).

- 95 In addition to the above EWS are undertaking a programme to remove resilient block side bearers and replace them with a UIC standard sprung side bearer (see also paragraph 70).
