Rail Accident Report

Derailment of a train at Croxton Level Crossing 12 September 2006

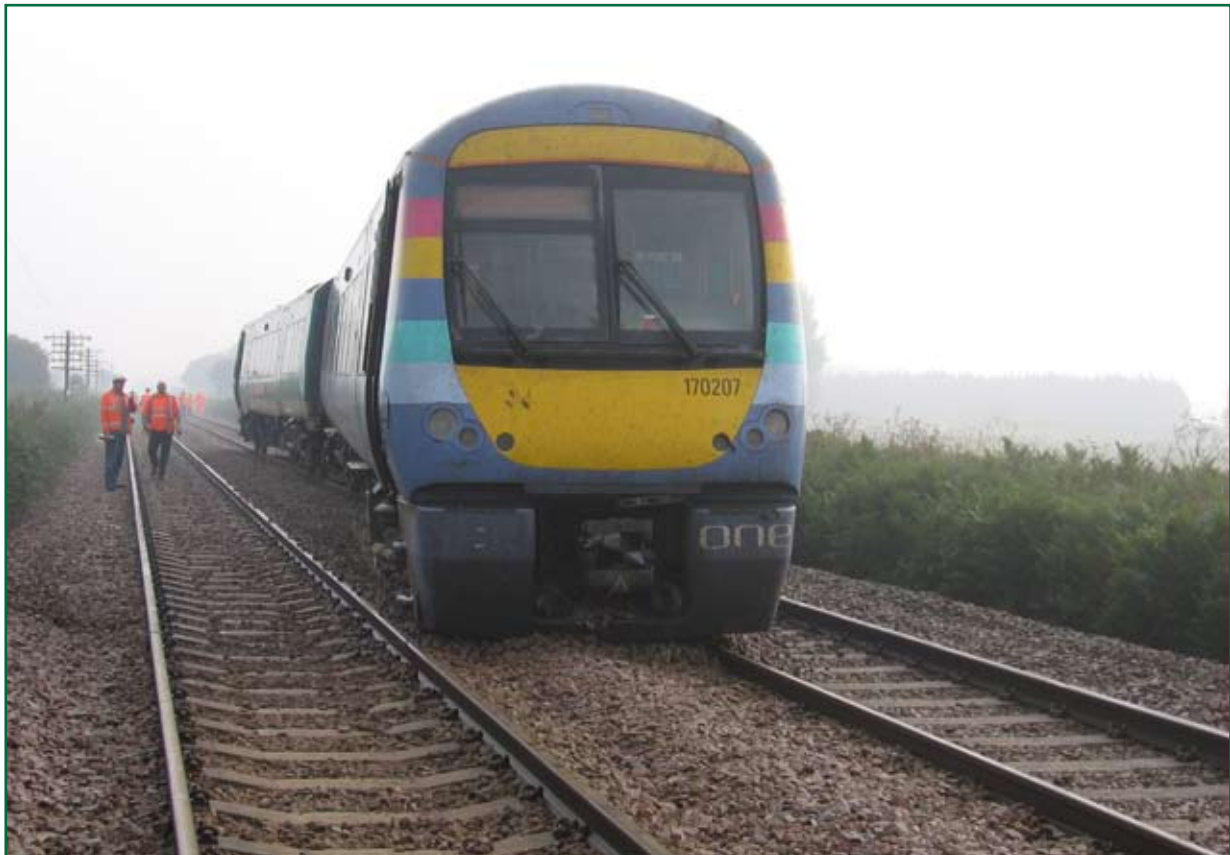
Figure 2: Derailed train after coming to a stop

- 89 At 06:03:23 hrs the train entered the crossing (Figure 8) and struck the dislodged panel. The collision derailed the leading bogie, but the rest of the train remained on the track. The train driver applied the emergency brake after realising that the train was running derailed, and the train ran 463 m before coming to a halt (Figure 2).

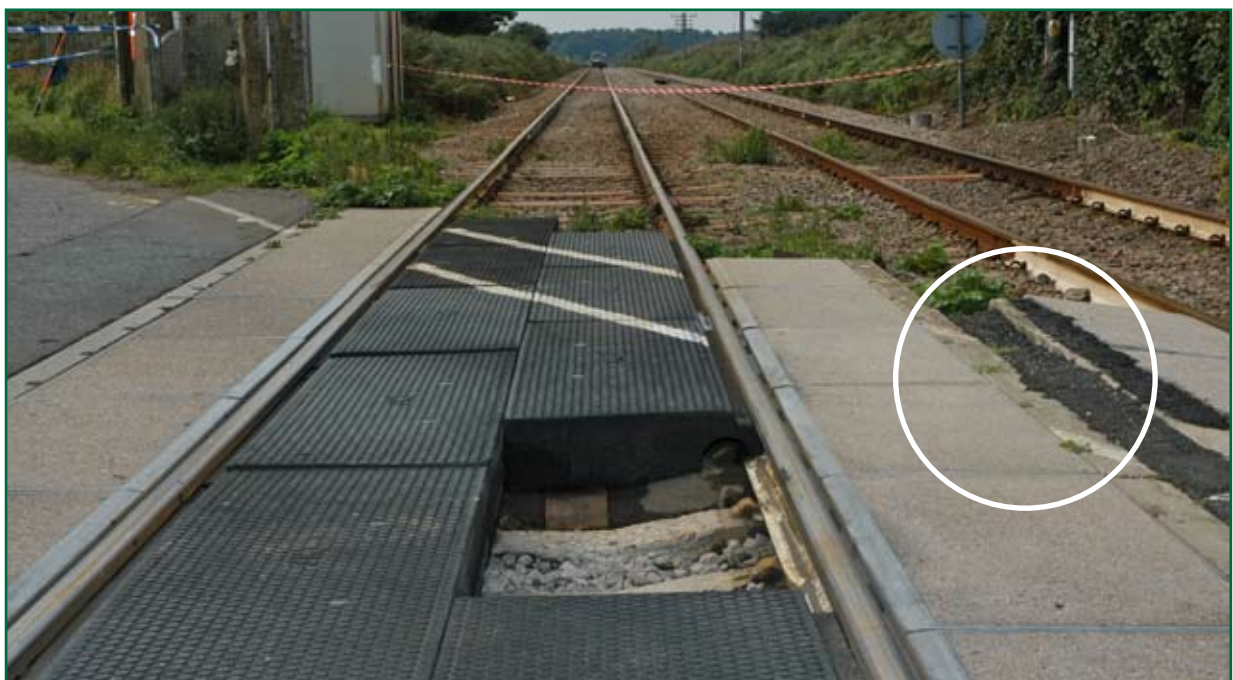
- 51 Network Rail *tamped* the down line of the crossing on 21 August 2005, which would again have required the removal of all panels on that line.
- 52 At some time between August 2005 and early 2006, and possibly related to the tamping in August 2005 Network Rail carried out track maintenance to correct *wet beds* on the down line at the crossing. During this work the staff carrying out the work accidentally lifted a concrete edge beam on the Thetford end of the down line. This was not corrected at the time and resulted in the edges of two of the six foot Bowmac panels being higher than the rest of the crossing surface (Figure 4).

Figure 4: Raised six foot Bowmac edge beams (circled)

- 53 A Network Rail Mobile Operations Manager (MOM) identified this during a regular inspection on 30 April 2006 and reported it to the Network Rail infrastructure fault control (IFC) at Cambridge, where it was entered into the Network Rail fault reporting system known as FMS.
- 54 In April 2006 Network Rail revised their method of inspecting level crossings, creating a dedicated level crossing team (paragraph 231).

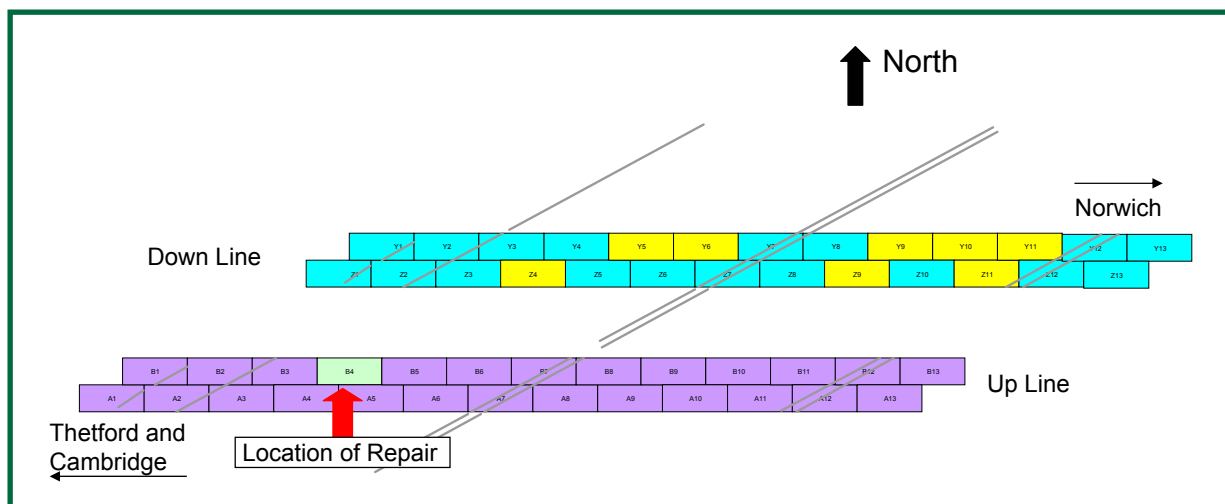
- 62 As a result, on 23 August the level crossing supervisor sent members of the level crossing team to visit the crossing. They noticed that a panel was rising a few inches when lorries travelled over it, and undertook a non-recognised repair. They inserted some timber strips, about 25 mm in thickness, between panel B4 and panels A4 and A5 of the crossing (Figure 5). They did this by forcing open a gap between the panels and hammering the timber down into the gap created. The team leader reported the finding of the loose panel, and the repair, to the level crossing supervisor and suggested that a road closure should be obtained to undertake a full inspection.

Figure 5: Position of panel B4 and region of repair on 23 August 2006 (arrowed)

- 90 The dislodged panel was found in the four foot of the down line 83 m towards Thetford from the point of impact (Figure 9).
- 91 The dislodged panel had come from the six foot side of the up line four foot, and was the fourth panel from the Thetford end of the crossing. This panel is referred to as panel B4 (Figure 5).

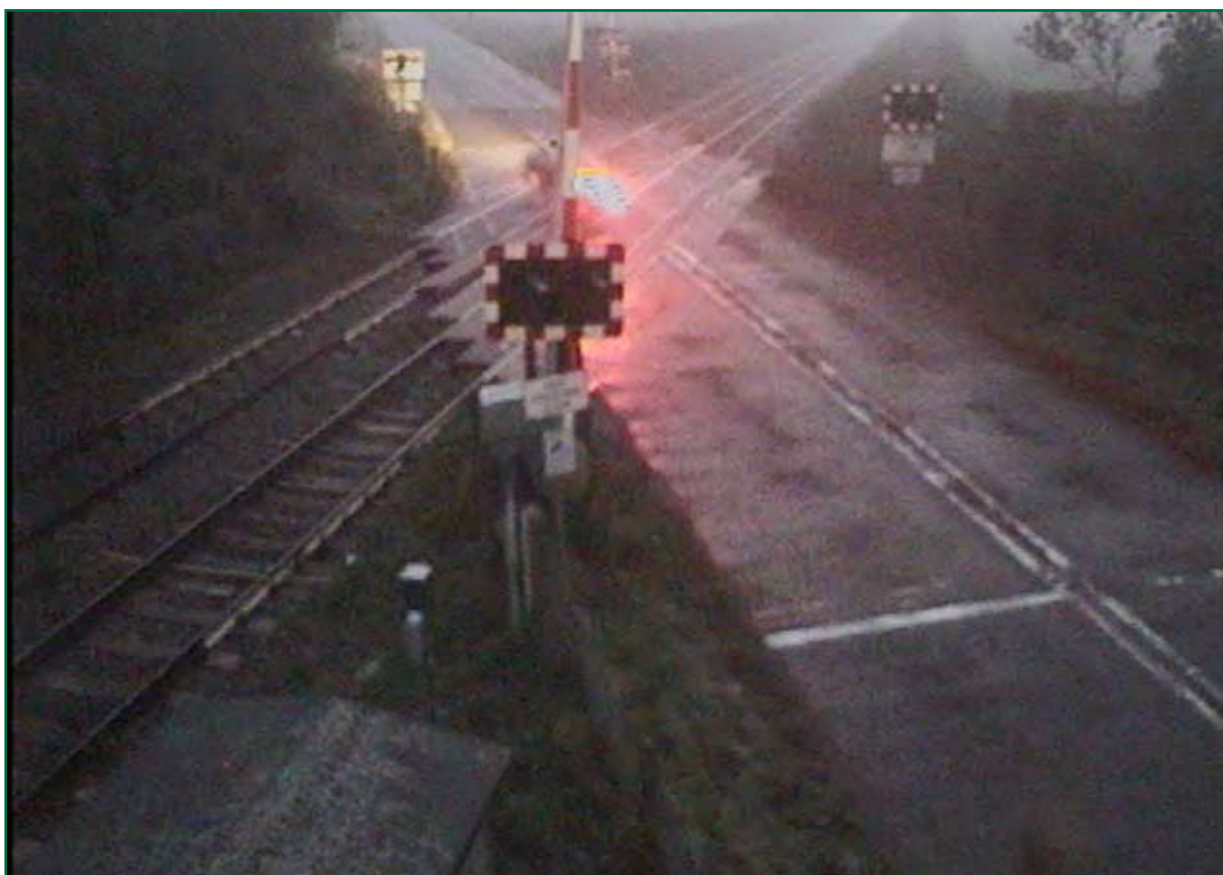
- 78 At 05:54:57 hrs a car passed over the level crossing. It struck the object and was lifted up on its nearside to an angle of around 30 degrees (Figure 7). The driver lost control of the car and it spun and came to a halt in the nearside road ditch some tens of metres north of the crossing, facing south-west. It was subsequently found that as a result of the collision with the object, two tyres had been punctured.

Figure 7: CCTV image of car striking dislodged HoldFast panel

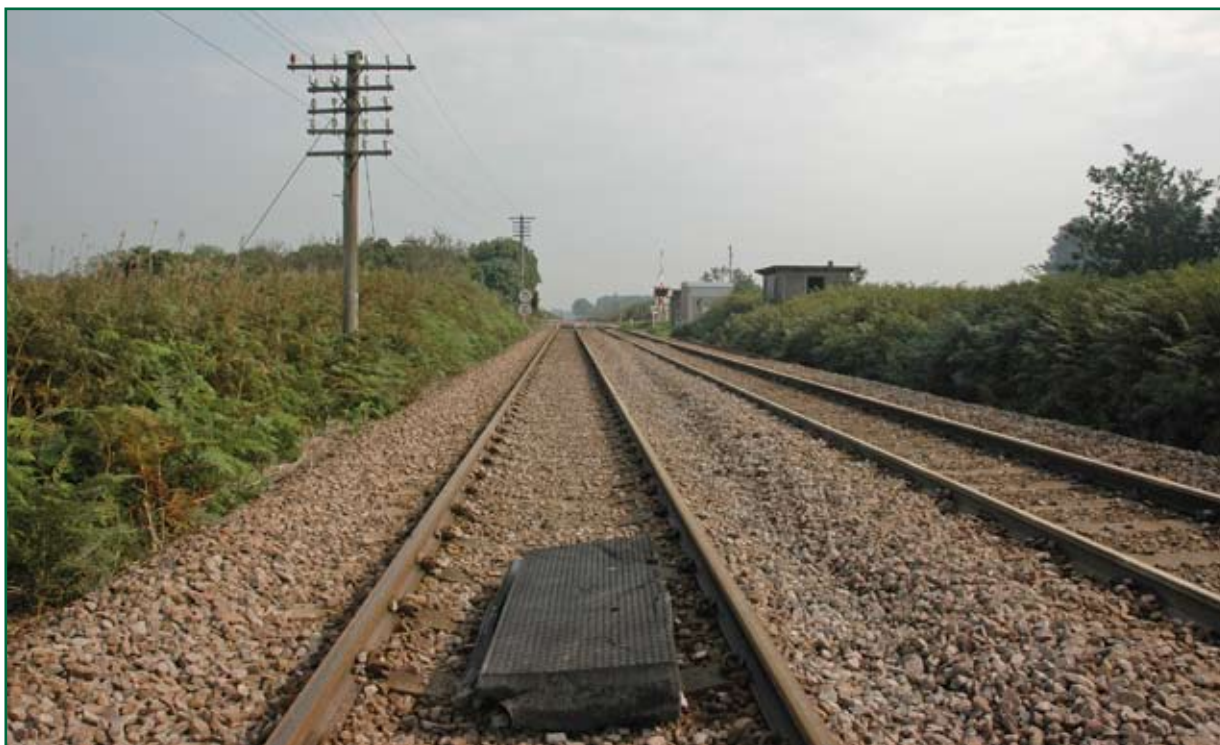
Figure 9: Dislodged HoldFast panel looking towards Croxton level crossing

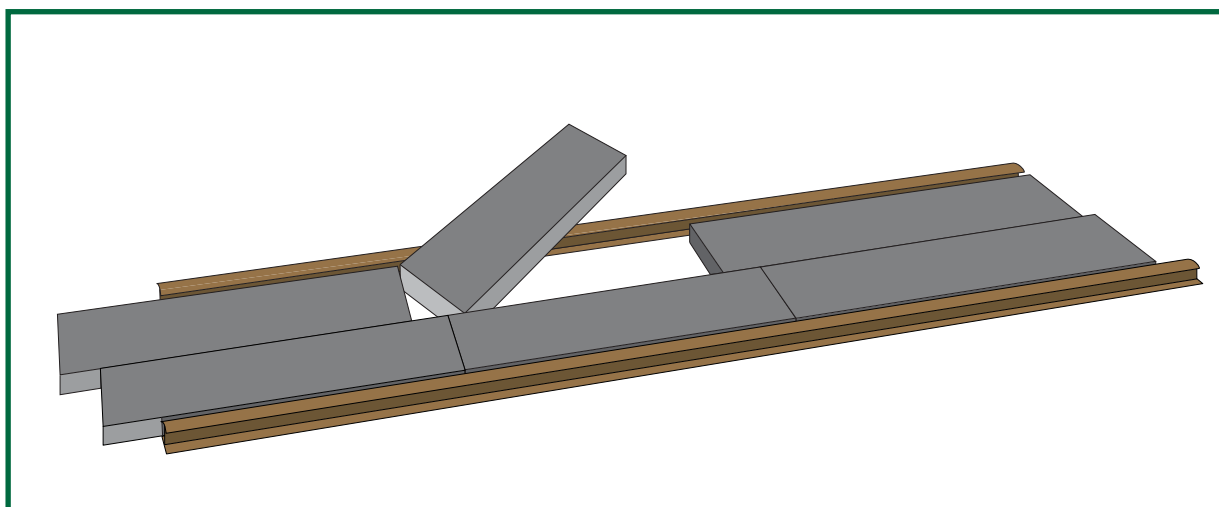
Figure 6: CCTV image of tanker trailer lorry passing over the crossing

Figure 10: Likely position of panel B4 immediately before train impact

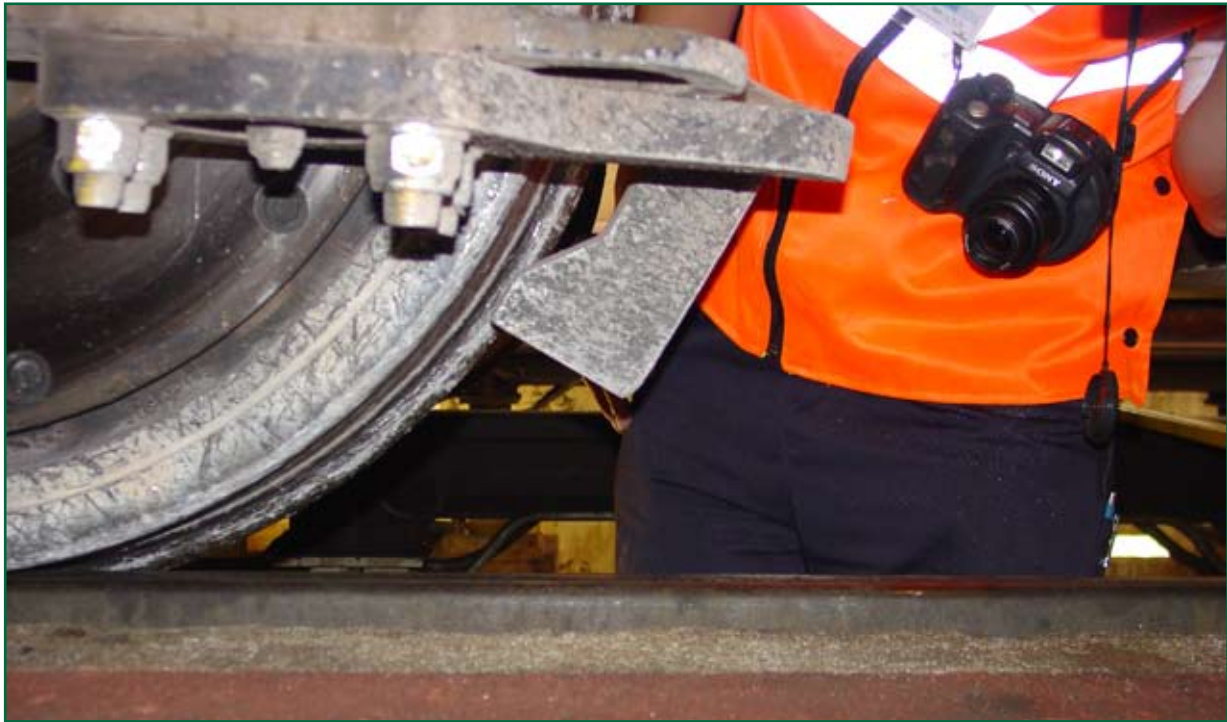
Figure 11: Distorted lifeguard on leading right-hand (six foot) side of derailed train

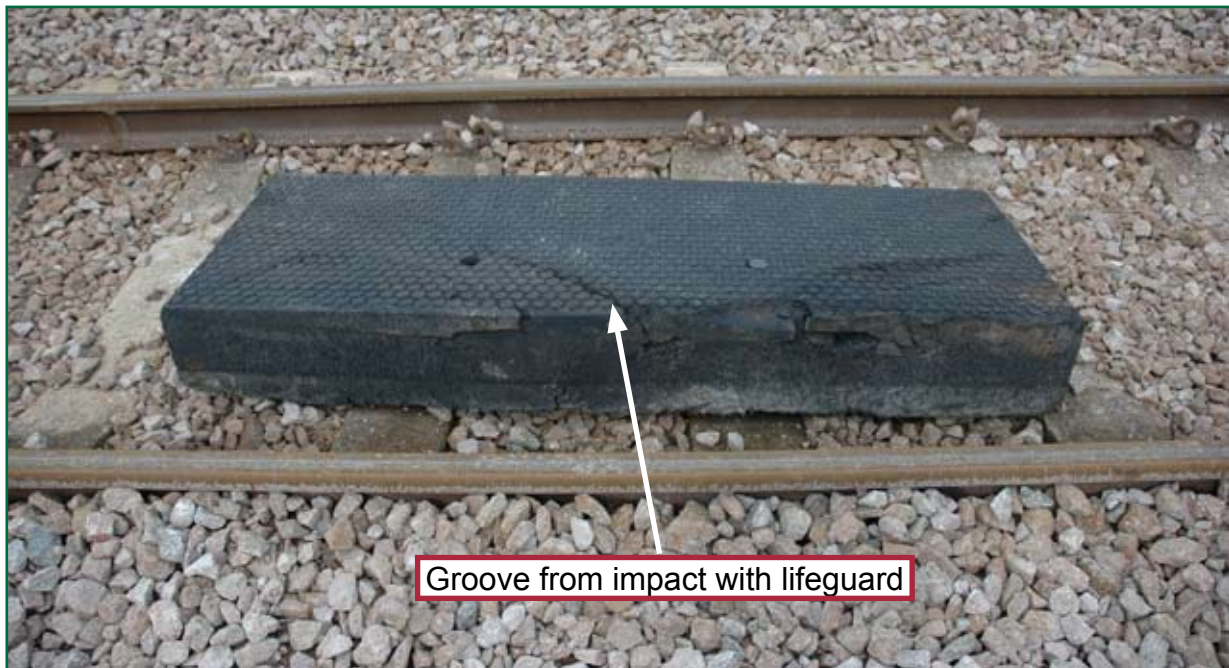
Figure 12: Impact marks to panel B4

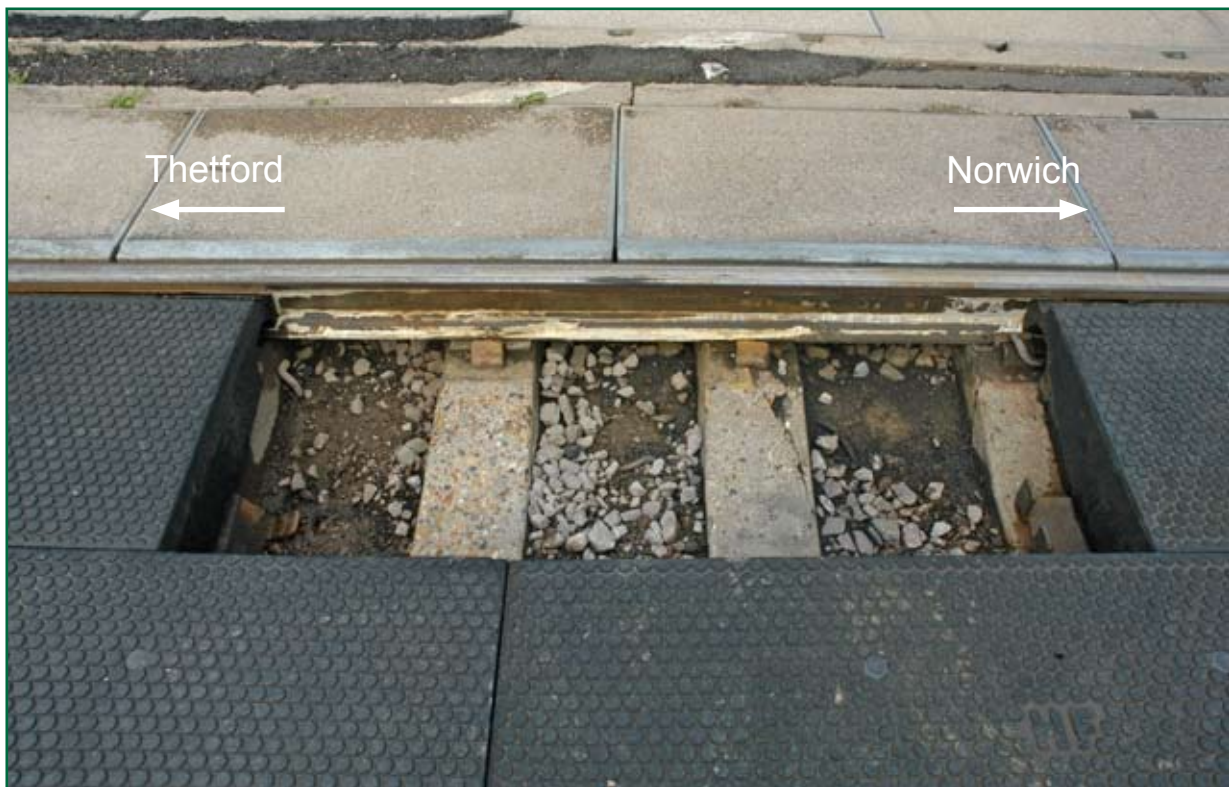
- 224 The ballast under the sleepers in the up line was eroded, with slurry having formed around the ballast (Figure 23).

Figure 23: Six foot rail and sleepers under dislodged panel B4

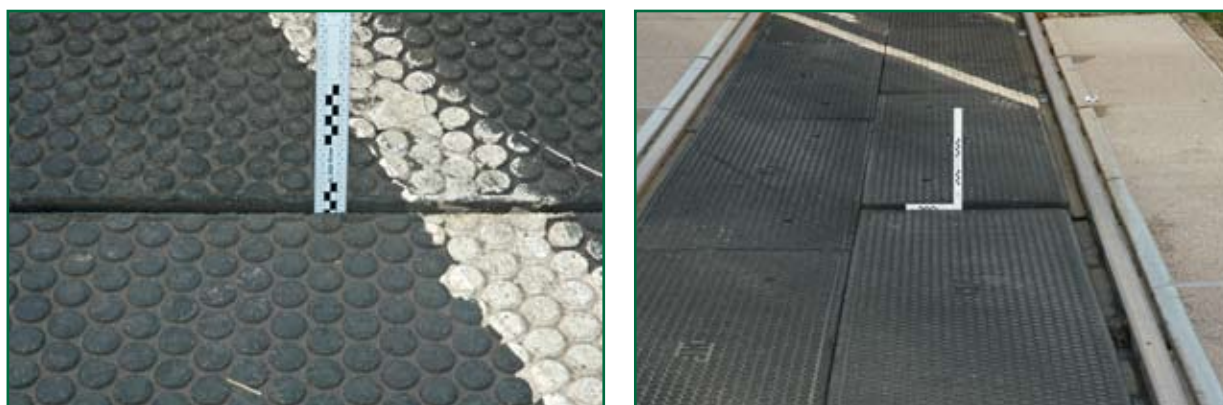
- 262 Examination of the crossing surface after the derailment showed that it was irregular, with vertical steps between different HoldFast panels in the four foot of both up and down lines. Some of these steps were in the order of 15 to 20 mm (Figure 24).

Figure 24: Vertical differences between upper surfaces of adjacent panels at Croxton

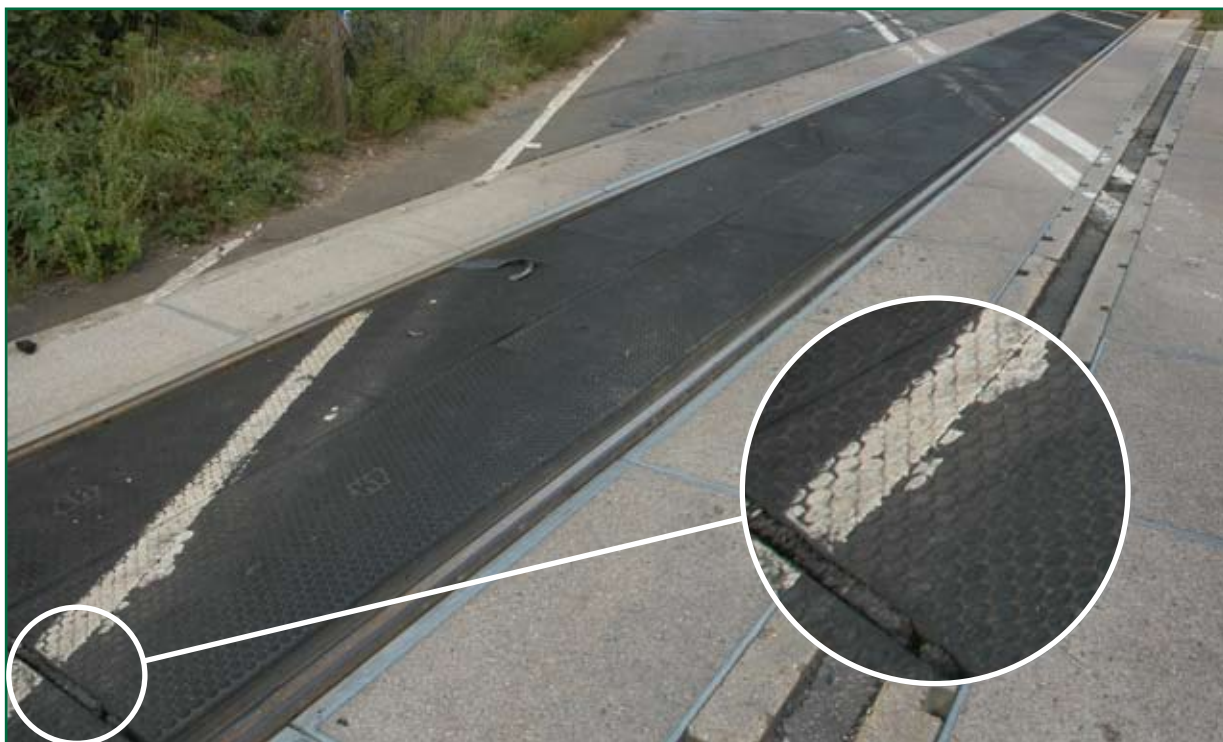
- 266 Contactors to Network Rail undertook a level crossing survey on 17 August 2006. This survey was to record the signalling infrastructure present at the crossing and was not related to the level crossing surface. A photograph from this survey, which was supplied to Network Rail by the contractor, shows a gap present between panels A5 and A6. This gap was in the order of 10 mm.

Figure 25: Gap with tarmac infill between panels in the down road (lower left corner)

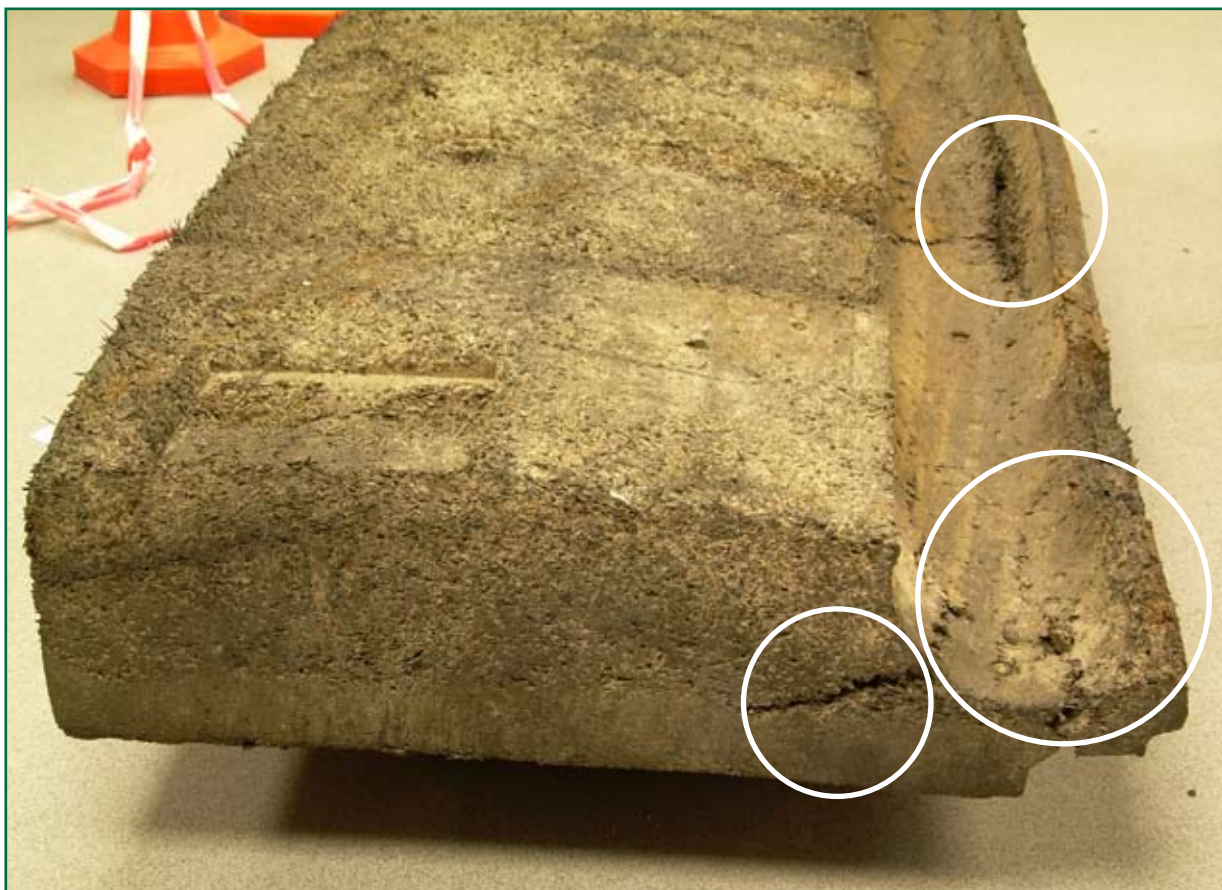
Figure 26: Panel B4 underside showing cracking in relief area and damage to nose

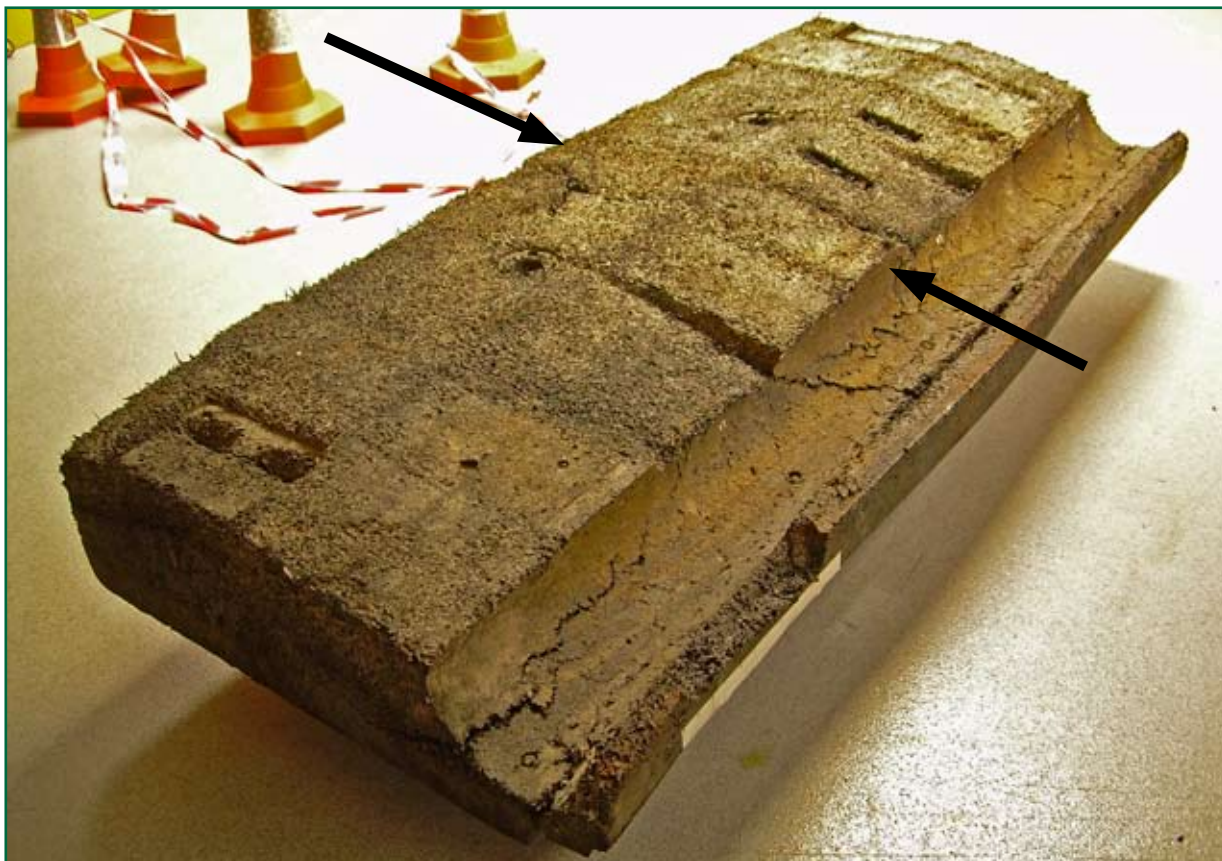
Figure 27: Panel B4 underside showing indentations from sleepers and transverse crack (arrowed)

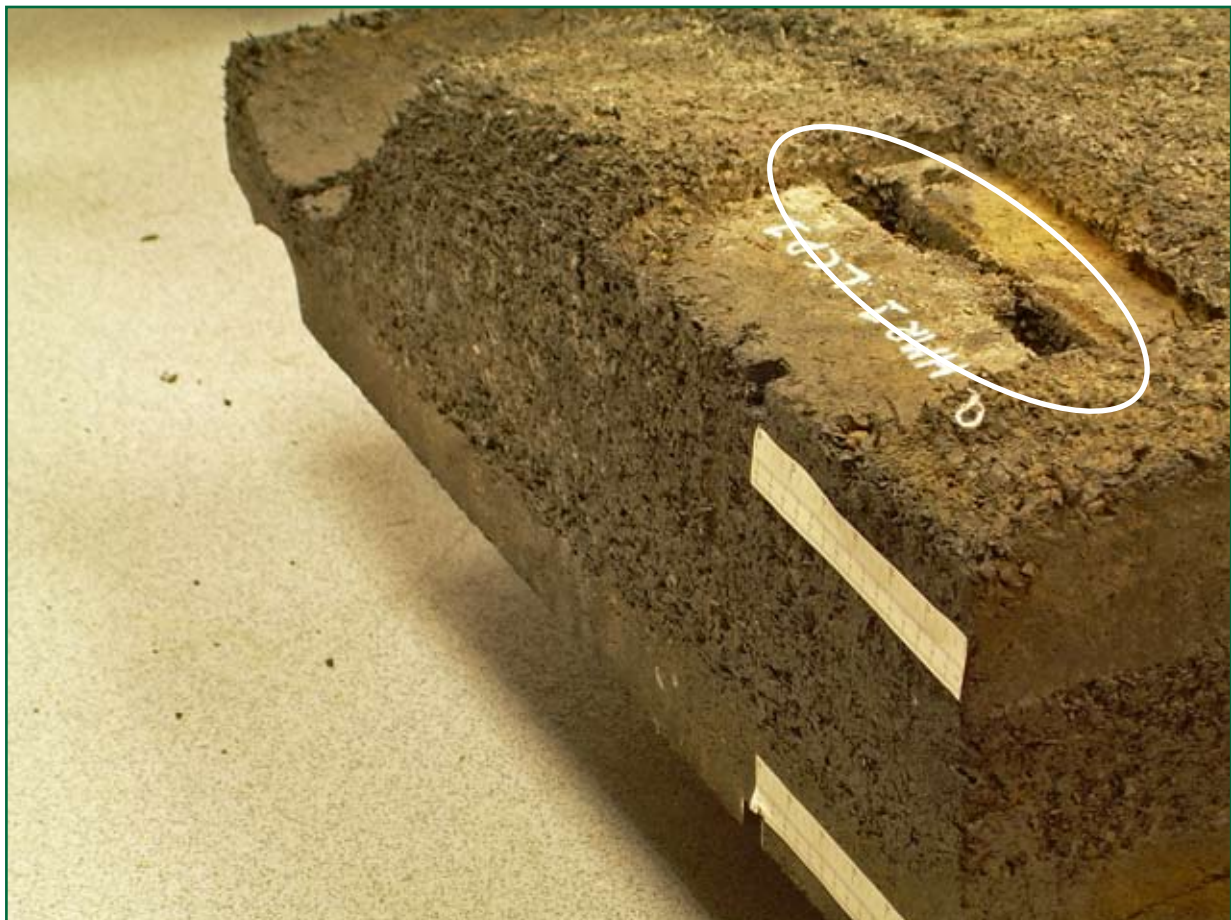
Figure 28: Panel B4 underside showing wear and cracking in the base plate location area

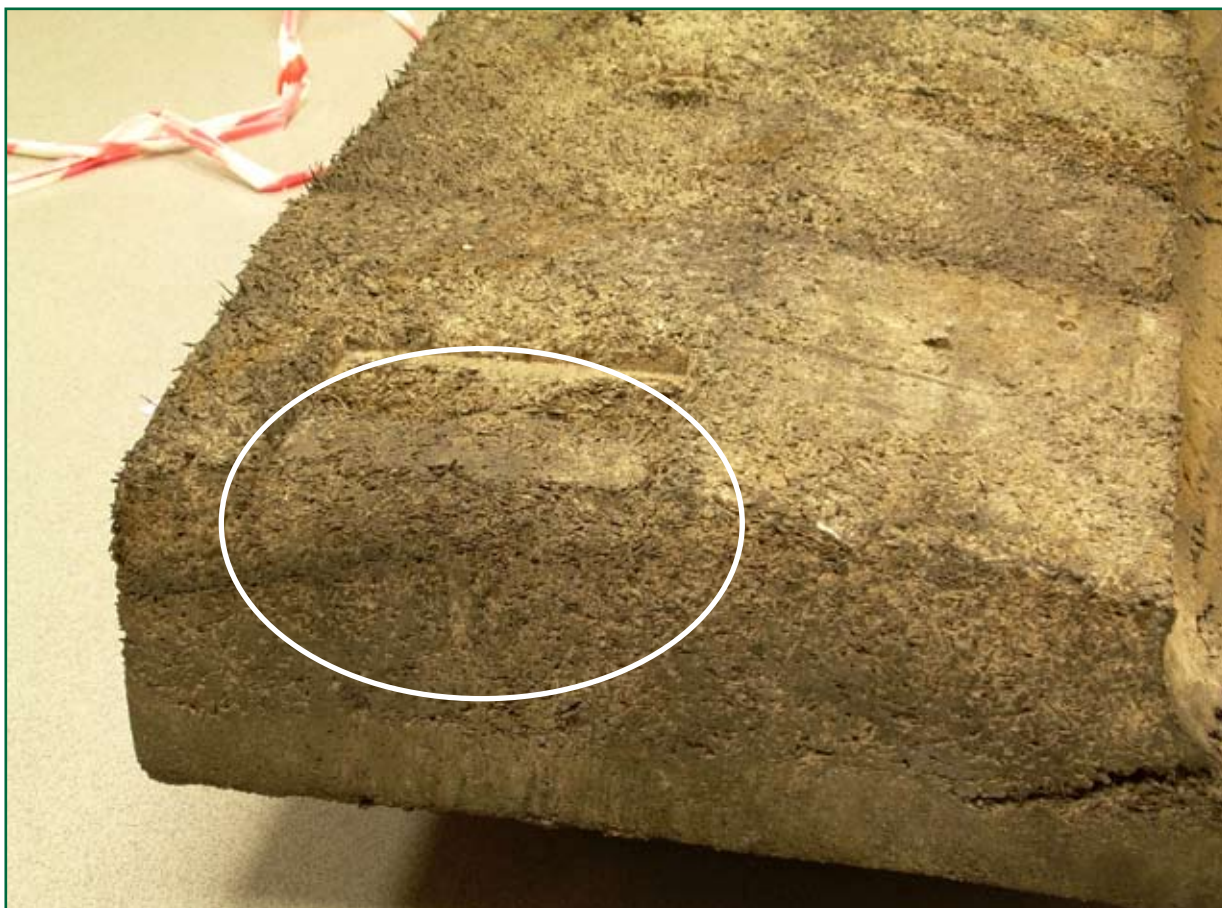
Figure 29: Panel B4 underside showing wear on panel edge in the base plate location area

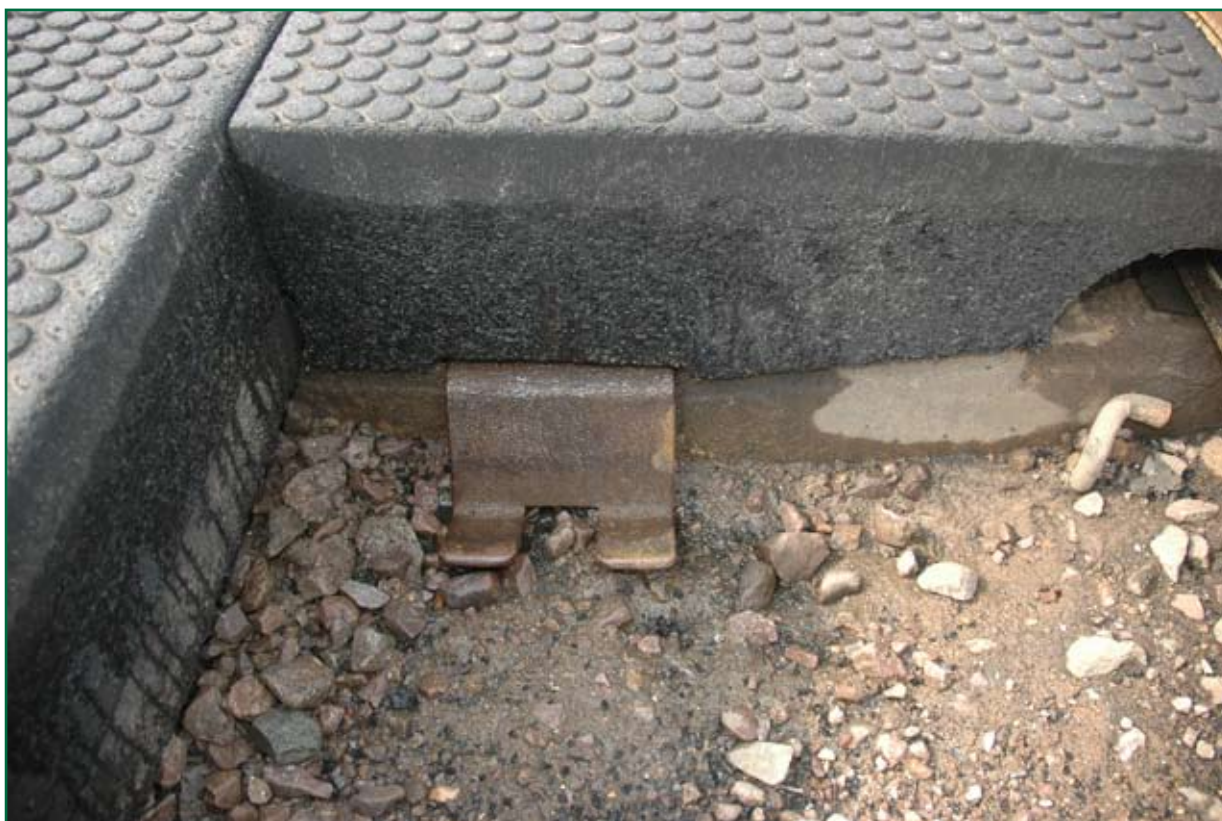
Figure 30: Deformed base plate under Thetford end of dislodged panel B4

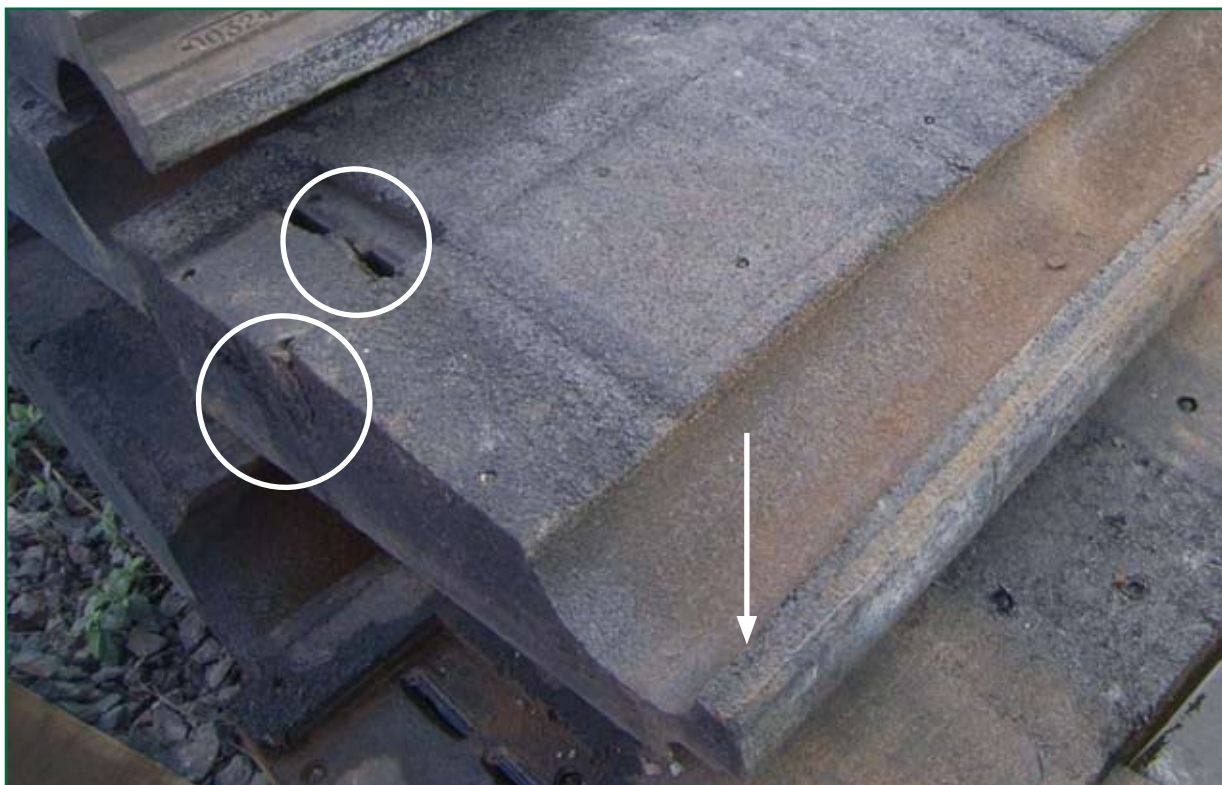
Figure 32: Side wall splits in panel base plate area (circled) and wear to nose (arrowed)

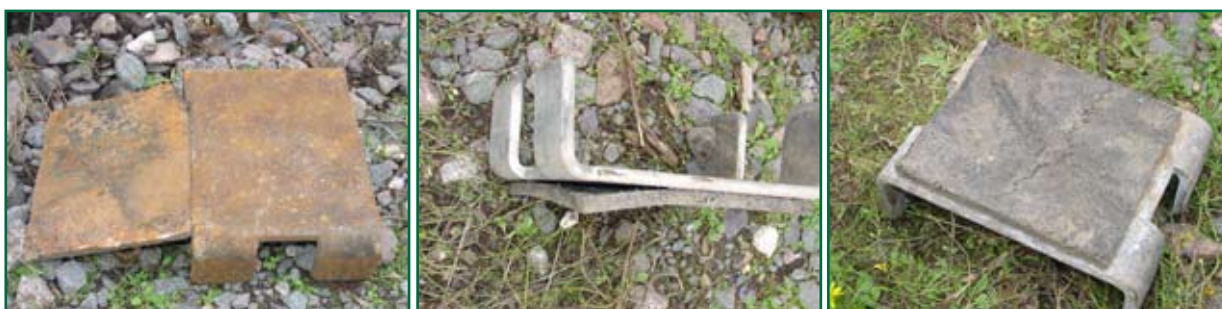
Figure 33: Loss of and damage to base plate pads

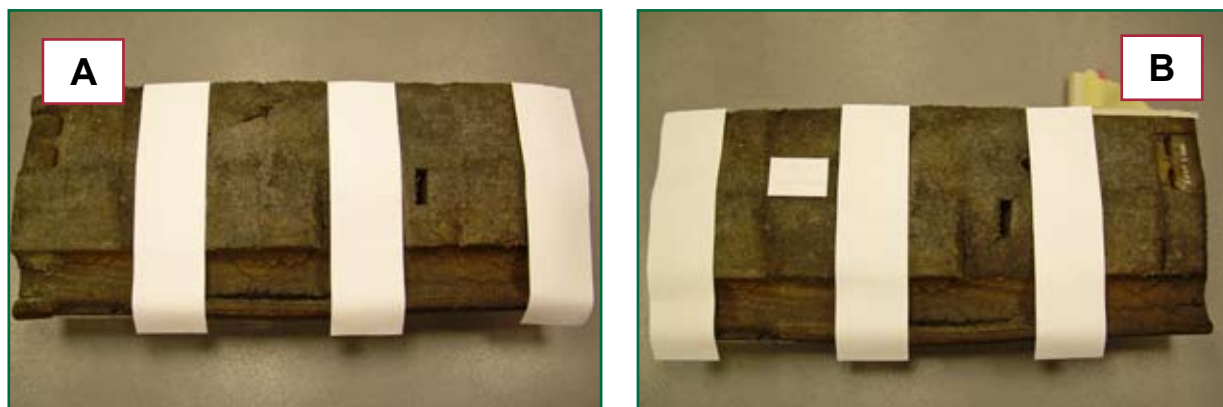
296 The other set of indentations on panel B4 indicate that at some other time panel B4 had been in a different position within the crossing. This is supported by the witness evidence that panels could have been in different locations at other times (paragraph 263). The distances between these other imprints indicate that the other end of the panel, ie its most recent Norwich end, may have been not fully supported when in this earlier location (Figures 35a and 35b).

Figure 35: Panel B4 underside showing sleeper positions : A - at time of accident; and B - at some earlier time

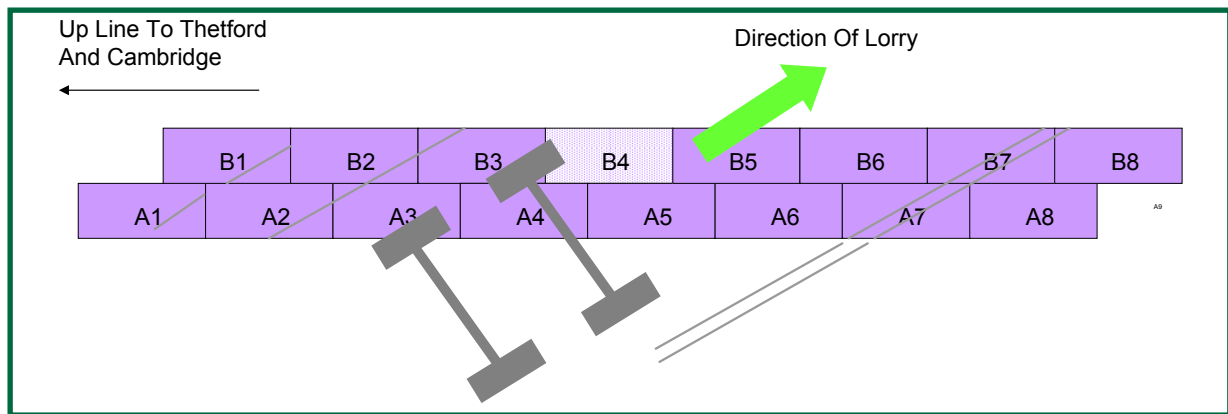
- 316 Records of the trailer's laden weight showed that it was within its allowable loading limit.
- 317 Analysis of the route of the lorry from the CCTV pictures indicates that its nearside wheels crossed panel B4 at its Thetford end, with the wheels crossing over the corner of the panel adjacent to the rail (Figure 36).

Figure 36: Likely path of lorry over panel B4
