Rail Accident Investigation Branch

Rail Accident Report

Runaway of two wagons from Camden Road Tunnel 19 July 2007

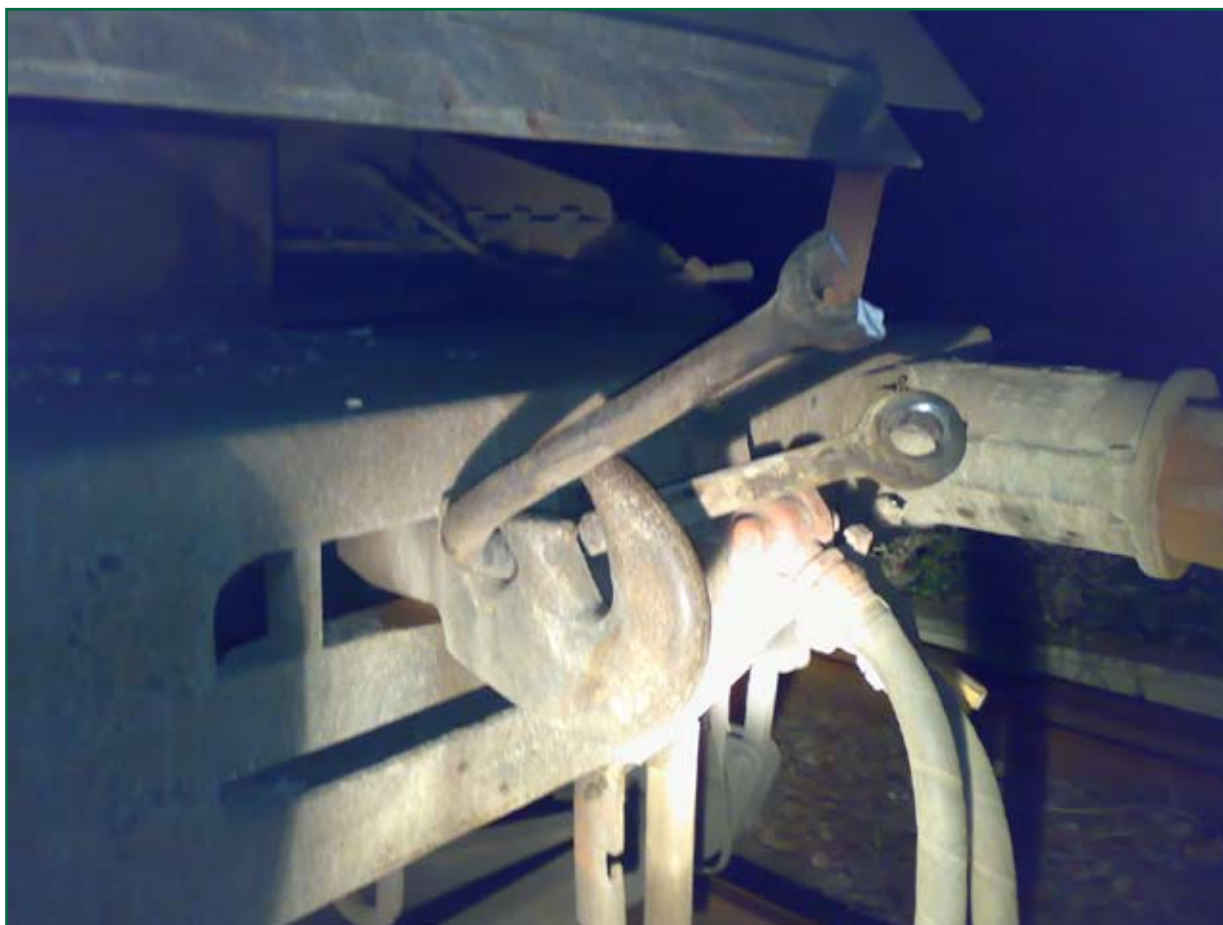
Figure 8: Remains of screw coupling, south end of MAR17712 (by courtesy of Network Rail)

- 36 With the permission of the signaller, the locomotive from train 7M59 was used to retrieve the two wagons and haul them to Churchyard Sidings.
- 37 The shunter and the driver found that the screw coupling at the south end of MAR17712 had broken with only part of it still attached to the wagon's *drawhook* (see Figure 8).

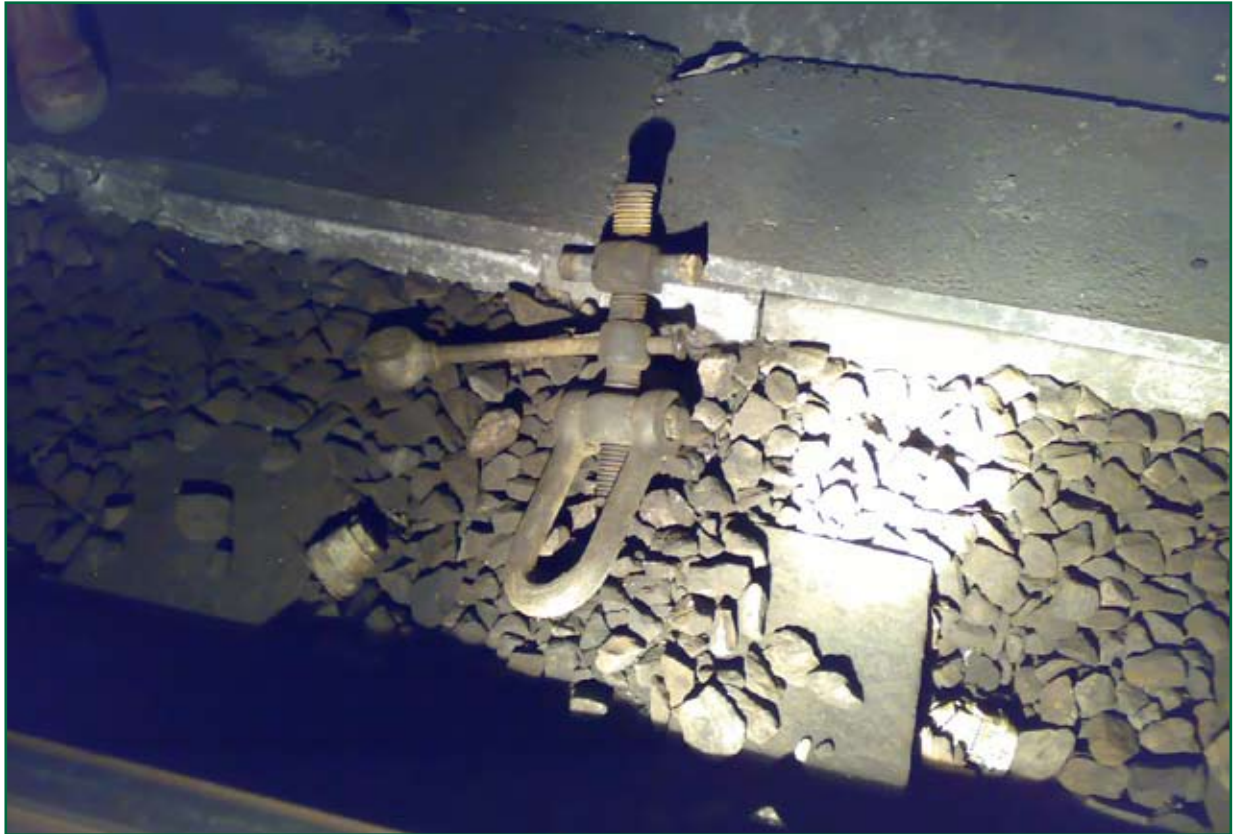
Figure 9: Other portion of coupler from south end of MAR17712 in the location where it was found (by courtesy of Network Rail)

- 38 Network Rail staff found the other portion of the broken coupling inside Camden Road Tunnel, 40 metres from the south portal (see Figure 9). The portion of broken coupling was retrieved for metallurgical examination to determine the cause of failure before trains re-commenced running.
- 39 The driver was subjected to the standard railway industry tests for drugs and alcohol and the results were negative.

- 84 The figures in paragraph 83 are confirmed by the fact that railway staff reported that they found part of the broken coupling 40 metres from the south end of Camden Road Tunnel, inside the tunnel (paragraph 38).

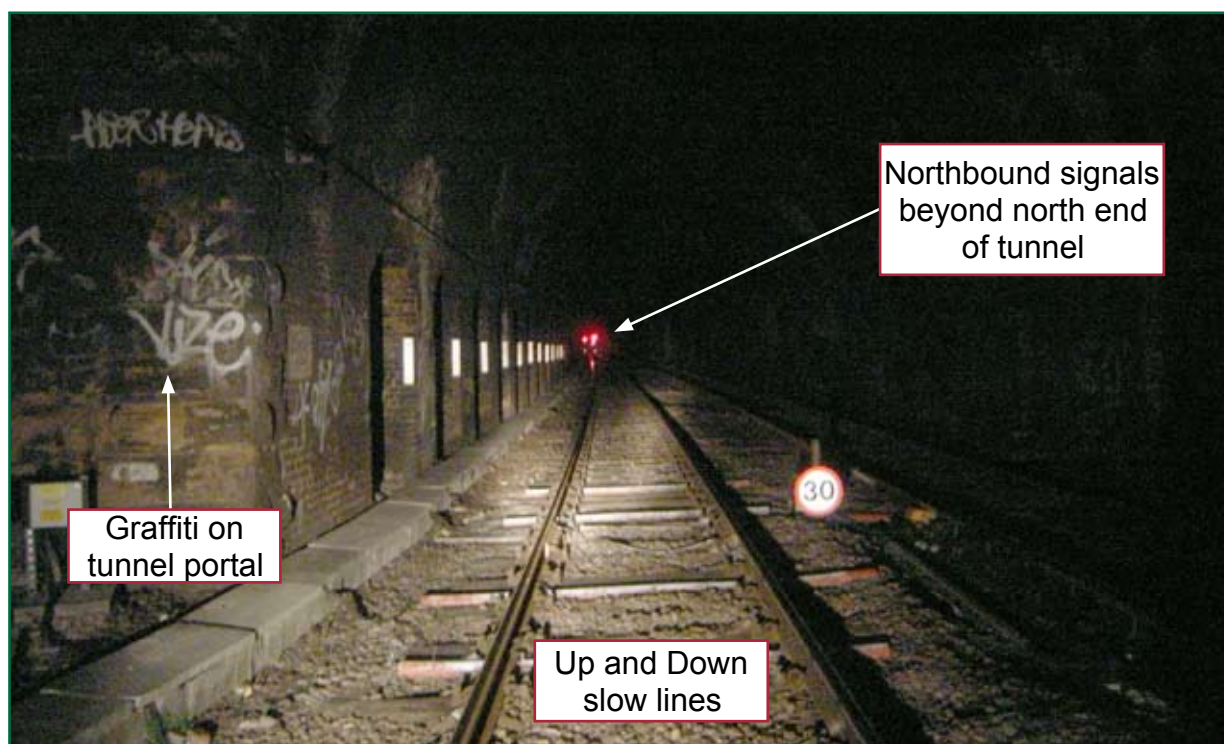
Figure 11: View looking north through Camden Road Tunnel

- 46 Camden Road Tunnel is straight, and northbound signals WH223 and WH429 beyond the north portal can be clearly seen from outside the south portal. Figure 11 shows the view through the tunnel looking north.

- 90 Despite the two detached wagons being only about 24 metres away from the rear of the front portion of the train (paragraph 83), the driver did not see them standing there in the darkness of Camden Road Tunnel, even though they might have been visible, given the ambient light conditions (Figure 11 and paragraph 46). This is a contributory factor.

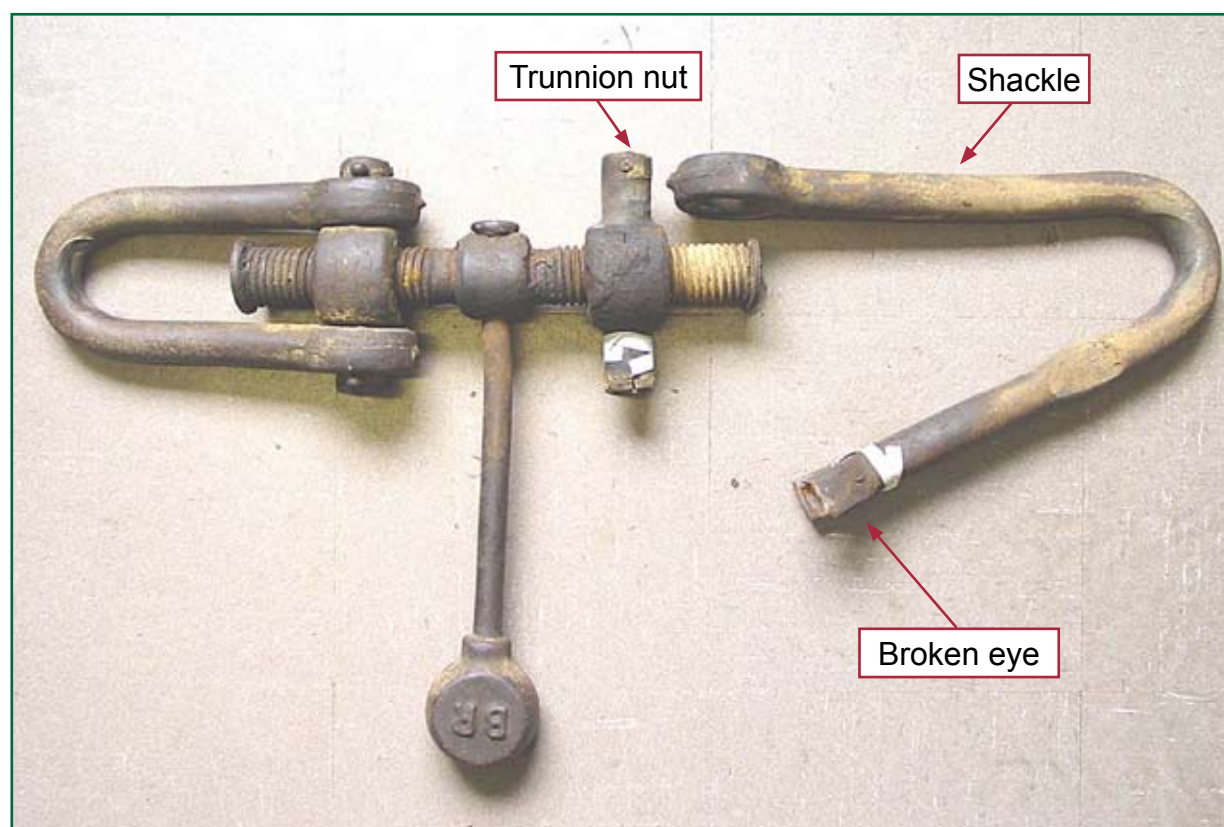
Figure 12: General view of the coupling (by courtesy of Serco Technical and Assurance Services)

47 Figure 12 shows a general view of the coupling and the eye which broke. The eye breaking caused the shackle to detach from the trunnion nut and deform.

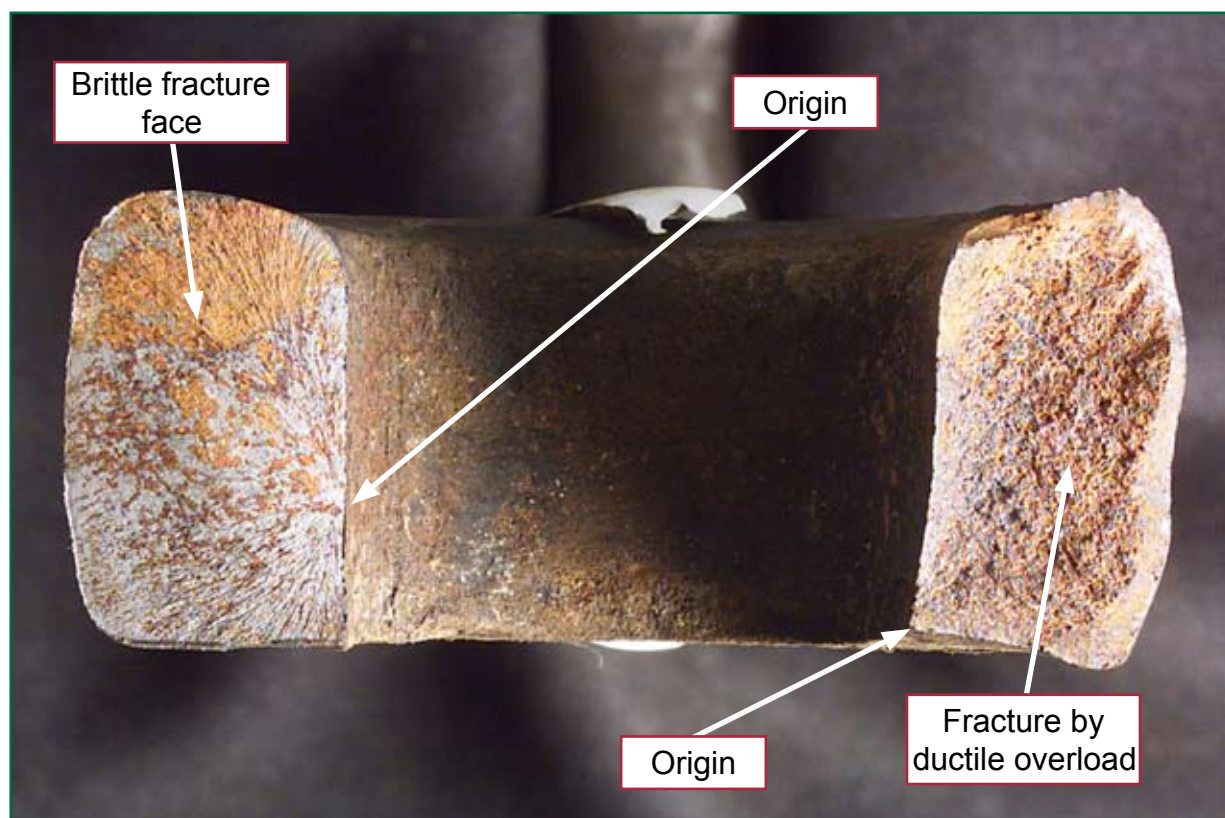
Figure 13: Eye end fracture faces (by courtesy of Serco Technical and Assurance Services)

- 48 Examination of the broken eye revealed that the two fracture faces had different material properties (Figure 13). One of the fractures had occurred rapidly with the break being through material that was predominantly brittle while the other fracture was a rapid ductile failure. No evidence of fatigue was found. The brittle fracture suggested that the material in that part of the eye had been subjected to localised heating and cooling some time after manufacture. The hardness measured (more than 600HV30¹) was greatly in excess of that specified for the coupling (255 – 305HV). The hardness of the ductile fracture was found to be within the specification for the type of steel used in the manufacture of the coupling (BS970 945M38).

- 49 From the results of the metallurgical examination, the RAIB believes that the brittle fracture occurred first, followed by the more ductile portion of the eye, which was in the correct condition.
- 50 Based on the amount of wear exhibited, it appeared that the coupling had been in service for some time, although the maintenance records showed that both couplings fitted to MAR17712 were renewed on 2 June 2004. Examination of the records thereafter (which were incomplete) showed no clear indication that heat might have been applied to the failed coupling as part of a repair carried out to the wagon.
- 51 It was not possible therefore to determine when or why the localised heating had occurred.

- 99 The metallurgical examination of the failed coupling concluded that the failure occurred where the hardness was much greater than that specified in BS970 945M38 (paragraph 48). The metallurgist thought this could have occurred due to localised heating and cooling of the coupling in the area where the failure occurred, although it has not been possible to determine why such heating and cooling might have occurred. The failure of the coupling is a causal factor of the runaway and the hardness of the coupling material in the area where the coupling failed is a contributory factor.

- 4 EWS should implement a process to brief its maintenance staff that heat should not be applied to forged components such as couplings to prevent a degradation in the material properties (paragraph 103 f).

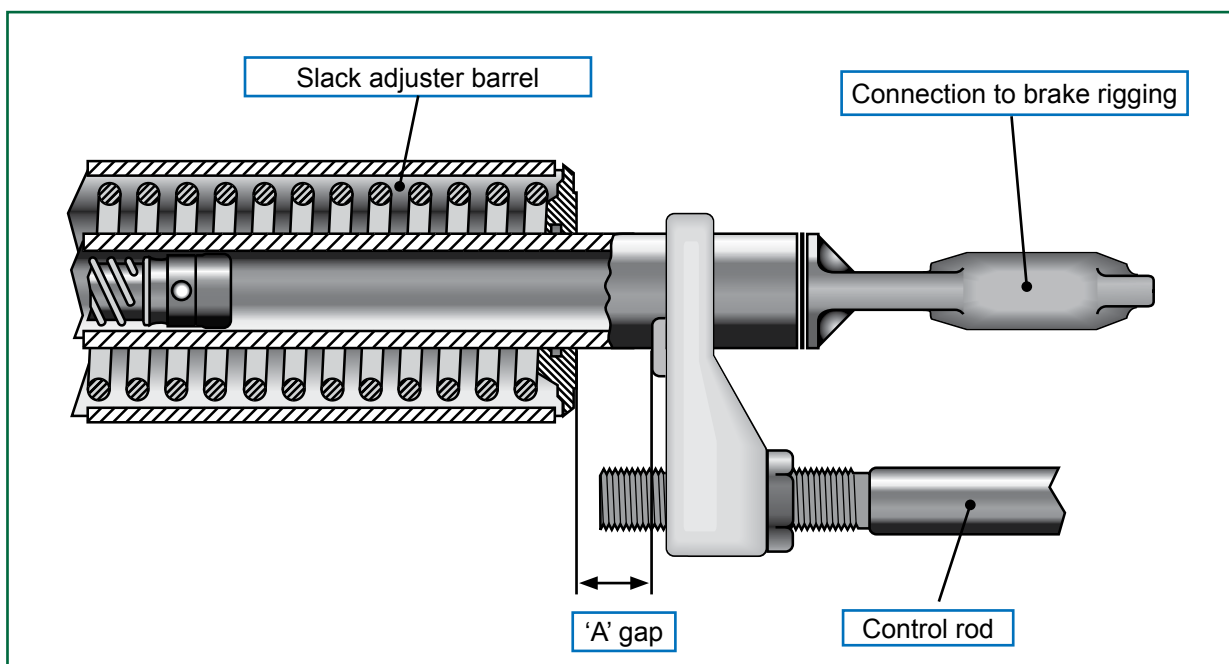
Figure 15: Slack adjuster 'A' gap

- 57 The brake system includes slack adjusters whose purpose is to ensure that slack in the brake rigging is taken up as the brake blocks wear. A dimension known as the 'A' gap in the slack adjuster assembly must be set to the value laid down in maintenance specification EWS/ES/0085 so that the brake blocks are set the correct distance from the wheels (Figure 15).

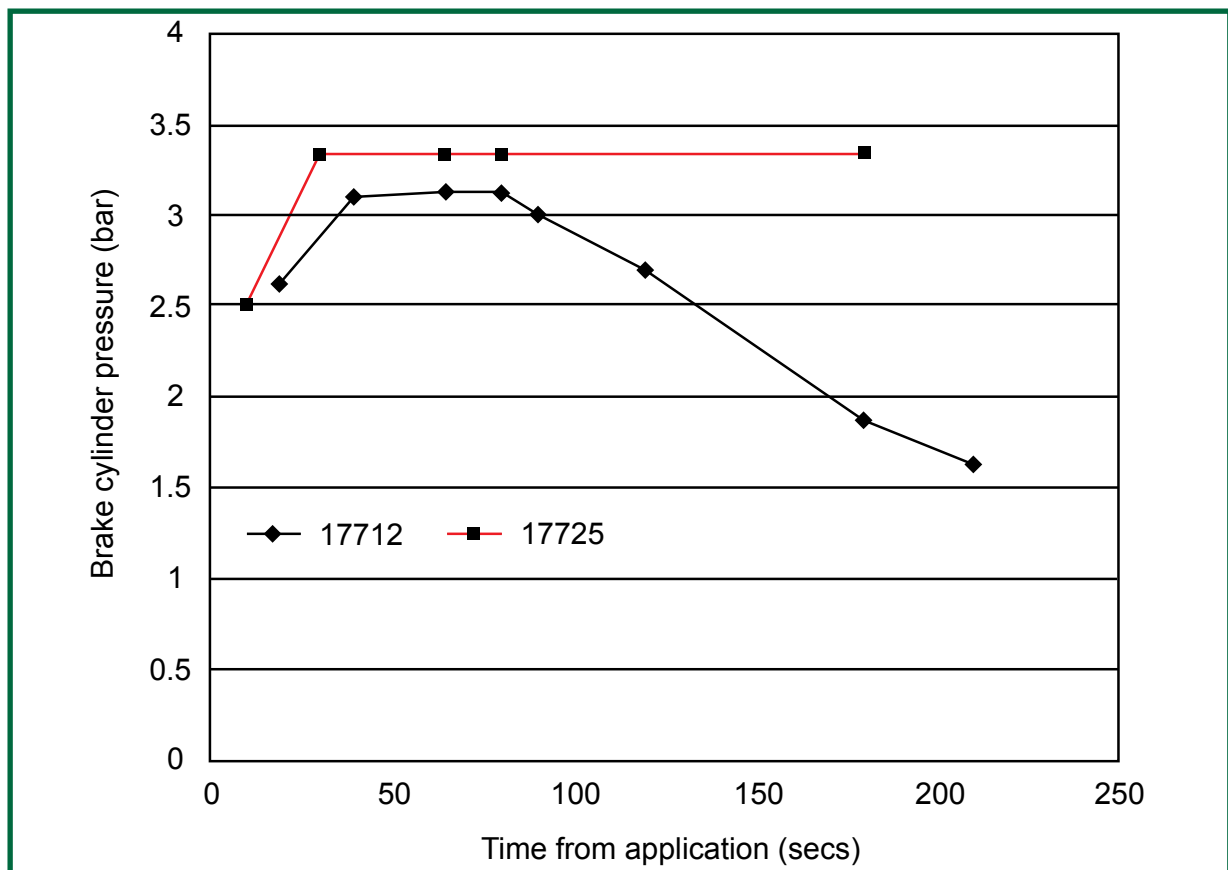
Figure 16: Results of brake cylinder leakage tests for wagons MAR17712 and MAR17725

58 Following initial tests of the train consist excluding the two runaway wagons, tests were carried out on the complete train consist as it was at the time of the incident and then on the two runaway wagons themselves. The testing found that neither of the two runaway wagons met standard EWS/ES/0097 due to the following defects:

- MAR17712 did not meet EWS/ES/0097 for brake cylinder leakage (maximum 0.2 bar over 5 minutes). The results suggest that the brakes would lose half their pressure within a matter of minutes (Figure 16), although the rate of leakage would not be linear and would reduce as the brake cylinder pressure reduced. However, EWS's tests revealed no obvious air leaks.
- The 'A' Gaps for the two slack adjusters fitted to MAR17725 were found to be 80 mm and 82 mm which is more than twice the design value of 32 mm. This would probably have reduced the amount of brake force for a given brake cylinder pressure, although this was not measured during the tests.

- 97 At Camden Road Tunnel, only two wagons were detached and they were on a gradient that was considerably less steep than 1 in 40 (paragraph 23). It would be reasonable to expect therefore, that these two wagons would have remained stationary for much longer than they did. However, the combination of rapid leak off of the brake cylinder pressure in one wagon and degraded brake force in the other due to incorrectly set slack adjusters (paragraph 58) caused the two detached wagons to run away when they did (paragraph 34). Had the braking system met the specification, the runaway would not have occurred, because the presence of the detached wagons would have been discovered before the brakes had leaked off sufficiently to allow the wagons to run away (the wagons were detached for 58 minutes before it became apparent from the signalling system that the train was in two parts – see paragraphs 30 and 33). The condition of the brakes fitted to the two runaway wagons is therefore a causal factor.
