Rail Accident Report

Collision with the gates at Lydney Town level crossing 15 August 2007

Collision with the gates at Lydney Town level crossing, 15 August 2007

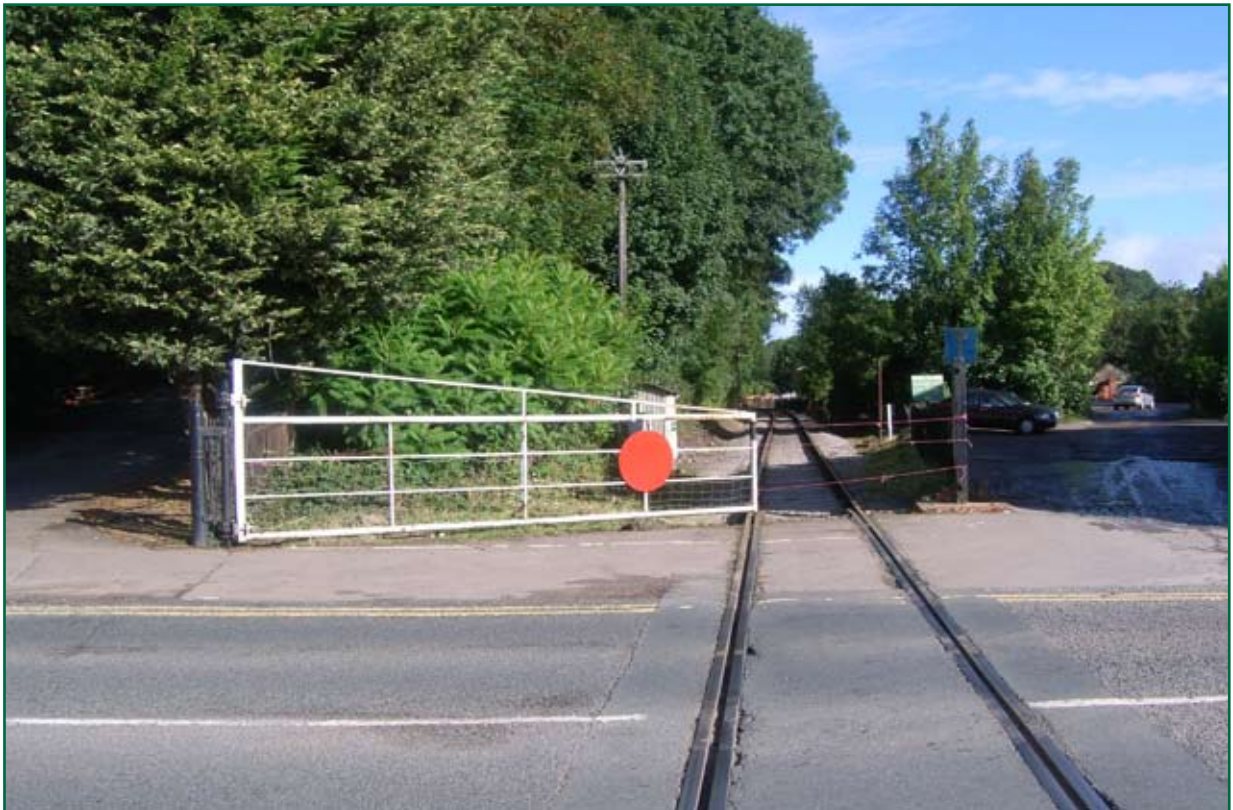
Figure 4: Lydney town crossing looking north (secondary gate missing following accident)

- 70 The rolling stock was recovered from site later in the day and taken back to Norchard for examination.
- 71 The crossing was taped over and the line closed for the remainder of the day. A replacement for the damaged gate has subsequently been provided.

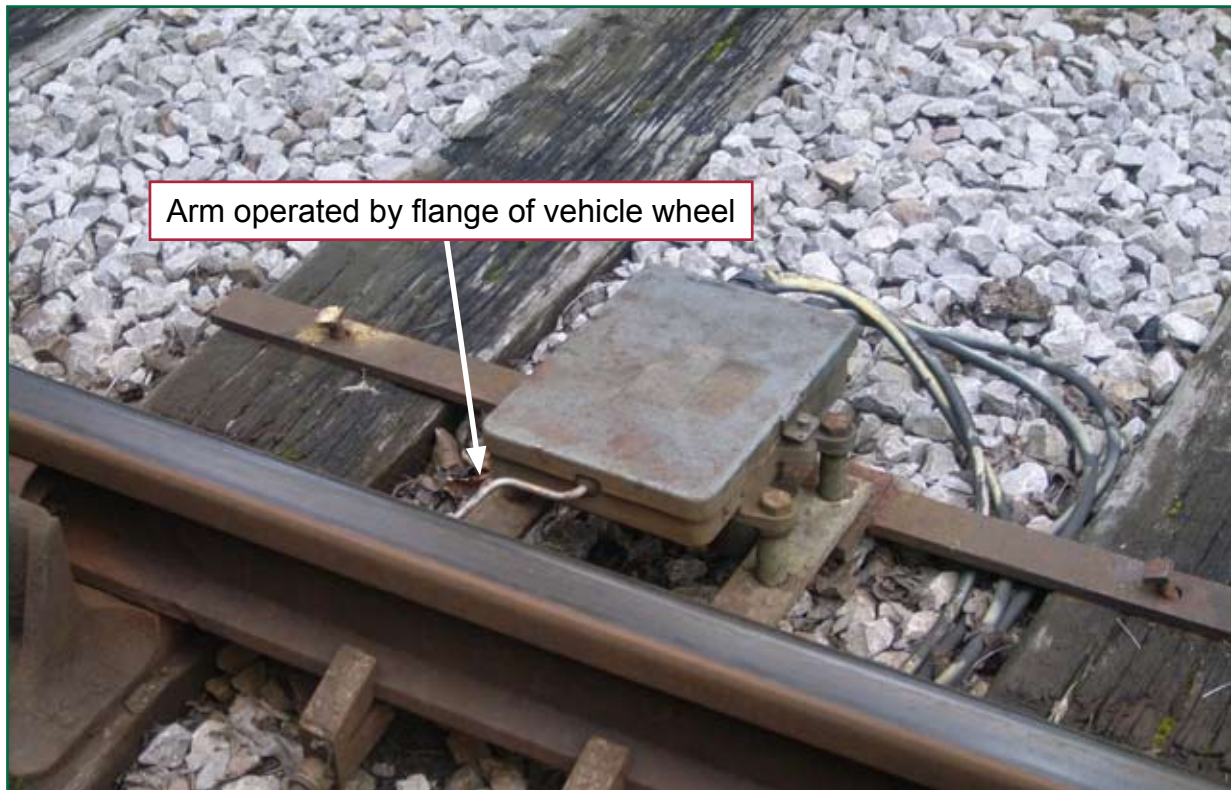
Figure 6: Treadle

- 32 In order to warn the crossing keepers of approaching trains there is a treadle placed 455 metres (500 yards) north of the crossing (Figure 6). Operation of this treadle by a train causes a buzzer to sound, and a light to flash, at the crossing keepers' hut.

- 84 Inspection of the system following the accident identified that the buzzer was faulty and not working at all. The treadle operated warning light was intermittent. The length of the warning given by the flashing light is a function of the train length and how long the treadle arm takes to return to the normal position once depressed by the wheel flanges of a passing train. The return motion is *damped* to extend the period of warning. At 20 mph, the wheels of the auto-train would depress the treadle arm for less than 3 seconds. If the arm is correctly adjusted, it should take between 6 and 8 seconds to return to its rest position. This gives a total length of warning of 9 to 11 seconds, which will be reduced if the arm is not set at the correct height (so that it is not fully depressed by wheel flanges) or if the damping not adjusted correctly.

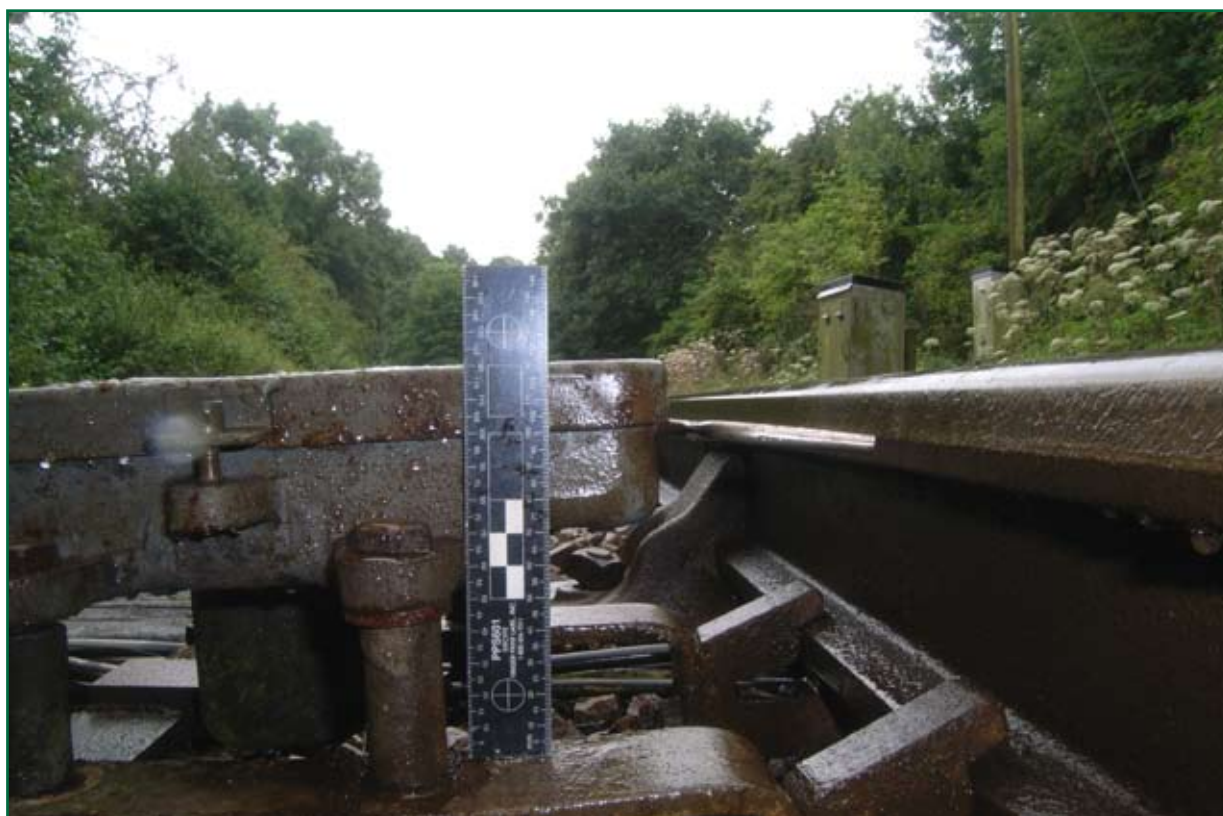
Figure 14: Displaced treadle arm

- 85 The treadle was found to be in working order. However, it was not functioning correctly, because its operating arm had been positioned or displaced about 22 mm below the rail head (Figure 14). Network Rail company standards NR/GN/SIG/19046 and RT/SMS/TEST/044 give guidance on the correct method for setting up treadles, and the correct distance of the arm below the rail head for this type of treadle is 16 mm (+/- 1 mm). The lower position of the arm meant that it was being depressed a small distance, or not at all, depending on the actual depth of the wheel flanges (which have a nominal depth of 24 mm). Therefore the warning light was showing for a very short time, or not at all.

- 86 The incorrect positioning of the warning treadle arm was contributory to the accident. The lack of corrective action by the DFR after it became aware of problems with the buzzer and warning light was also contributory to the accident.

- a. relaid the track under the treadle, thus improving the security of the fixing of the treadle;
- b. tested and proved the wiring circuits from the treadle to the crossing equipment box;
- c. replaced the battery that powers the buzzer and the white light at the crossing;
- d. moved the 'stop' board at Lydney Town to a greater distance from the crossing; and
- e. issued a reminder to all drivers of the need to observe the published speed limits.
