# Rail Accident Report

**Fatal accident at Moor Lane footpath crossing,  
Staines  
16 April 2008**

# Fatal accident at Moor Lane footpath crossing, Staines, 16 April 2008

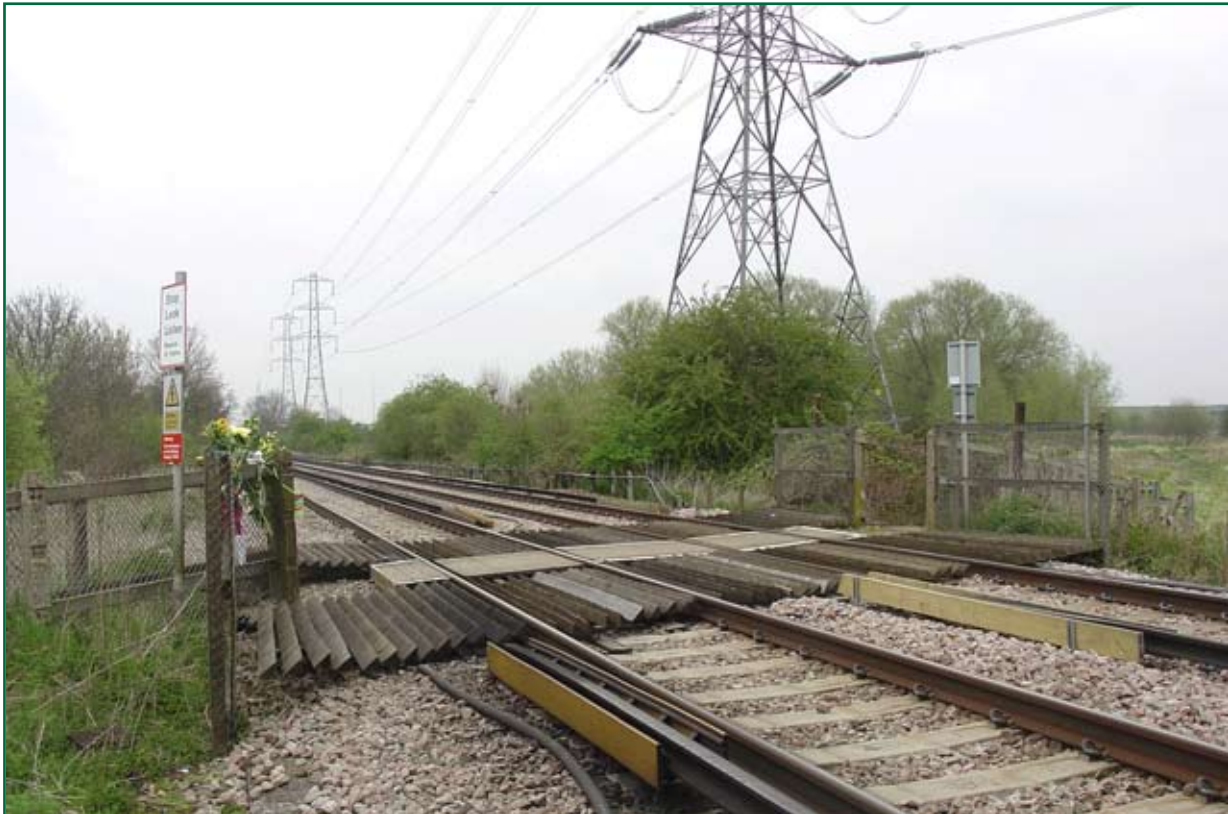
- 19 The crossing (Figure 2) carries a public footpath which runs from Moor Lane itself, about 50 m south-west of the railway, onto Staines Moor. It is used by people walking on the moor, and is part of the Colne Valley Way footpath.

Figure 2: Moor Lane crossing from the south-east

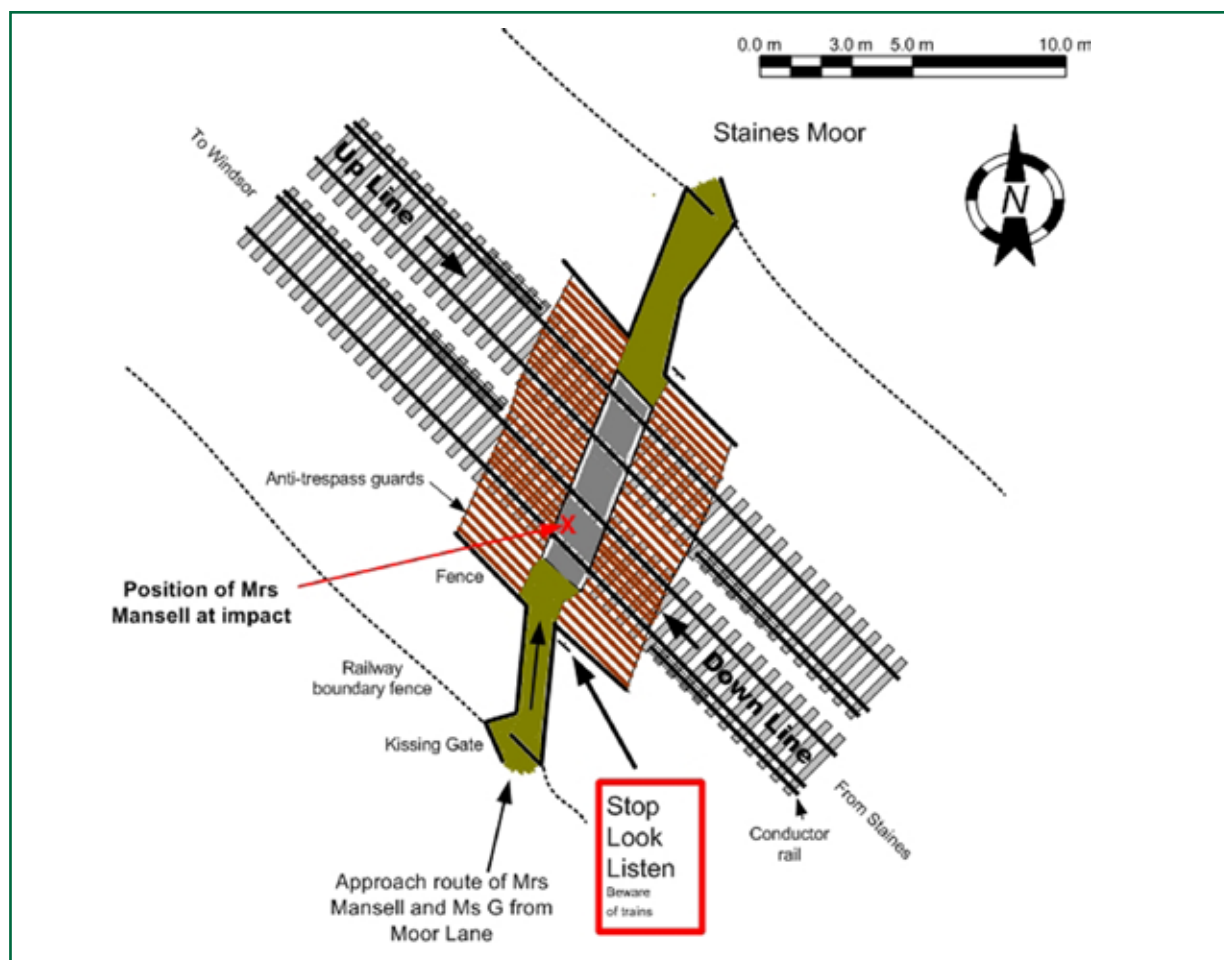
Figure 3: Plan of crossing

- 37 The approach to the crossing from Moor Lane is by two paths which converge immediately outside the railway boundary. There is a 'kissing' gate in the boundary fence, and beyond this the path runs between chain-link fences about 1m apart up to a point about 1.4 m from the nearest rail of the *down line*. The path is not at right angles to the railway, but approaches at about 45°. The path emerges from dense bushes close to the boundary fence, which stop about 3 m from the railway itself. There is a notice warning pedestrians to stop, look and listen, positioned on the right-hand side of the approach path about 2.5 m from the nearest rail (Figure 3). The crossing itself has a boarded timber surface, reached by a single step up from the approach path. It crosses the track at an angle of 66°. The boards of the crossing surface run parallel to the direction of the footpath, except for those on the outside (cess side) of the rails on both lines, which are parallel to the rails (Figure 4). There are 1.5 m high chain link fences extending from the end of the footpath for about 3 m, running parallel with the railway in both directions.

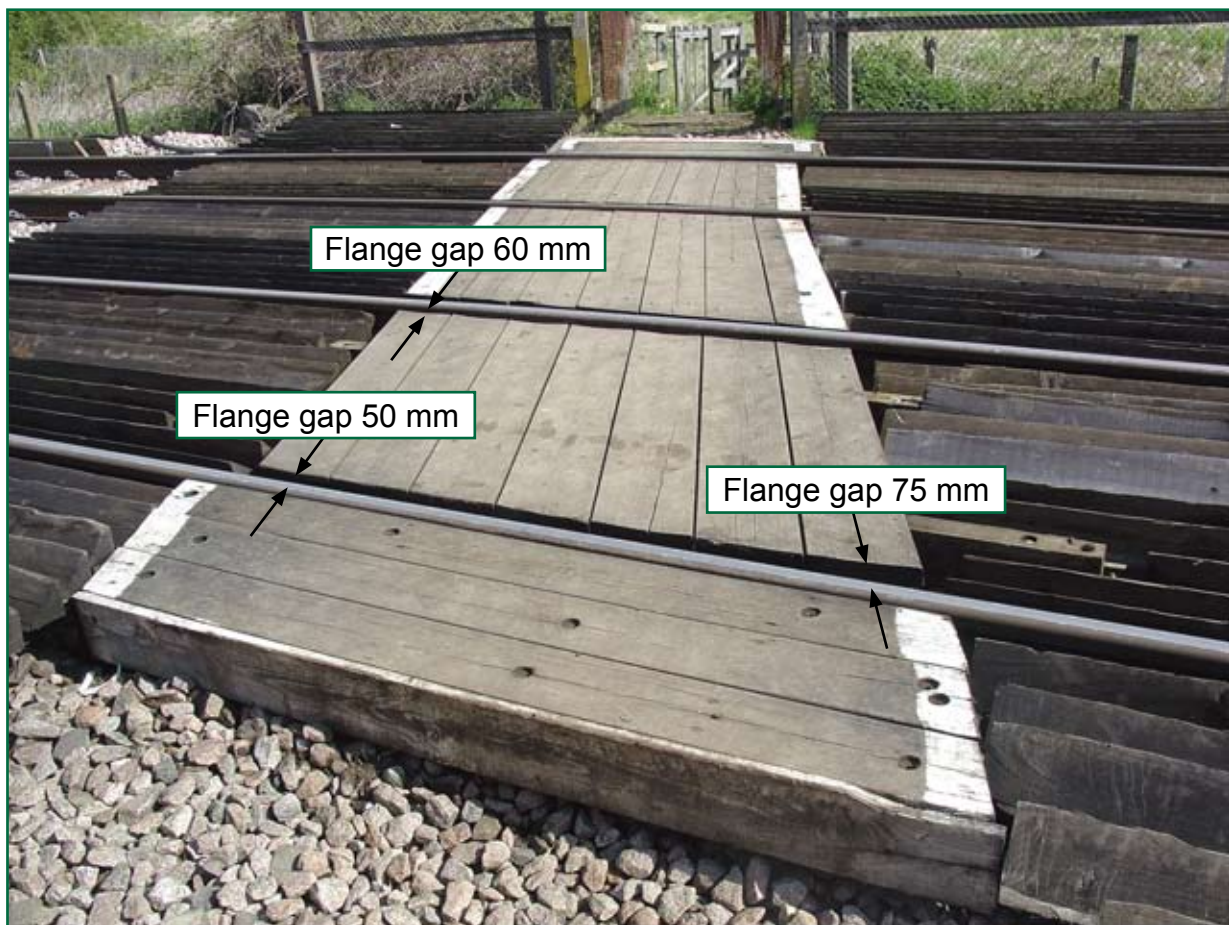
Figure 4: Moor Lane crossing surface, from the south side

- 40 There are white lines, about 50 mm wide, painted along both edges of the crossing. At the time of the accident these lines were missing from the timbers in the *four-foot* of the down line (Figure 4).

- 89 The surface of the crossing was of planed timber, neither painted nor varnished (Figure 4). The orientation of the crossing timbers parallel to the direction of the footpath was unusual. However, tests carried out by the RAIB, using walking shoe soles weighted with concrete blocks and pulled across the surface, found that the slip resistance was the same in both directions, along and across the crossing.

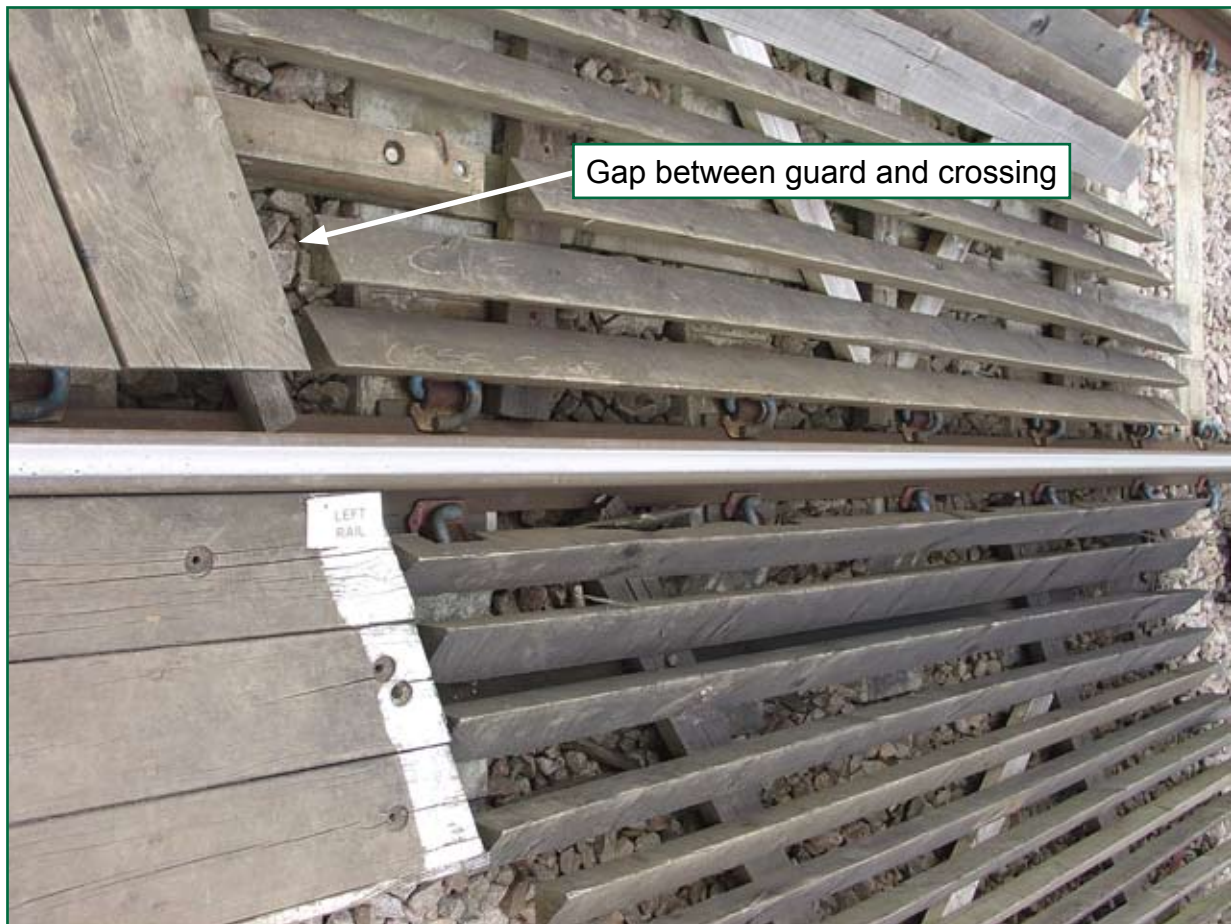
- 38 The conductor rails are interrupted at the crossing, and the gap extends over about 7 m. On either side of the crossing there are anti-trespass guards, consisting of triangular section timbers approximately 2.6 m long, fixed parallel to the rails at 80-100 mm intervals. These guards extend across the full width of the crossing between the fences on both sides. They are fixed close to the edge of the crossing surface, and terminated about 300 mm short of the ends of the conductor rails on both lines. There is in some cases a gap of up to 120 mm between the crossing surface and the end of the anti-trespass guard (Figure 5).

Figure 5: Anti-trespass guards

- 136 The guards are supposed to be fitted 'adjacent' (RSPG 2E paragraph 177) to the footway. In practice there may be a small gap between the footway and the end of the guard rails (Figure 5). This may create a hazard in which a person's foot can become trapped, should they stumble or slip off the footway itself. This hazard would be eliminated if there were a substantial gap (more than 300 mm) between the crossing and the anti-trespass guard, but this is not permitted in the current guidance.

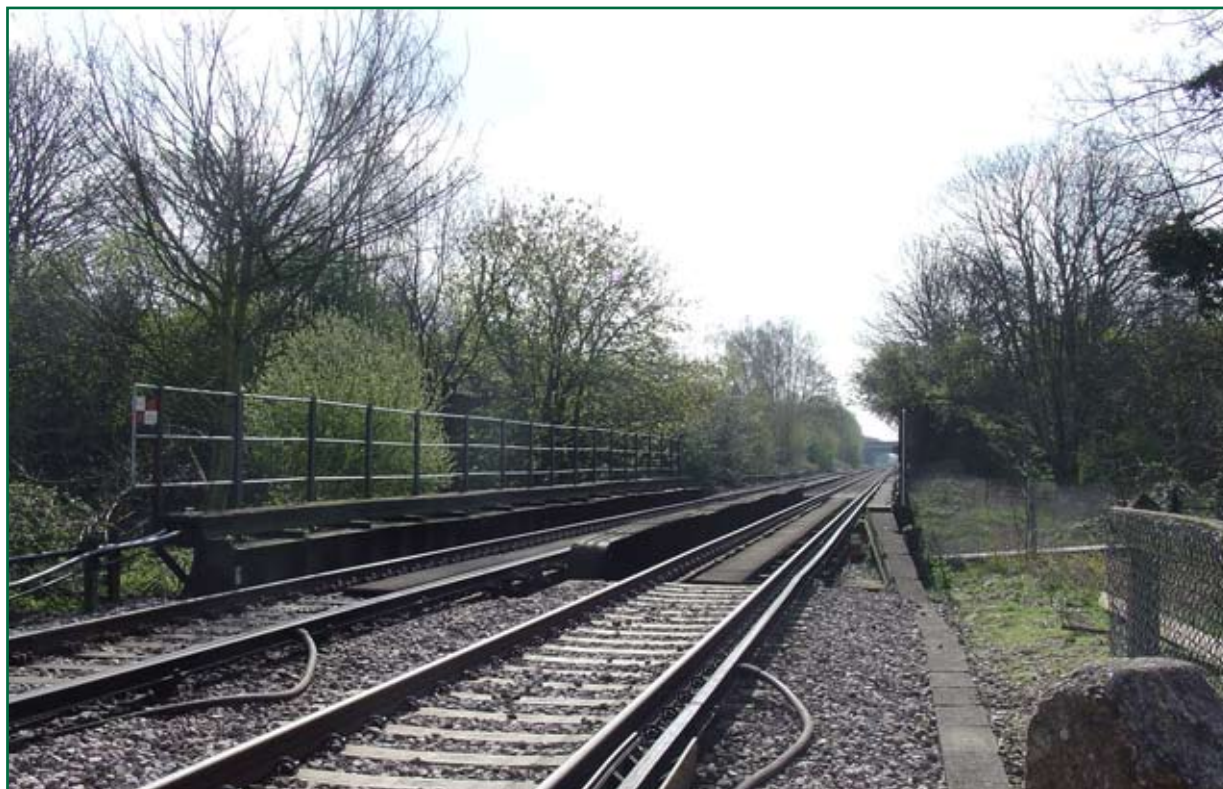
- 78 At Moor Lane crossing, trains approaching from Staines come into view approximately one mile (or one minute and fifteen seconds running time) away. For a person approaching the crossing from the south-west side, the visibility of trains is limited by, first, the vegetation to the right of the approach path, then the disused railway embankment and abutment about 75 m away beyond the river bridge, and finally by the railings on the river bridge. By the time the approaching pedestrian has reached a position where all these things are no longer obstructing their view to the right, they are at the fence posts at the end of the approach path, about 1.5 m away from the down line, and just past the warning notice (Figure 6), from where they can see trains up to one mile away.

*Figure 6: View south-east from end of approach path*

- 79 At this point, the pedestrian must make a decision on whether it is safe to cross the railway (see paragraphs 127 to 131 for further discussion of this issue). The view that is naturally presented to the approaching pedestrian is to the north-west, of trains approaching from Wraysbury. The angle of the approach path, at  $45^{\circ}$  to the line, means that to look along the line to the right toward Staines and London a person must look over their right shoulder, or turn their body significantly to the right. A person who is not paying close attention to what they are doing may, because of the direction they are facing when walking, not make the check to the right until they have stepped onto the crossing itself.
- 80 The angle of the approach path, and of the crossing itself, is a contributory factor in the accident.
