# Rail Accident Report

**Fatal accident at West Lodge crossing, Haltwhistle  
22 January 2008**

This report is published by the Rail Accident Investigation Branch, Department for Transport.

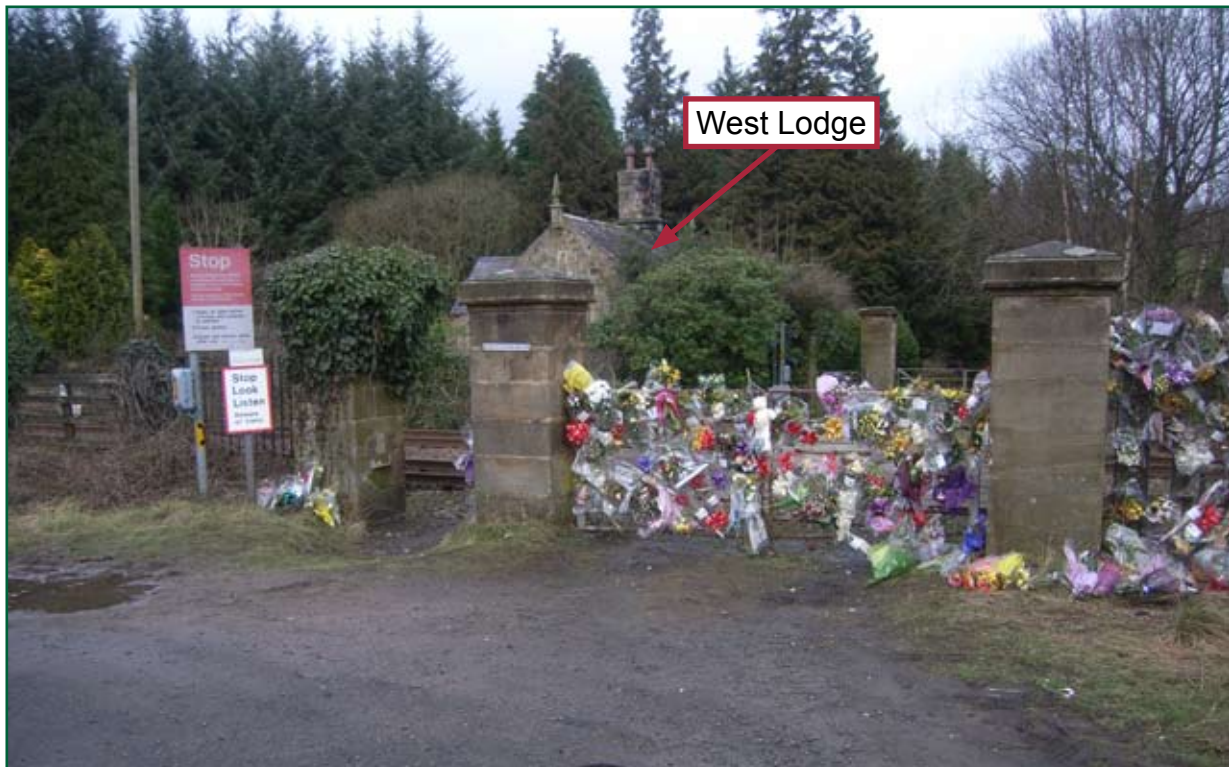
- 13 The approach from the A69 is narrow and has no slip road. It is difficult to drive off the A69 when it is busy with traffic and correctly position a vehicle to drive over the crossing. A vehicle that is incorrectly positioned or longer than 3.5 metres may foul the vehicle gates that open 3.5 metres into an approach that is 7 metres long (Figures 3 and 6).

Figure 3: West Lodge crossing viewed from the A69

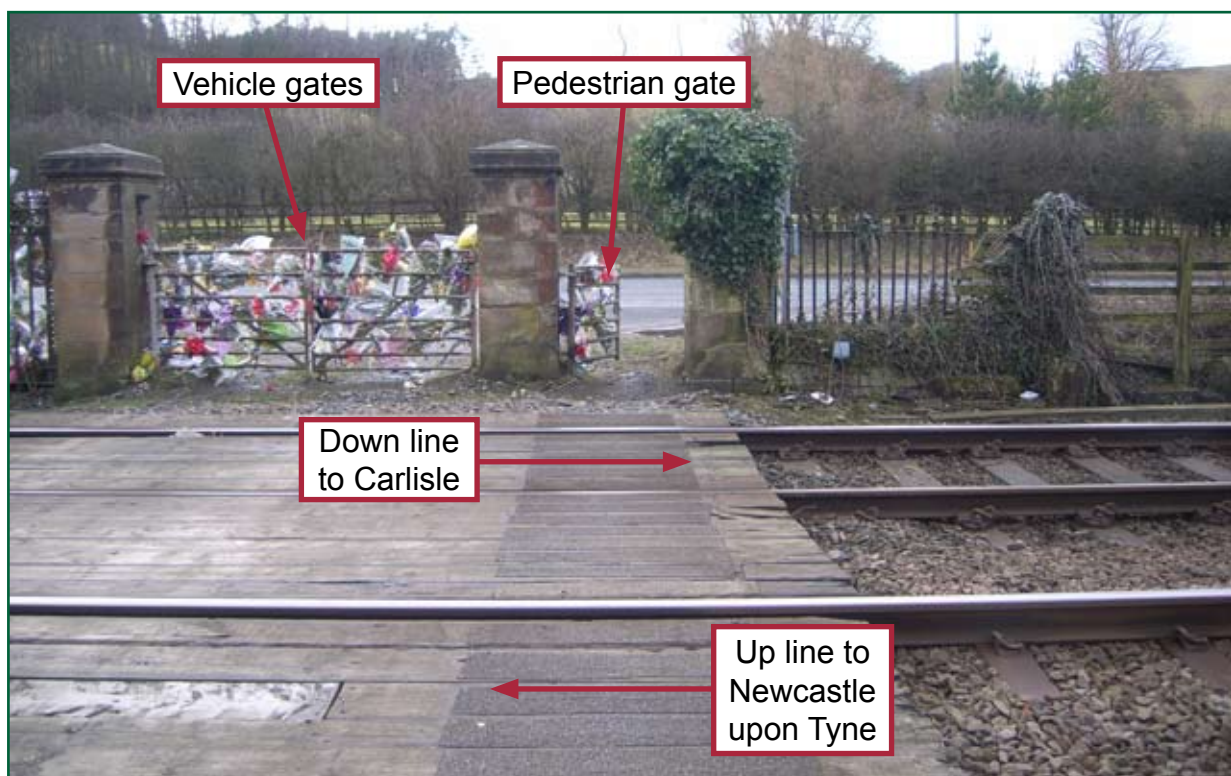
- 12 The crossing had pedestrian and vehicle gates and warning signs that stated 'always telephone before crossing with vehicles or animals to find out if there is time to cross' and 'stop, look, listen' and 'beware of trains'. It is not fitted with any system to give indication of a train's approach (Figures 3, 4 and 8).

Figure 4: The crossing viewed from West Lodge

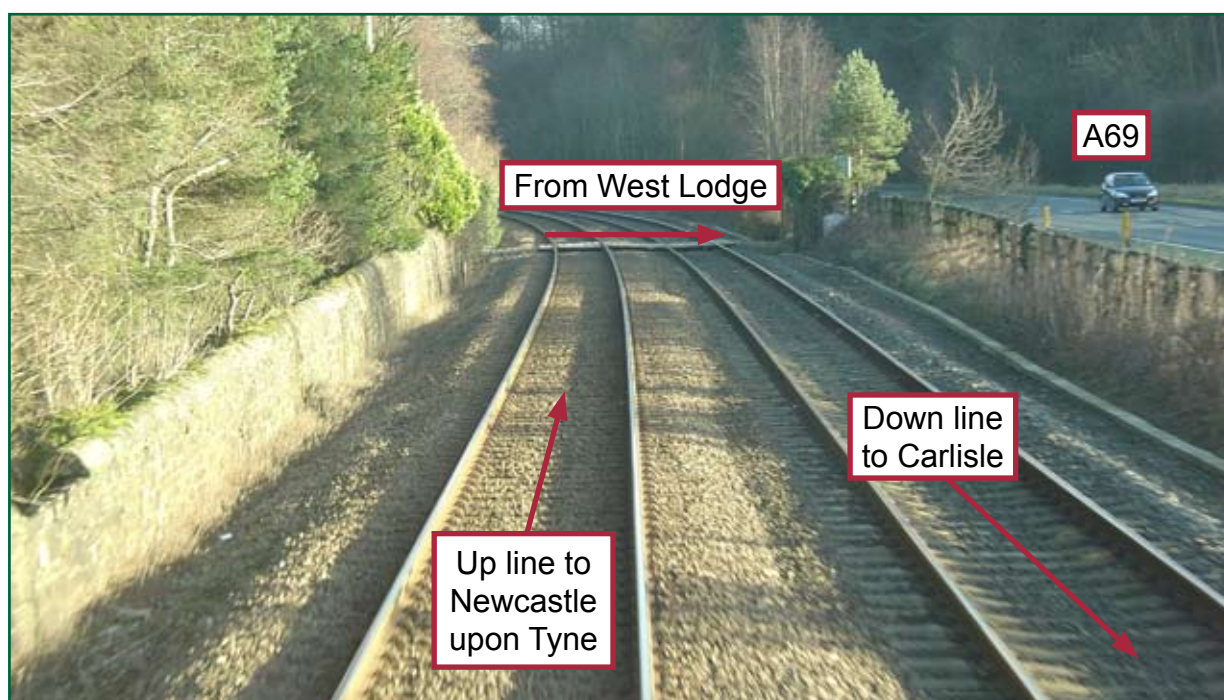
Figure 5: West Lodge crossing seen in daylight from the driving cab of a train

- 23 At 17:13 hrs the train driver saw a person appear from trackside vegetation to his left (Figure 5); he sounded the warning horn immediately and continuously as the person walked the few steps to the crossing and onto the up line.

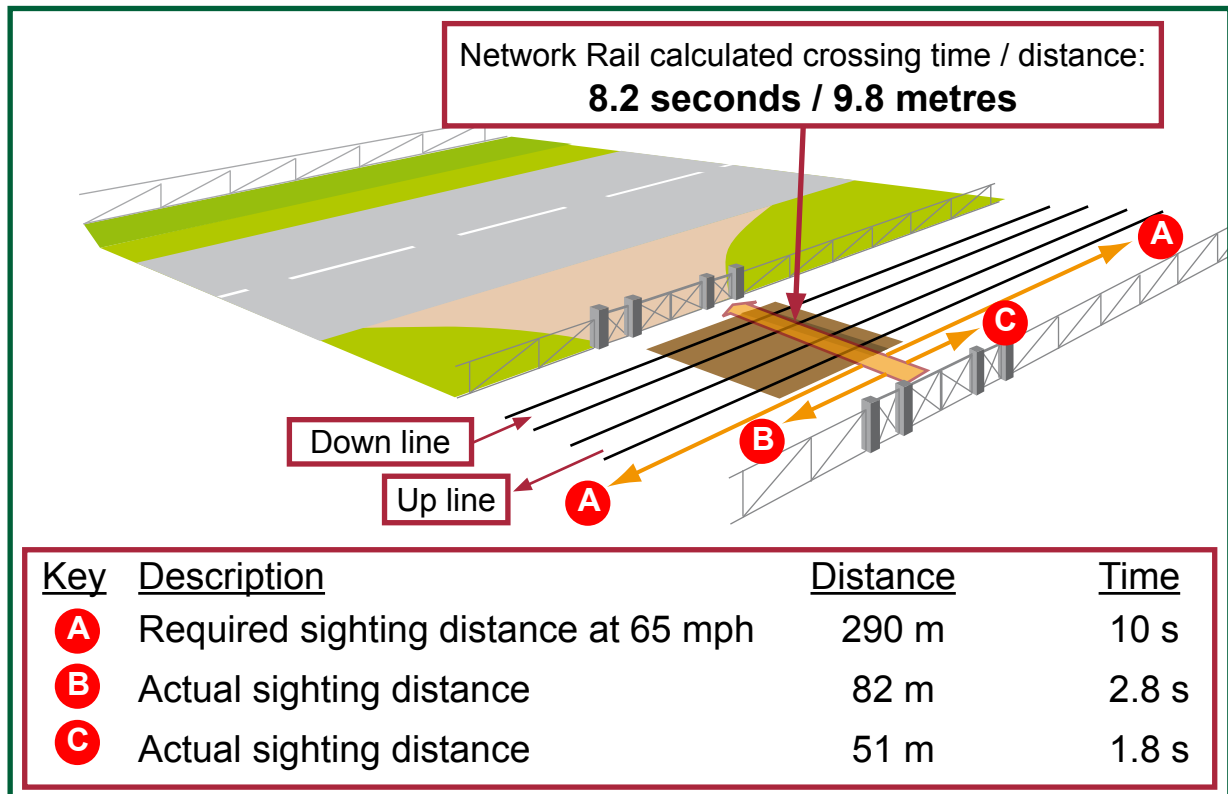
- at 2.4 metres from the nearest rail (the decision point defined in Network Rail's crossing assessments) the sighting distance was 51 metres to the north-west and 82 metres to the south-east, giving warning times of 1.8 seconds and 2.8 seconds respectively (Figure 7).

- 48 From the West Lodge decision point, a user's sighting distance, and thus warning time, were less than laid down in ORR guidance and required by Network Rail's inspection process (paragraphs 71 - 73). Sighting distance was reduced by track curvature and vegetation.

Figure 7: Sighting distances from the West Lodge decision point

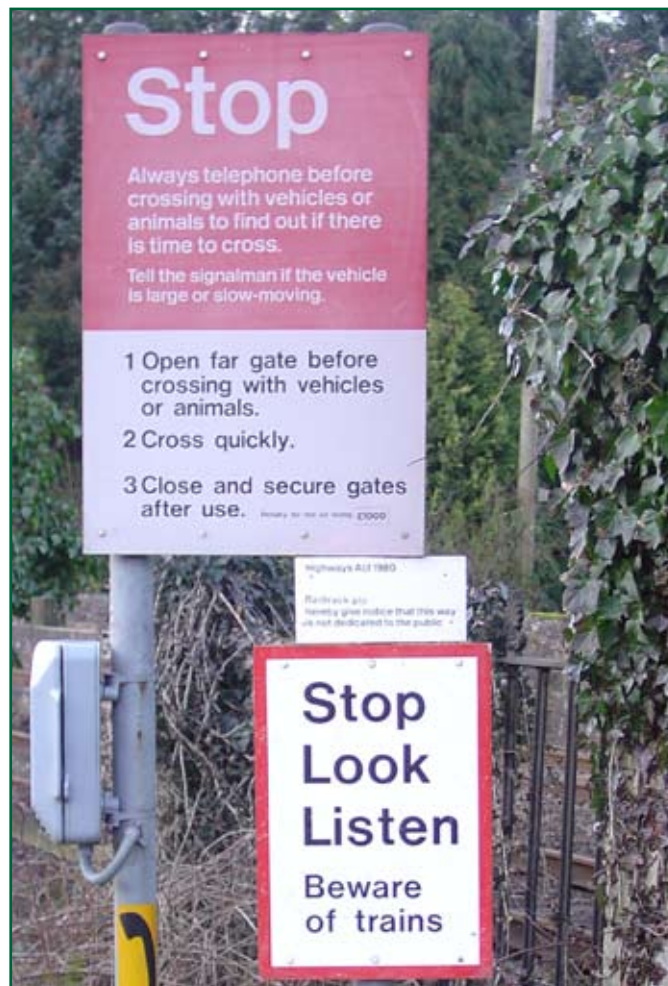
Figure 8: Warning signs at West Lodge crossing

- 49 Warning signs at West Lodge crossing state that users with vehicles or animals should always use the telephone to contact the signaller and find out if there is time to cross; pedestrians are required to stop, look and listen for trains and cross when it is safe to do so (Figure 8). The signs do not require pedestrians to contact the signaller.

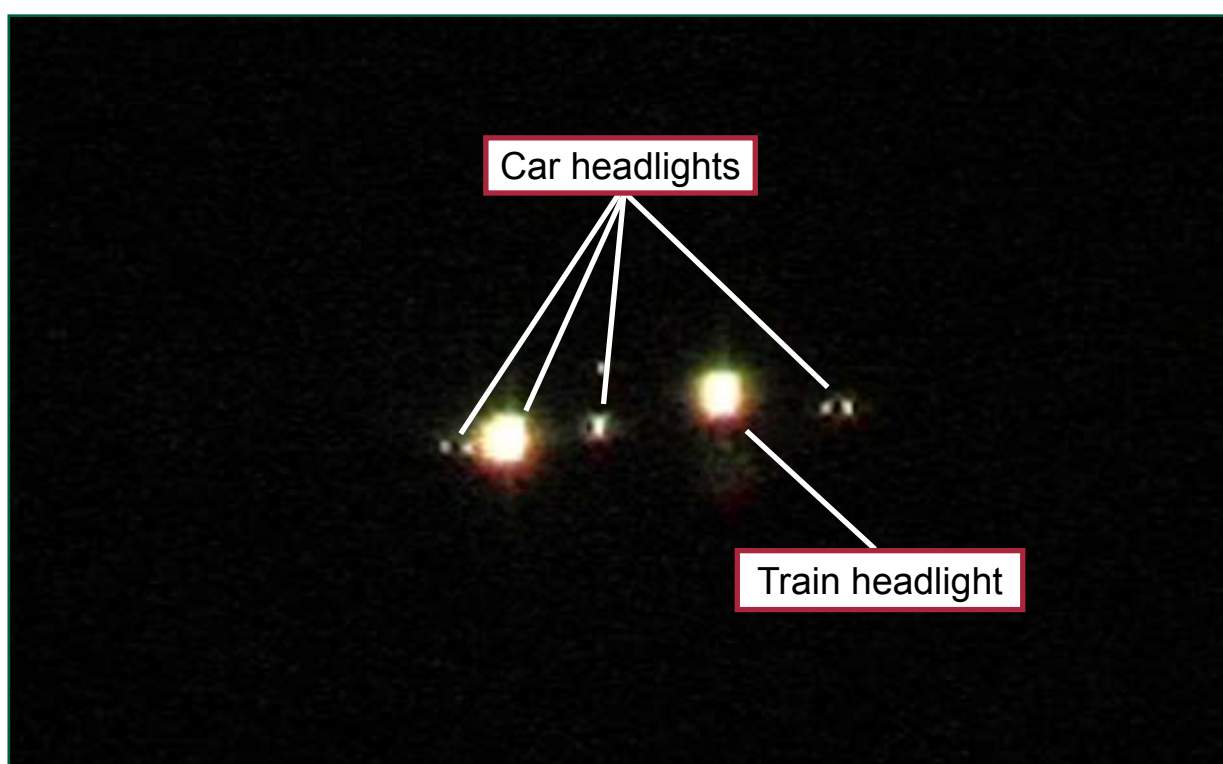
- 50 At West Lodge crossing in daylight, a user can recognise an approaching train as its appearance is different from the vehicles on the A69; in darkness, the headlights of a train are not easily recognised among those of road vehicles.
- 51 The headlights of a train are most difficult to recognise among those of road vehicles when sighting north-west from West Lodge, the direction from which the freight train came, as the railway and the A69 run adjacent and aligned (Figure 9).

Figure 9: Train approaching West Lodge crossing in darkness

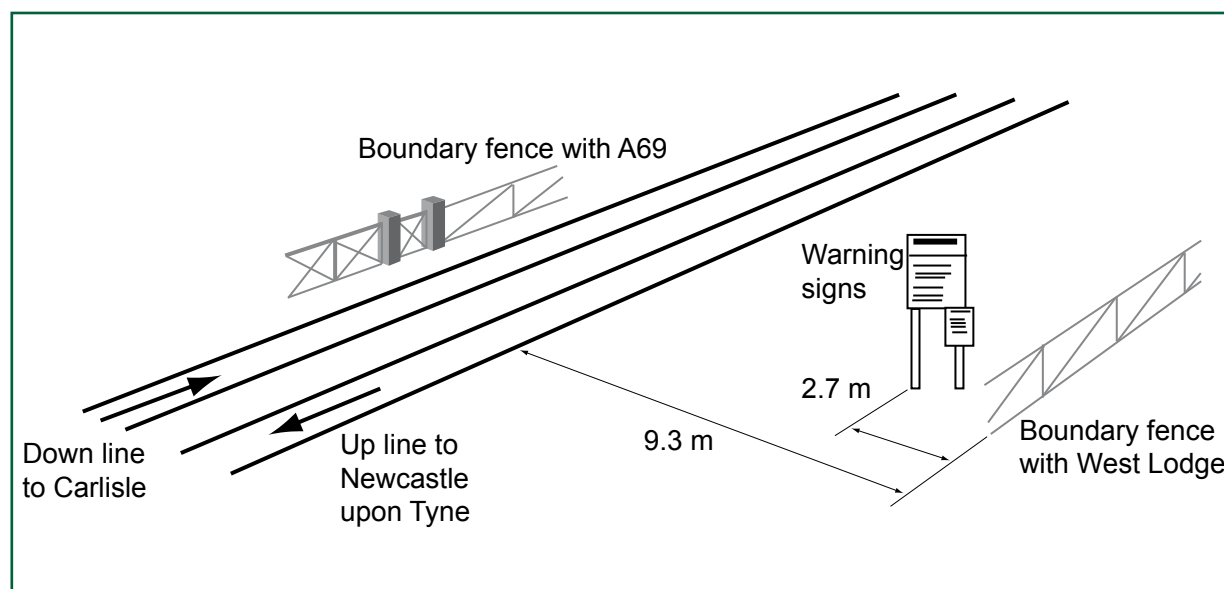
- 65 RSSB human factors risk number 90 recognises that a user's detection of a hazard improves when information is available in close proximity to the hazard itself. This is also recognised by the ORR guidance that states that the '[decision point]...is where guidance on crossing safely is visible and at which a decision to cross or wait can be made in safety.'
- 66 At the decision point on the West Lodge side of the crossing, the warning signs and guidance are not visible as they are 6.6 metres back from the track. The decision point itself is not physically marked or indicated to the crossing user (Figure 10).

Figure 10: Warning sign location

- 67 Users are less likely to be aware of and prepared for a crossing if they do not see the warning signs at the decision point.
