Rail Accident Report

Derailment at St Peter's Square, Manchester **29 June 2008**

This report is published by the Rail Accident Investigation Branch, Department for Transport.

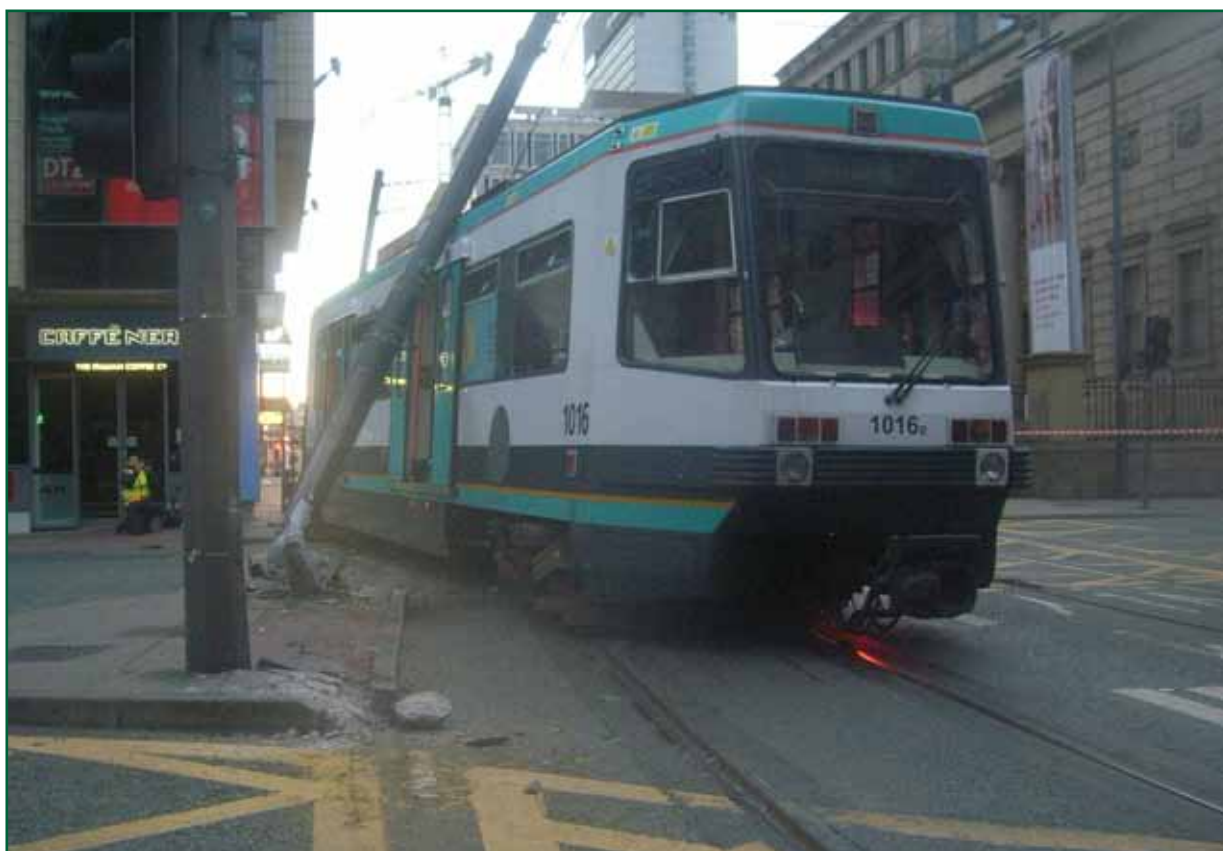
Figure 2: Tram 1016 after the derailment

- 32 A number of passengers sustained minor injuries. No pedestrians were injured as a result of the derailment.
- 33 The derailed bogie damaged street furniture, a traffic signal, two overhead line stanchions and the kerb and highway in several locations.
- 34 Tram 1016 incurred damage to the body-side, *solebar*, underframe and deformation to the main bodyshell's structural pillars and *cantrail*.

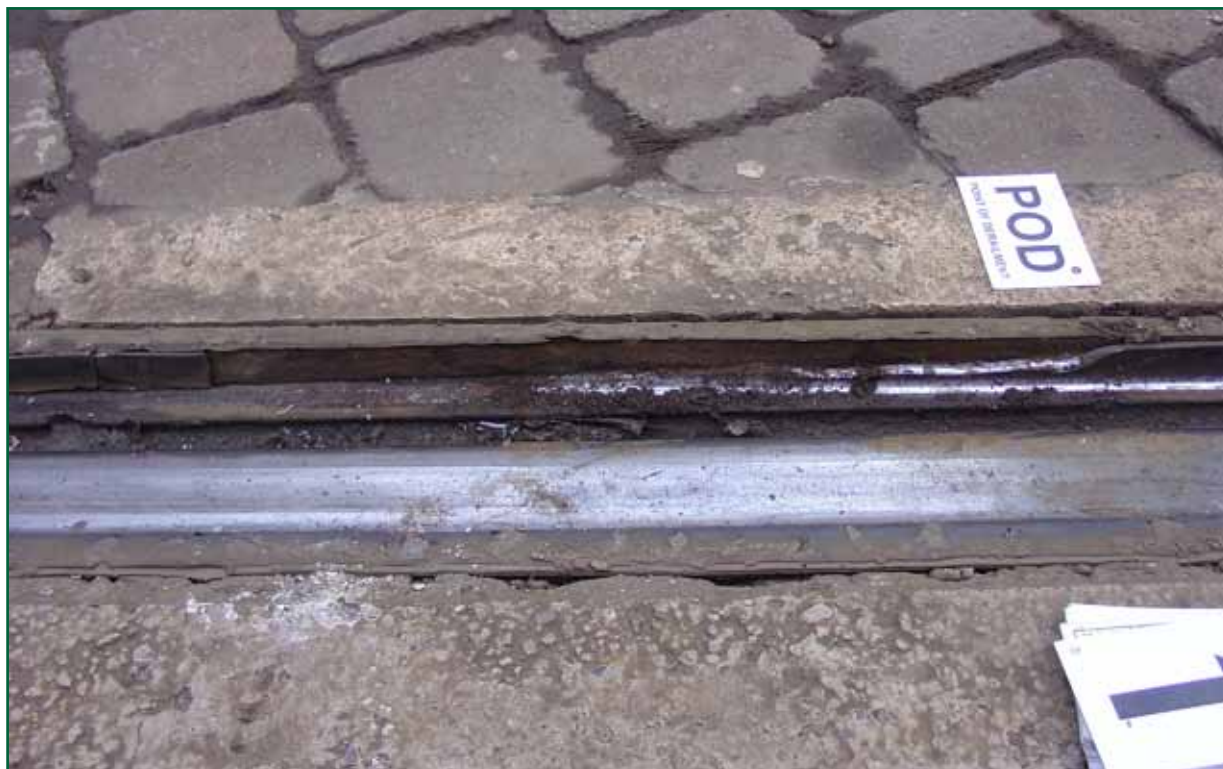
- 29 The leading right-hand wheel on the centre bogie of tram 1016 derailed by its flange riding to the left of the right-hand rail's keep. The wheel flange was allowed to climb behind the keep because a 400 mm section of keep had broken and detached (Figures 4 and 5). It is considered likely that the keep failed due to contact by a previous wheel on the double unit, because other wheelsets of this tram and previous trams had successfully negotiated the curve. The bogie ran for 33 metres with the left-hand wheel riding against the *gauge face* of the left-hand rail and the right-hand wheel running between the back of the right-hand rail's keep and the road surface; the mechanism is shown diagrammatically in Figure 6. The wheels continued on this path due to the *gauge spread* from the sidewear (paragraph 43); when the track gauge narrowed to the design value the left-hand wheel climbed over the left-hand rail, eventually leaving the rail head three metres later. The second wheelset of the middle bogie followed the first wheelset into derailment to the left (Figure 7).

Figure 4: The right-hand rail at the point of derailment where the keep had failed

- 88 The immediate cause of Tram 1016 derailing was failure of the right-hand rail's keep allowing the leading right-hand wheel flange to climb the face of the broken keep.
- 89 The keep of the right-hand rail failed because the excessive sidewear on the left-hand rail had resulted in the back of right-hand wheel flanges contacting and wearing the keep. The keep became worn so thin that it could no longer withstand the force on it from the flanges pressed against it. Rails on the outside of curves are subject to sidewear due to the curving forces exerted at the wheel-rail interface during the normal passage of trams.

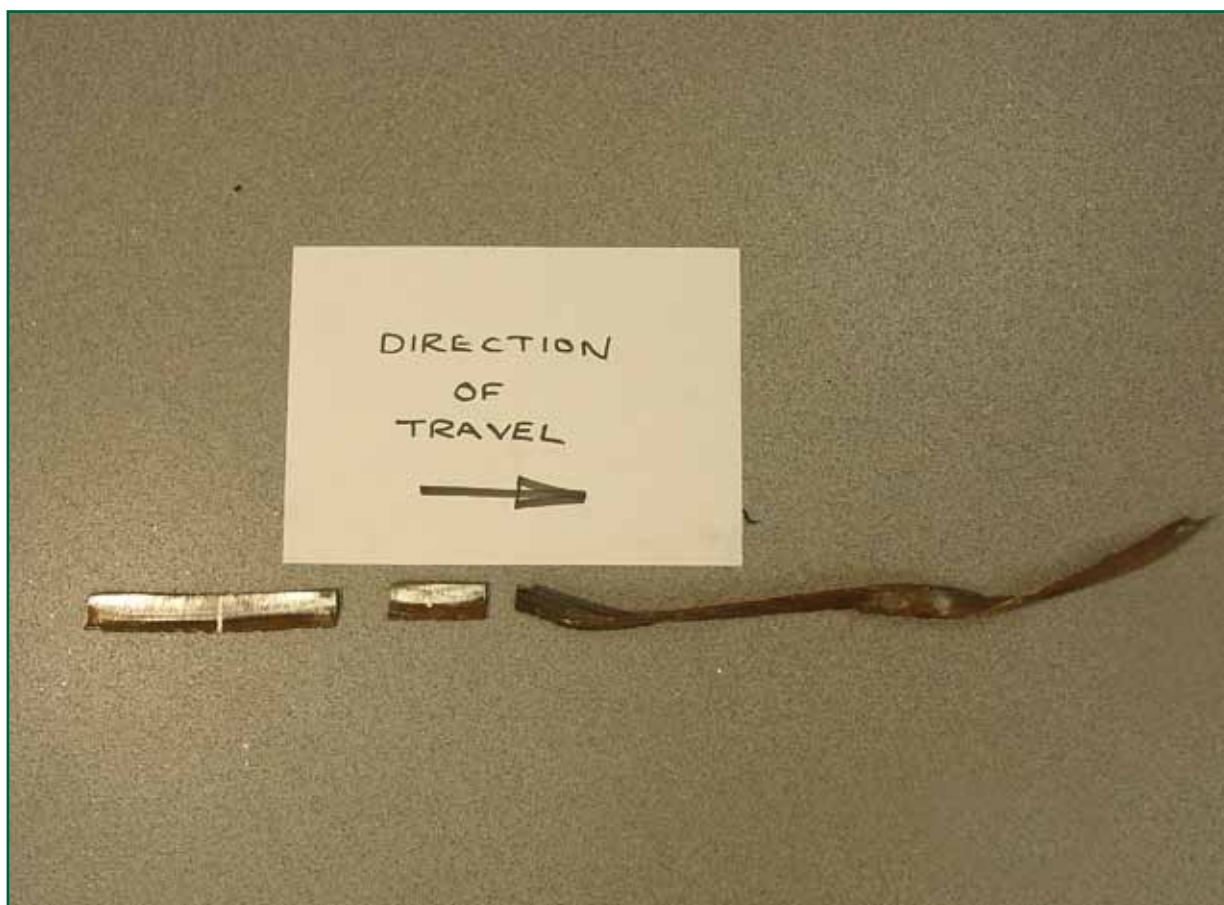
Figure 5: The failed section of the keep

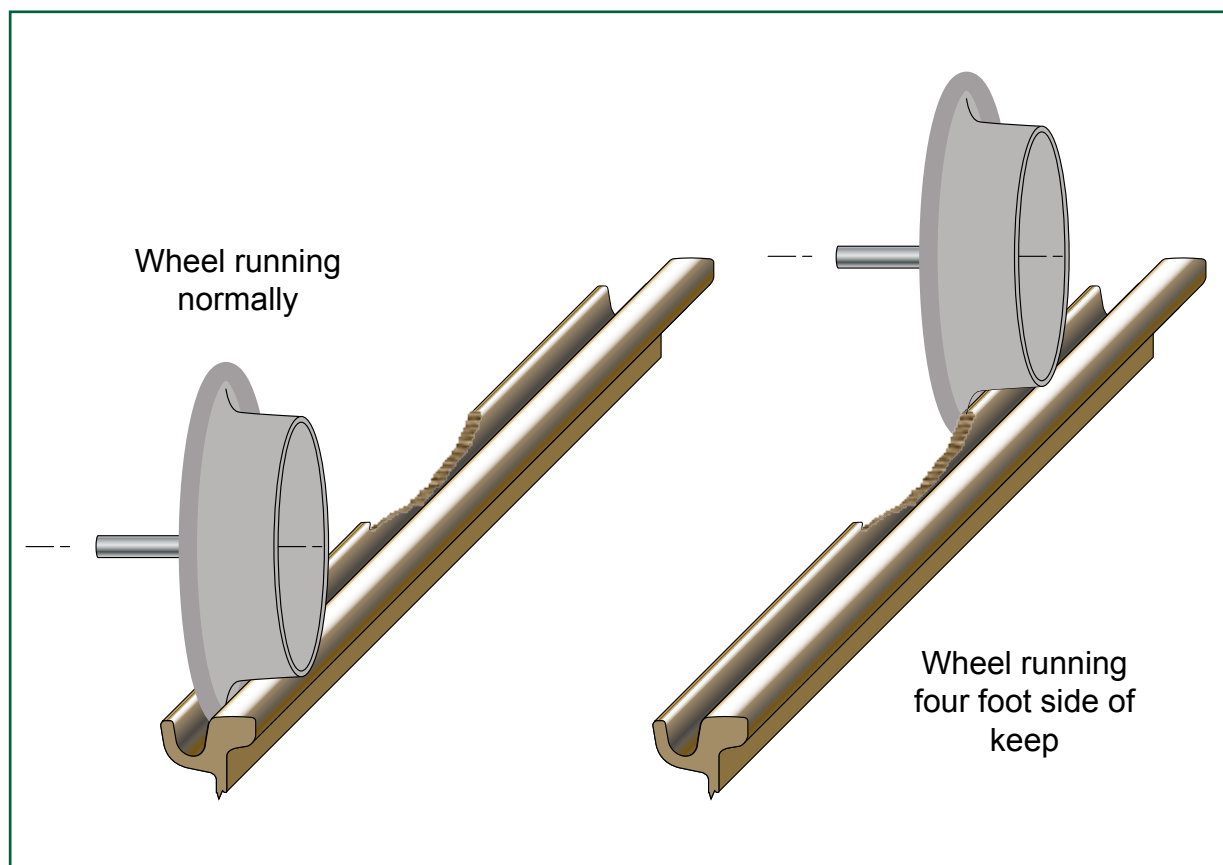
Figure 6: Image showing derailment mechanism

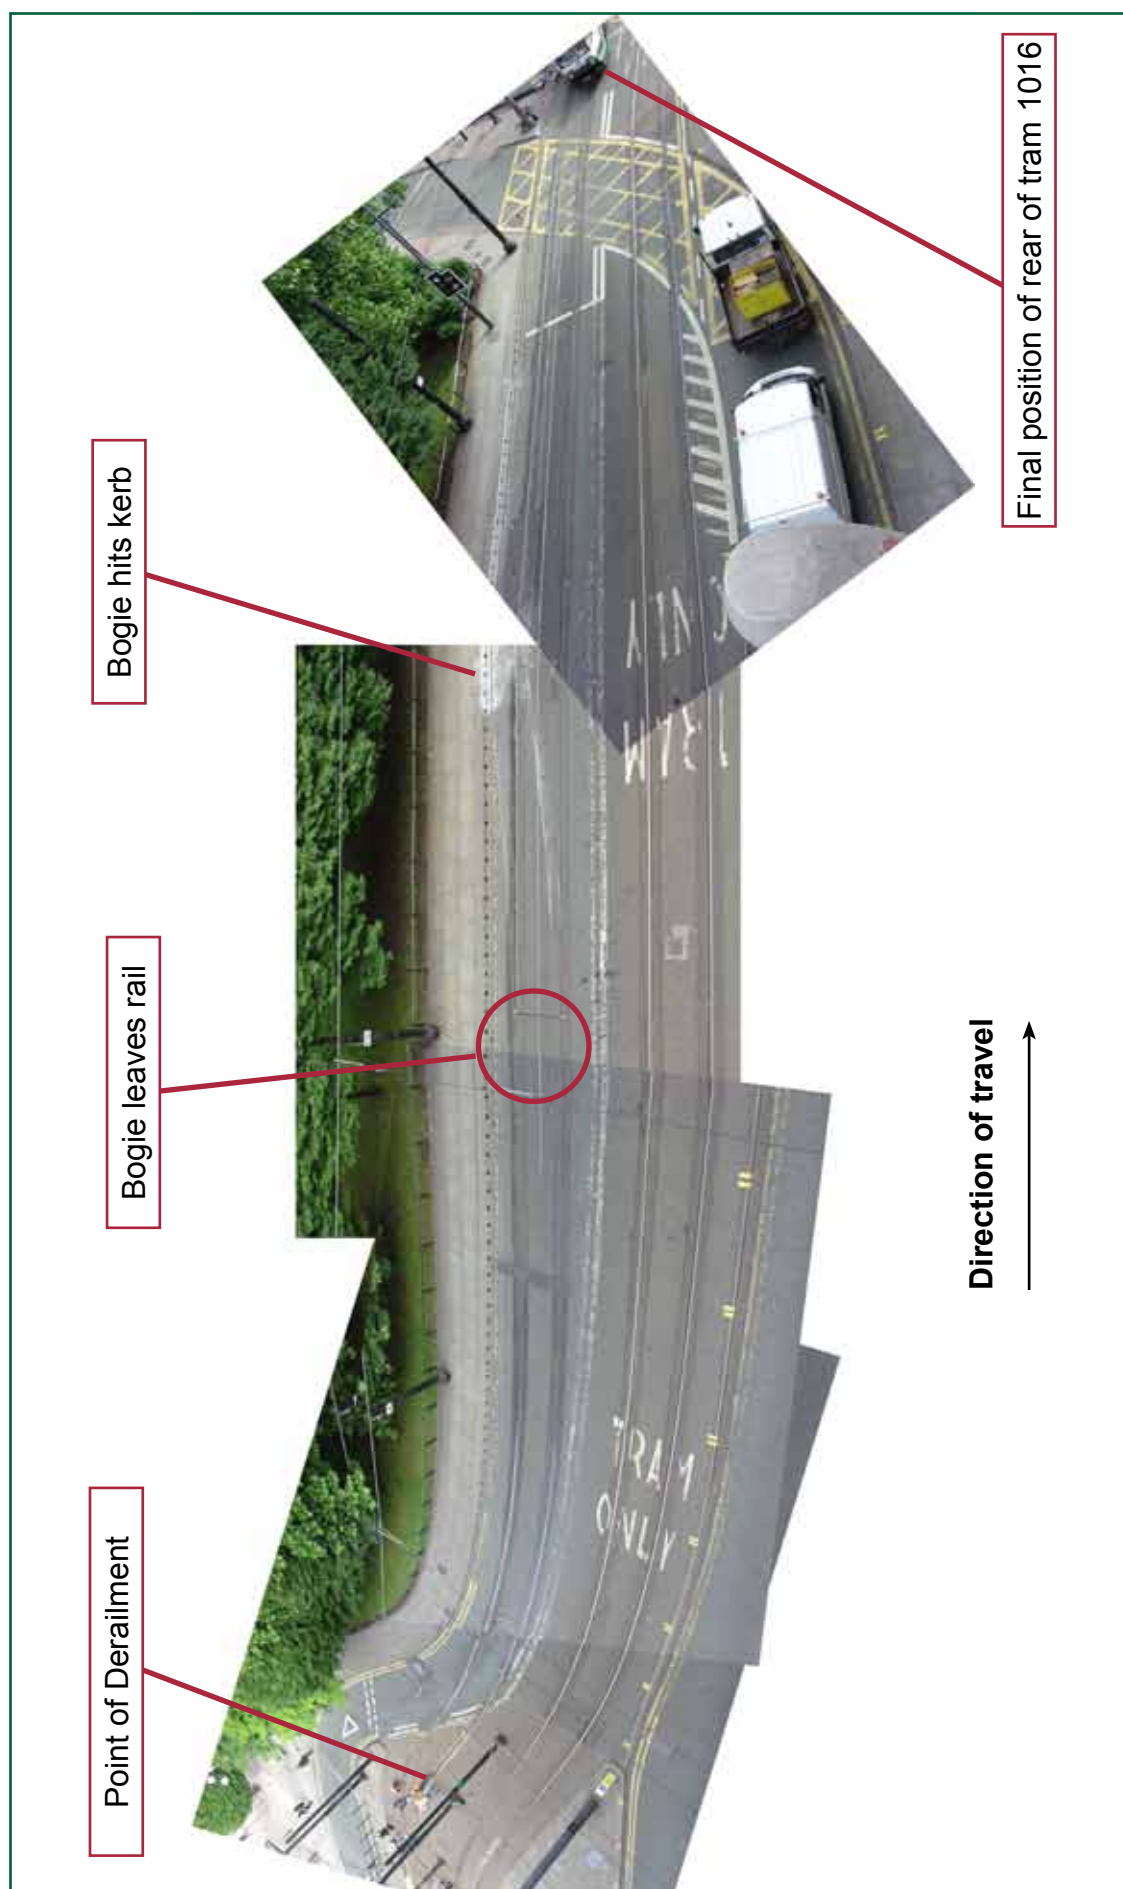
Figure 7: The derailment marks on the road surface

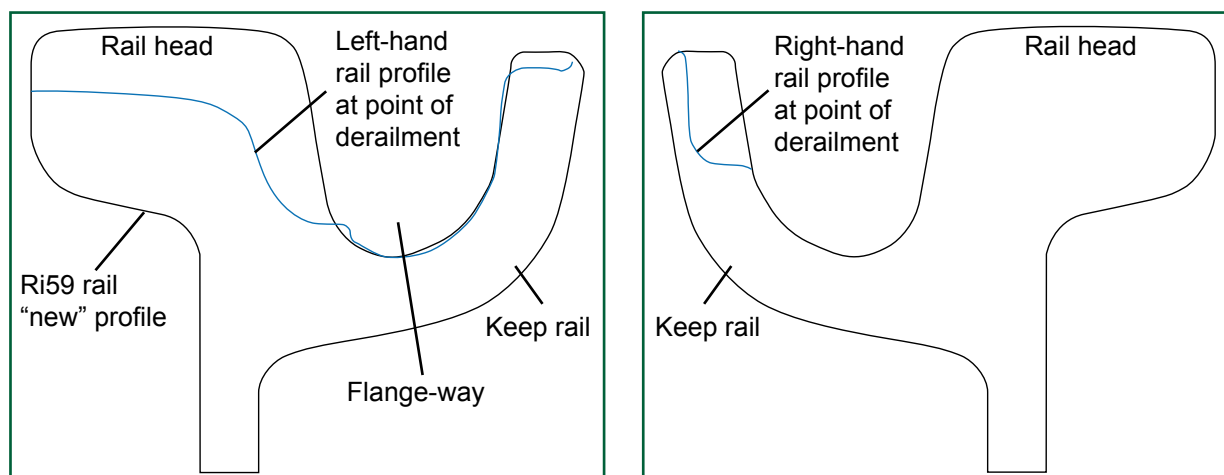
- 43 At the point of derailment the left-hand rail was significantly side worn (Figure 8) by the passage of wheels (Figure 9) and the right-hand rail's keep was worn to a thickness of 2.5 mm, from an original thickness of 15 mm. The right-hand rail's keep had worn because of contact from the backs of passing wheel flanges as a result of wheelsets riding to the left, as allowed by the side worn left-hand rail.

Figure 8: Image showing side wear on left-hand rail and worn keep on right-hand rail (indicative) at the point of derailment

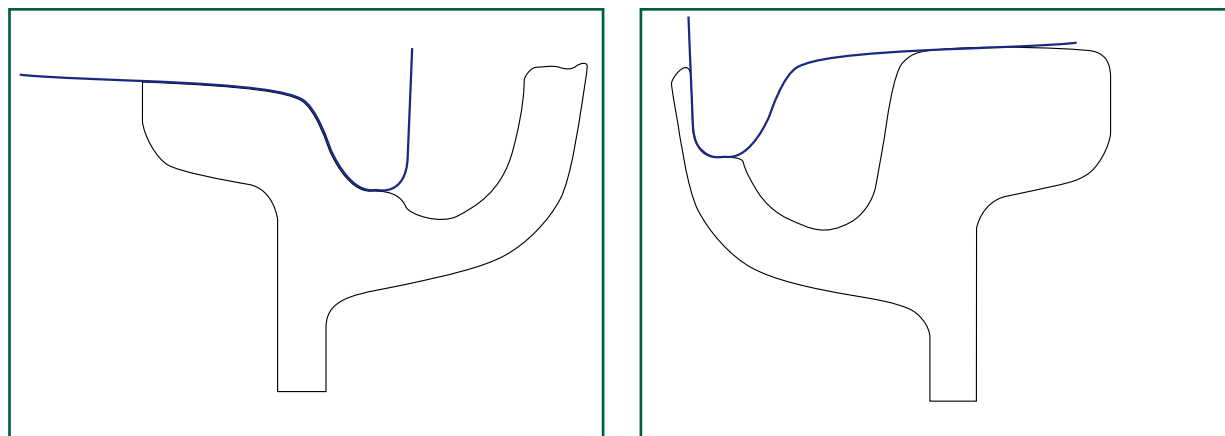
Figure 9: Image showing wheel riding on worn rail and worn keep
