Rail Accident Report

**Fatal accident at Wraysholme crossing,
Flookburgh, Cumbria
3 November 2008**

Fatal accident at Wraysholme crossing, Flookburgh, Cumbria, 3 November 2008

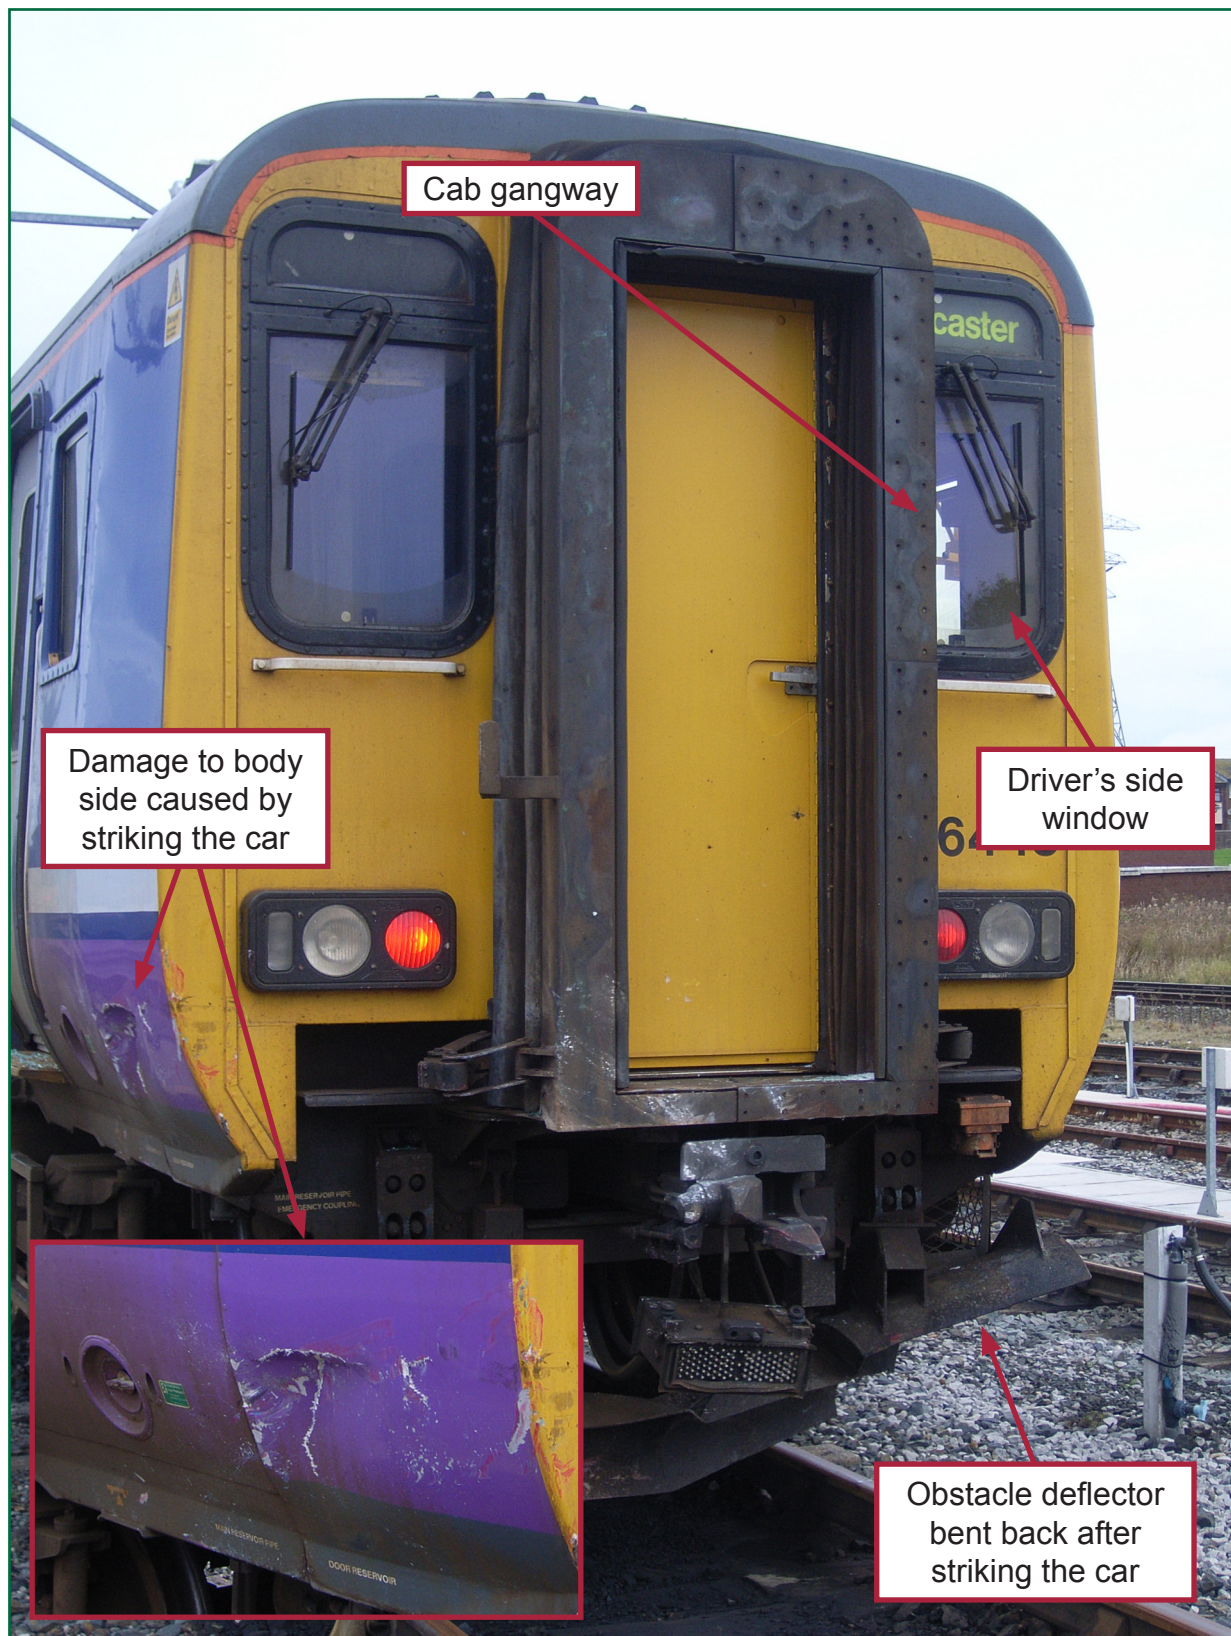
Figure 8: The train and its leading cab

- 36 The car driver suffered immediately fatal injuries and his car sustained damage to its front left-hand side. The driver's two dogs were travelling in the car's boot at the time of the accident and survived the collision. The train sustained damage to its bodyside and obstacle deflector (Figure 8).

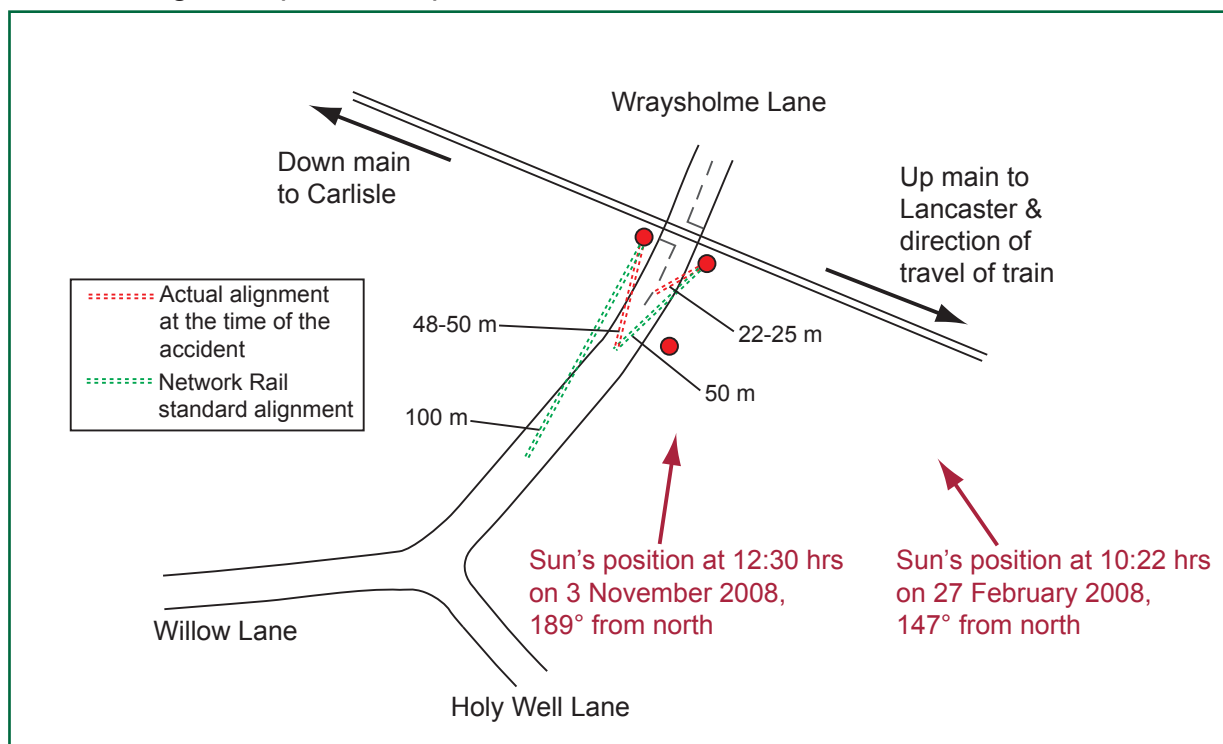
Figure 11: The standard and actual alignment of signals at Wraysholme crossing on 3 November 2008

- 92 Network Rail could not position the Wraysholme signals to its standard alignment; if it had, the left-hand signal would align behind vegetation in the field to the left of the road because of the bend on Wraysholme Lane (Figures 7 and 11). At the time of the accident, Network Rail had no procedure for optimising signal alignment so it aligned left and right-hand signals at 48 - 50 metres and 22 - 25 metres from the stop line respectively, and did not record their alignments on the ground plan as required.

- 118 Network Rail inspected the crossing 30 minutes before the accident; at this time and in accordance with past practice, the inspector noted that the left-hand signal was misaligned due to the bend in the road and did not raise the matter as a defect.

- 147 On 21 November 2008, the Office of Rail Regulation issued an improvement notice for Wraysholme crossing; it required Network Rail to (a) correctly align the wig wag lamps; (b) fit longer hoods; and (c) replace the existing signal lamps with LED (light emitting diode) lamps.

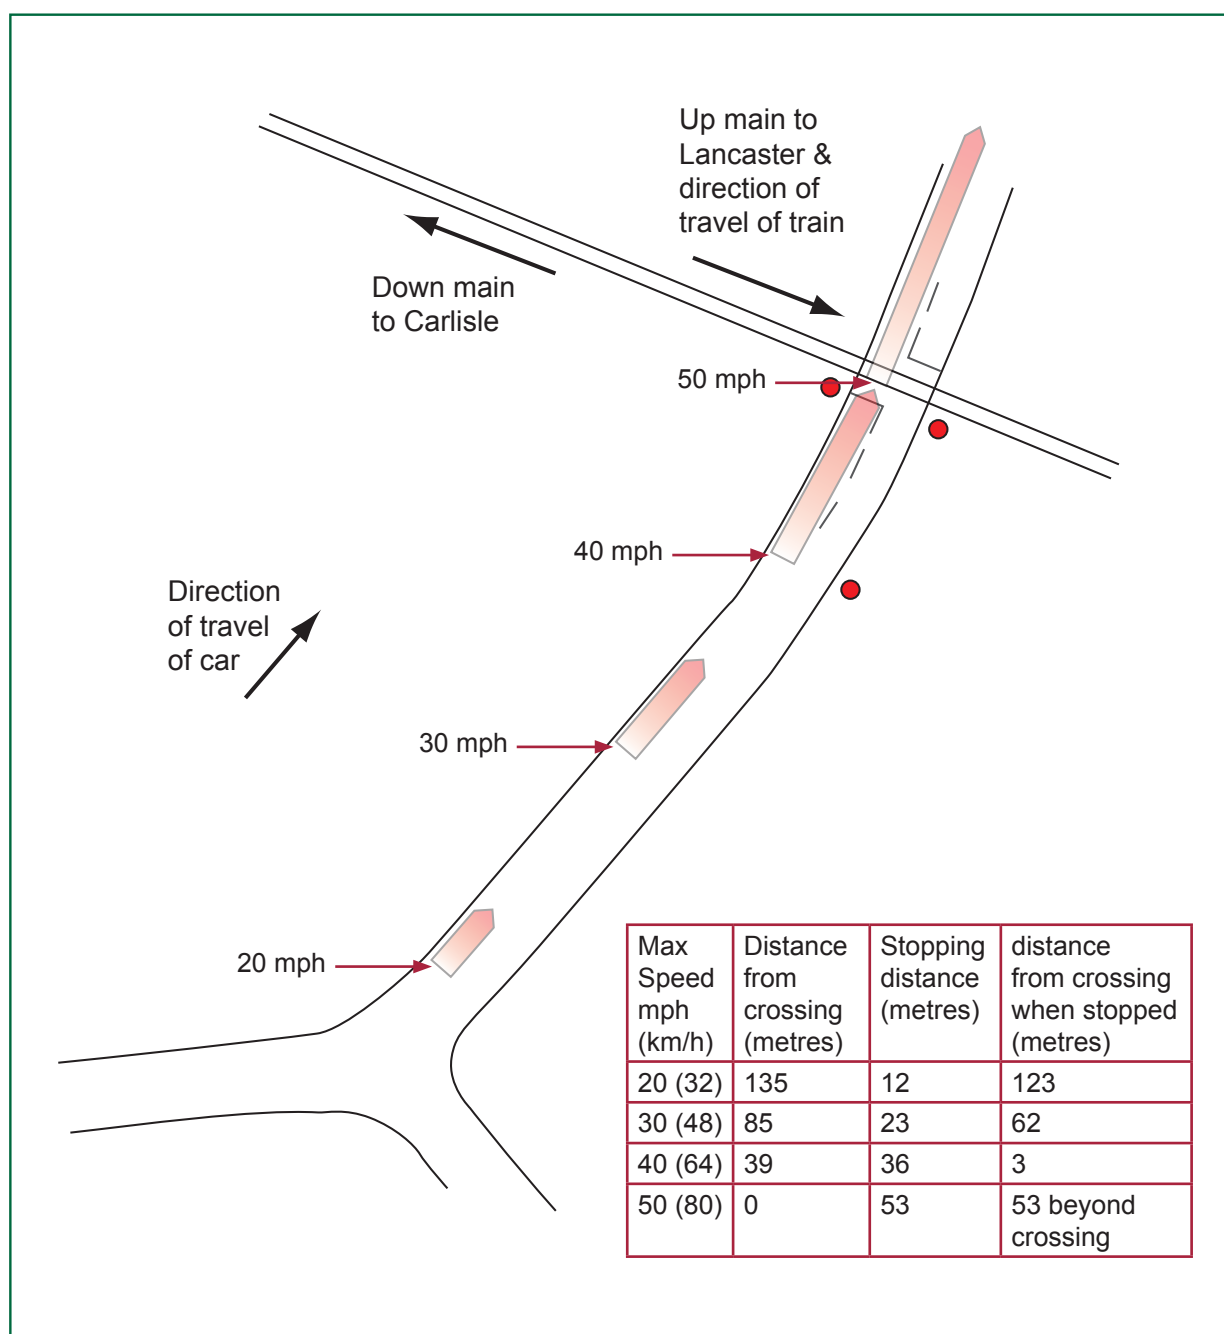
Figure 13: Stopping distances from maximum safe speed on the approach to Wraysholme crossing

- 101 These stopping distances are achievable in good conditions; if conditions deteriorate, then drivers should adjust their driving accordingly. Figure 13 summarises the maximum safe speed limits along Wraysholme Lane and the Highway Code stopping distances. For these reasons, the crossing's layout is satisfactory if a road user can discern its signals' aspects at distance.

- 102 However, because the signals were affected by substandard brightness, colour, misalignment and sunlight, the car driver may not have discerned them until he was close to the crossing. He may then have ignored them, believing that it was safer to continue in an attempt to clear the crossing rather than to attempt to stop.
