Rail Accident Report

Derailment of two locomotives at East Somerset Junction 10 November 2008

Derailment of two locomotives at East Somerset Junction, 10 November 2008

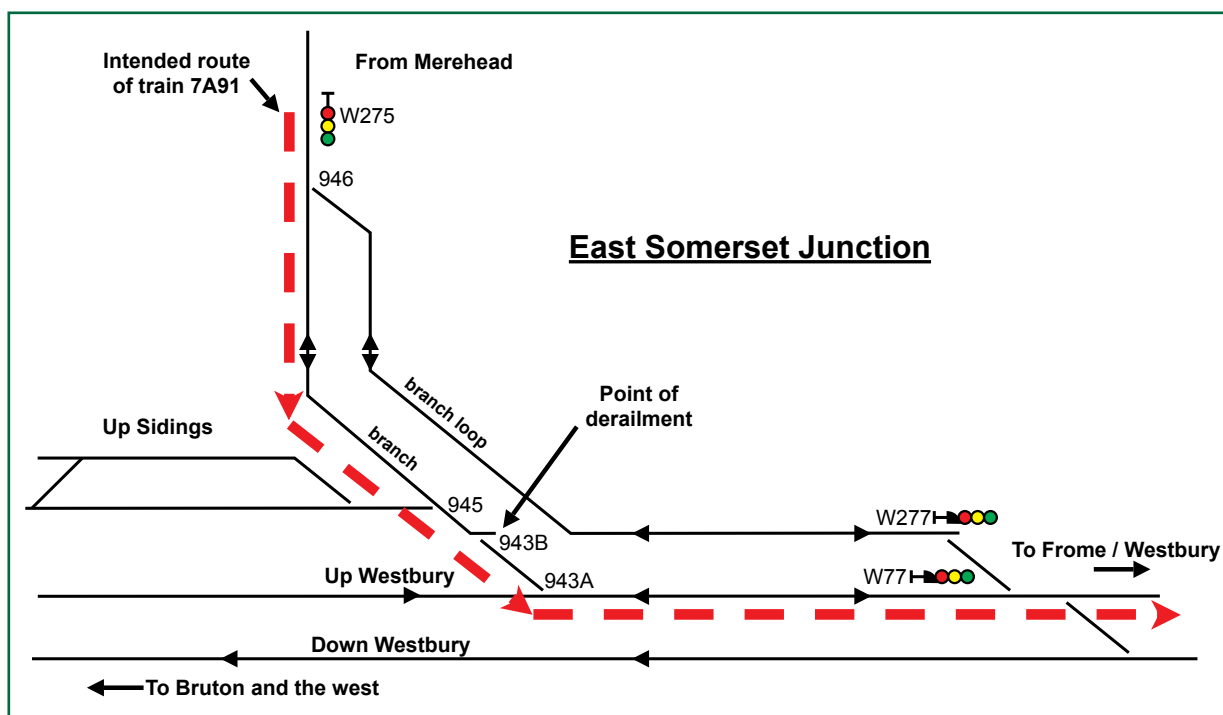
Figure 2: Track layout at East Somerset Junction

- 11 The immediate cause of the accident was that the signaller did not operate a set of points (943 points) to the correct position for the safe movement of train 7A91 (Figure 2).

- 35 At 00:25 hrs, the signalling fault team restored normal signalling arrangements to the Up and Down Westbury lines by replacing a blown fuse in Witham Friary relay room. The area affected by the failure was then confined to the Merehead Quarry branch alone, up to and including 946 points (Figure 2).

- 38 The signaller could not monitor the train's progress on the branch as all the track circuits were showing occupied because of the power supply failure. He waited for train 7A91 to appear on the track circuits beyond 946 points, which it did at around 02:38 hrs. It was at that point that he realised that 943 points were not in the correct position for the safe movement of train 7A91.

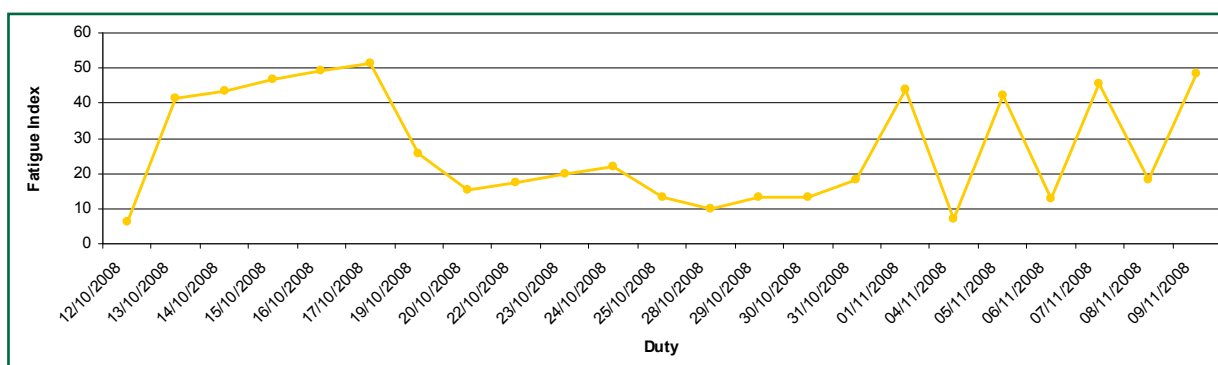
Figure 4: Fatigue index for the shifts worked by the signaller in the four weeks leading up to the accident

107 Paragraph 106 and Figures 4 and 5 indicate that it was probable that the signaller involved in the accident at East Somerset Junction was suffering from fatigue at the time.
