Rail Accident Investigation Branch

Rail Accident Report

Derailment of a freight train at Marks Tey, Essex 12 June 2008

12 June 2008

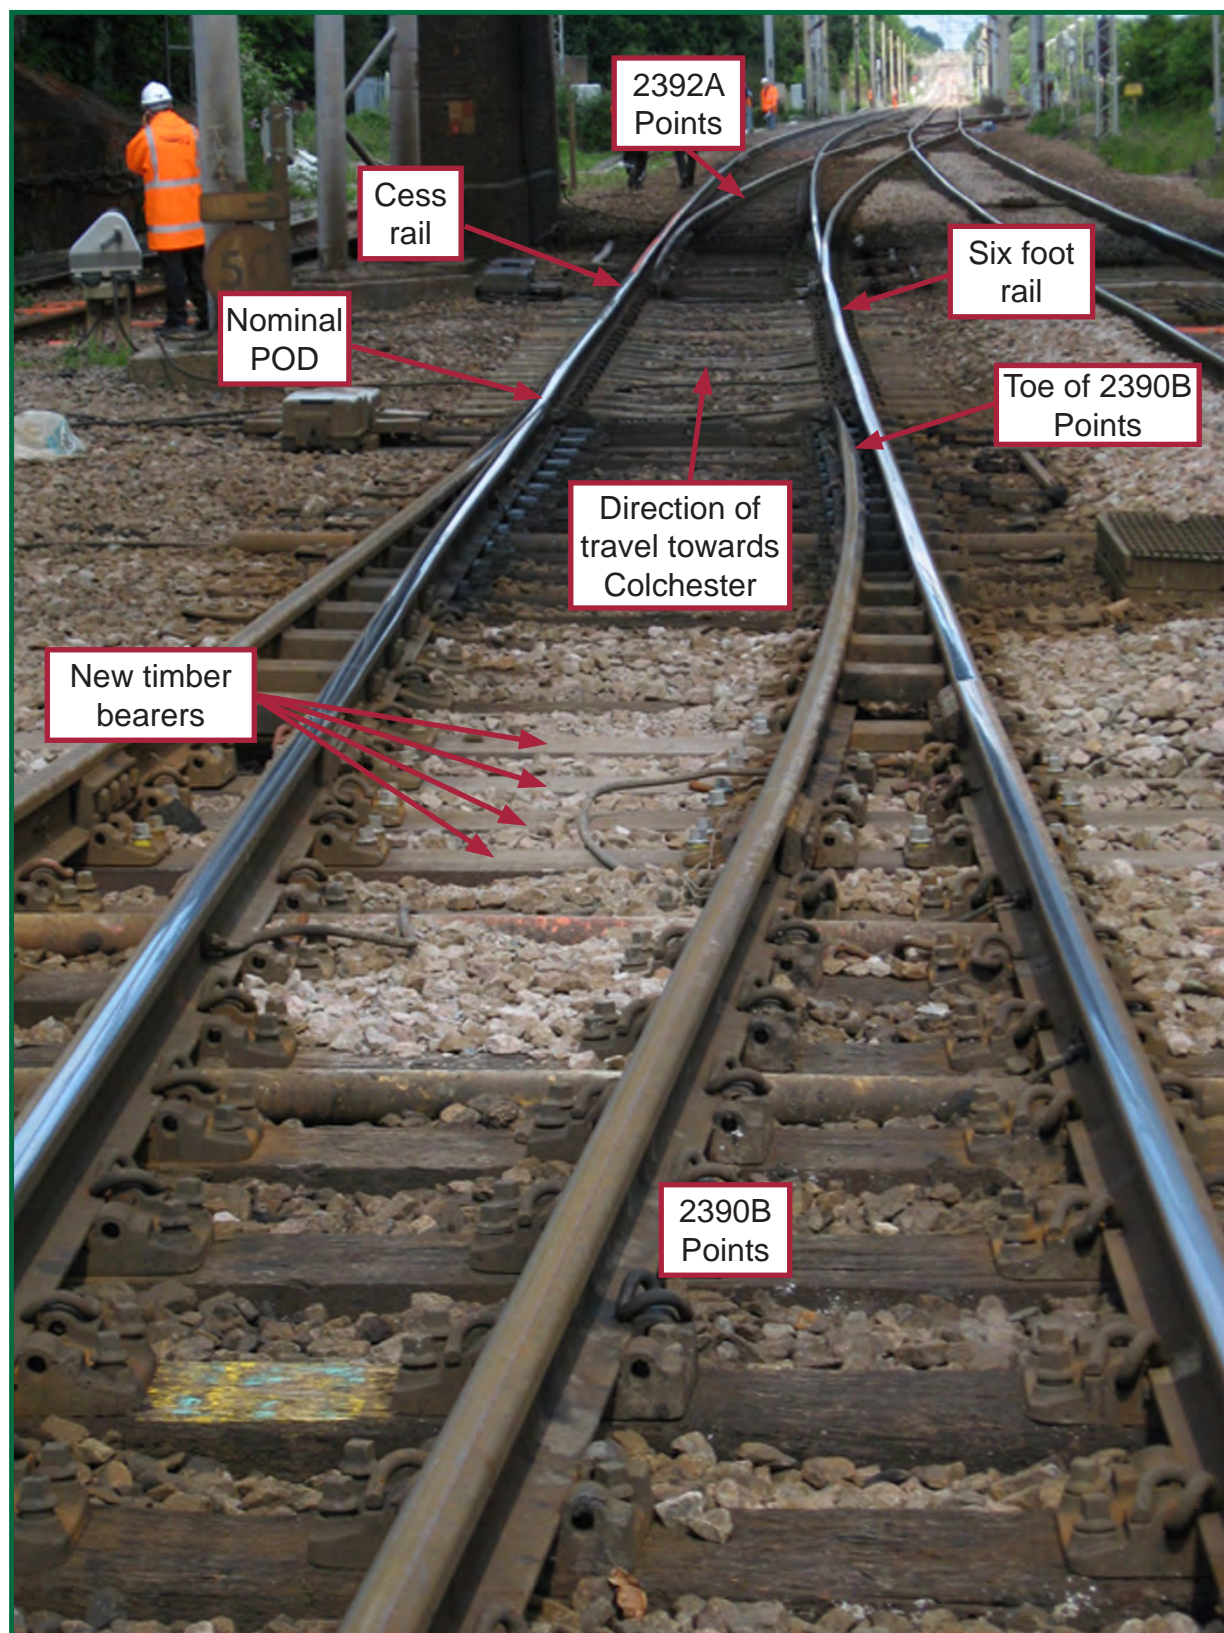
- 63 On the six-foot rail head there was a 'drop-in' mark between sleepers -14 and -15 (around 9.1 to 9.7 metres beyond the nominal point of derailment). This mark was caused by the tread corner of a wheel as it left the rail head and entered the *four-foot*. Contact marks on track components confirm that a wheelset was running derailed beyond this point.

Figure 7: Nominal point of derailment, facing the direction of travel

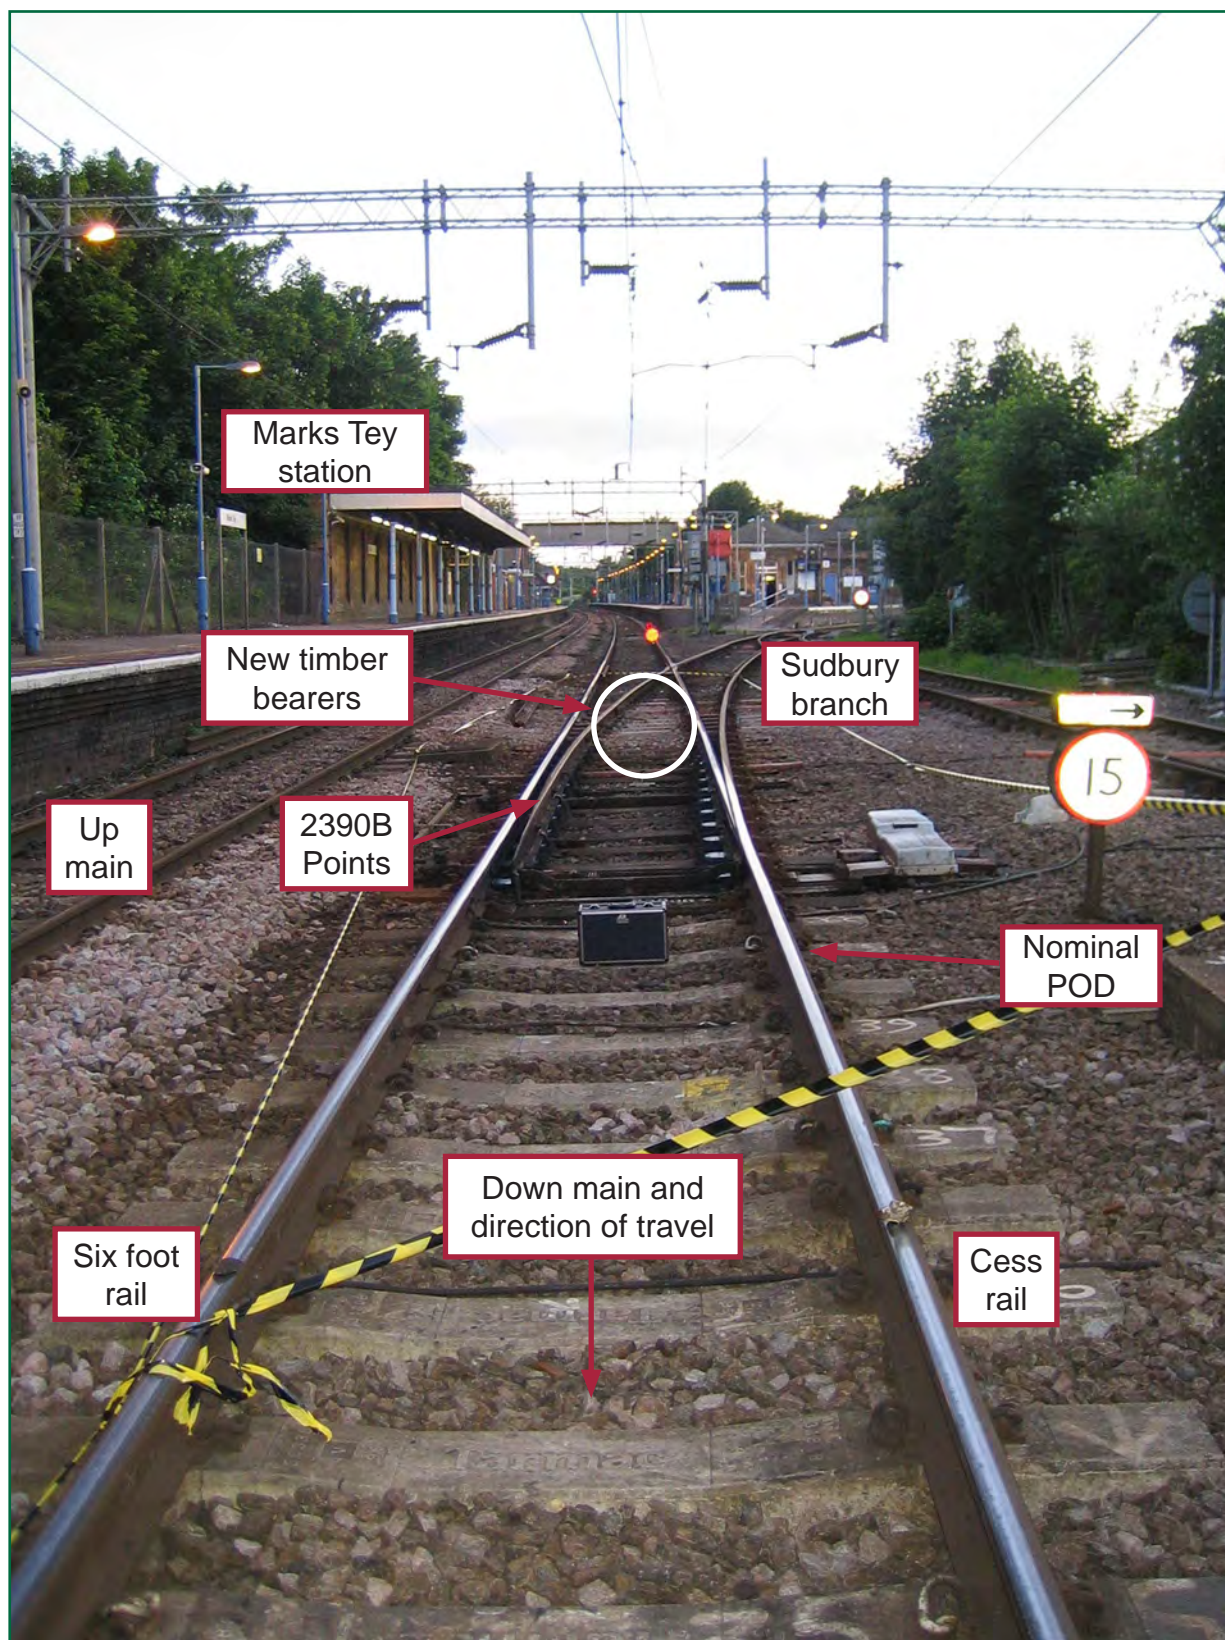
Figure 8: Nominal point of derailment, facing against the direction of travel (photograph courtesy of Delta Rail)

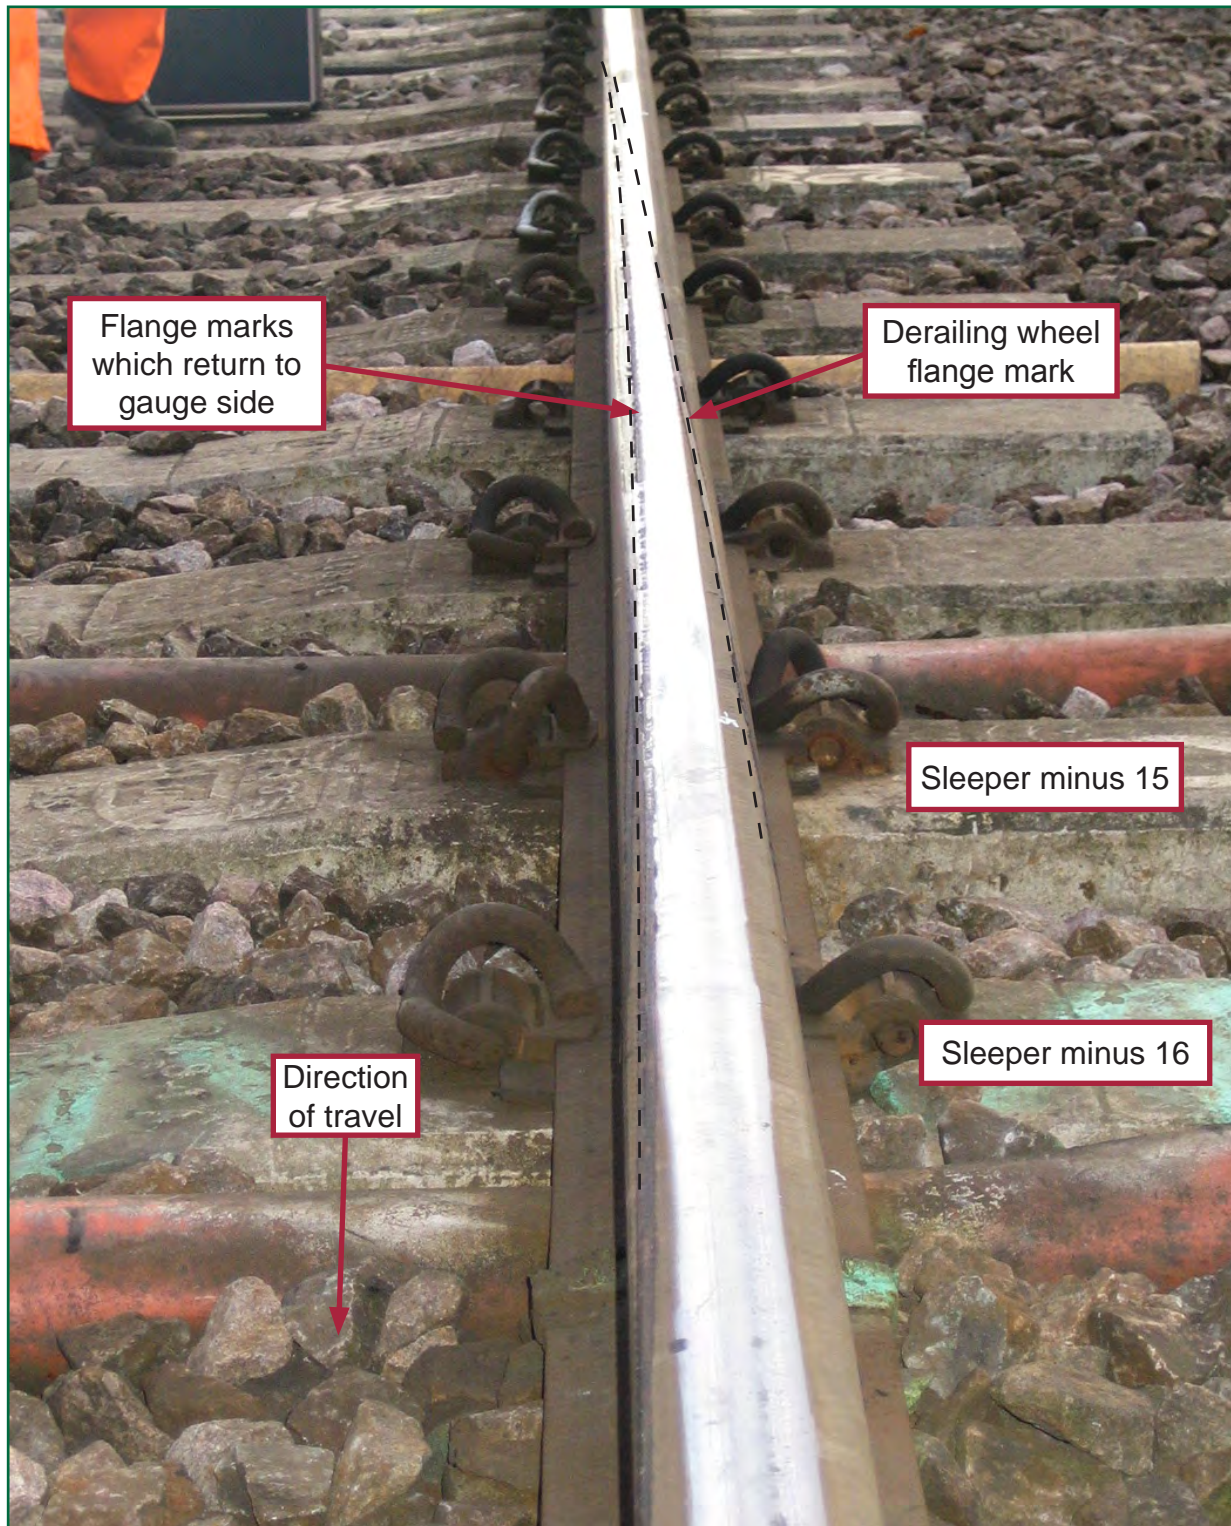
- 64 There were additional flange marks on the cess rail head around sleeper -7 (approximately 4.5 metres beyond the nominal point of derailment), indicating that a number of other wheels had climbed onto the rail head. These flange marks stayed on the rail head before returning to the gauge side of the rail head in the vicinity of sleepers -15, -16 and -17 (around 9.7 to 11 metres beyond the nominal point of derailment, see figure 9).

Figure 9: Flange mark on cess rail, facing against direction of travel (photograph courtesy of Delta Rail)

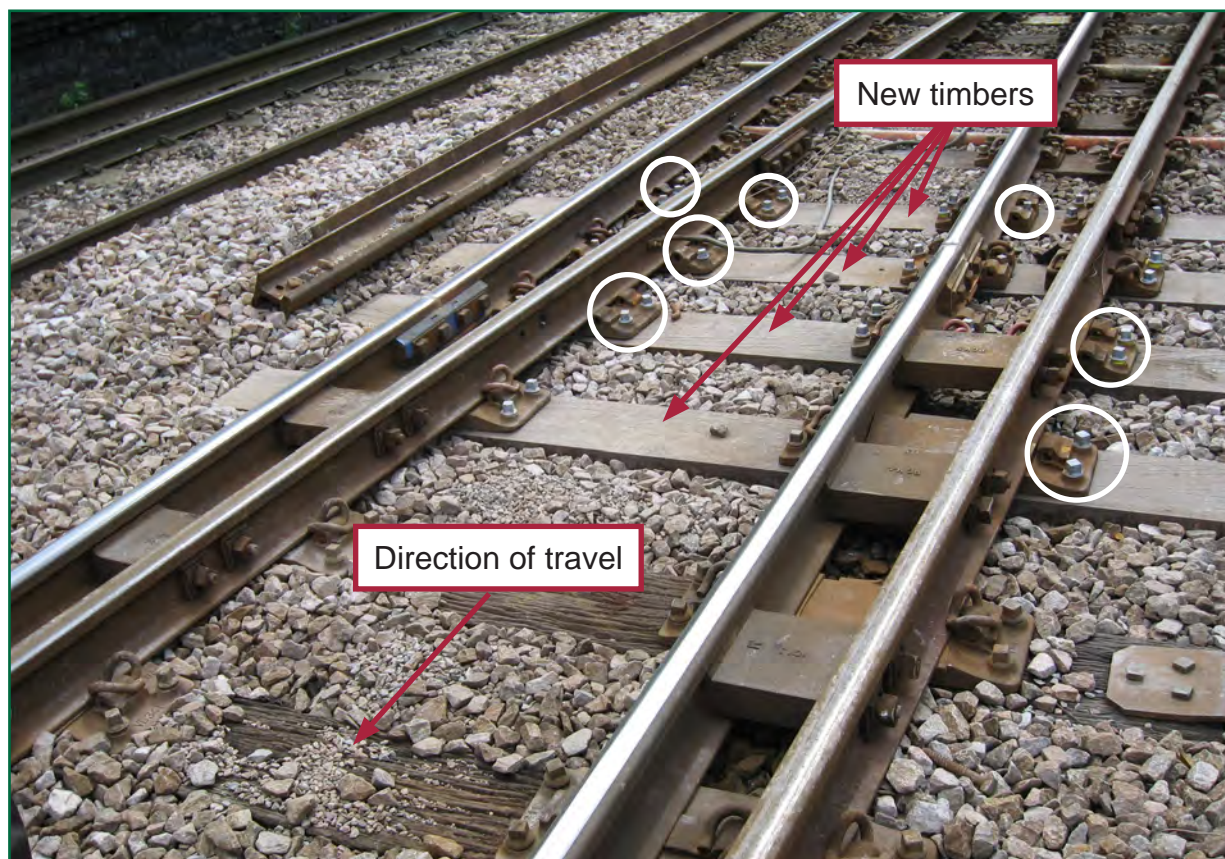
- Pandrol rail fastenings were missing from some of these replacement timber bearers - rust markings on the rails indicated that the fastenings had probably been in place until a few days prior to the derailment (figures 10 and 11); and

- contrary to normal practice, new insulating rail pads had not been fitted to the replacement timbers - in some cases old pads had been reused (however, there is no requirements in standards for such replacement).

Figure 10: New timbers fitted to heel of 2390B points; missing fasteners highlighted

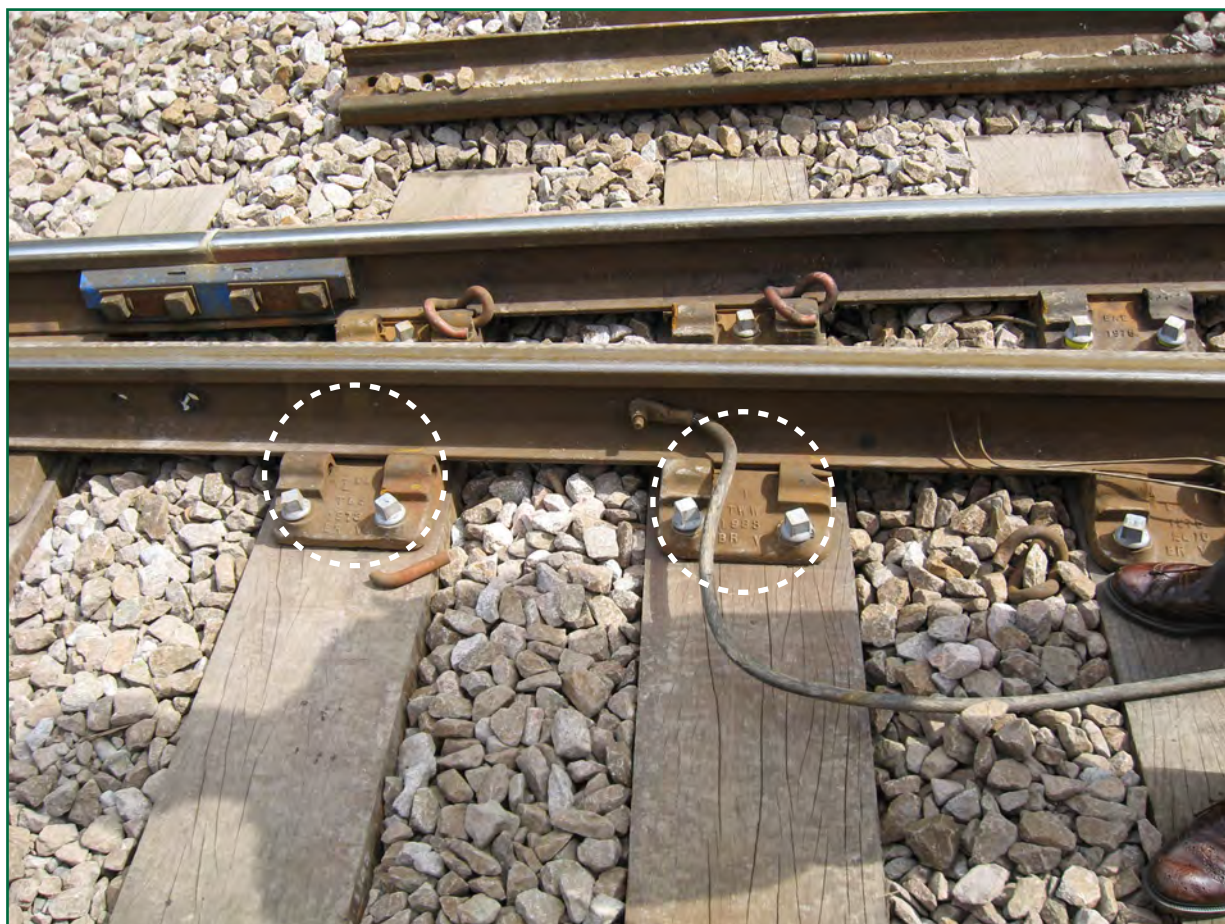
Figure 11: Close up of baseplates with missing fasteners

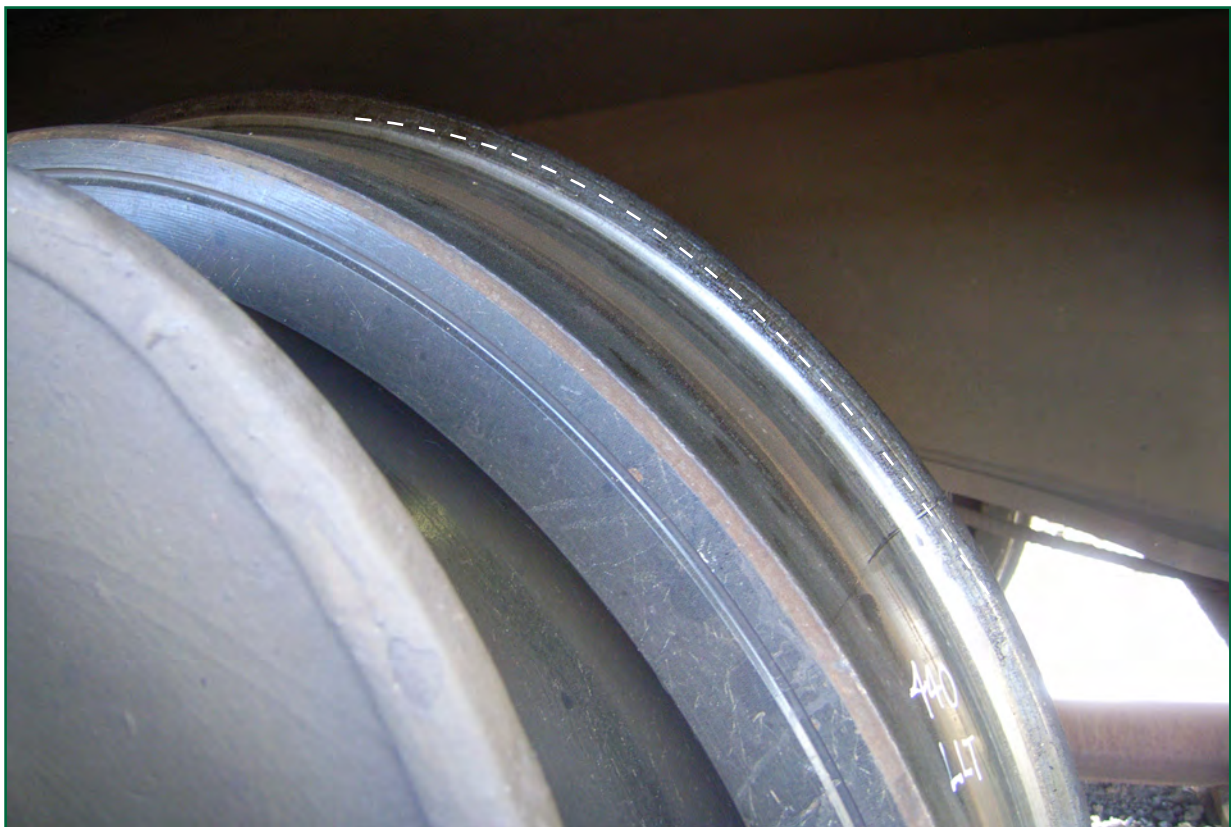
- 79 Examination of the front bogie of wagon 608440 revealed contact marks high on the flange of the left-hand wheel of the leading wheelset and a possible climb mark on the left-hand wheel of the trailing wheelset (figure 13).

Figure 13: Possible climb marks on the left-hand wheel of the trailing wheelset of the rear bogie of wagon 608440

- 80 The wheels of the leading and trailing wheelsets of the rear bogie were damaged by running derailed, with the trailing one having sustained the most damage, consistent with it having derailed first.

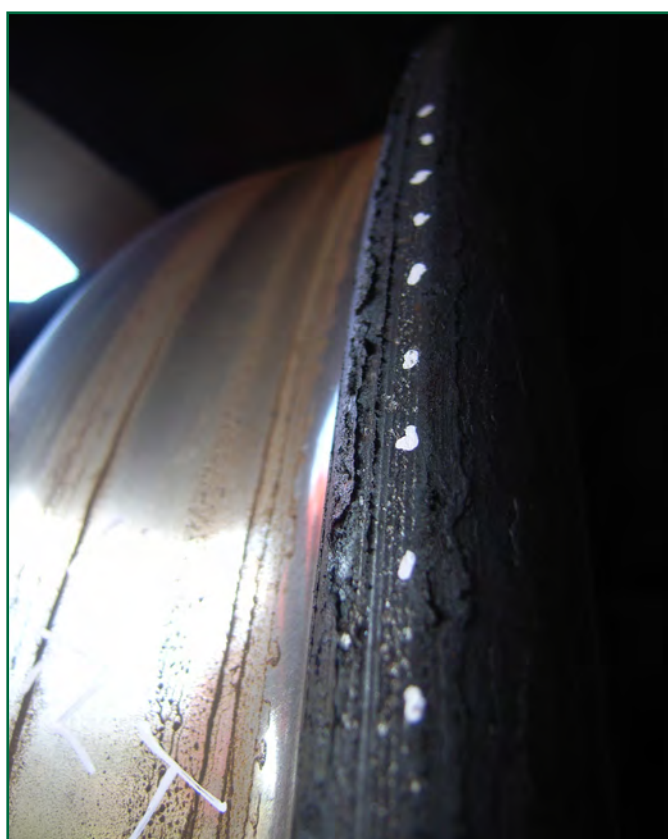
- 83 The rear bogie leading wheelset showed contact marks indicating that the left-hand wheel had also ridden high on the wheel flange. The trailing wheelset of the rear bogie had contact marks on the tip of its left-hand wheel flange; this wheel also had a fresh mark on its tread that was indicative of it having dropped onto a rail head (figure 14). There was a possible contact mark on the right-hand wheel of this wheelset, and evidence of contact on the underside of the lift stop on the right-hand wheel of the trailing wheelset (figure 6), indicating that the bogie frame may have applied a lifting force to this wheel.

Figure 14: Contact marks on the left-hand wheel of the trailing wheelset of the rear bogie of wagon 607129

- 84 These marks demonstrate that this wagon had run partially derailed prior to returning to normal running. Paragraphs 204 to 217 explore how this might have happened.
- 85 The wagon was found to have an overall body twist of 10 mm, which was not considered to be significant.
- 86 No issues of relevance were recorded with respect to the wheel profiles and diameters of the wheels which displayed contact marks.

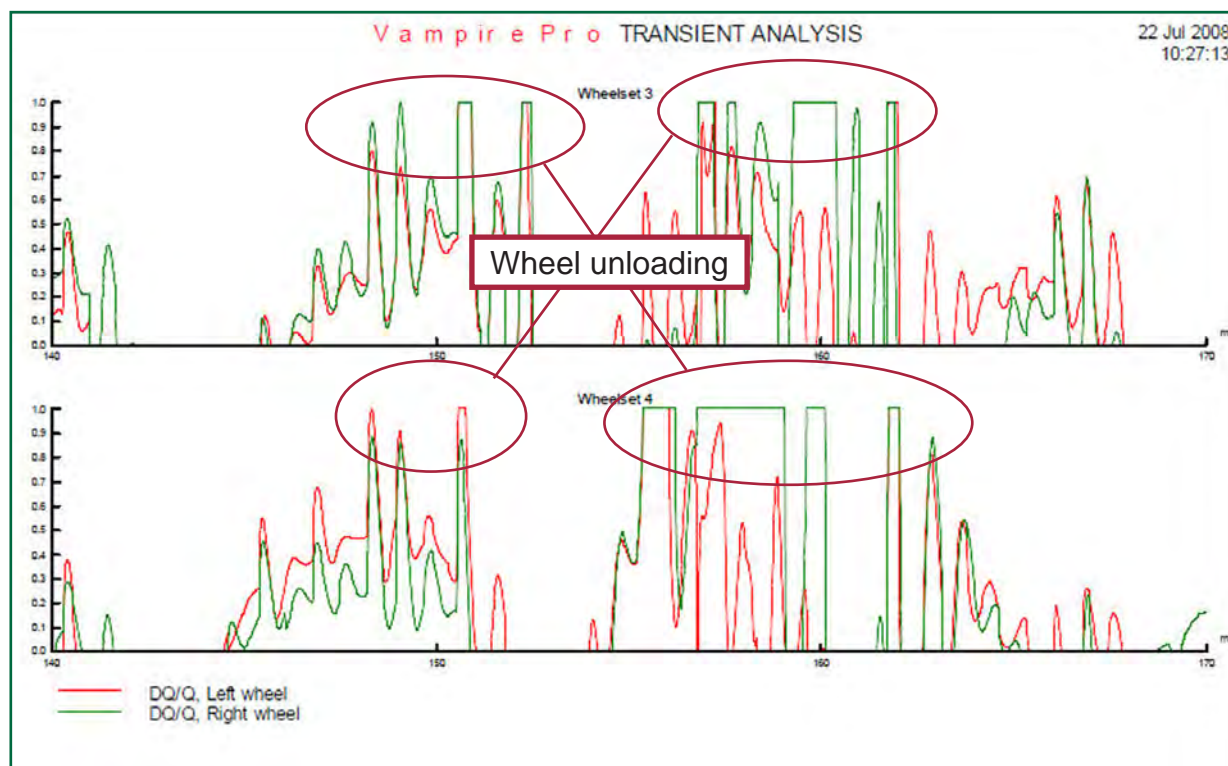
Figure 18: Cycle of wheel unloading on trailing bogie on approach to nominal POD (image courtesy of Delta Rail)

- 199 The modelling was able to confirm that the measured cant, curvature, horizontal alignment and gauge of the track contributed little to creating the wheel unloading events, and that the dominant mechanism was the vehicle's response to changes in vertical track alignment.

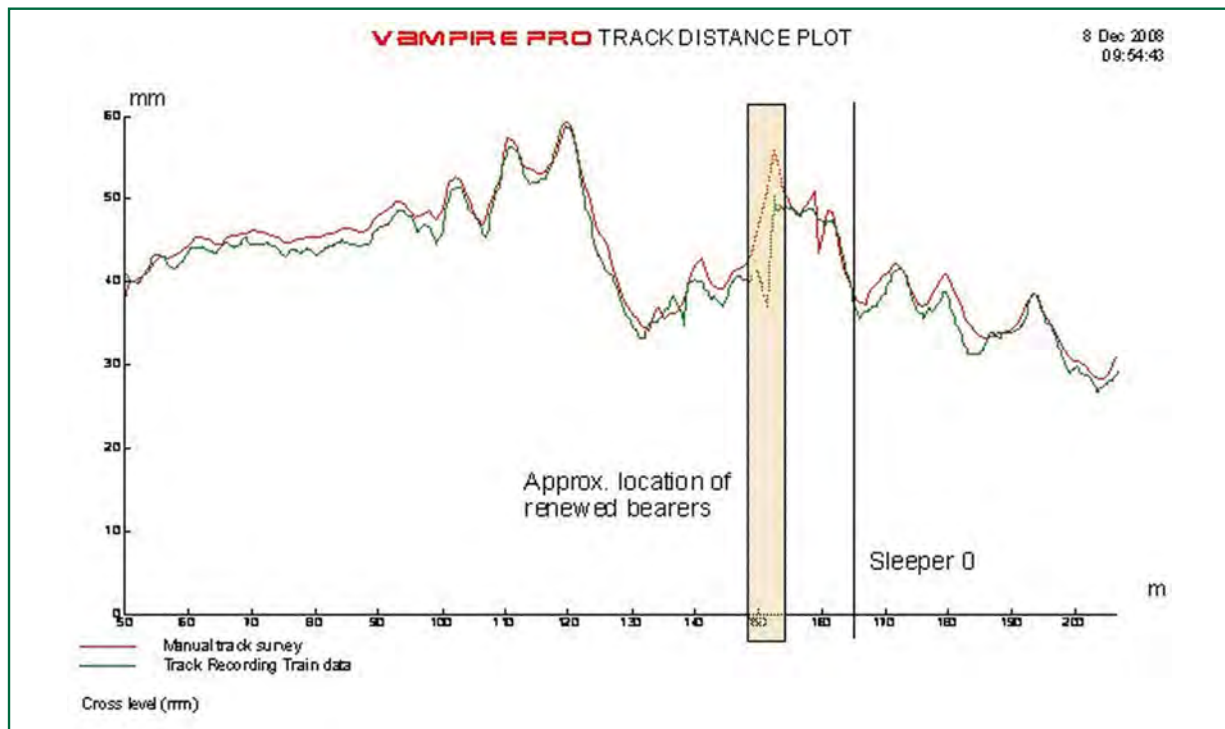
Figure 19: Comparison between the post-accident survey and the data recorded on 27 May 2008 (image courtesy of Delta Rail)

202 This meant that the geometry of the track on the approach to the defect (i.e. the down main through Marks Tey station platform) was not causal to the derailment. It also meant that, although the dip at the heel of 2390B points found following the accident was necessary for the derailment to take place, it was not on its own sufficient for the wagons to pose a derailment risk. For such a derailment risk to exist, it was also necessary for the track beyond this dip to have the presence of the cyclic top that was measured post-accident and which matched well with that recorded on 27 May 2008 (paragraph 167).

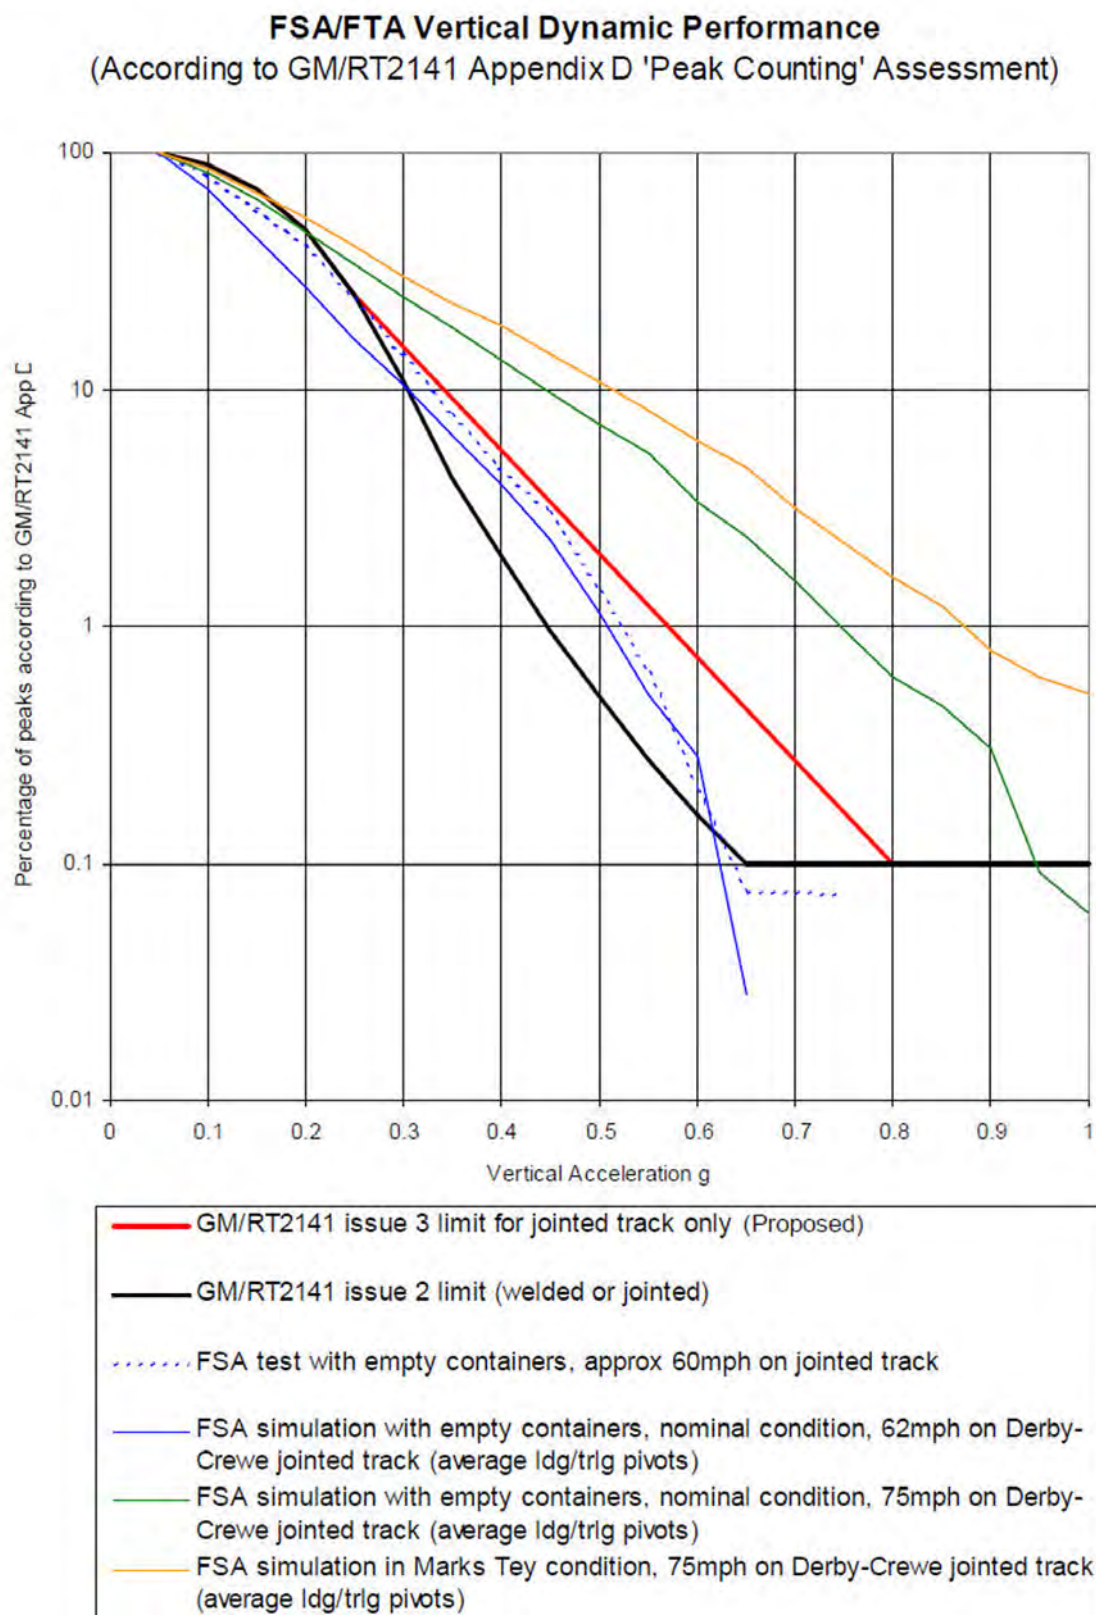
205 The model showed that, over jointed track, a part-laden FSA/FTA wagon did not satisfy the requirements of GM/RT 2141 Issue 2. In the nominal condition at 60 mph, it exceeded these requirements only slightly; however, in both the nominal and Marks Tey conditions at 75 mph, its performance fell significantly outside that required. The Marks Tey condition was the worst performing of all, which reflected the effect of reduced friction damping (caused as a result of the worn Lenoir links) on vertical dynamic behaviour (figure 20).

Figure 20: FSA/FTA Vertical Dynamic Performance comparison (image courtesy of Delta Rail)

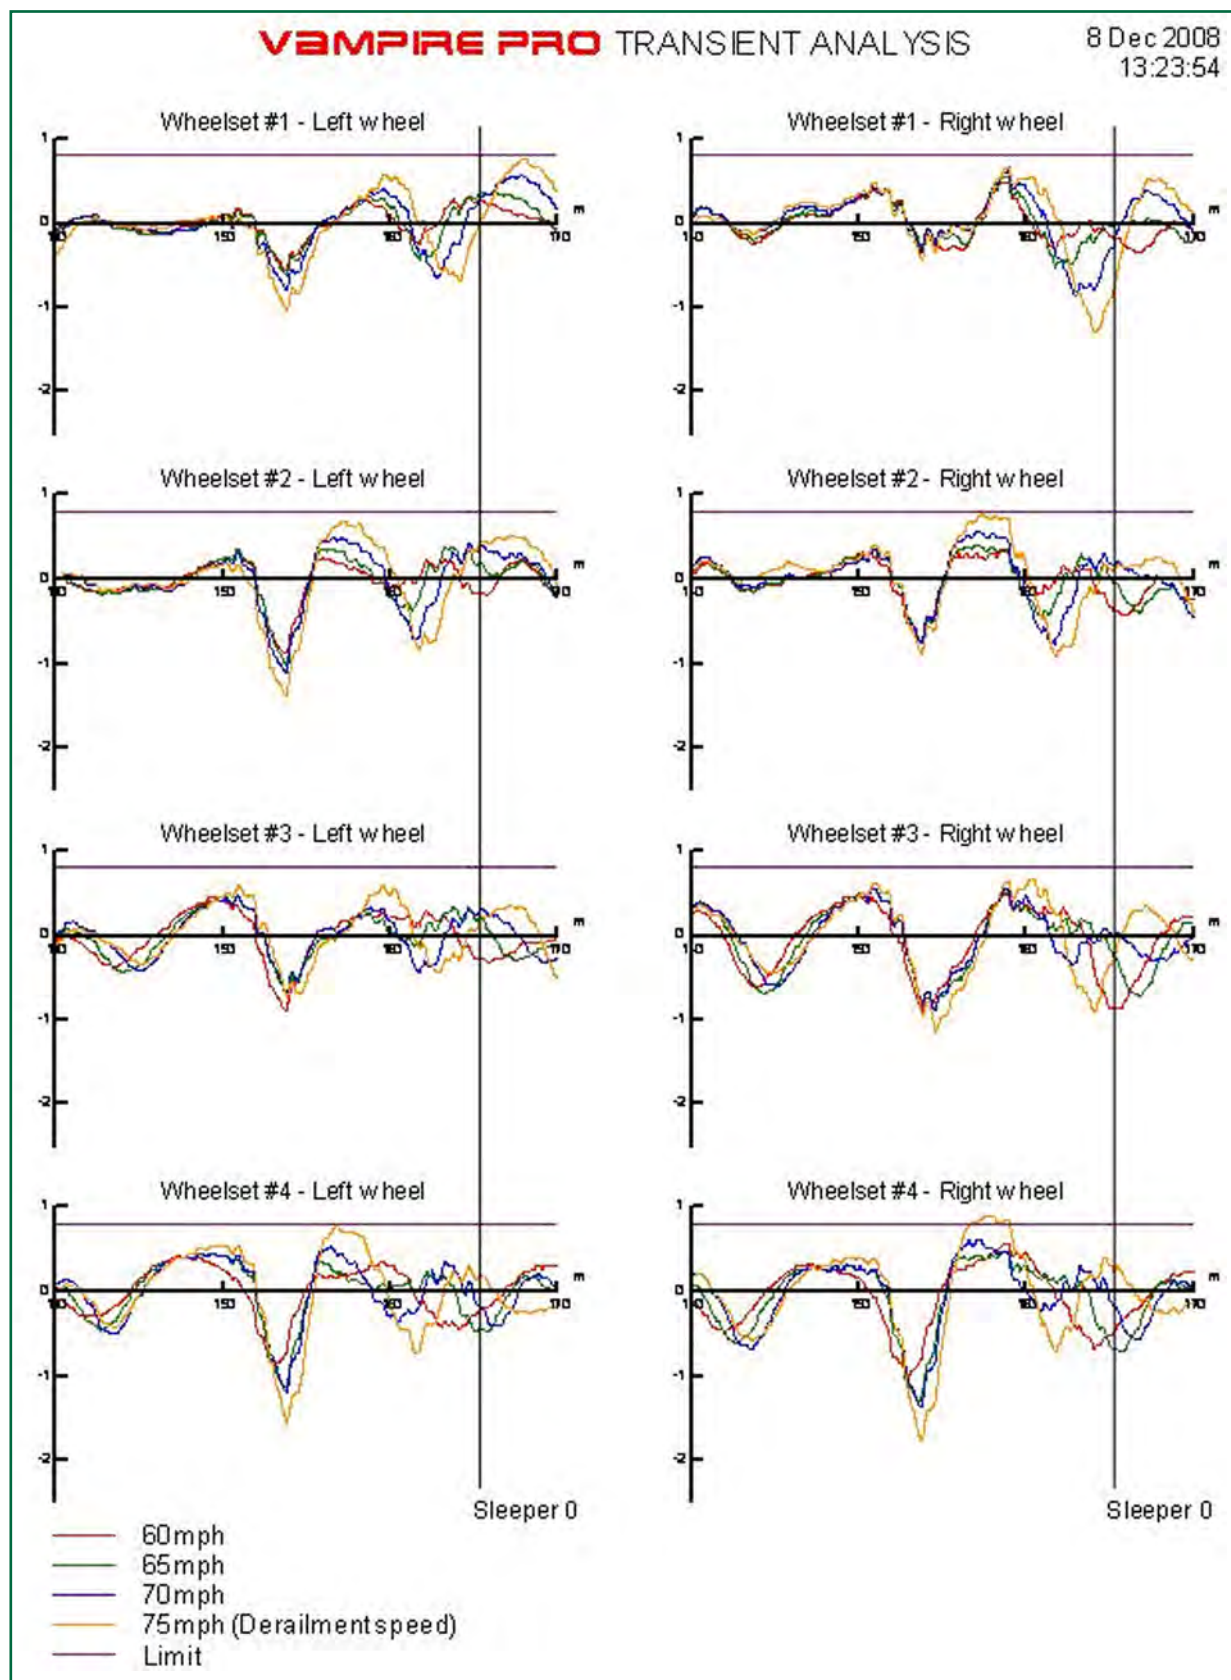
- 210 The effect of speed on the behaviour of a wagon in the Marks Tey condition over the accident track geometry was also modelled. Speeds ranging from 60 mph to 75 mph were examined in 5 mph increments and the results showed that cyclic wheel unloading was still present at all speeds (figure 22); however the dynamic wheel unloading was not sustained for a large enough distance to present a significant risk of derailment at speeds of 70 mph or below. The permitted speed of the train was 75 mph; this was a causal factor in the derailment.

Figure 22: Filtered cycle of wheel unloading on Marks Tey condition wagon at various speeds (image courtesy of Delta Rail)
