Rail Accident Report

**Incident at Greenhill Upper Junction, near
Falkirk
22 March 2009**

Incident at Greenhill Upper Junction, near Falkirk, 22 March 2009

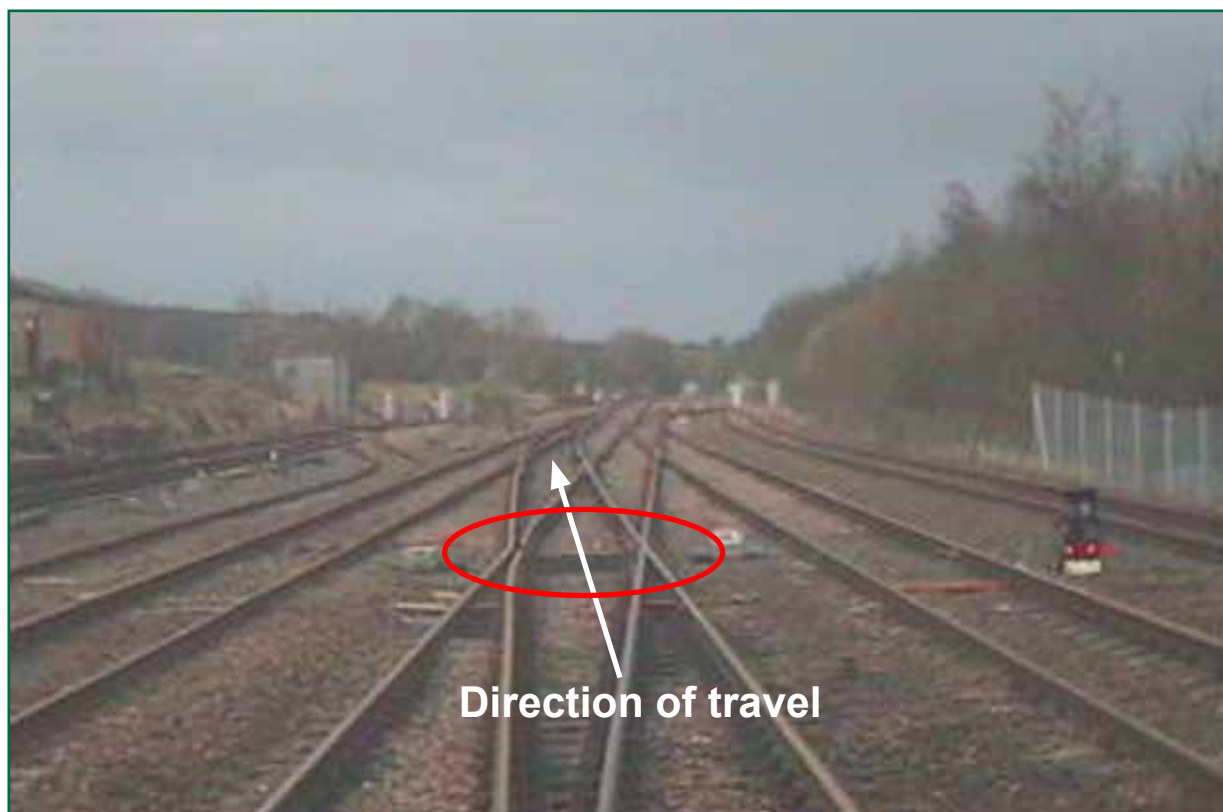
- 31 Train 2N50 trailed through 125C point ends at 64 mph (103 km/h) causing damage to them. This became apparent to the signaller because he received an '*out of correspondence*' indication on the panel indicating that 125 points had lost detection. Figure 4, taken from the train's forward facing CCTV equipment, shows the position of the switch diamonds as the train approached them.

Figure 4: Forward view of Greenhill Upper Junction as train 2N50 approached showing the position of 125C point ends (normal) and 125B point ends (reverse)

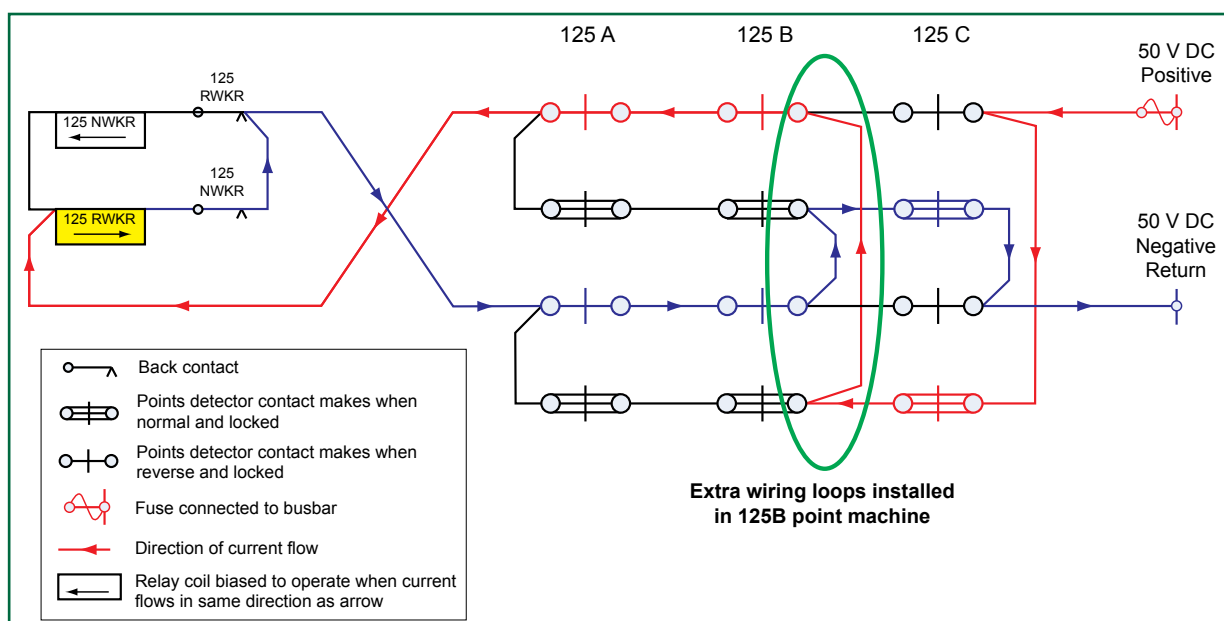
- 93 A single drawing (appendix D) showing the wiring for both 125B and 125C point machines was used to wire up the tail cables and fit additional wiring that was required in 125C point machine. 125C point machine was wired correctly, but 125B point machine was incorrectly wired the same as 125C. This resulted in additional wiring being installed in 125B point machine (figure 6).

Figure 6: Simplified diagram of 125 points detection circuit showing the wiring error

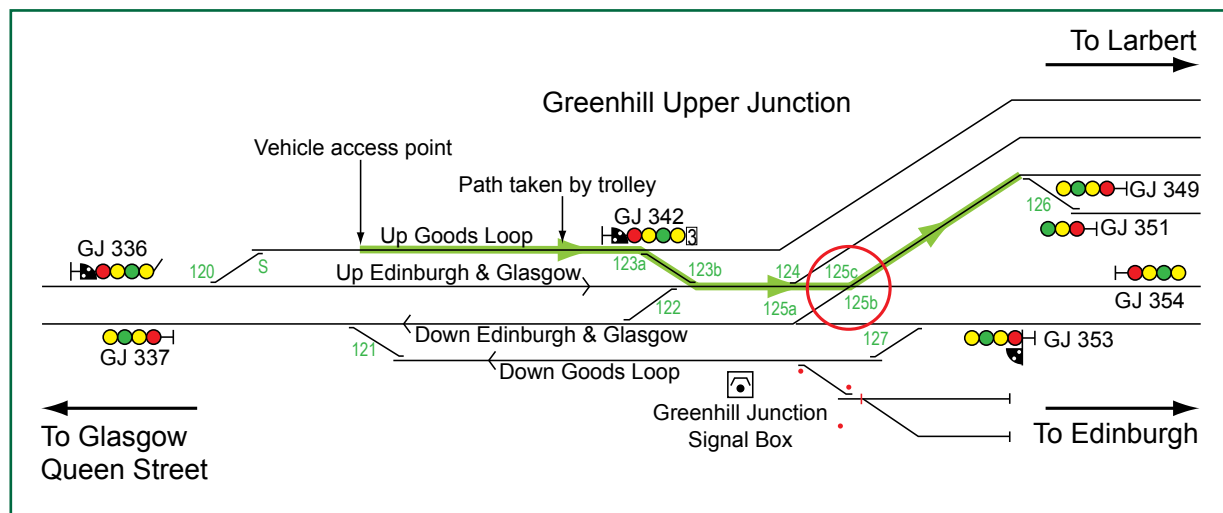
126 Figure 8 shows the route that was taken by the trolley used to transport the point machine from the access point to 126A point ends. This required 125C point ends to be manually operated to the reverse position.

Figure 8: Route taken by trolley over 125C points on 21/22 March 2009

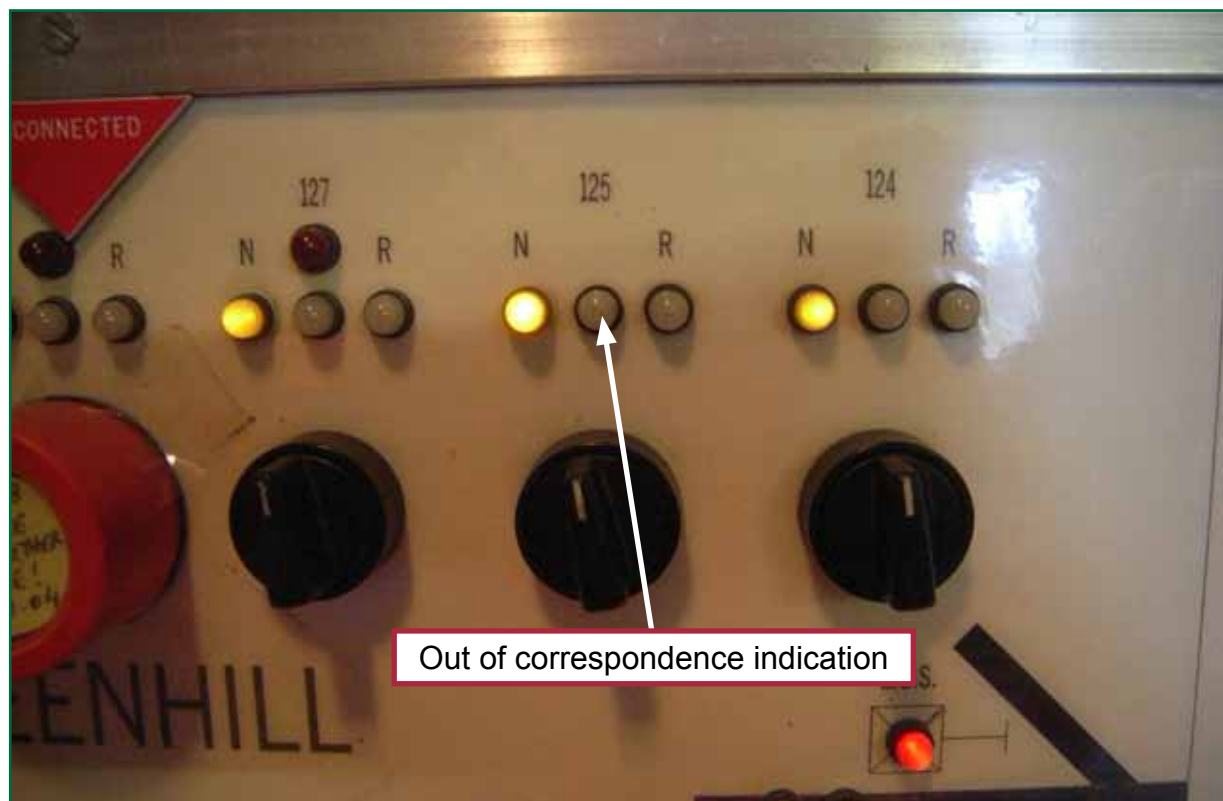
127 Manually operating 125C point ends to the reverse position, with the other ends normal, should have caused the out of correspondence light to flash on the signaller's panel (figure 9), when 125C point ends were detected in the reverse position. The wiring fault would have prevented this indication of out of correspondence occurring, but the signaller did not notice this (there was no requirement that he had to check this).

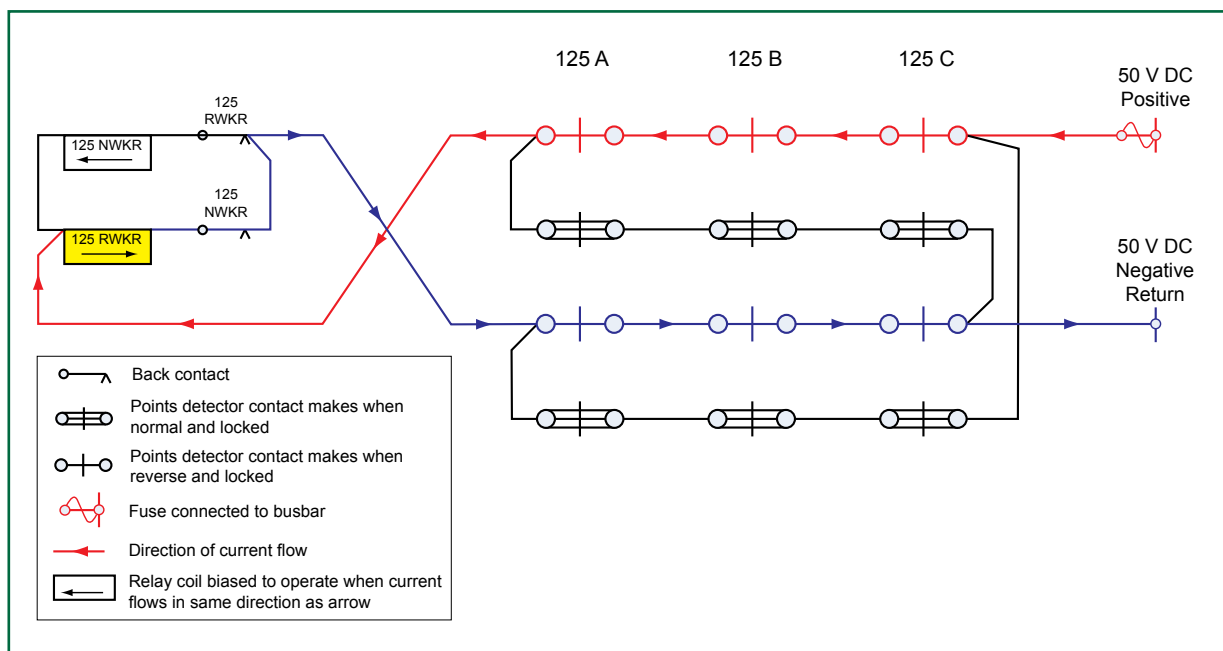
Figure 12: Simplified diagram of the detection circuit associated with 125 points (showing points detected and locked reverse)

9. The circuit containing the 125 detection relays uses only two wires to connect them to the detection contacts in the point machines and is therefore known as a two wire detection circuit. Such a circuit is a pole changing circuit as the polarity (the direction of the electric current) is changed depending on which detection contacts are made which reduces the number of wires that would otherwise be required. The circuit requires wire straps to be fitted to the terminals inside 125C and 125A point machines (figure 12) to enable it to work.

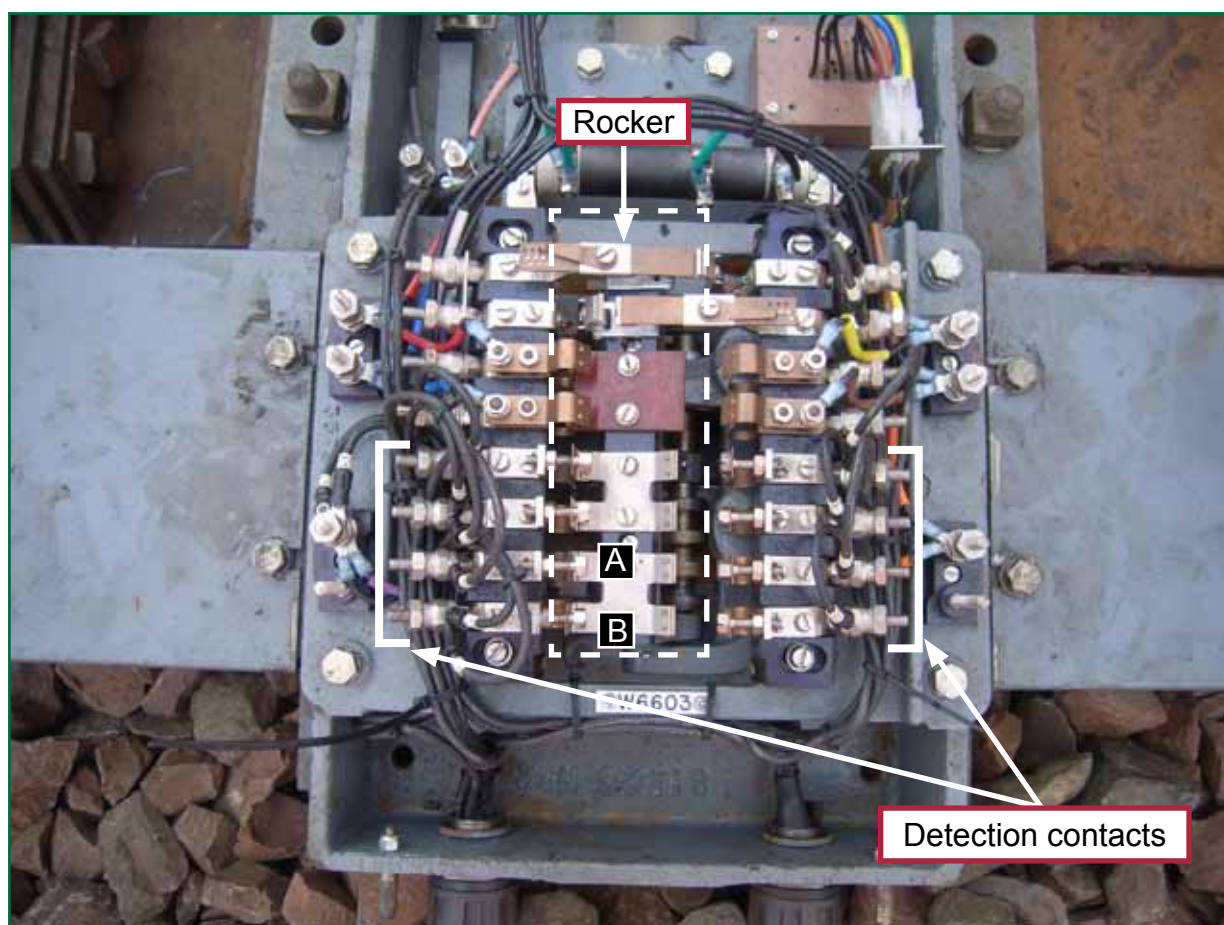
- 170 One interpretation is that the 'H' shaped piece (appendix F, paragraph 7) forms one contact and the contact should be broken once at 'A', once at 'B' and a third time at either 'A' or 'B' (appendix F, figure 14). When broken for the third time, this contact should be broken for at least 10 seconds to test that the 'slow to energise' relay in the motor decision circuit, which stops the points motor from running for too long, energises after approximately 7.5 seconds (breaking a detection contact causes the motor to run).

- 171 Another interpretation is that each spring contact forms one contact. Therefore, each spring contact at 'A' is broken three times and then each spring contact at 'B' is broken three times. Again, for one of these breaks, the contact should remain broken for at least 10 seconds to test operation of the 'slow to energise' relay.

172 In either case, both the incoming wiring to contact 'A' and outgoing wiring from contact 'B' should be broken separately.

Figure 14: HW2000 point machine detection contacts
