Rail Accident Report

Near-miss at Hanger Lane junction 27 March 2009

This report is published by the Rail Accident Investigation Branch, Department for Transport.

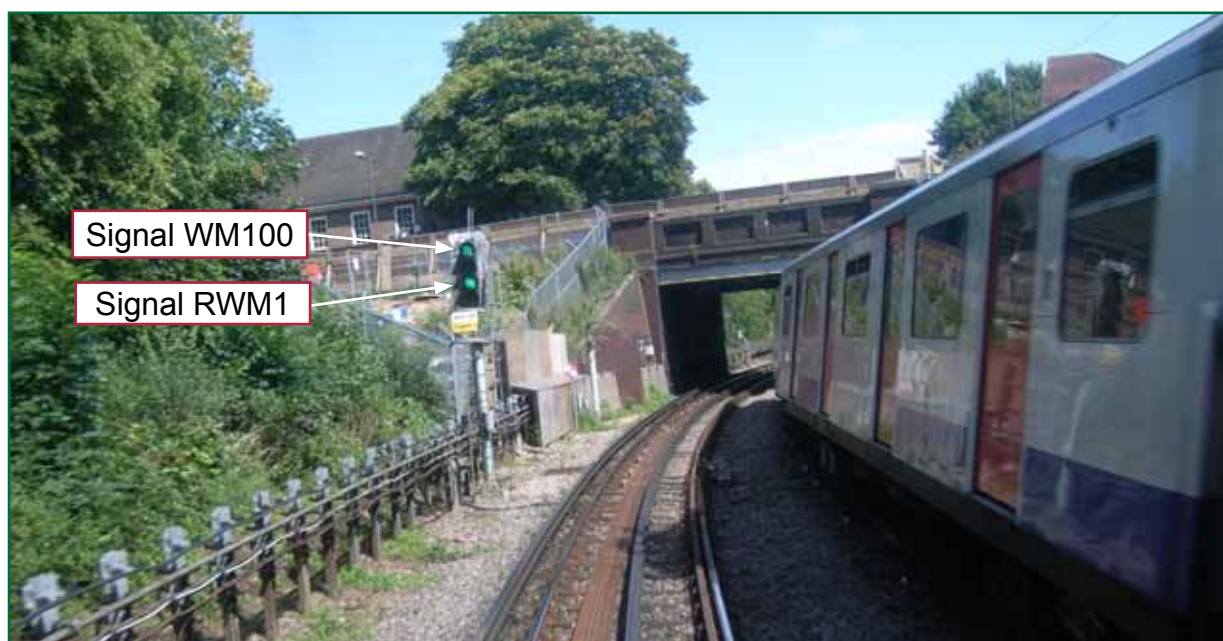
Figure 5: Signal WM100 mounted above signal RWM1. Signal WM1 is beyond the road bridge ahead

- 26 Signal WM1 is preceded by signals WM100 and RWM1. Those two signals are located 74 metres before signal WM1 and mounted together (figures 4 and 5). They provide a train operator with information on the status of signal WM1:

- Signal WM100, mounted at the top of the post, is provided to reduce the risk of a train passing signal WM1 at danger, and doing so at a speed which would make it unable to stop before reaching the junction. When signal WM1 is at danger, signal WM100 shows a red aspect to approaching trains travelling at more than 10 mph (16 km/h). A timing device, linked to track circuits which can detect a train's position, measures the speed of an approaching train. If signal WM1 remains at danger, signal WM100 will only clear to green once the signalling system has verified that the approaching train's speed is sufficiently low and that the trainstop at signal WM1 is raised.

- Signal RWM1, mounted below signal WM100, is a *repeater signal* for signal WM1. This signal is designed to show a yellow aspect if signal WM100 is showing green but signal WM1 is at danger, or a green aspect if signal WM1 is green. It shows no aspect if signal WM100 is at danger. Signal RWM1 is provided to assist a train operator if the sighting of signal WM1 becomes obstructed when a train is approaching on the opposite line due to curvature of the track.

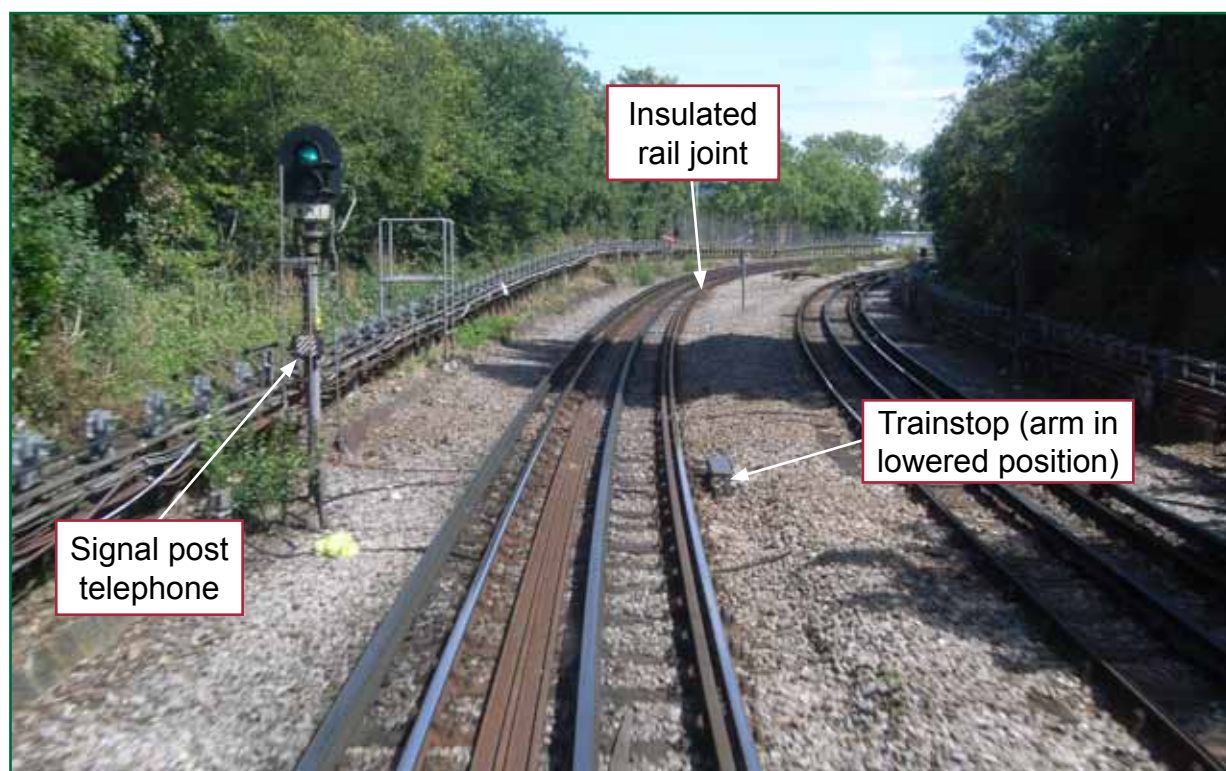
Figure 6: Signal WM1, with Hanger Lane junction in the distance

27 The *insulated rail joint* for signal WM1 is located 43.6 metres in advance of (ie beyond) it, as shown in figure 6. This separation is much greater than that found at more modern installations for historical reasons. If a train passed signal WM1 at danger, it would have to travel at least 43.6 metres in order to occupy the next track circuit before the infringement was detected by the signalling system and displayed to the signaller. It could then continue for a further 76 metres before reaching the junction (figure 7). If a train passed signal WM1 at danger but stopped within 43.6 metres, the overrun would not show on the track diagrams in the control room or affect other signals at the junction.

- 119 The relatively long distance (43.6 metres) between the signal and the insulated rail joint also meant that the signalling system did not detect that train 103 had passed signal WM1 at danger. In a modern signalling layout, where the insulated rail joint would be much closer to the signal, the wheels of train 103 may have crossed onto the next track circuit. This would have caused signal WM20/21 to remain at red, and in doing so, would have stopped train 316 on its approach to the junction.

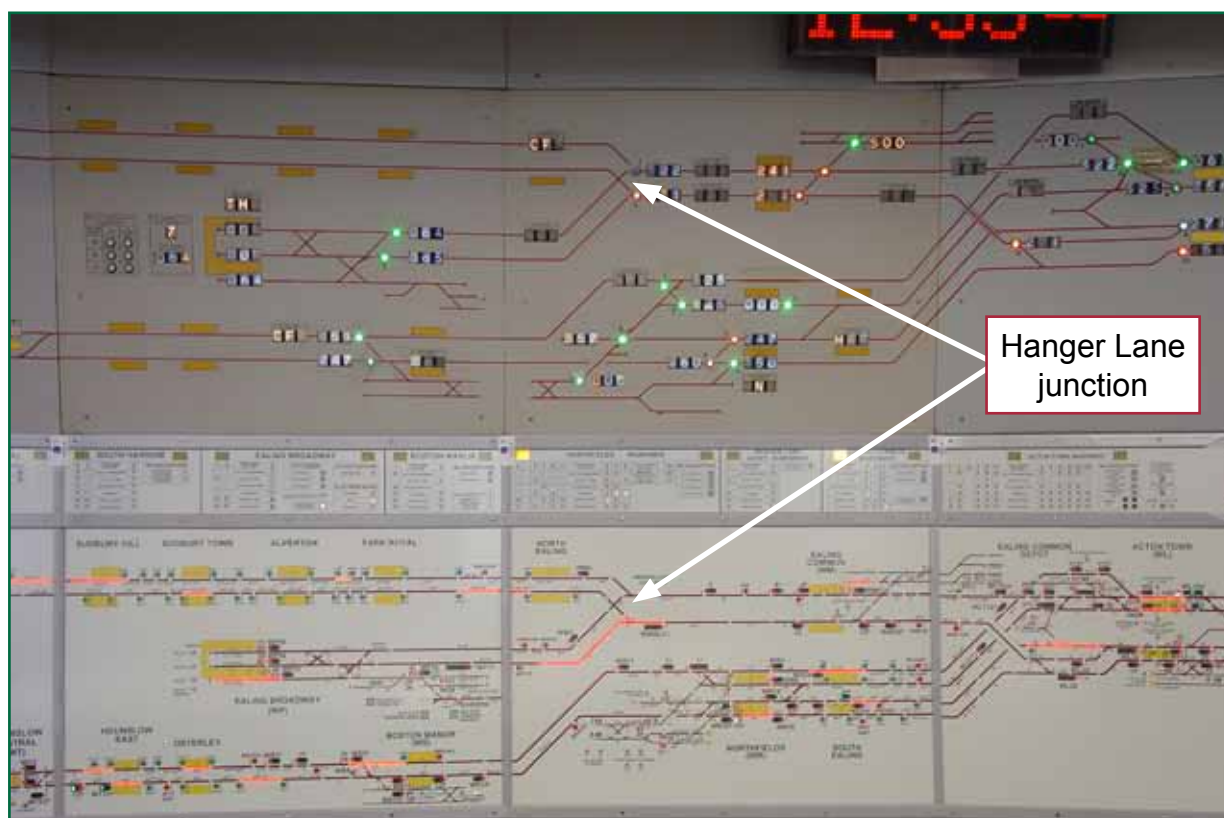
Figure 10: Display panel (top) and signalling diagram within the Earls Court control room

- 49 At 17:27:50 hrs, train 316 passed signal WM22. Its position was automatically updated on the large signalling diagram in front of the control desk (figure 10). The display panel above it also lit at the same time to show the train's destination as 'UX' for Uxbridge, both displays being visible to anyone within that part of the control room. An off-duty signaller who was seated close to the signaller observed this and drew the signaller's attention to train 316. The signaller, who had already been waiting for the controller to answer for 20 seconds, was startled by this. He was aware that there was the potential for a collision and his first action was to check the signalling diagram to see whether train 103 had moved.

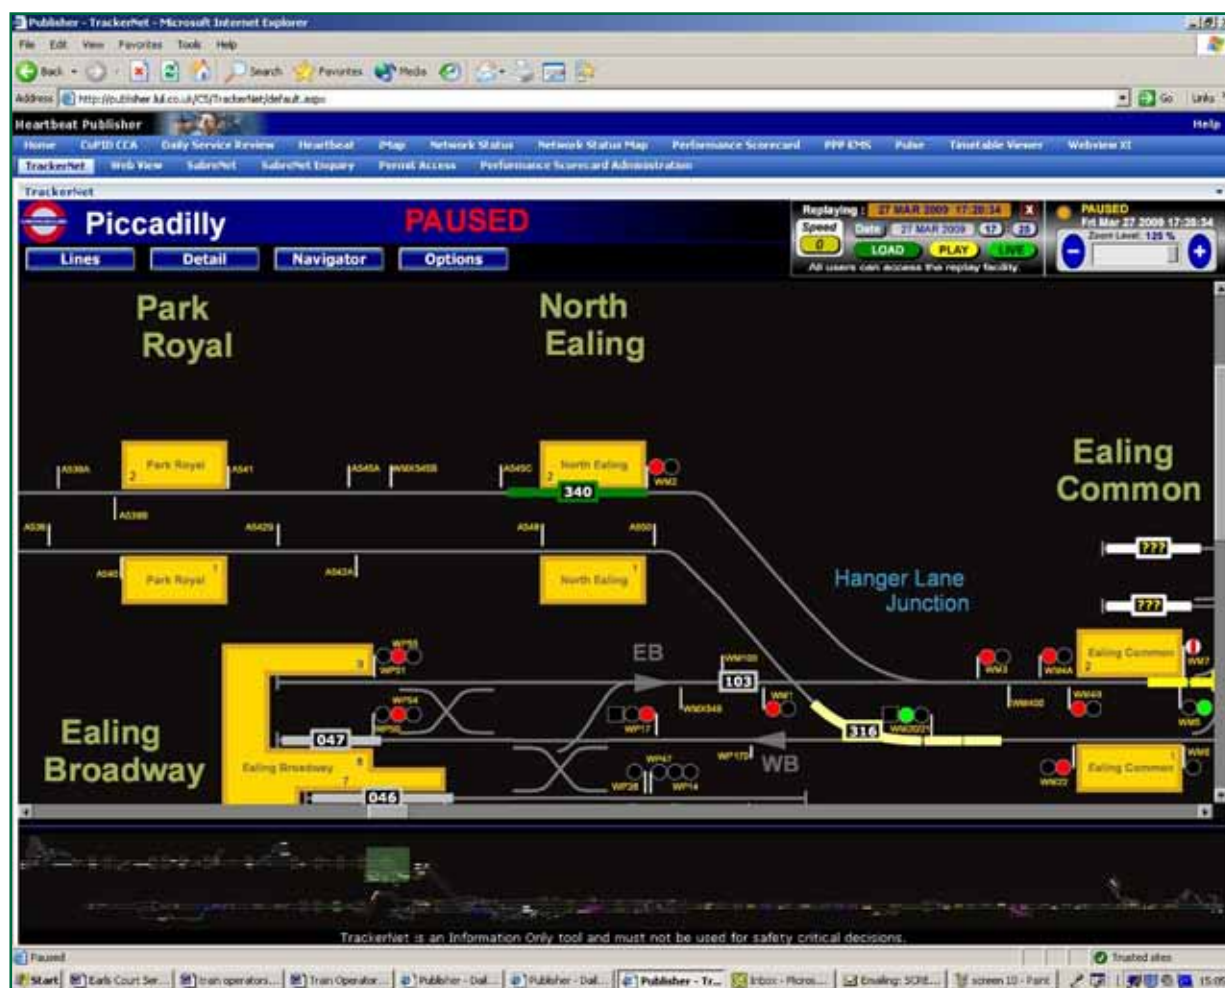
Figure 11: Tracknet screen image at 17:28:34 hrs showing train 316 crossing junction ahead of train 103

- 57 At Barking, the Duty Manager (Trains) started to investigate the circumstances of the SPAD incident while waiting for the train operator to arrive. This was triggered by a telephone call from the train operator in which he expressed concern about how the SPAD incident had been handled, and involved comparing train movement information from Tracknet (figure 11) with the signaller's report.

- 58 The Duty Manager (Trains) identified that a near-miss incident had occurred in the aftermath of the SPAD, and the subsequent interview with the train operator confirmed this. The train operator alleged that the SPAD had occurred due to sunlight on signal WM1 which had led him to believe that the signal had cleared to green, and that he was alerted to the signal being at danger by seeing the trainstop in a raised position by which time it was too late to stop.
