Rail Accident Report

Derailment of a passenger train near Cummersdale, Cumbria 1 June 2009

This report is published by the Rail Accident Investigation Branch, Department for Transport.

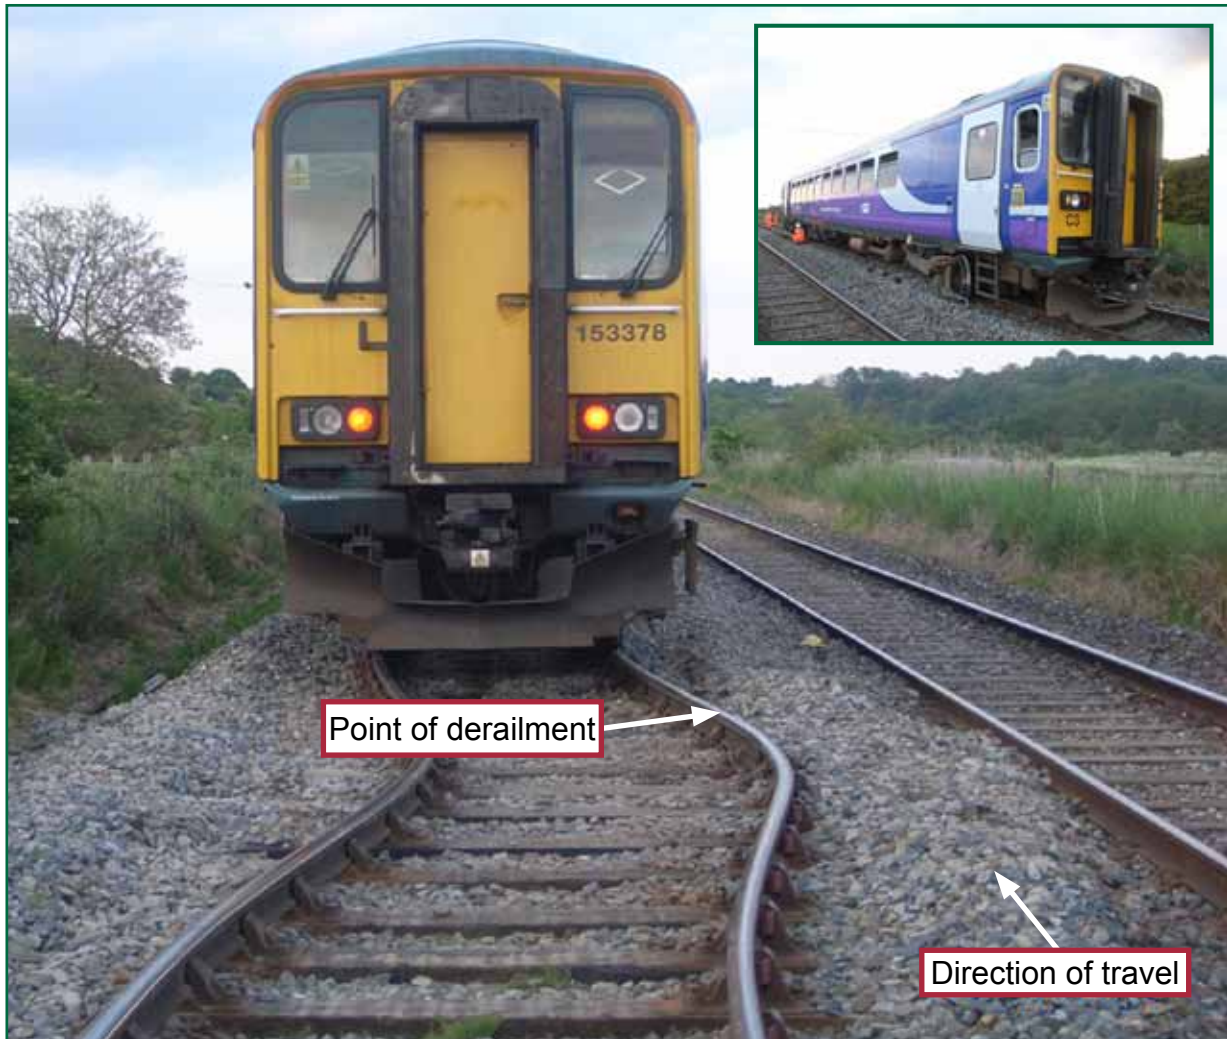
- 6 There were no injuries among the 15 passengers and two crew on board. Damage to the single car train was principally around the leading bogie and surrounding vehicle body. Damage to the track arising directly from the track buckle and derailment was confined to a length of about 30 metres around the point of derailment. However, more extensive repairs to stabilise the track over a distance of approximately 1.6 km were carried out. Figure 2 shows the track buckle and derailed train.

Figure 2: The derailed train showing the track buckle and the rear of the train 2C31 and (inset) the front of the train and derailed leading bogie

- 7 The line was closed until 05:00 hrs on 3 June 2009 when it was initially opened with a temporary speed restriction of 20 mph (32 km/h). Full line speed operation was restored on 10 June 2009, after the track had been *tamped*.

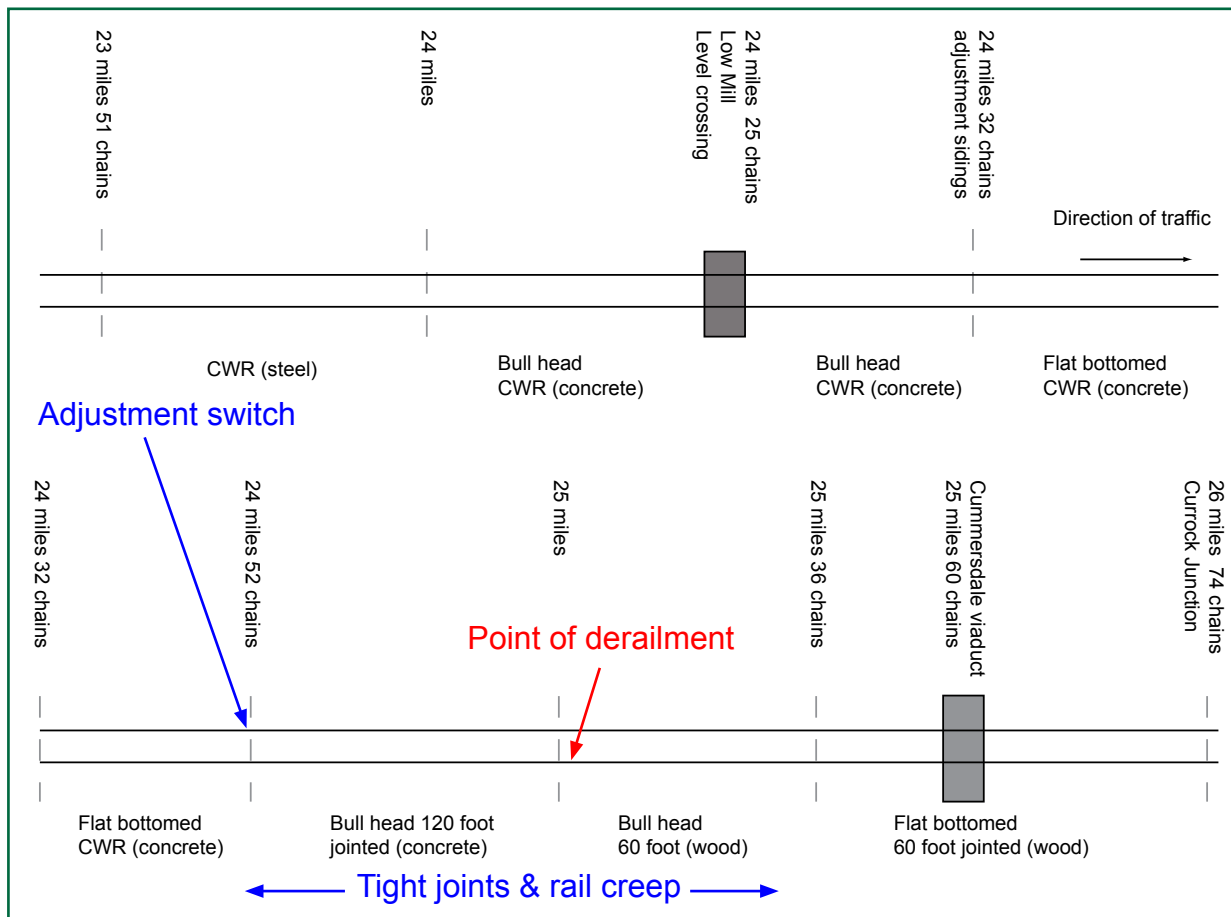
Figure 3: Track schematic showing variation in construction in relation to point of derailment

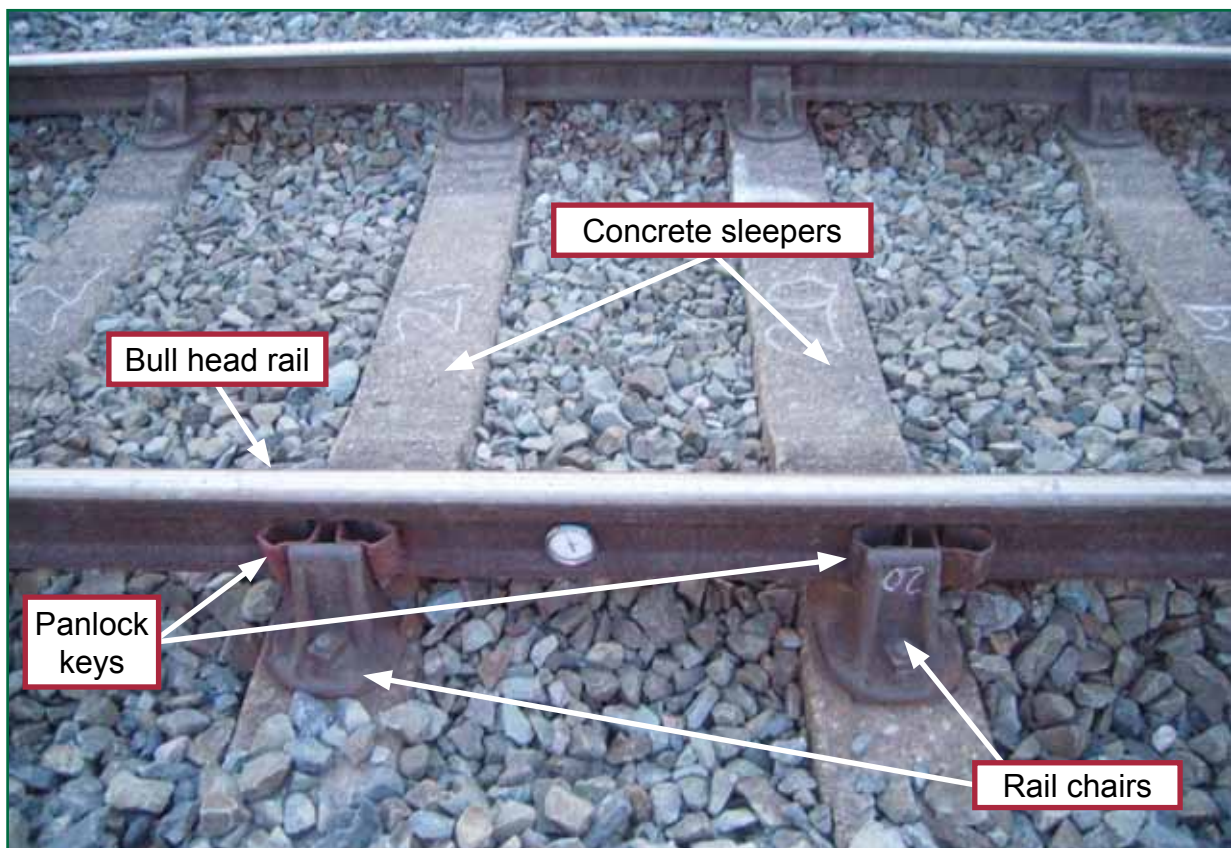
Figure 4: Construction of the down line on approach to the point of derailment

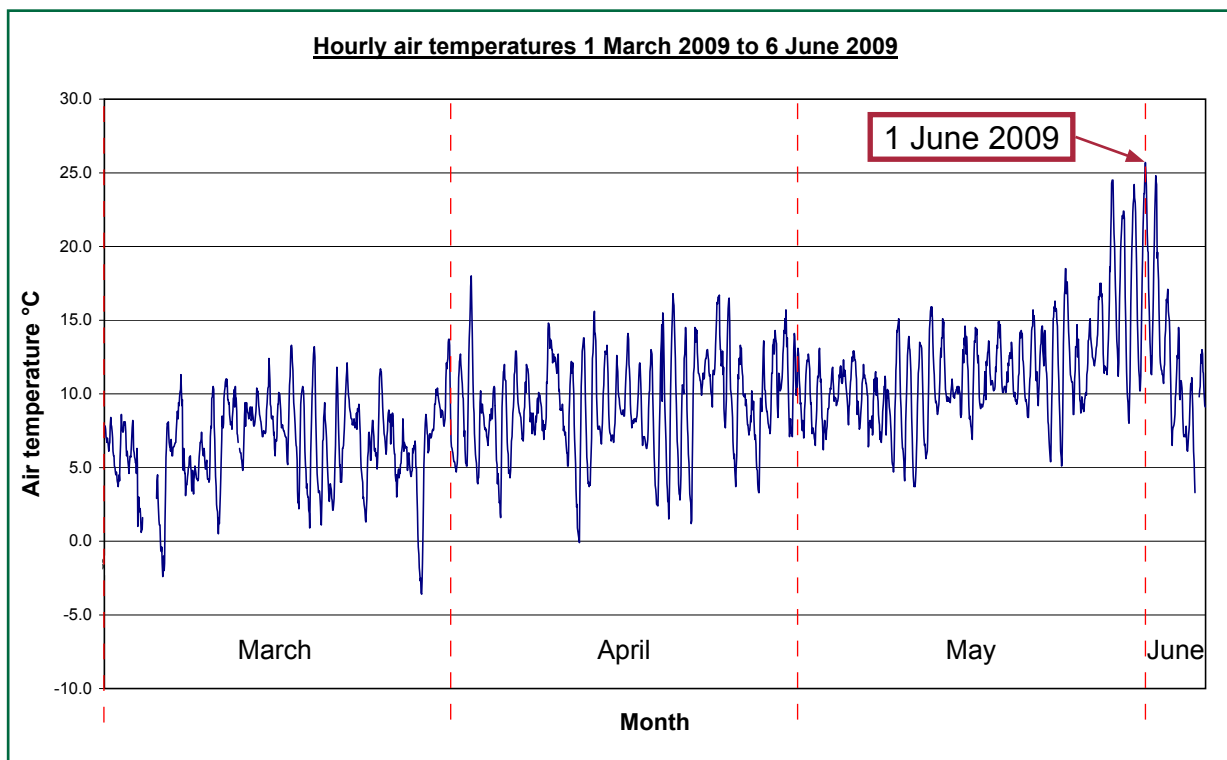
- 41 Air temperature data for the southern Carlisle area shows that during the first half of 2009, the maximum was reached on 1 June 2009, peaking at 25.5°C. This temperature is not abnormal. The variation of temperature between 1 March and 6 June 2009 is shown in figure 6.

Figure 6: Air temperatures for South Carlisle area 1 March - 6 June 2009

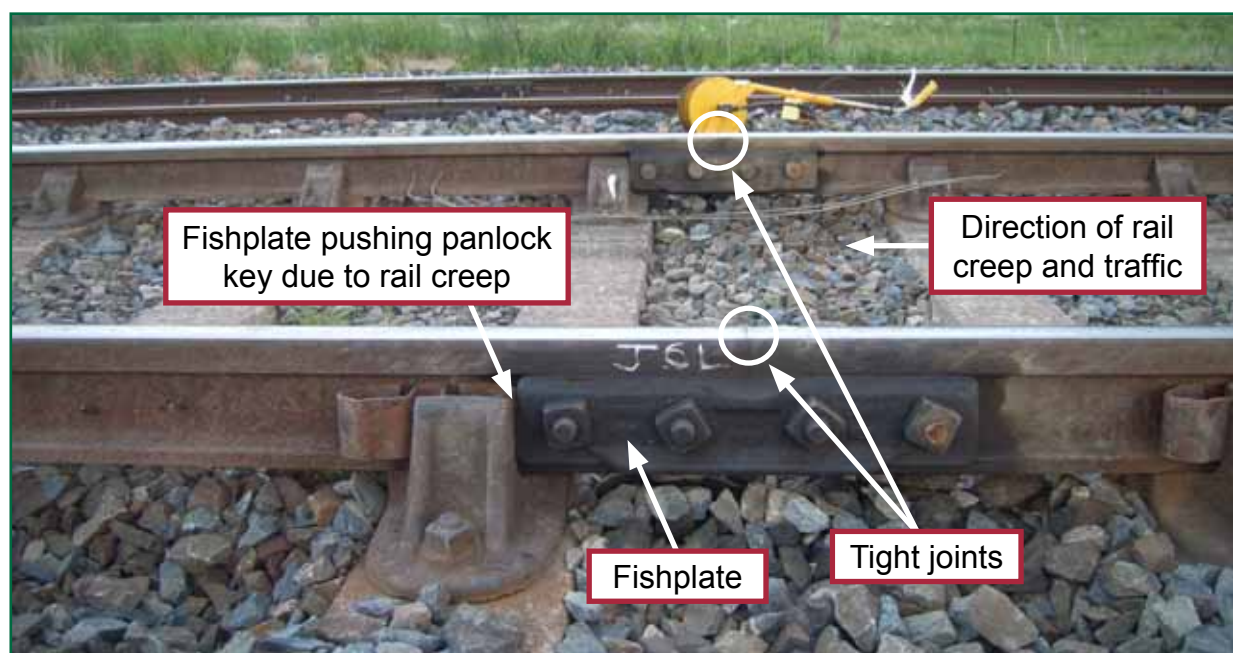
50 The control of rail creep at the derailment site had not been effective, resulting in accelerated closure of the installed expansion gaps and this was a causal factor.

51 There was clear evidence of extensive rail creep at several joints on the approach to the point of derailment. Figure 7 shows the degree of rail creep at one of these joints on the down line. The rail joint, which should be in the middle of the space between the sleepers, had moved longitudinally in the direction of traffic such that it was bearing on and pushing out the Panlock key. The effect of rail creep could be seen on most of the joints on the approach to the point of derailment, although some of the movement seen after the derailment could have resulted from the formation of the track buckle itself.

Figure 7: Tight joints and rail creep at the Cummersdale site

- 107 Network Rail repaired the track at the derailment site, carried out rail adjustment, installed additional rail anchors and removed Panlock keys to minimise the risk of further track buckles. It also made organisational changes and carried out briefings to front line staff on relevant track standards.
