Rail Accident Report

Derailment at Hampton Loade, Severn Valley Railway 28 September 2009

Derailment at Hampton Loade, Severn Valley Railway, 28 September 2009

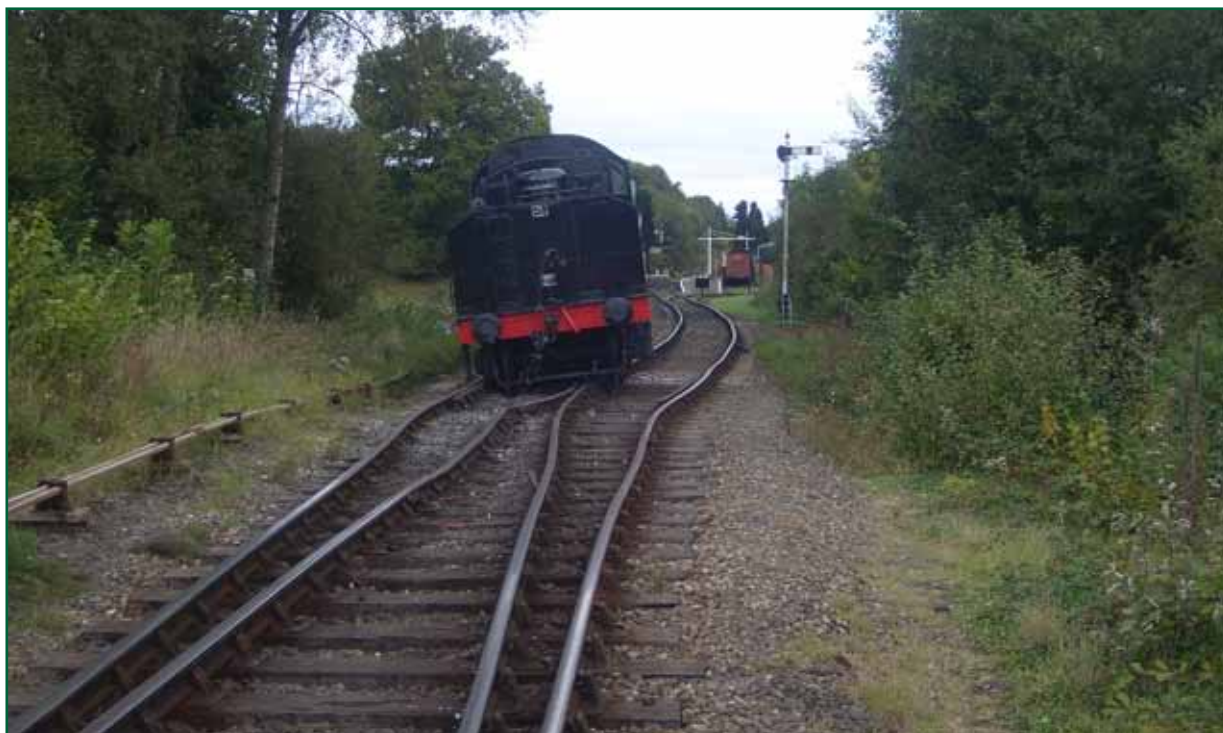
- 21 The locomotive was running chimney first towards Bridgnorth. As the train was approaching Hampton Loade the locomotive crew heard an unusual sound from the tender and applied the brakes. The train was still slowing down as it reached the points into the loop when the tender pitched over to one side.
- 22 The train came to a stand with the tender on the points (figure 3).

Figure 3: The derailed tender following removal of the train's coaches

- 23 Nobody was injured in the accident. All wheels of the tender derailed causing the leading and centre axle to be bent, damage to 35 metres of plain track and irreparable damage to the points.
- 24 The railway between Highley and Bridgnorth was closed for five days and the loop at Hampton Loade was put out of use pending installation of a new set of points.

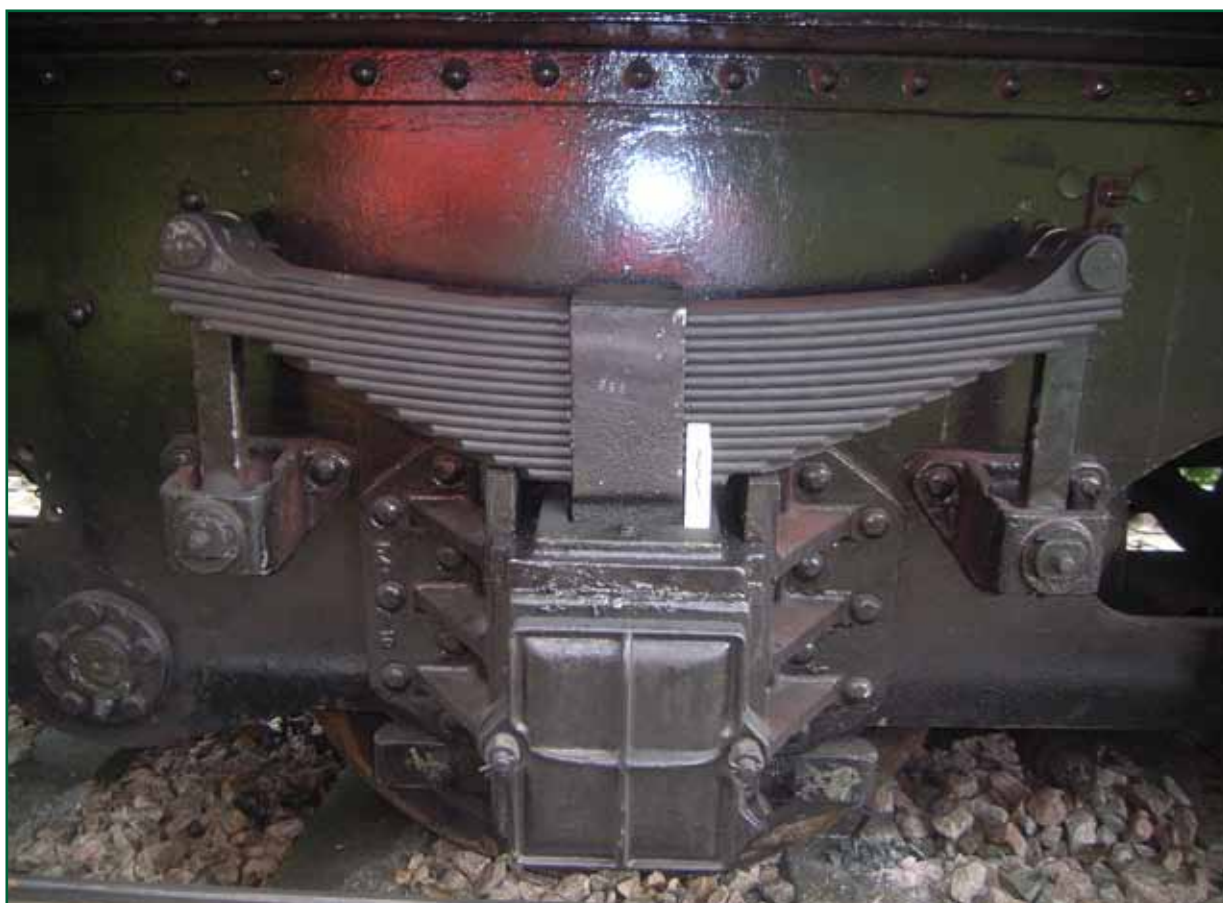
- 34 The new spring fitted to the leading left-hand wheel on 24 September 2009 was of a different design to the springs on the other five tender wheels (figure 4). Figure 5 shows the spring on the leading right side (the photographs in figures 4 and 5 were taken while the tender was derailed with all the weight of this axle on the right-hand side wheel). The new spring had 14 leaves, each ½" (12.7 mm) thick. The original spring had 15 leaves, each 7/16" (11.1 mm) thick. The other springs fitted to the tender also had leaves 7/16" (11.1 mm) thick except for the top leaf in each spring. The springs fitted to the centre axle of the tender both had top leaves ½" (12.7 mm) thick. On the rear axle the spring on the left side had a top leaf 5/8" (15.9 mm) thick and the spring on the right had a 7/16" (11.1 mm) thick top leaf.

Figure 4: New spring fitted to leading left side of tender

- 41 When the free height of the springs was measured, the new spring on the front left side had a greater free height than the others (257 mm compared to 217 mm – 229 mm for the original springs). This meant that it had to be compressed further to fit the tender. The RAIB calculated the theoretical weight on each wheel based on the measured spring stiffness and the initial free height plus packing thickness of each spring. The results of this calculation were in agreement with the wheel loads measured following the derailment (see figure 6) and showed that the effect of the increased preload of this spring led to that wheel carrying a disproportionately high load whilst the load on the other wheel on the axle was reduced to almost zero.

- 70 The SVR have replaced all of the springs on the locomotive tender with ones that have been tested and declared by the spring manufacturer to be suitable for use as a set. On completion of this work the wheel weight distribution was checked.

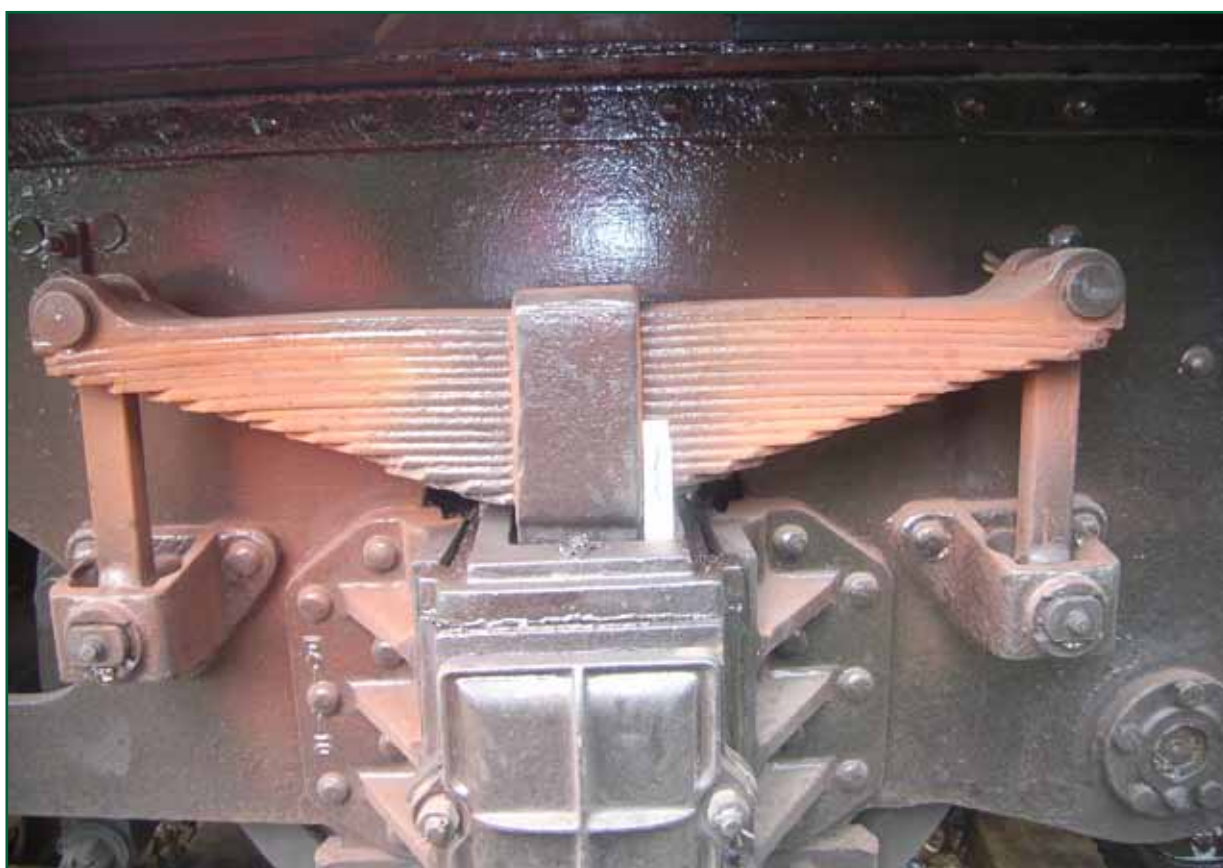
Figure 5: Existing spring fitted to leading right side of tender

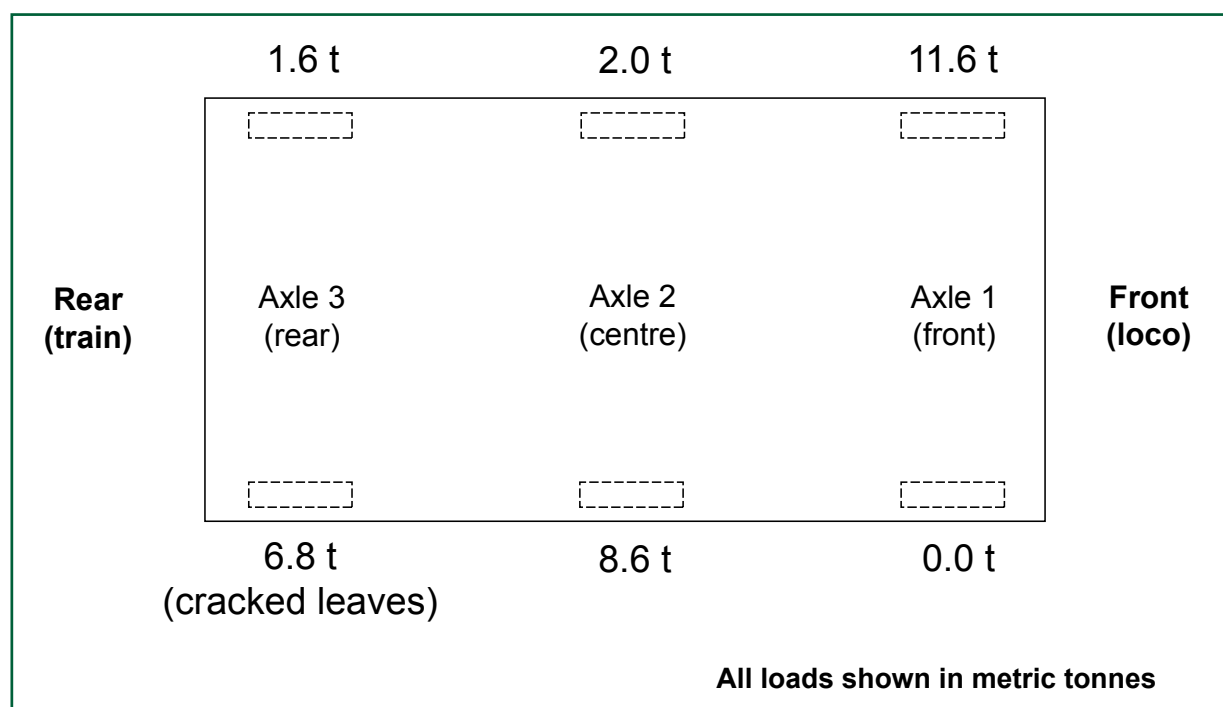
- 35 The RAIB measured the loads on each wheel of the tender after the locomotive had been recovered to the SVR maintenance shed at Bridgnorth. The results are given in figure 6. The high load on the leading left wheel would typically cause the wheel at the rear right side of the tender to also have a high load, in order to maintain the static equilibrium of the tender. However, in this case the centre wheel on the right side had a higher load than the rear wheel. When dismantled, the spring at the rear right side had three cracked leaves. This reduced its stiffness and would have led to a lower wheel load than would otherwise be the case.

- 36 The wheel loads shown in figure 6 were recorded after the tender had been rerailed and taken to Bridgnorth. It is likely that it suffered some damage to its suspension in the derailment, as evidenced by the bent front and centre axles, so the load on the leading right wheel was likely to have been reduced, but not zero, at the time of the derailment. If it had been zero before the incident it is likely that the tender would have derailed on any left-hand curve. The extent of the bend in the front axle was such that, when rotated, the wheel rim run out was approximately $\frac{1}{4}$ " (6 mm).

Figure 6: Plan showing wheel loads on tender following re-railing

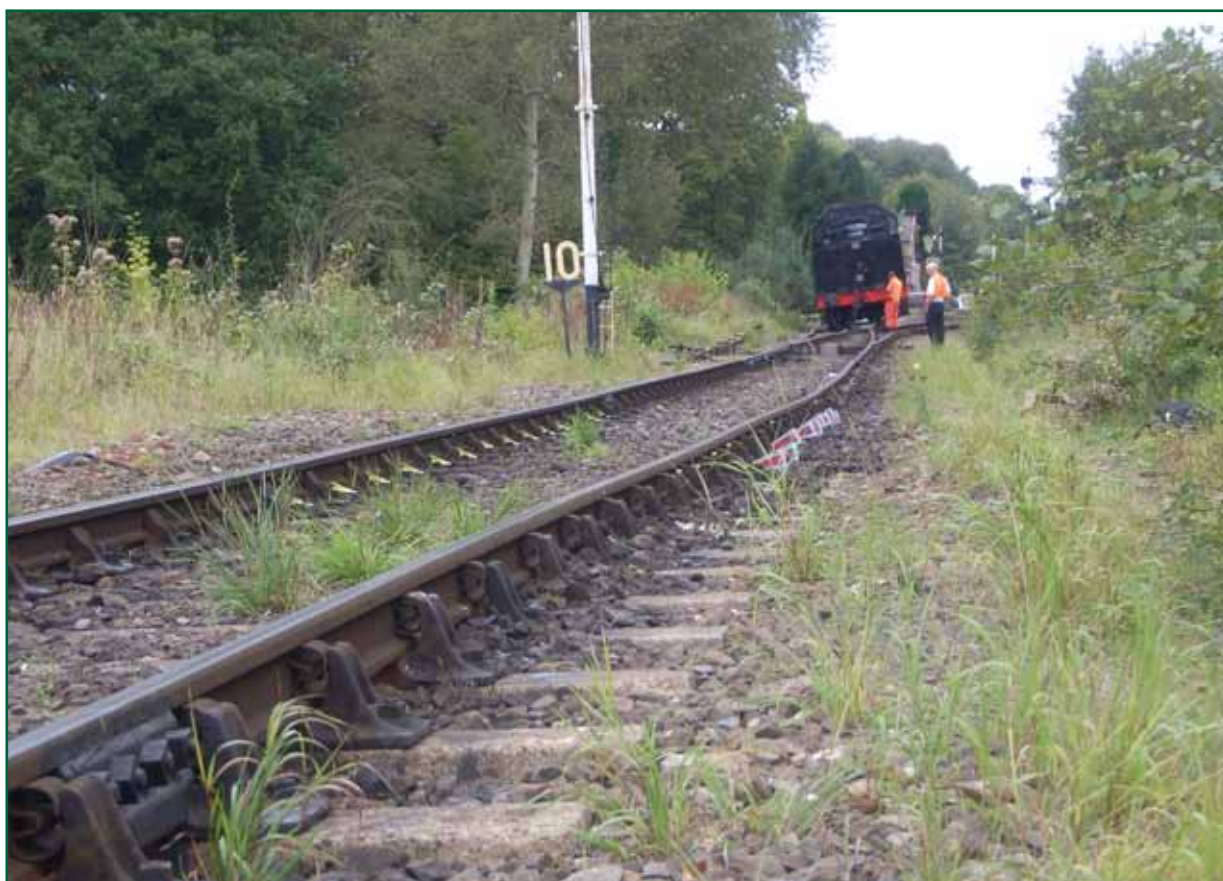
Figure 7: Site of the derailment

- 49 The section of track on which the tender derailed was surveyed by the RAIB after the derailment. The *cant* and *gauge* of the track was measured in the unloaded state and the extent of *voiding* beneath the sleepers was measured as the coaches were taken back over that section of track. Figure 7 shows a general view of the track at the site of the derailment.

- 50 The static track twist was found to be 1 in 94, measured over a 3 m base. The Network Rail limit for track twist over 3 m is 1 in 90. If a track twist of 1 in 94 had been found on Network Rail tracks it would have been considered a defect requiring attention within 36 hours.

- 69 The SVR relaid the track at the site of the derailment and have subsequently commissioned a geotechnical site investigation to determine the reason for the track movements there. The embankment has been reconstructed and new track and points installed.
