Rail Accident Investigation Branch

Rail Accident Report

Fatal accident at Fairfield crossing, Bedwyn, 6 May 2009

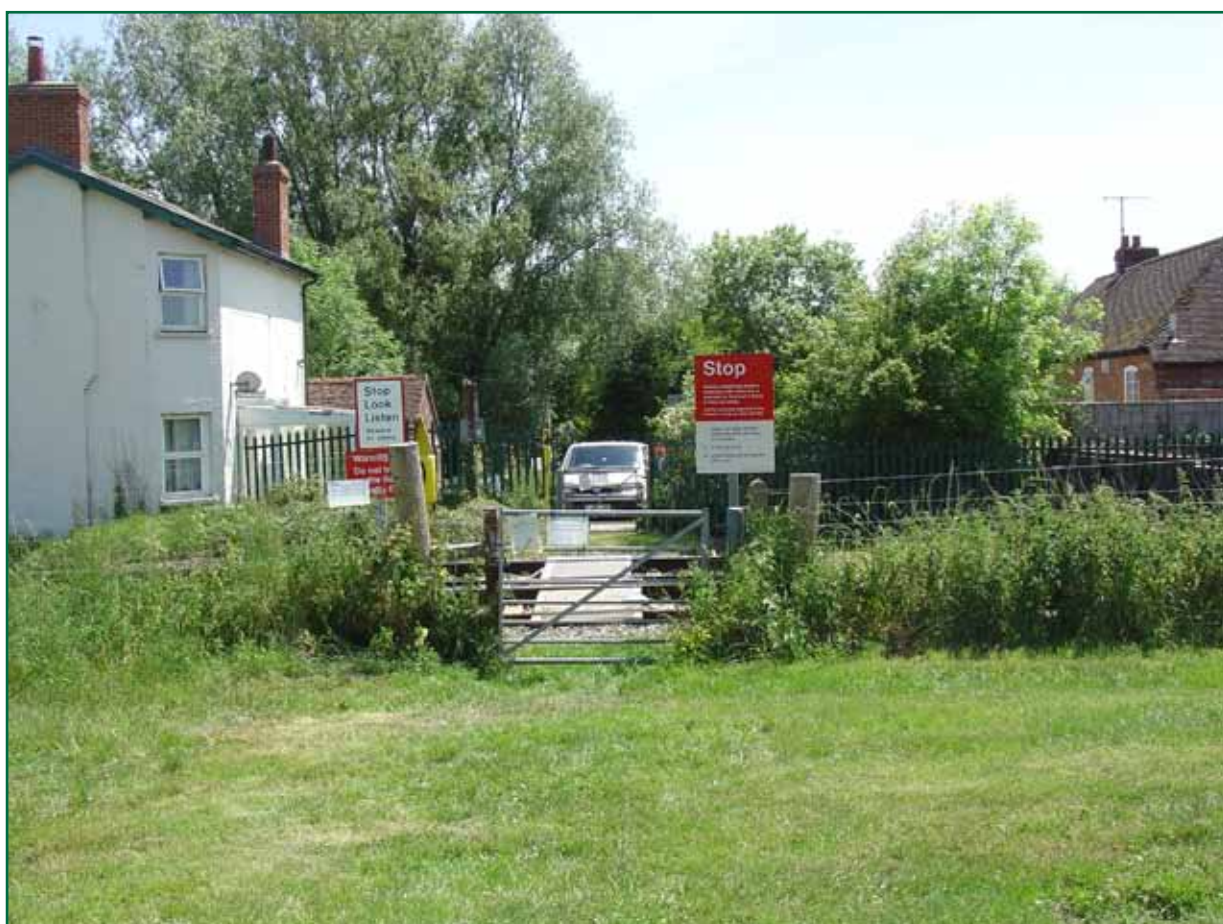
Figure 2: Fairfield level crossing from the north-west

- 12 There are single gates 1.3 metres wide on each side of the crossing, opening away from the railway. At the time of the accident, the crossing had a timber surface over both lines, but the space between the tracks (the six-foot) and the approaches to the crossing were unsurfaced (figure 2).

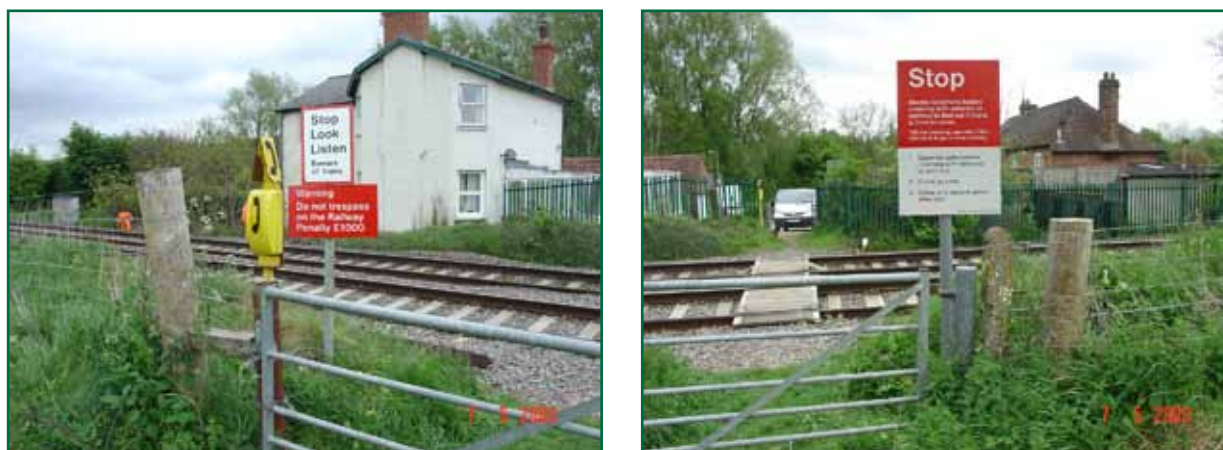
Figure 4: Notices and telephone on the up side at Fairfield crossing

- 32 The gate on the north-west (up) side of the crossing is 5.7 metres from the nearest rail. There is a 'Stop – Look – Listen' notice inside the gate, 4 metres from the nearest rail (figures 3 and 4).

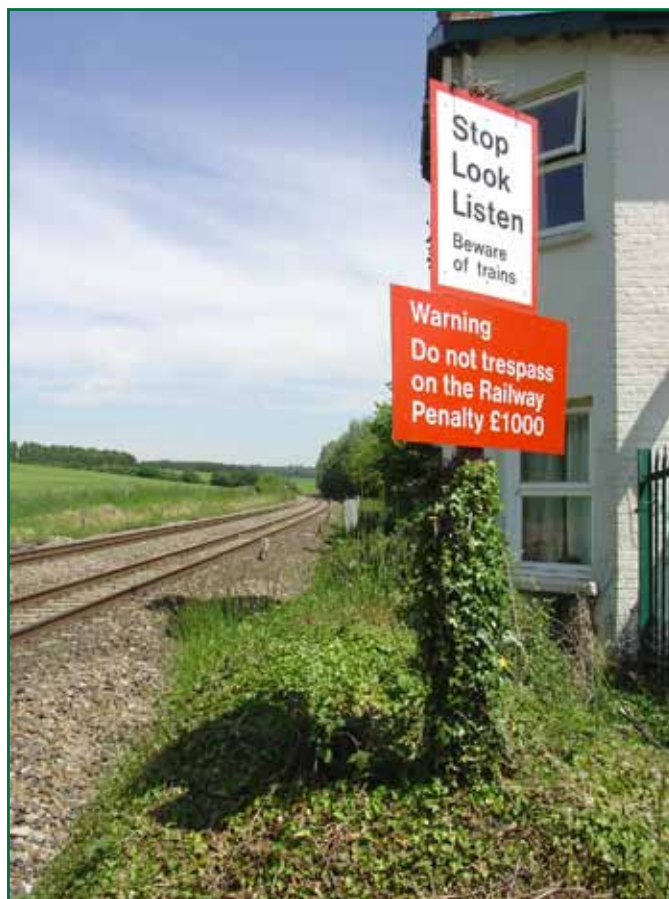
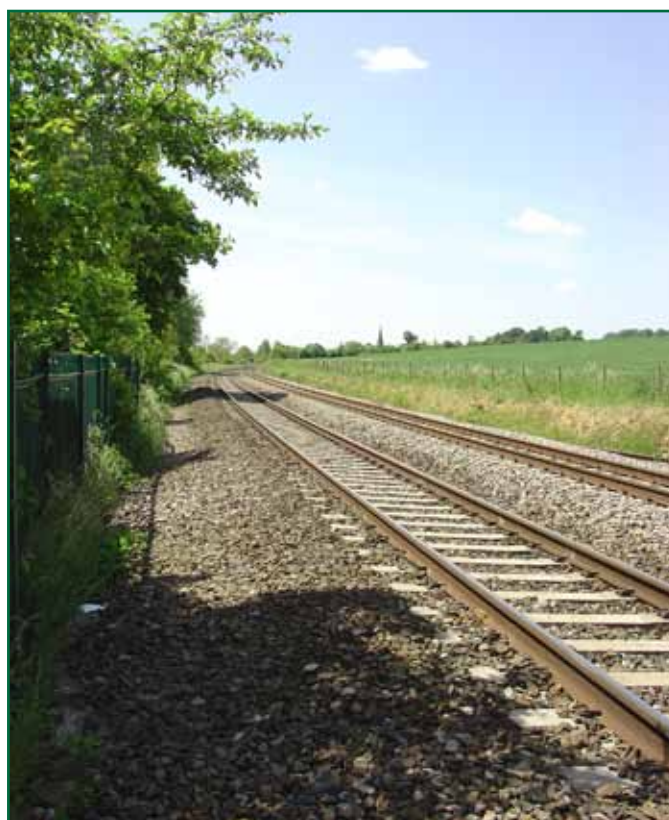
- 36 The visibility of trains approaching Fairfield crossing can vary greatly depending on where the observer is standing and how well the vegetation along the sides of the line on the approaches to the crossing has been cut back. The views from both sides of the line in both directions are shown in figures 5 to 8.

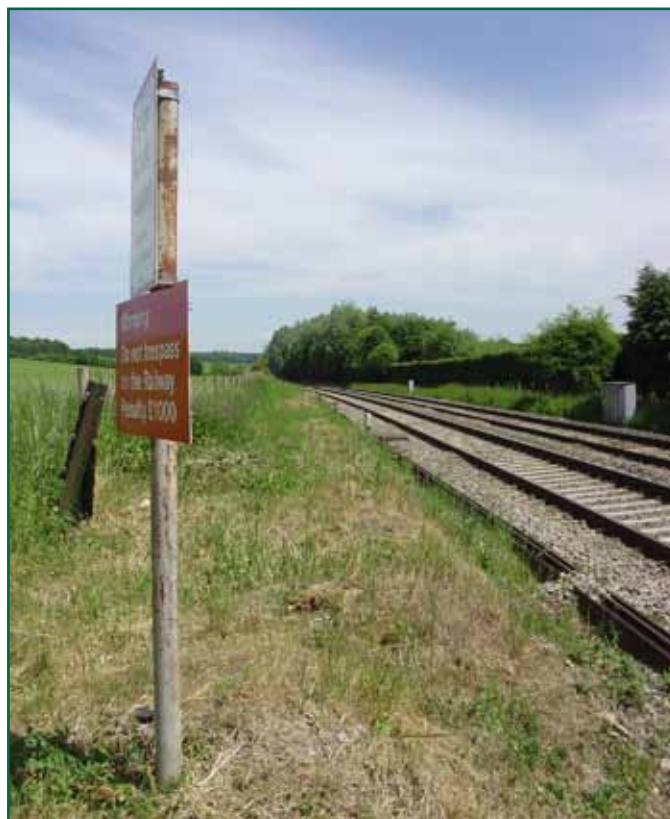
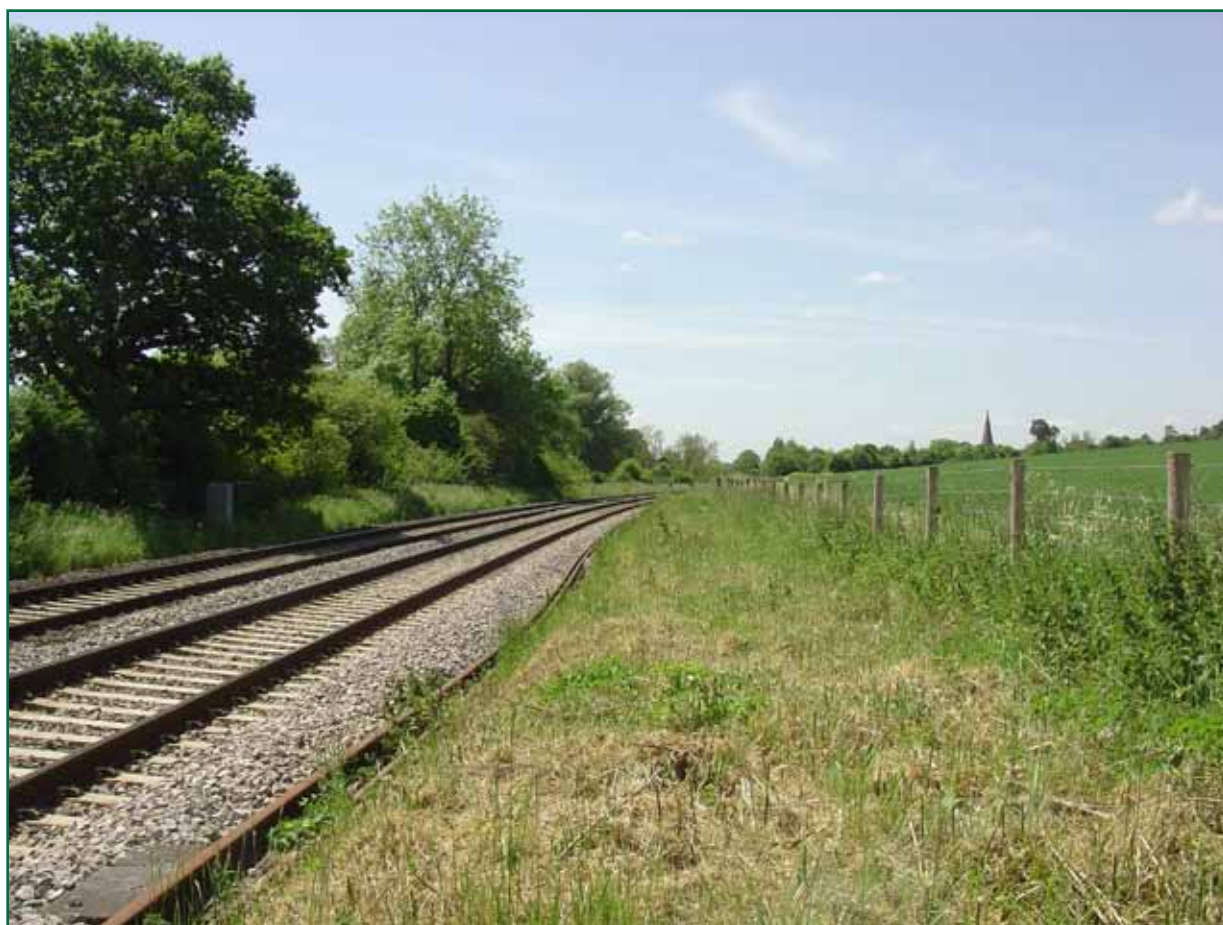
- 37 Figures 7 and 8 show the views that the pedestrian (Mrs Canning) would have had as she approached the crossing from the north-west.
- 38 All of these views show the situation on 7 May, the day after the accident, and the state of the lineside vegetation had not changed since the accident. They are from the viewpoint of an observer standing near the 'Stop – Look – Listen' signs on each side.

- 41 Table 1 shows that there are significantly different sighting distances at Fairfield crossing, particularly from the up side of the line, as measured or estimated at the various inspections and assessments. Inspection of the crossing and photographs taken at different periods show that a lot of this variation is related to vegetation growth: there is a grassy bank on the up side of the line on both sides of the crossing, and long grass on this bank masks the long-range view of approaching trains.

- 105 The sighting distance from the up side of the crossing for trains approaching in the up direction does not provide adequate warning time (paragraphs 55, 94, **recommendation 1**).
- 106 The database issued to the level crossing inspection team, and including details of sighting distances, contained incorrect and inconsistent information. This gave the inspectors sub-standard distances to use when checking sighting at some level crossings on the Western route (paragraph 50).

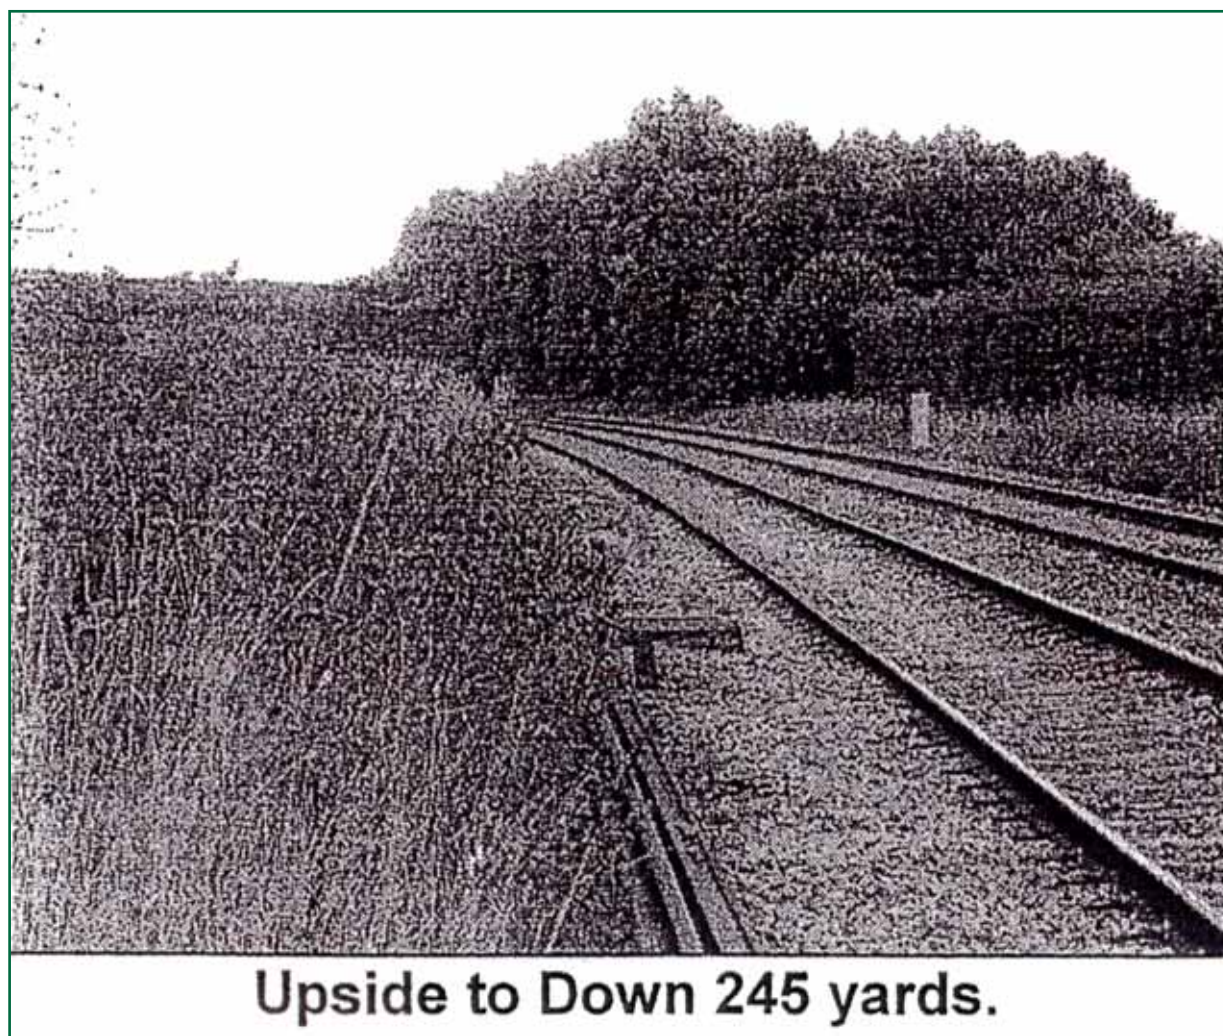
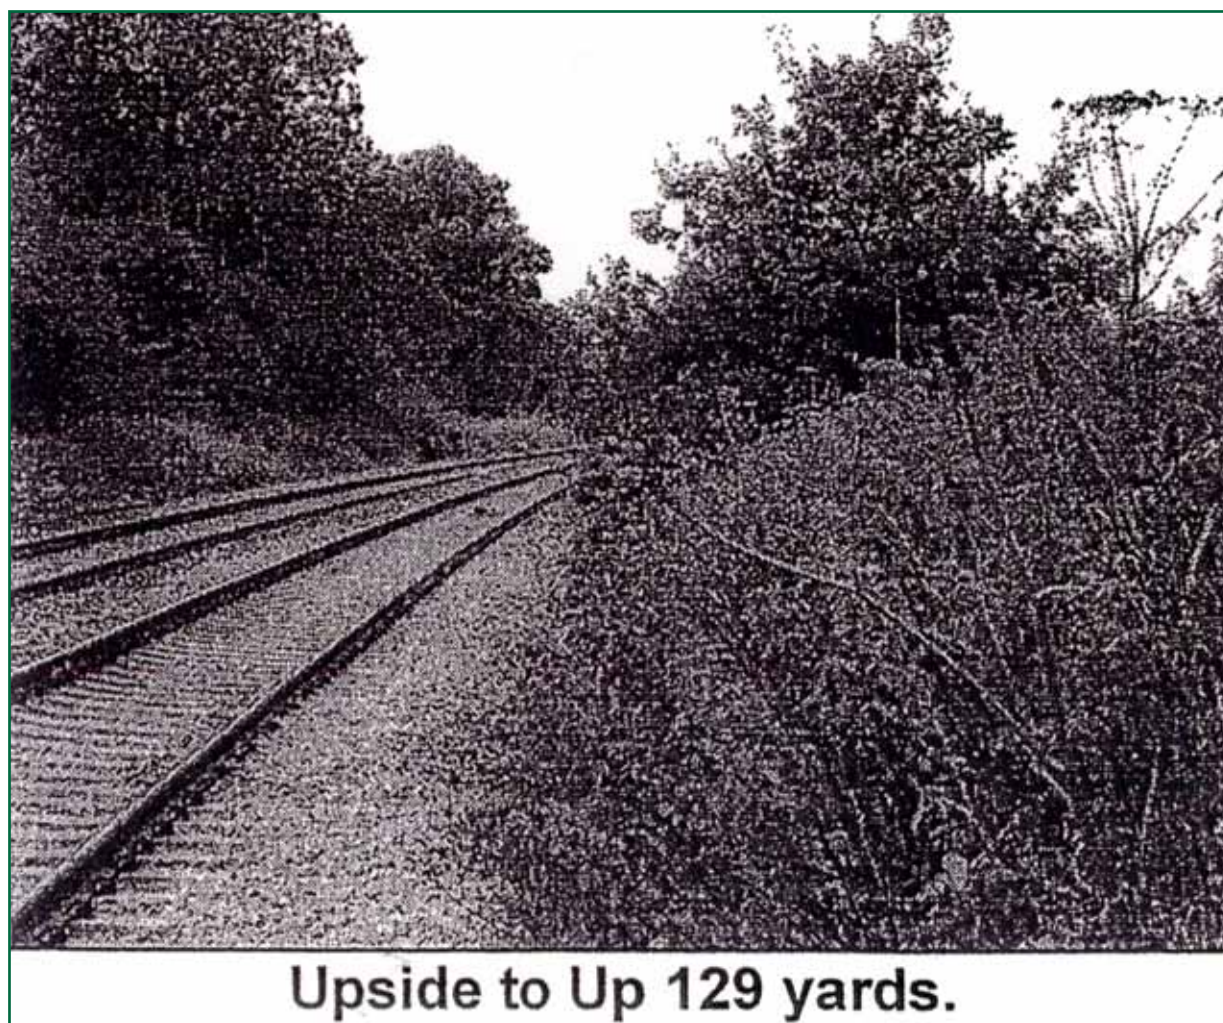
- 45 The MOM took photographs showing the effect which vegetation was having on the sighting distances on the up side (views C and D, figures 9 and 10). He recommended that the vegetation should be cut back. He noted that telephones were available for users, but that the signs did not invite pedestrians to make use of the telephones. He considered that the crossing was safe if the telephones were used, and suggested that signs should invite pedestrians to use the telephones before crossing from the up side. This assessment was not acted upon, possibly because at the time that it was done, an organisational change was taking place in the Western Route, with the central level crossing department for the route being disbanded and responsibility for level crossing management transferring to area level. There was a delay of six to eight weeks in the transfer of records and it seems likely that the report of the assessment was filed without being seen by the level crossing risk control co-ordinator for the area.

- 46 Some time after this assessment, Network Rail cut back the vegetation, removing bushes and small trees and cutting the grass on the slope of the shallow cutting on the up side of the line.

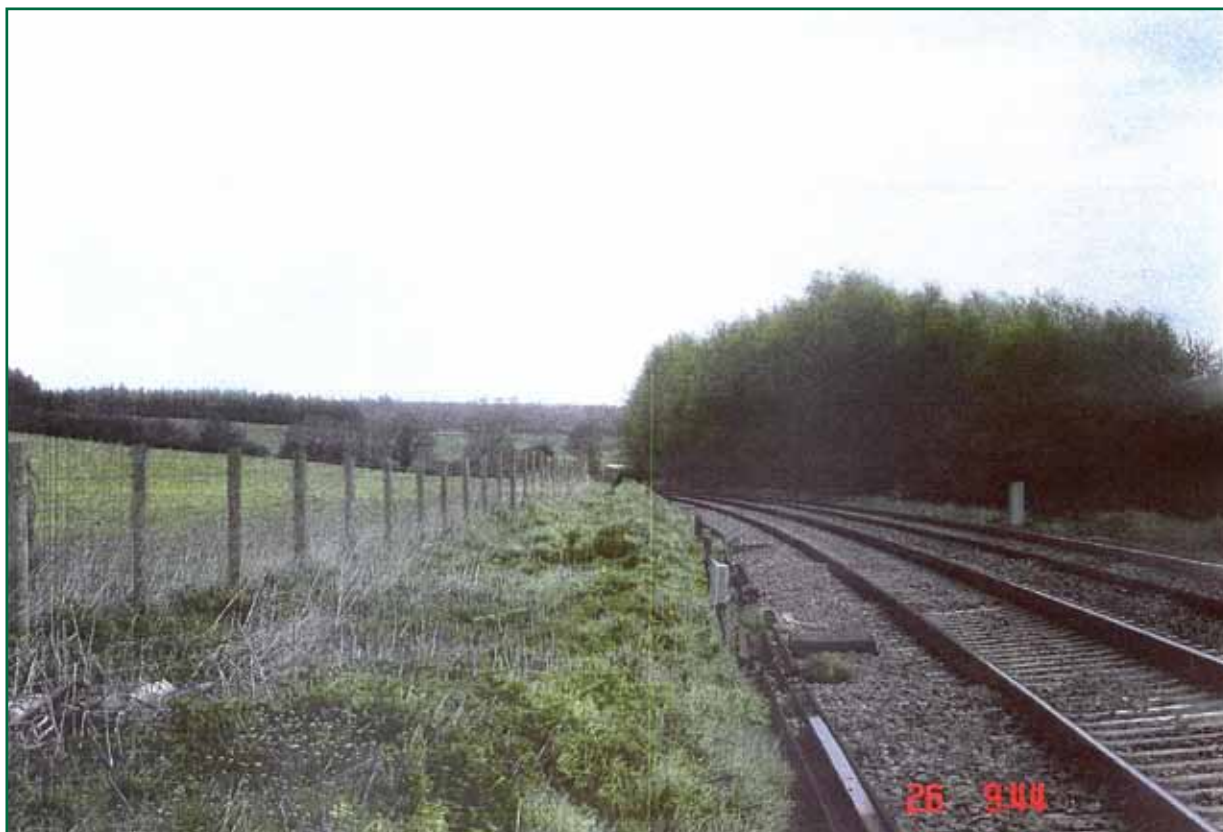
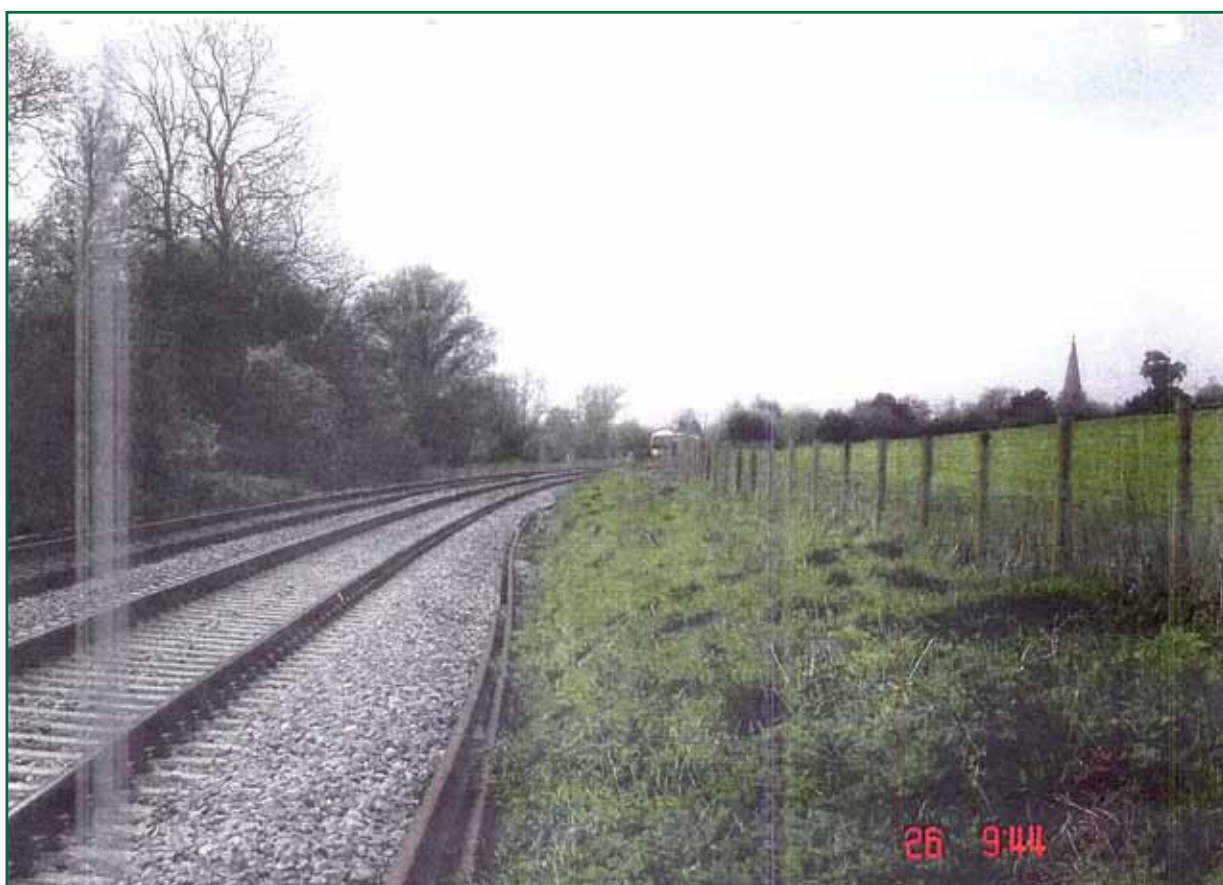
- 47 Fairfield crossing was put forward for risk assessment again in 2008, in the second year of the full ALCRM cycle of risk assessments of footpath crossings. The same MOM carried out another visit to collect data for risk assessment, on 26 May 2008. The pictures of views C and D that he took on this occasion are shown in figures 11 and 12. In both cases an approaching train is shown in the picture. The pictures show that the removal of vegetation has resulted in a considerable increase in sighting distance, as shown in the table.

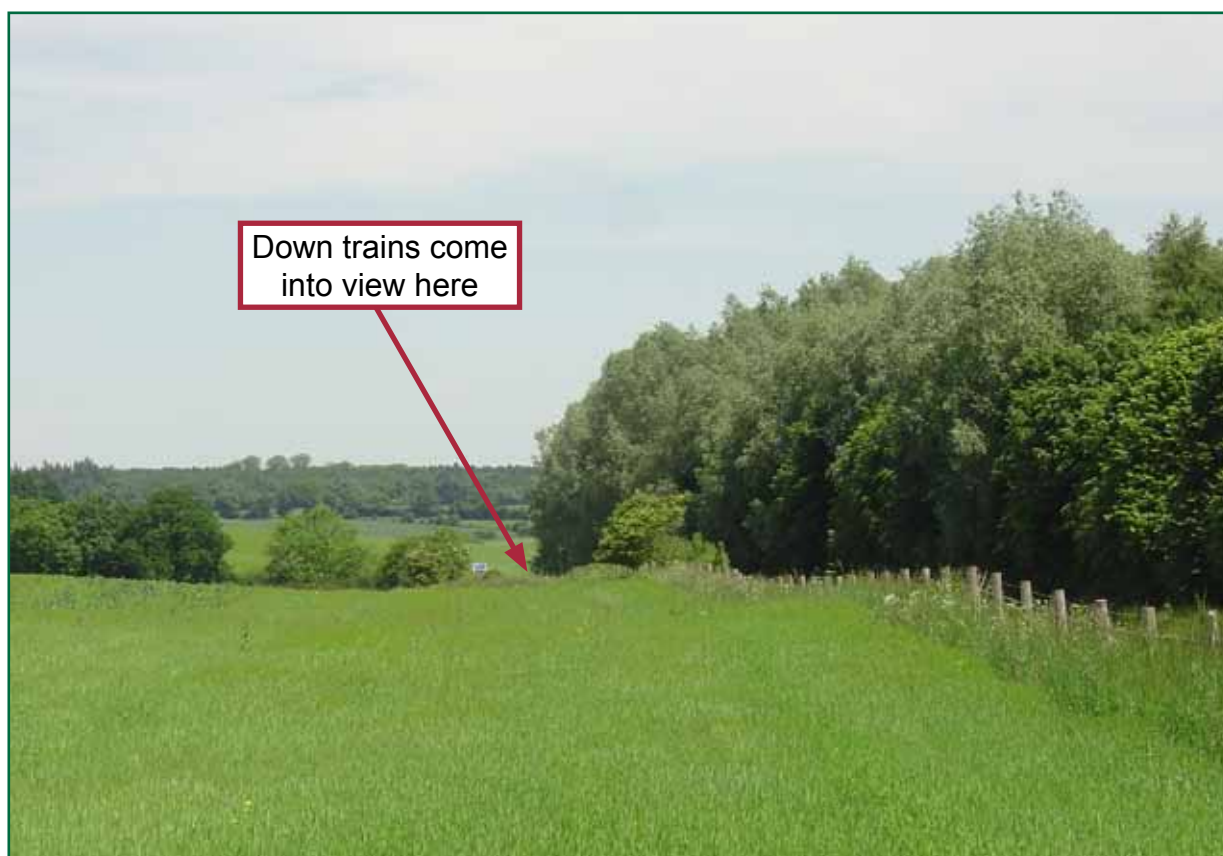
Figure 13: View from up side towards Newbury (view C) from 3 metres back from fence line

- 71 It is possible that regular users of the crossing (such as Mrs Canning was) had become accustomed to looking for approaching trains as they were walking towards the gate, because of this longer view. However, the time taken to get through the gate, particularly for a person encumbered with dogs, would be such that much of this additional warning time resulting from the longer view would have been used up by the time the person reached the side of the track. The way in which people made use of the longer view obtainable before passing through the gates is a possible causal factor in the accident.

- 72 If Mrs Canning had begun to cross at the time the train became visible from a point two metres from the track, she would have been clear of the down line about 3 seconds before the train, travelling at about 69 mph, reached the crossing. The sub-standard sighting time was not a causal factor in this accident. However, if the train had been an express travelling at the permitted line speed of 100 mph, it would have reached the crossing 6.4 seconds after coming into view and there would not have been time for a pedestrian to get clear of the line.
