Rail Accident Report

Fatal accident at Norbreck, Blackpool 5 August 2009

Fatal Accident at Norbreck, Blackpool

5 August 2009

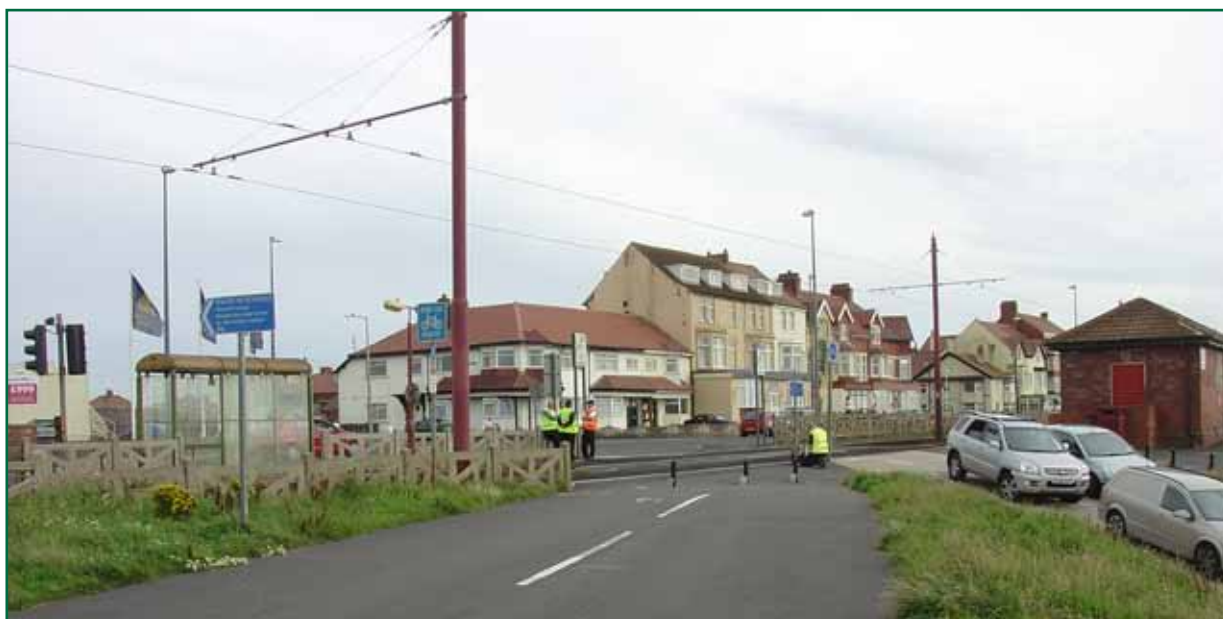
Figure 3: View of crossing approaching from northerly cycle/footpath

- 20 As the pedestrians approached the roadway crossing, whilst still clear of the tramlines, the husband looked and saw the tram approaching from the north and estimated it to be close to the foot crossing. Expecting it to stop at the tram-stop, he and his wife continued walking side-by-side and started to cross the tracks; he was on the left-hand side, nearest to the approaching tram (figure 4).

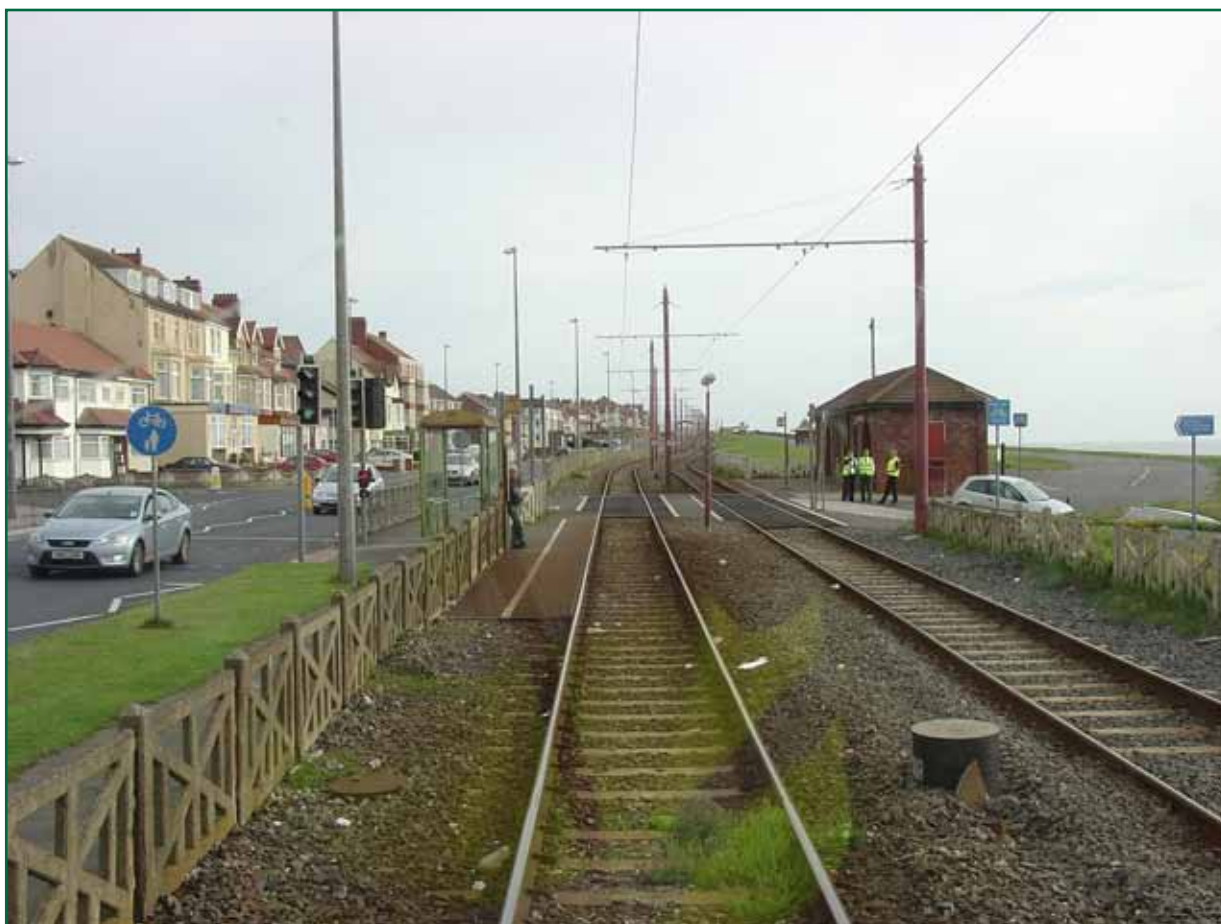
Figure 5: Tram driver's eye view of the southbound approach to Norbreck tram-stop

- 21 The tram approached the tram-stop having slowed from the line speed of 30 mph (48 km/h) to around 20 mph (32 km/h). The driver decided that as the people in the tram shelter did not put out their hands or move towards the tramlines, they did not want to catch the tram, and continued through the tram-stop without stopping (figure 5). These issues are discussed in more detail in the analysis section of the report.
- 22 On transferring his attention from the tram-stop to the roadway crossing ahead, the driver sighted the couple crossing the tramway from his right to left. He sounded the tram horn, and applied full air and electric brakes. The husband stopped clear of the southbound track but his wife stepped into the tram's path. She was struck by the front offside (right side) of the tram as she started to cross the southbound track.

35 Southbound visibility of the crossing is not significantly restricted (figure 5). As such, the reasons the driver did not perceive the risk in sufficient time could have been that:

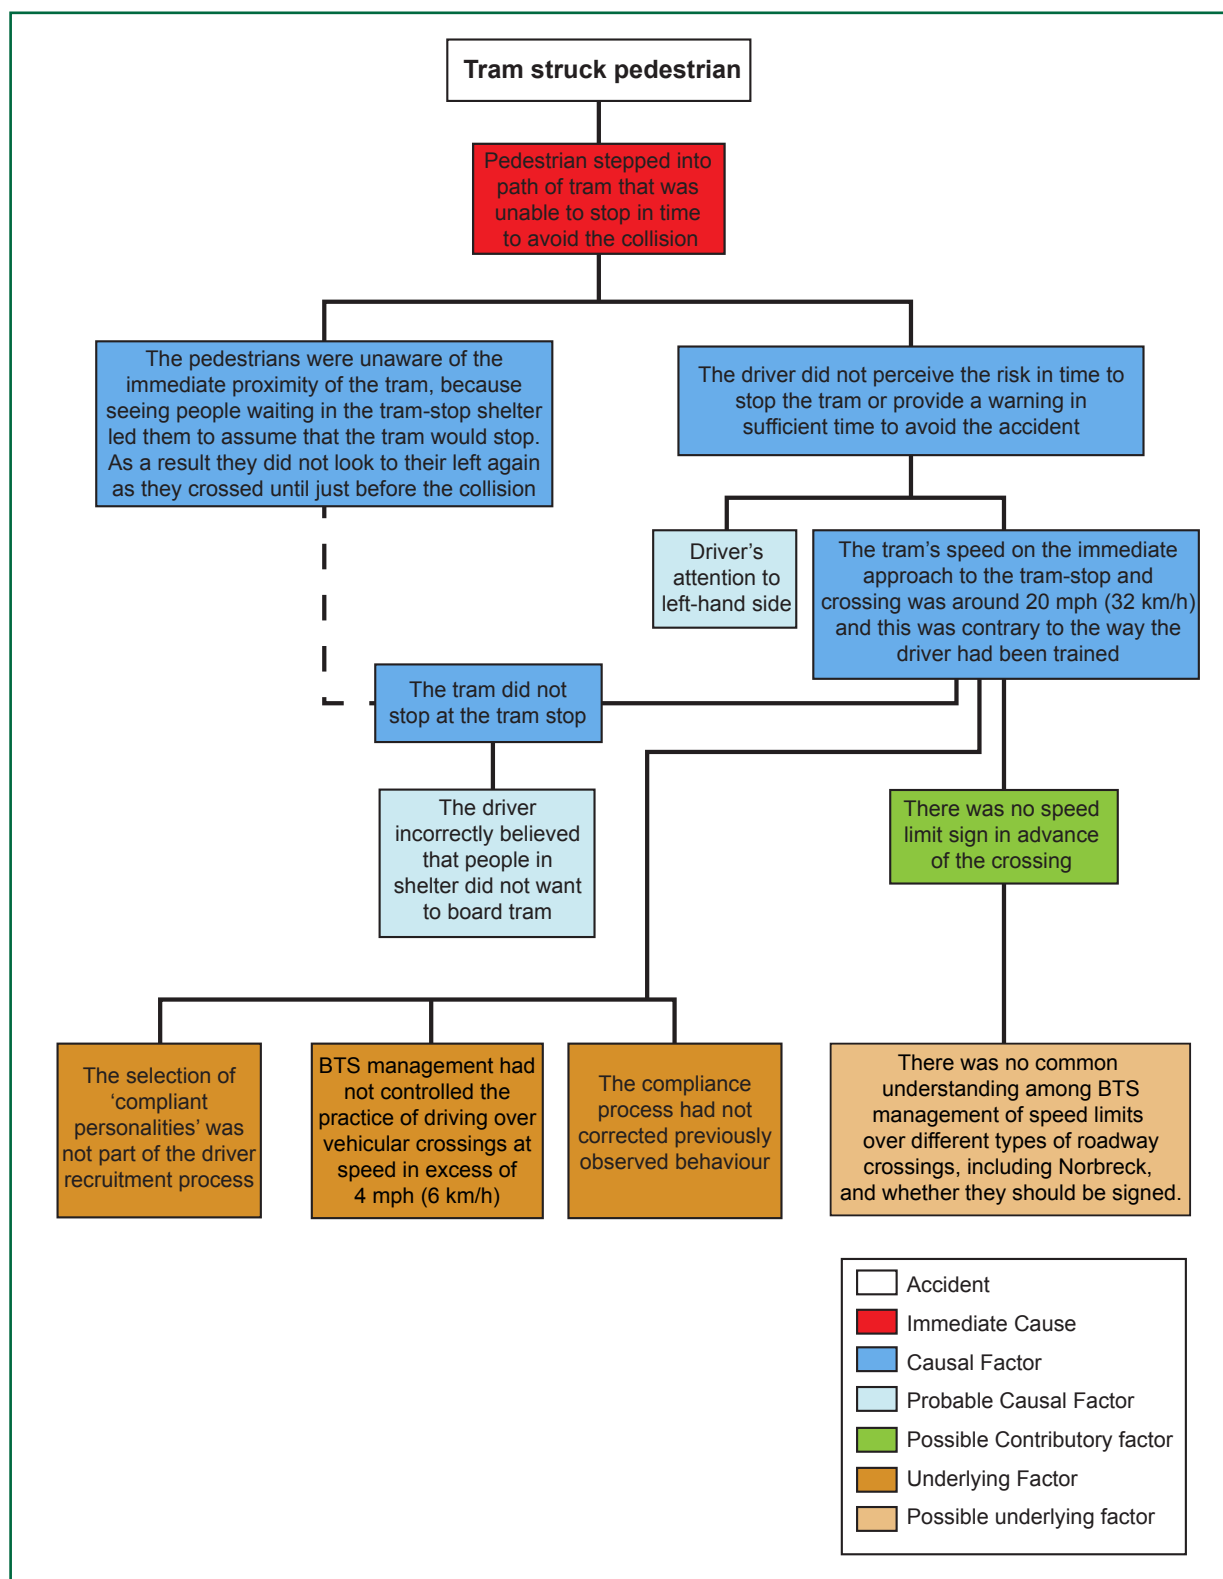
Figure 6: Diagram of causal factors

- 30 The RAIB identified four causal factors and two probable causal factors. The causal factors relate to:
- the tram driver not perceiving the risk in sufficient time;
 - the speed of the tram and its relationship to the driver's training;
 - the tram not stopping at the tram-stop; and
 - the couple's assumptions about the tram's position.
- The probable causal factors relate to:
- the tram driver's attention towards the tram-stop;
 - the tram driver's assumptions about the people in the tram shelter; and
 - the feasibility that the tram driver's inexperience played a part.
- 31 Figure 6 shows how these factors fit together. The following paragraphs then explore each of them.

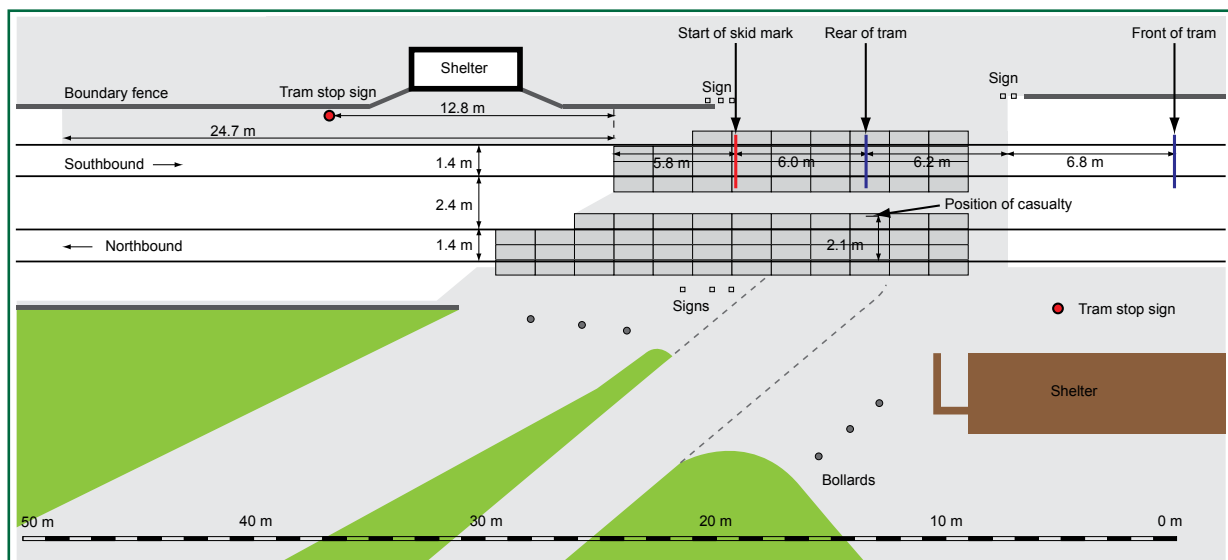
Figure 7: Layout of Norbreck tram-stop and crossing

A diagram of the crossing and tram-stop is provided in figure 7.

- 42 At this range of speeds, the range of distances from the front of the tram when it started braking and sounding the horn to the front of the tram after it had stopped was between around 26 and 40 metres. This corresponds to a likely time from the horn being first sounded to collision of between 1.5 and 2.7 seconds. If a 1 second driver reaction time is allowed for⁵, the driver saw the pedestrians and perceived the need to brake when the front of the tram was between 35 and 50 metres before the point where it stopped. Figure 7 can be used to identify where those positions would be.
