# Rail Accident Report

## **Derailment at Windsor and Eton Riverside station 11 October 2009**

This report is published by the Rail Accident Investigation Branch, Department for Transport.

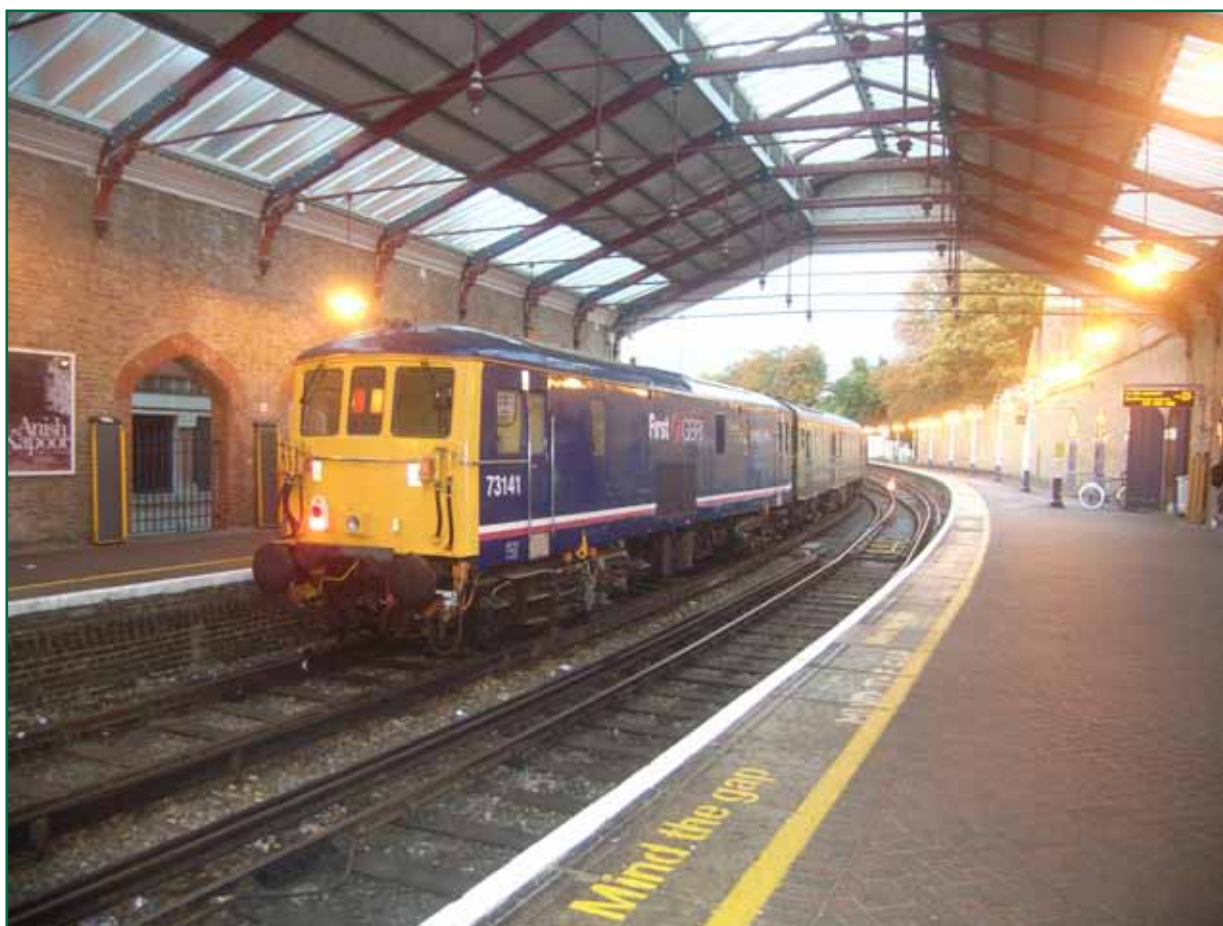
Figure 3: Locomotive and derailed Hastings unit at Windsor and Eton Riverside station platform 1

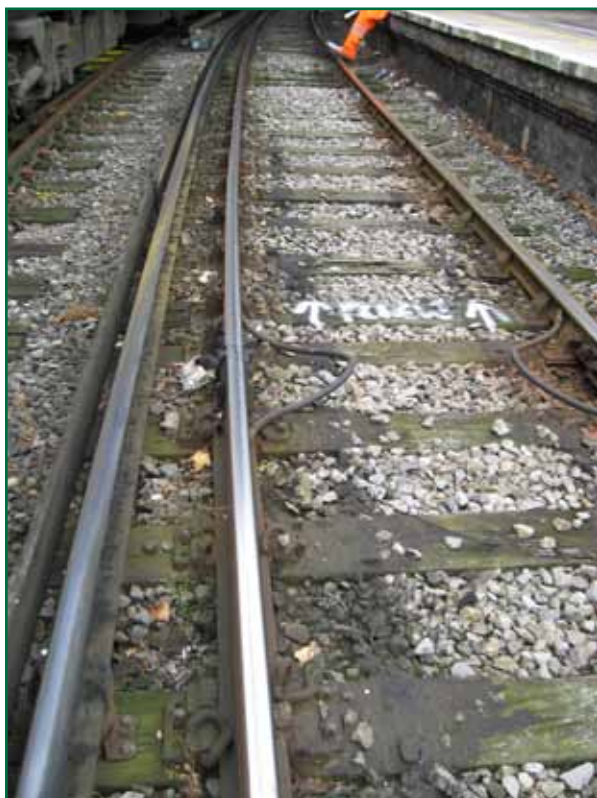
- 28 On 8 October 2009 the Track Section Manager and his assistant inspected the twist fault. When they had completed their assessment they walked along the track towards the buffer stops at Windsor and Eton Riverside station. As they walked on the track at platform 1 they saw a number of rotten sleepers in the vicinity of 25 miles 46 *chains*. The rotten sleepers were marked by the Track Section Manager using spray paint and the fault was entered onto the Ellipse database later that day. Resources and equipment were then allocated to replace the sleepers in week commencing 12 October 2009.

Figure 4 (left): Track in platform 1 looking towards the buffer stops

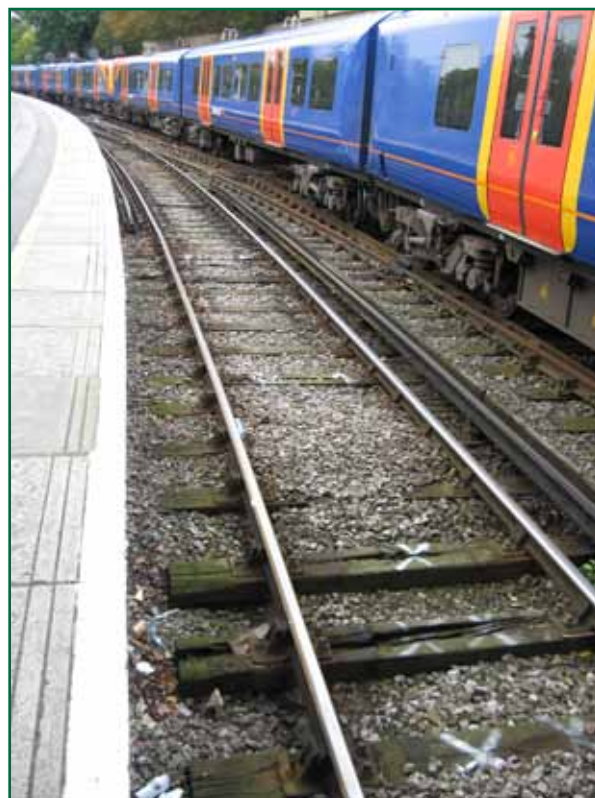
Figure 5 (right): Track in platform 1 looking towards London showing condition of sleepers (both photographs taken by Network Rail staff on 8 October 2009, three days before the derailment)

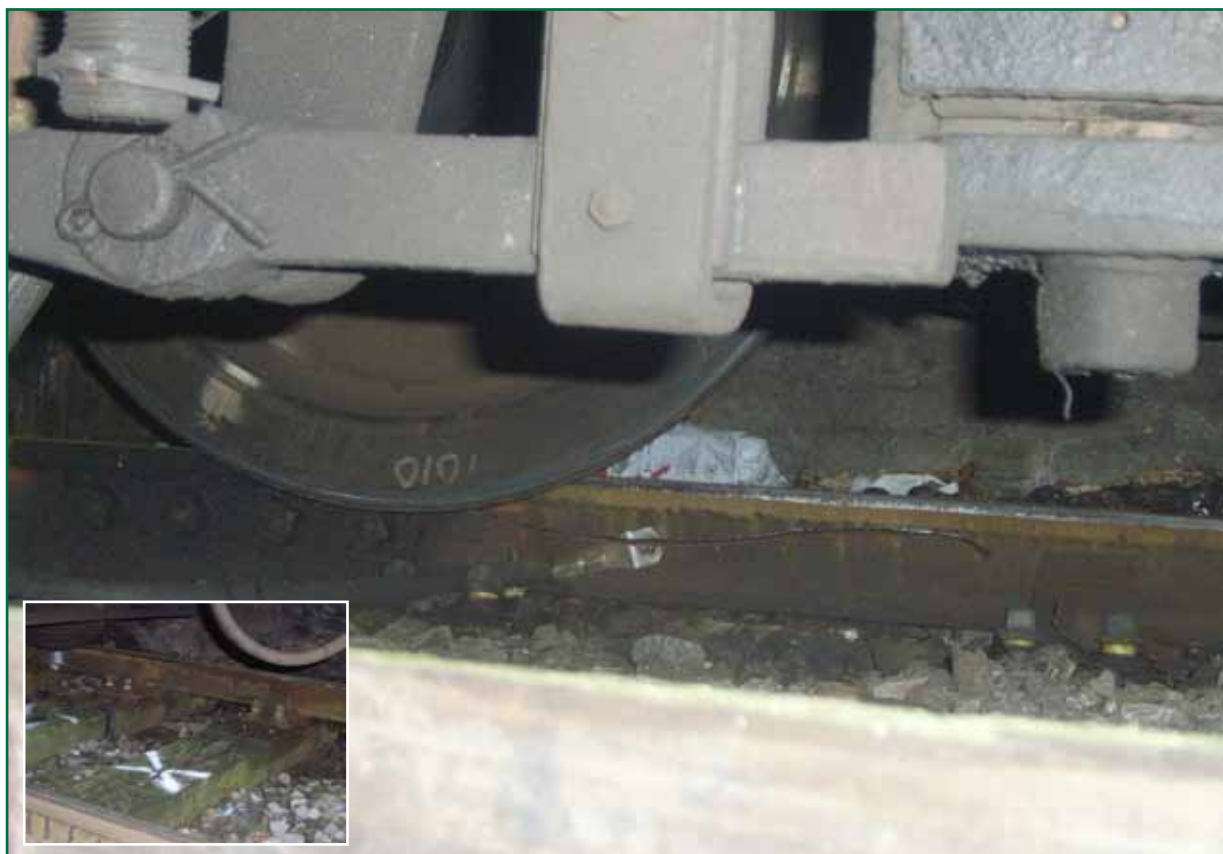
*Figure 6 (main): 'Swarf' debris and derailment marks on the rail from the derailed wheel*

*Figure 7 (inset): Decaying sleepers and wheel set of the DEMU*

- 36 **The immediate cause of the derailment was that the track was unable to maintain the correct gauge as train 1Z75 passed over.**
- 37 The location of the fault was at 25 miles and 46 chains. The area in the vicinity of the point of derailment showed signs of chair shuffle. Chair shuffle is a mark or indentation on the sleeper or *bearer* which has been generated by the load of the train causing the chair to move. This movement can cause the distance between the rails to deviate from the designed gauge. The wooden sleepers at the location of the derailment were either degrading or rotten and unable to retain the gauge under the load of the train.

- 39 The track was examined after the derailment. The gauge was found to be 1469 mm at the point of derailment and between 1471 mm and 1478 mm at various locations beyond the point of derailment.

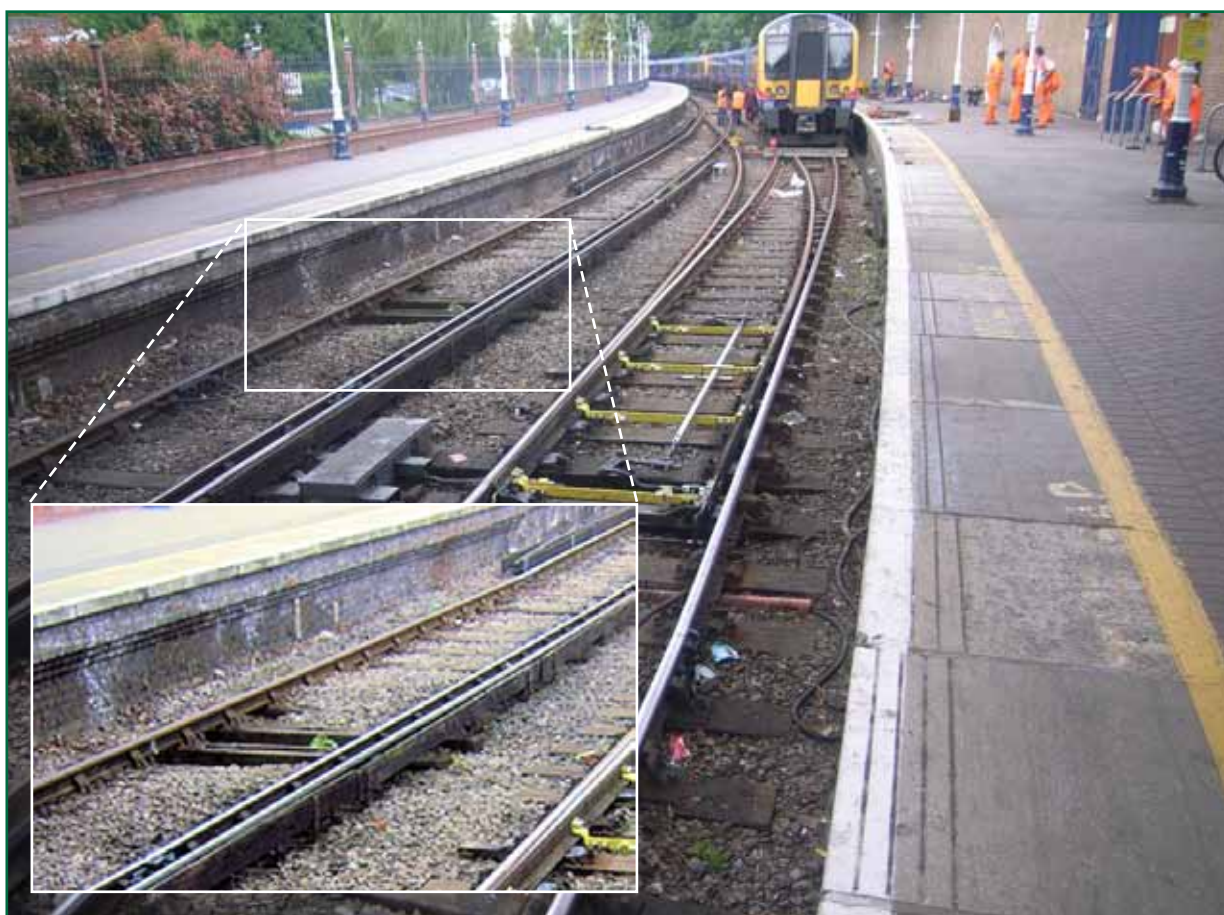
- 65 Network Rail's company standard NR/SP/TRK/029 (Section 13.11) states that no wet or dry rot or other decay or fungal growth in sleepers is permitted. This is a subjective assessment and therefore a sleeper may show signs of degradation, but still be considered as effective. However, post-derailment examination identified that a number of sleepers were rotten. It cannot be determined with certainty for how long the sleepers had been in a condition that allowed gauge-widening to occur. However, the initial WAIF entry in 2005 described the fault (at 25 miles 31 chains) as 'rotten sleepers' and photographic evidence from a previous (unrelated) derailment at Windsor and Eton Riverside in May 2008 showed sleepers in the vicinity of 25 miles 46 chains to be visibly rotten with vegetation growing through the centre of some of them. The sleepers visible in figures 9 and 10 show signs of the area being examined (removal of *ballast* between the sleepers). It has not been possible to identify who conducted this examination. The ballast between the sleepers should have been replaced after the examination (in accordance with Network Rail's standards).

*Figures 9 and 10 (inset): Condition of the sleepers at Windsor and Eton Riverside in May 2009 showing that some ballast has been removed in one area*

- 66 Standard NR/L2/TRK/001 mandates that up to six sleepers can be ineffective (not able to support or retain the gauge) within a 60 feet section (18 metres). No more than two consecutive ineffective sleepers are permitted. Each group of two ineffective sleepers must be separated by at least two other effective sleepers that are capable of maintaining gauge.

- 68 The ballast extended over some of the sleepers as well. The covering of the sleepers with ballast was contrary to the requirements of NR/L2/TRK/001 and prevented the patroller and Track Section Manager from inspecting the track to ensure its compliance and safe condition.
