Rail Accident Report

Overhead line failure, St Pancras International 23 September 2009

Overhead line failure, St Pancras International

23 September 2009

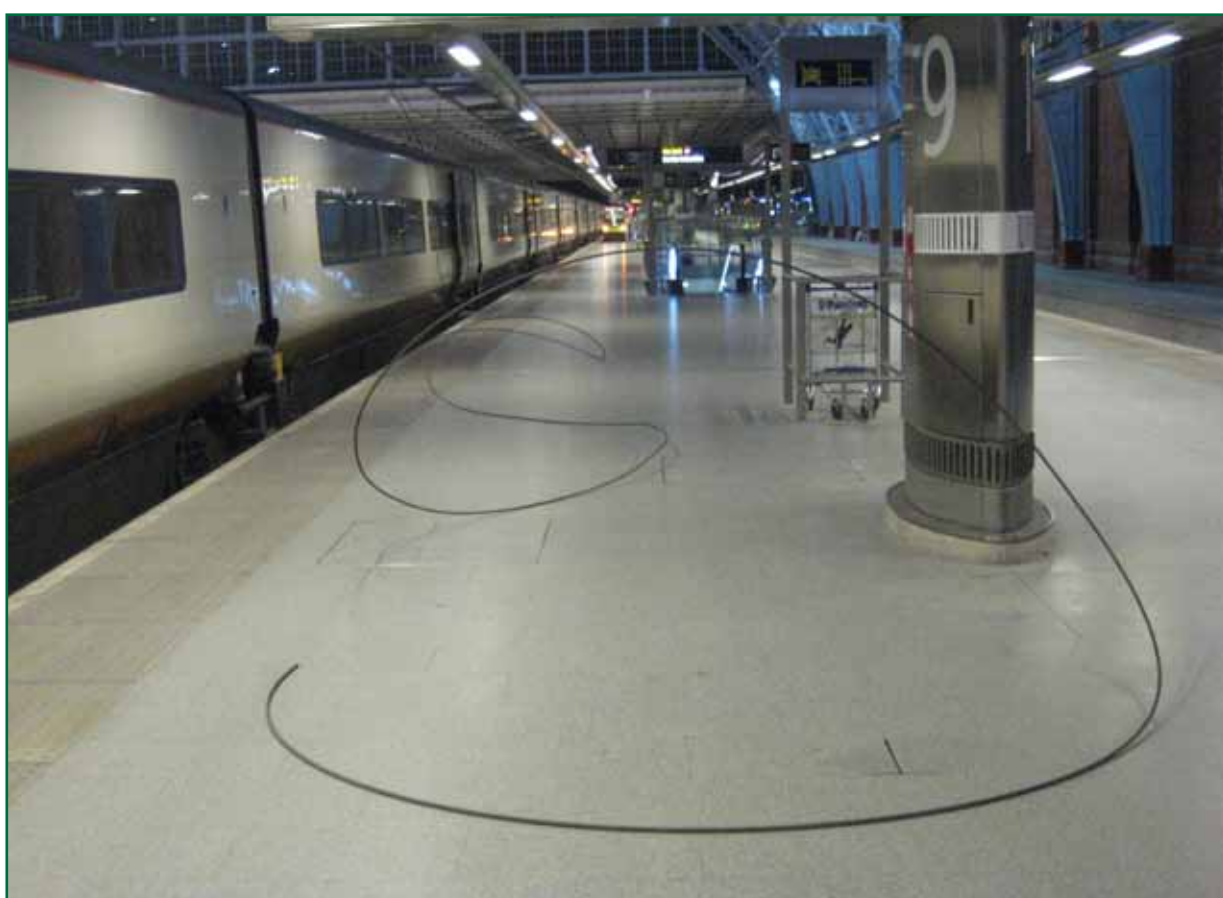
- 4 At approximately 18:35 hrs on 23 September 2009, the overhead wire supplying electric power to trains parted and fell onto the platform where passengers were leaving a Eurostar train which had just arrived at platform 9 of London St Pancras International station.
- 5 The supply system circuit breaker opened automatically to de-energise the wire, but the electrical controller made two attempts to re-energise the wire manually, in addition to the automatic reclosure of the supply system circuit breaker shortly after each automatic opening.

Figure 1: Photograph of displaced wire on platform (courtesy of Network Rail)

- 68 **The immediate cause of the incident was that the overhead line failed mechanically because of local overheating caused by high current flow.**
- 69 Data recordings of the supply system show that a current of 5200 amps had passed for 370 milliseconds. The voltage drop between the pantograph head and the wire is likely to have been of the order of 20 volts; this will produce 19.25 kilojoules of energy at each of the two contact points² between the pantograph and the wire, 38.5 kilojoules in total. This energy could only have passed as heat into the wire and the pantograph head. Since the train was stationary, the heat was concentrated at one point in the wire. This overheated the wire, caused it to start to melt and reduced its strength sufficiently for it to break.

- 70 Laboratory analysis of changes in the grain structure of the copper wire adjacent to the break shows that a temperature high enough to cause the underside of the wire to melt had been achieved. The melting of the wire reduced its effective cross section and the heating reduced the strength of the remaining section.

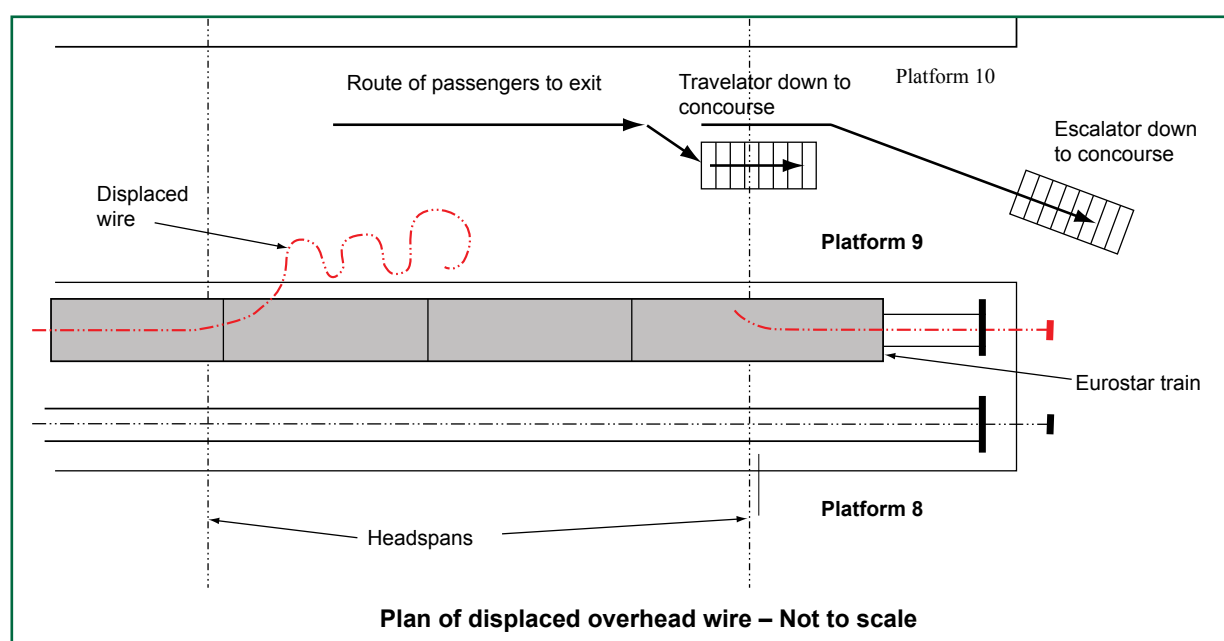
Figure 3: The route taken by passengers to leave the platform past the displaced overhead wire

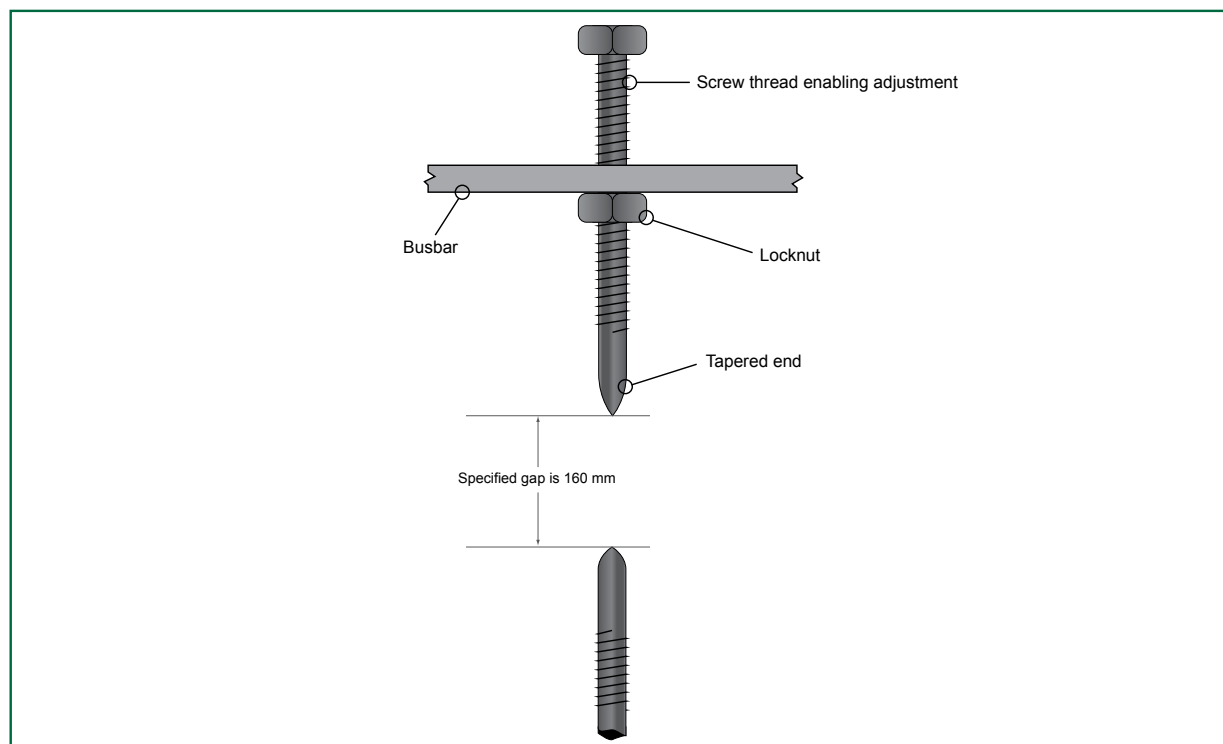
Figure 6: Arrangement for locating the upper electrode in the busbar

77 When the lightning arrester was examined after the incident there was erosion present, the lock-nut had fully wound down and the upper electrode was loose. If the electrodes had been in as-new condition, this position of the upper electrode would have produced a spark gap of 122 mm. The gap is specified to be 160 mm.

- 78 The electrode and busbar were subjected to vibration tests by mounting them firmly on equipment used to calibrate accelerometers. Vibrations were induced at varying frequencies to establish any conditions under which the electrode would move. Movement occurred when vibration between 180 and 250 Hz was applied and both the lock nut and the electrode would rotate and move downwards when a maximum acceleration of 0.2g was applied. This showed that, when the lock-nut was not correctly tightened, the electrode could rotate and move freely downwards.

- 79 The maintenance instructions specifically state that the spark gap is to be checked as being 160mm +/- 2mm, and adjusted as necessary, every six months. Its last scheduled examination before the incident was in April 2009, but the records of that examination have not been found. If the electrode had been adjusted and the lock-nut had not been tightened adequately, sufficient time would have elapsed to permit the nut to loosen and the electrode to move downwards.

- 80 One pantograph on power car 373016 had been changed on 12 March 2009. The pantographs are close to the section of the busbar where the lightning arrester is mounted. It is possible that that section of the busbar was disturbed during the pantograph change, the lock-nut was loosened very slightly and that at the examination in April the looseness was not found.

- 81 Eurostar initiated a special examination of the lightning arresters on all power cars, whether based in the UK, France or Belgium, to ensure that they are locked tightly at the correct separation. No other loose lock-nuts were found during this examination.

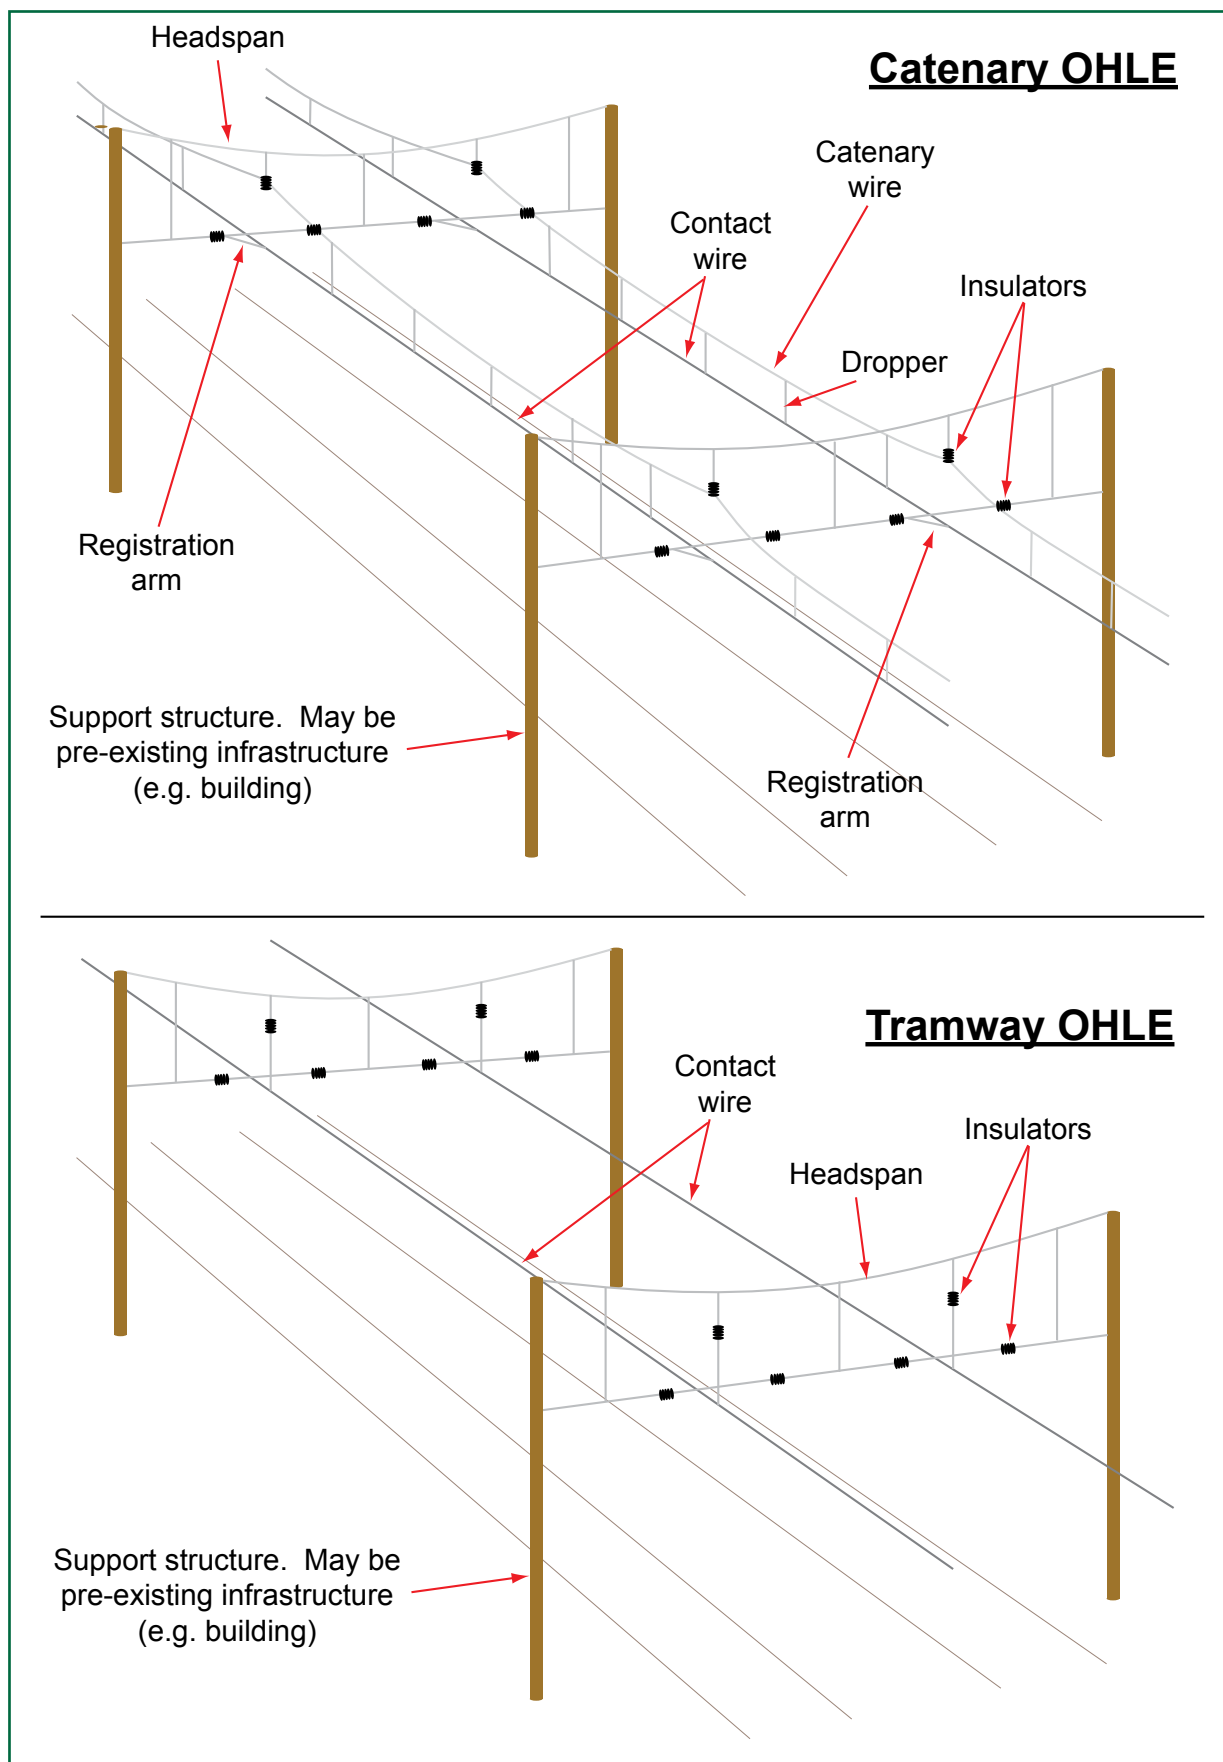
- 115 The 'tramway' OHLE provided no restraint to prevent the contact wire falling onto the platform once it had parted. This exacerbated the consequences of the failure and is therefore contributory.**
- 116 On HS1, OHLE installed above tracks other than at terminal platforms comprises a catenary wire and a contact wire. The catenary wire is supported at intervals and carries the weight of the assembly.
- 117 The contact wire is suspended from the catenary wire by vertical 'dropper' wires. It provides an approximately horizontal surface which the pantograph contacts to collect electric current. If the contact wire itself should part, then the length which falls is limited by the distance between adjacent dropper wires, which is not usually more than 10 metres.

- 124 If twin contact wires, connected to each other and each of the same cross section as the contact wire actually used, had been installed, the current density at the points of contact with the pantograph would have been halved. The heat input to each wire would also have been halved and it is possible that it would not have been sufficient to cause the wire to weaken and part.

Figure 7: Diagram showing the different types of OHLE
