Rail Accident Investigation Branch

Rail Accident Report

Collision on the Great Orme Tramway 15 September 2009

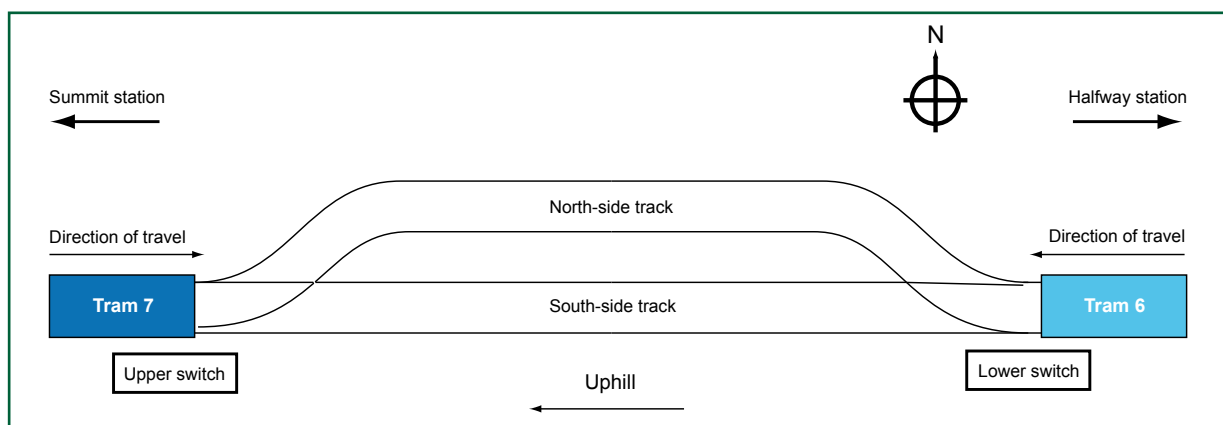
Figure 2: Plan of accident site

- 5 Tram 6 was travelling uphill and tram 7 downhill (figure 2). As tram 6 travelled over the lower *points* of the loop, its front *bogie* was correctly directed to the right-hand, north-side track, but its rear bogie was incorrectly directed to the left-hand, south-side track. Tram 7 was descending on the left-hand track and, although the braking systems of the winch and both trams were activated, the trams collided. The bodies of both trams were damaged in the collision (figure 3), but there was no damage to the infrastructure. The upper section of the tramway was closed for the remaining six weeks of the 2009 season.

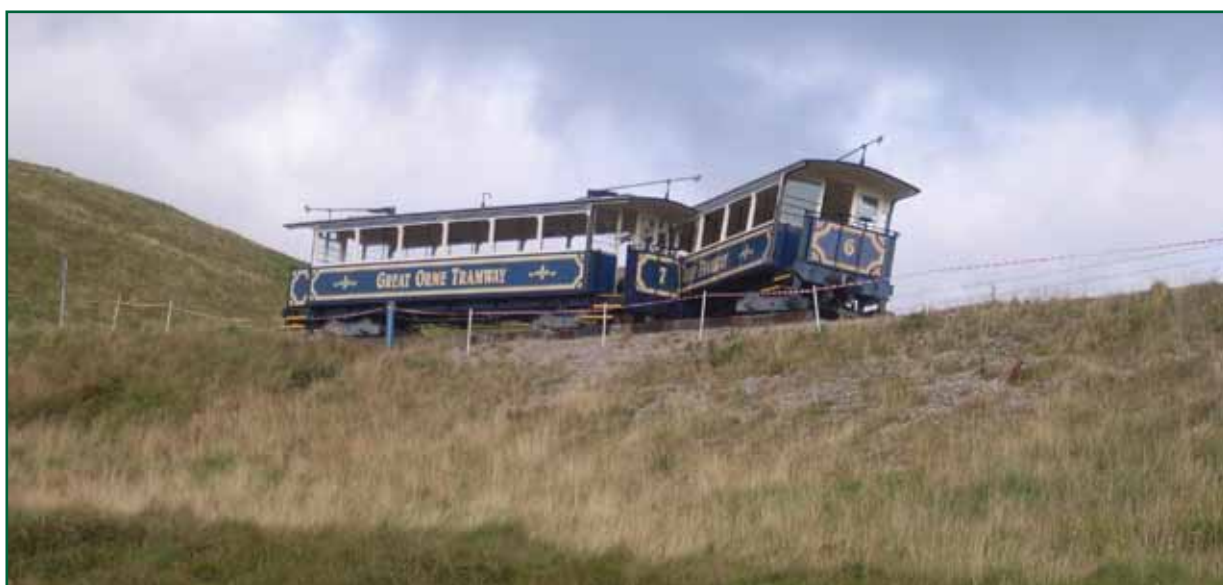
Figure 3: The trams after the accident

- 26 There was a minor injury to one person caused by debris.
- 27 All wheels of both trams remained on the rails until the collision when the wheels of the front bogie of tram 6 were derailed by the impact. The bodies of both trams were damaged, but there was no damage to the infrastructure.

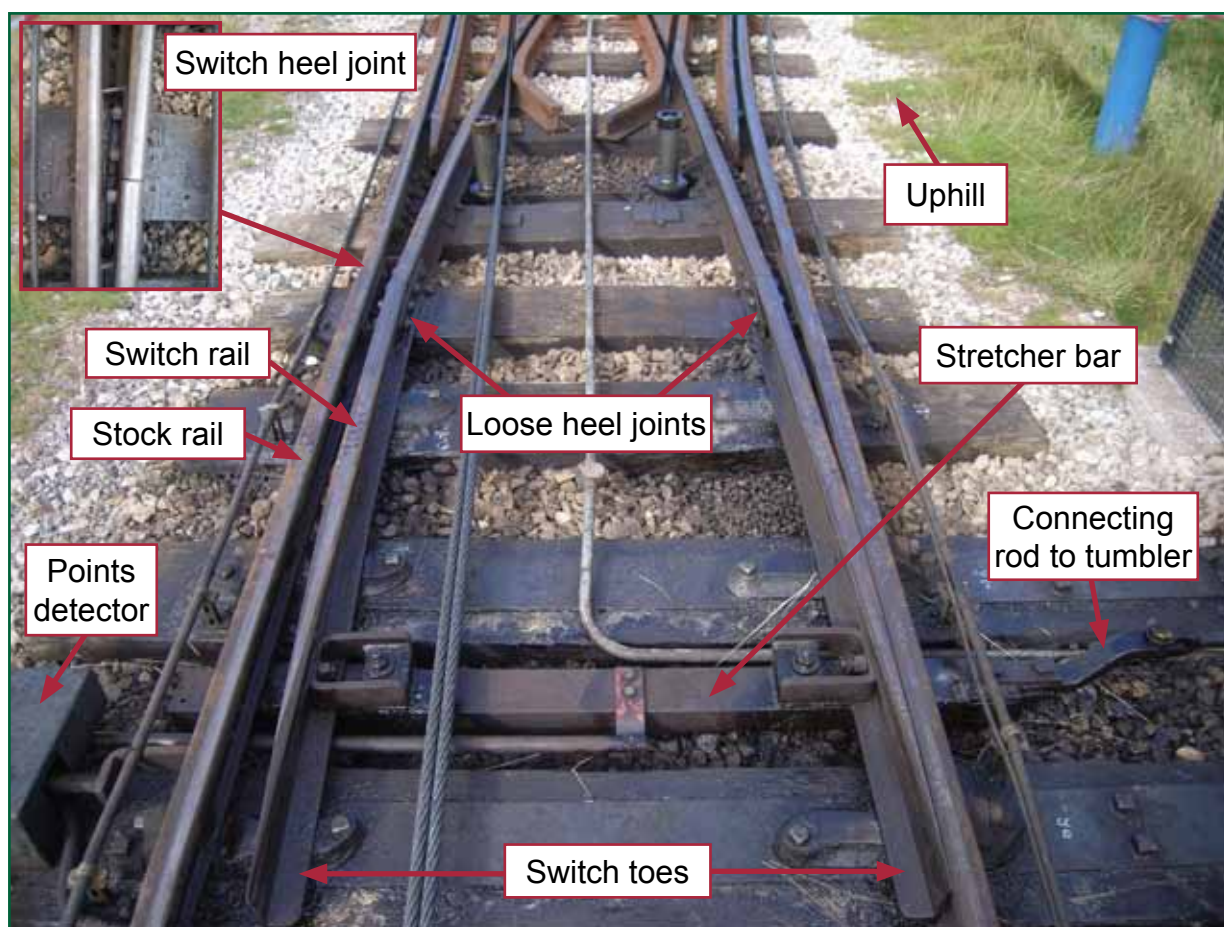
Figure 6: The lower points looking in an uphill direction

- 13 The points consisted of *loose heel switch* rails on timber *bearers*. A loose heel switch consists of switch rails that are hinged at the *heel*. This allows the rails' free ends (the *toes*) to be positioned for directing a tram to its intended route (figure 6).

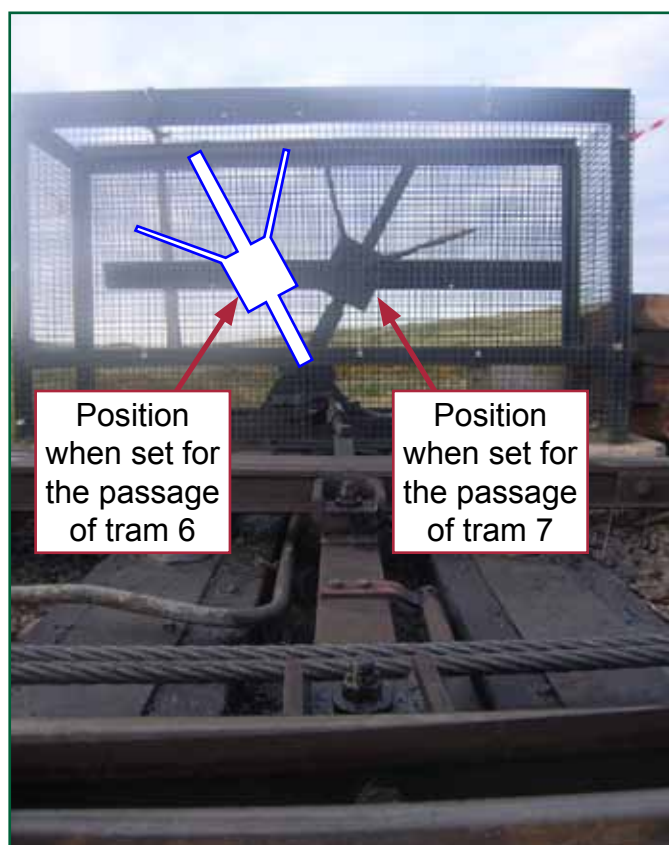
Figure 7: Tumbler weighted lever positions

- 14 The two switch rails of each point were connected together by a stretcher bar. The stretcher bar was connected to a track-side device, known as a tumbler, via a connecting rod. The tumbler was a mechanism that had a weighted lever. The lever was moved either side of its vertical position by the action of a tram leaving the loop (figure 7).

- 24 The trams did not stop immediately due to the delay in the monitoring system (paragraph 17) and in the control of the cable slack by the compensators (paragraph 9). The speed of each tram was less than 5 mph (8 km/h) at the point of collision.
- 25 After the accident the points and the tumbler were found to be in a position set for an uphill journey of tram 7 (figure 7).

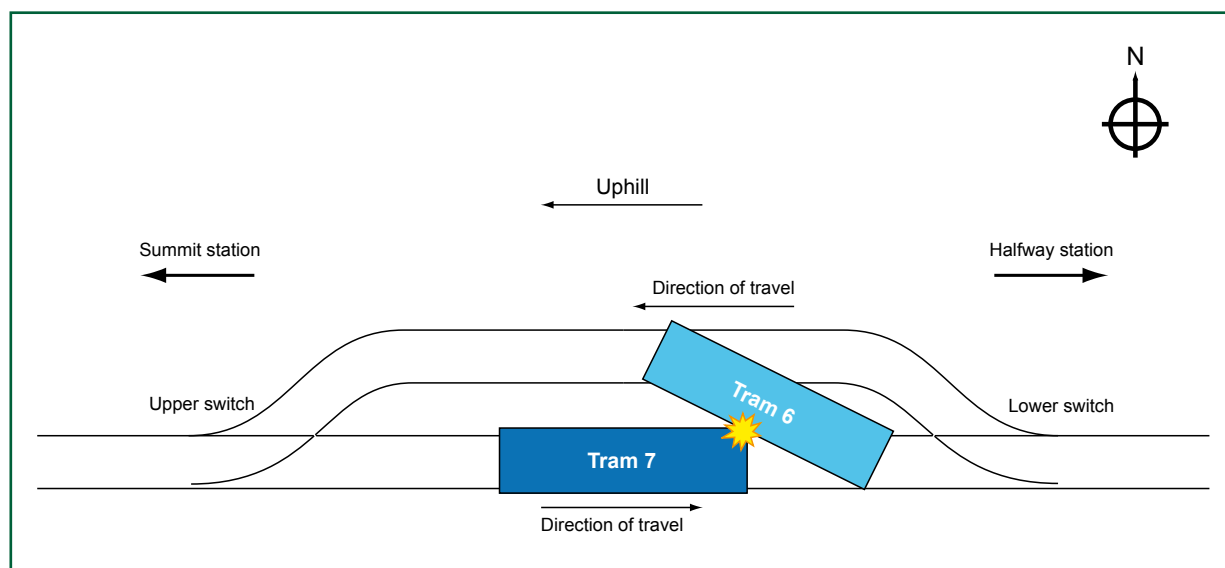
Figure 8: Positions of trams following the accident

- 22 The trams were travelling at around 5 mph (8 km/h) as each approached the loop. Tram 7 entered the loop via the upper points and was correctly directed to the south-side track. The front bogie of tram 6 was correctly directed to the north-side track by the lower points, but its rear bogie was directed to the south-side track and into the path of tram 7 (figure 8).

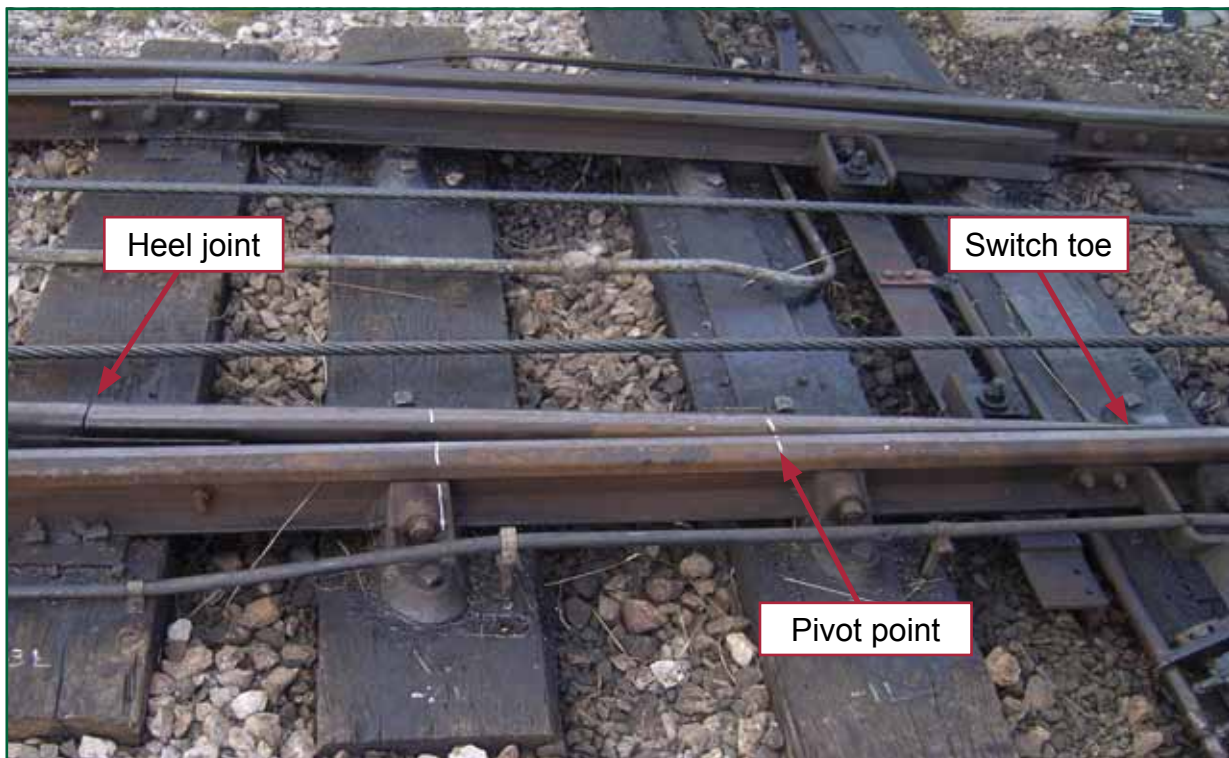
Figure 9: Left-hand switch and stock rails of the lower points

- 41 Tests conducted by the tramway's consultant found that the distance between the fully open switch rail and its *stock rail* was 98 mm (the toe opening). With the weighted lever moved from the position set for tram 6 to the vertical, the toe opening on the left-hand switch rail was recorded as 28 mm. With the weighted lever moved from the position set for tram 7 to the vertical, the toe opening on the right-hand switch rail was recorded as 43 mm. For a set of points and a tumbler which is balanced in both directions, it would be expected that these values would be approximately the same.

- 42 The force from the weighted lever tends towards its maximum when the lever is at one or other of its resting positions and reduces to zero when in a vertical position. The movement of the tumbler lever during these tests showed that there was sufficient energy from the wheels via the switch rails to accelerate the weighted lever towards a more vertical position and overcome its at-rest holding force.
- 43 RAIB observations showed that as the left-hand wheels of the leading bogie passed over the heel joint of the left-hand switch rail, the switch rail moved about a pivot formed by contact between the switch rail head and the adjacent stock rail head. This was at a point approximately half way along the switch rail (figure 9). The resulting switch rail deflection to the left at the heel led to the toes of the points moving to the right.

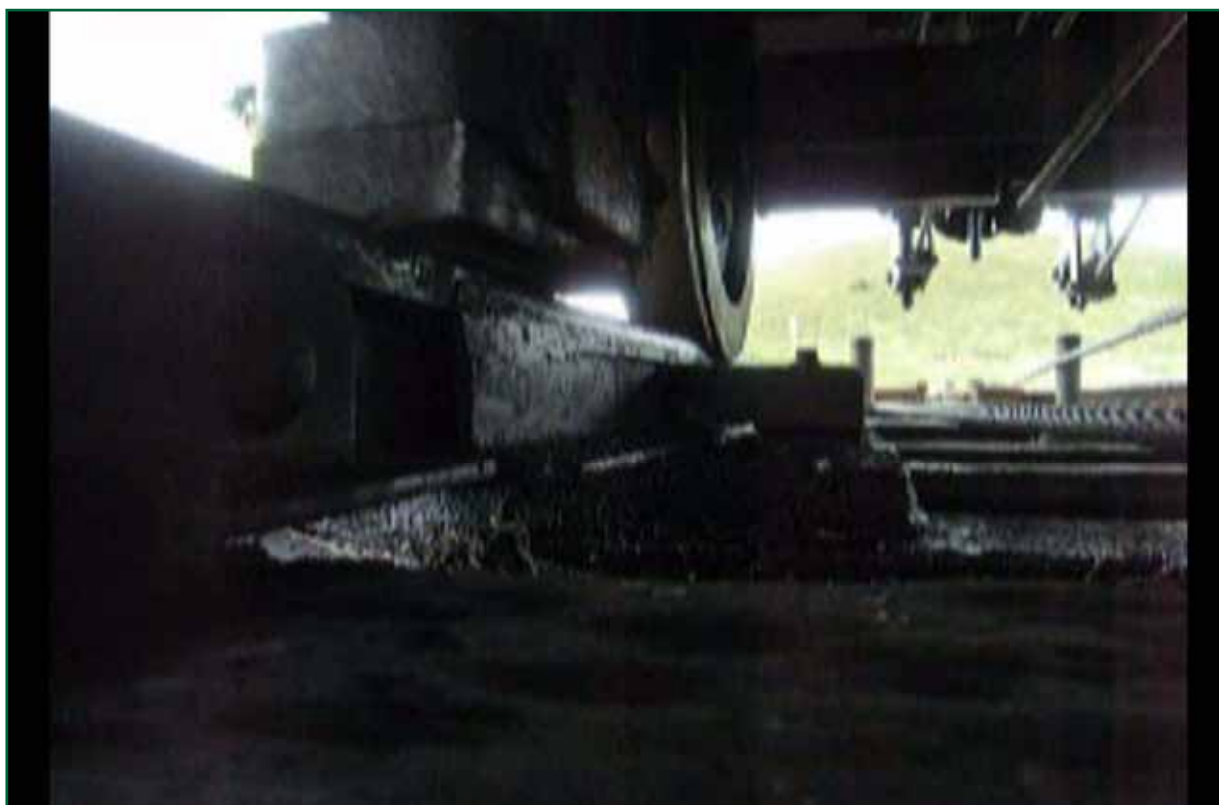
Figure 10: Flange contact between leading left-hand wheel and left-hand switch rail

- 47 The track geometry affected both the levels of rail forces and the way in which they overcame the holding force of the tumbler.
- 48 The alignment of the track changed significantly at the heel of the lower points in directing tram 6 to the right when travelling uphill, whereas the track for tram 7 followed a gentler left-hand curve. The RAIB video images of the tests showed that the left-hand leading wheel of the leading bogie was in flange contact with the left-hand switch rail before it reached the heel joint (figure 10). While flange contact is not an uncommon feature in tramway operations, it can result in high lateral rail forces. The change in geometry to the right at the heel area would have further increased this lateral force.

- 74 Over the closed period between October 2009 and March 2010, the tramway has undertaken remedial work on the upper loop, including:
- correcting the vertical alignment (cross-level and gradient) by lifting the track and adding approximately 70 tonnes of ballast;

- adding ballast retention boards to reduce the movement of ballast on the embankment;
 - correcting the lateral alignment of the track;
 - renewing deteriorated sleepers and bearers (paragraph 49);

- providing additional support to the heel areas of the points; and
 - measuring and overhauling the tumblers, including adding a variable length arm to allow the output force from the tumblers to be adjusted.
