Rail Accident Report

Fatal accident at Whitehall West junction, Leeds 2 December 2009

Fatal accident at Whitehall West junction, Leeds, 2 December 2009

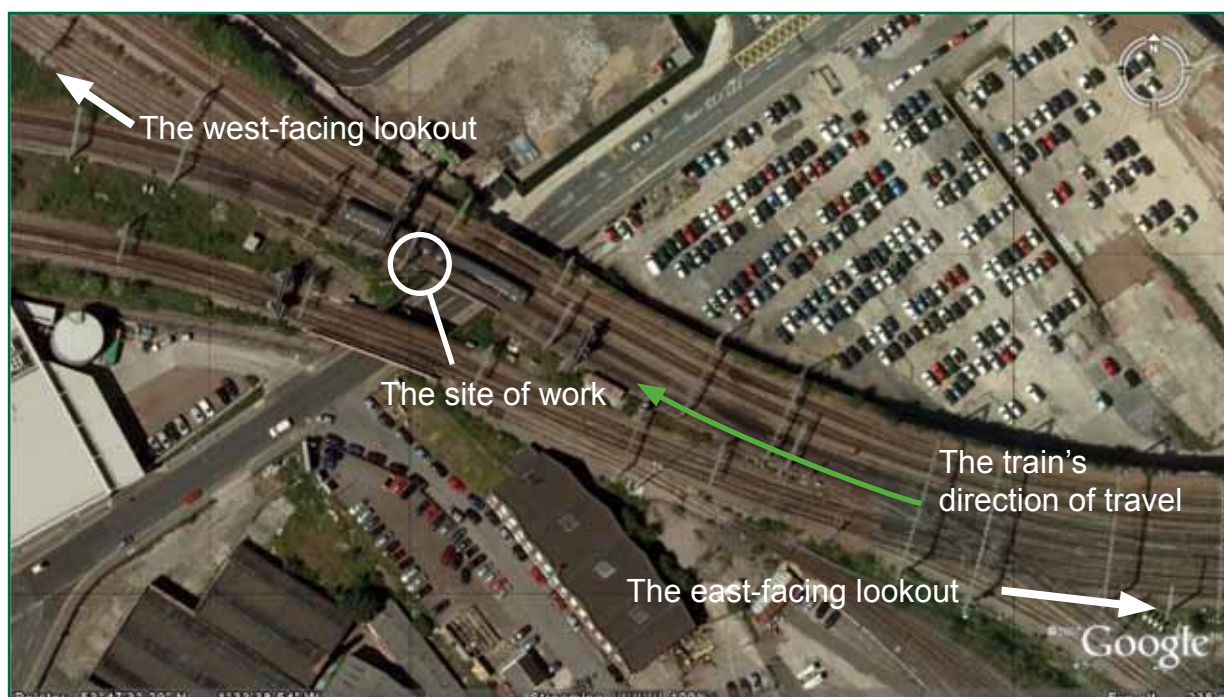
- 15 One of the track workers was assigned to be the 'controller of site safety' and in this role he was responsible for setting up and maintaining a safe system of work. He assigned two track workers to act as lookouts sighting for trains approaching the site of work from east and west respectively and a third track worker to act as site lookout (see figure 3).

Figure 3: The positions of the east and west-facing lookouts and the worksite (Courtesy of Google Earth)

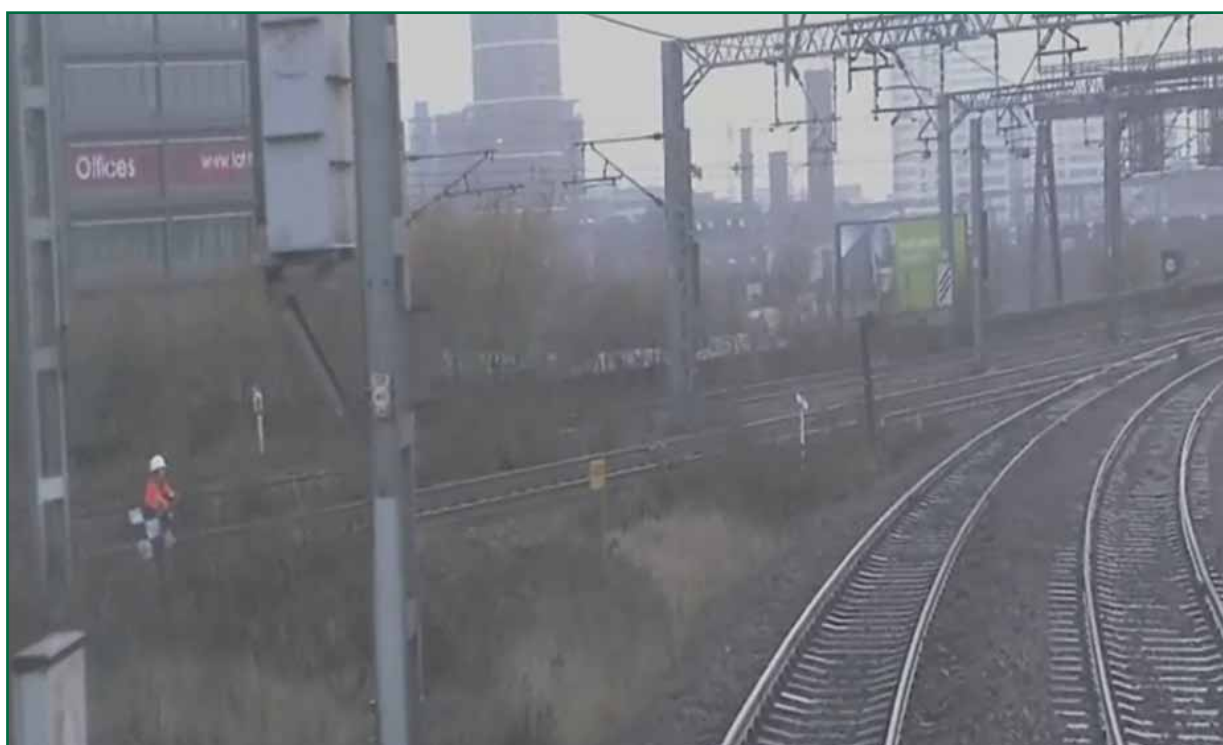
- 20 Figure 4 is a still image taken from the forward facing video camera of the 06:35 hrs London King's Cross to Leeds service as it approached the site of work at 08:52 hrs; it shows the west-facing lookout a short time after he had acknowledged the train's horn warning. Unit number 333013, the train involved in the accident, was not fitted with a forward facing camera.

Figure 4: The west-facing lookout viewed from the Leeds-bound train

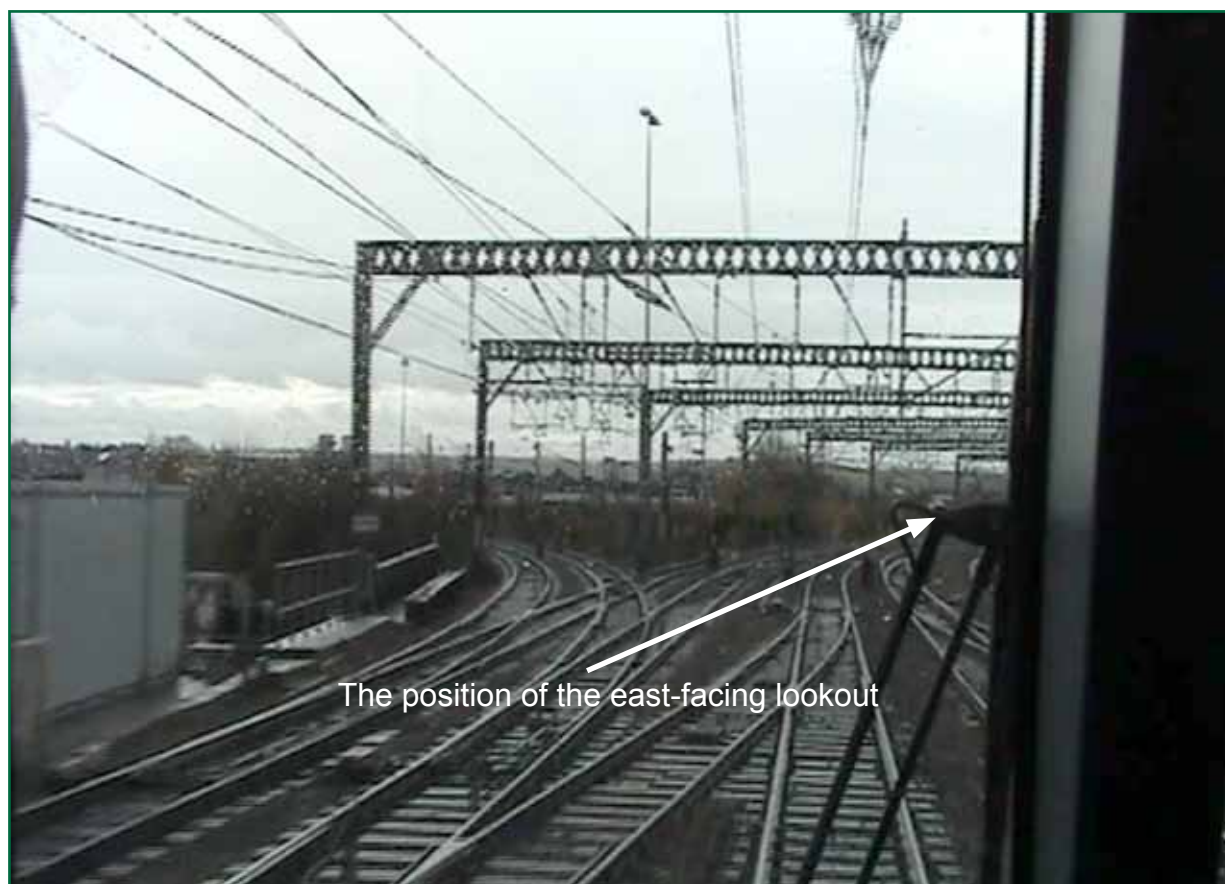
- 26 The trainee saw the east-facing lookout and sounded the warning horn at 09:36:53 hrs, 56 seconds into the journey and as the train curved to the right; the east-facing lookout acknowledged the warning by raising one arm and waving his blue and white flag. The trainee and supervisor drivers could not see the work group or the west-facing lookout at this location as they were obscured by track curvature, vegetation, overhead line equipment and the cab's structure (figure 8).

Figure 8: The driver's view when he saw the east-facing lookout and sounded the train's warning horn

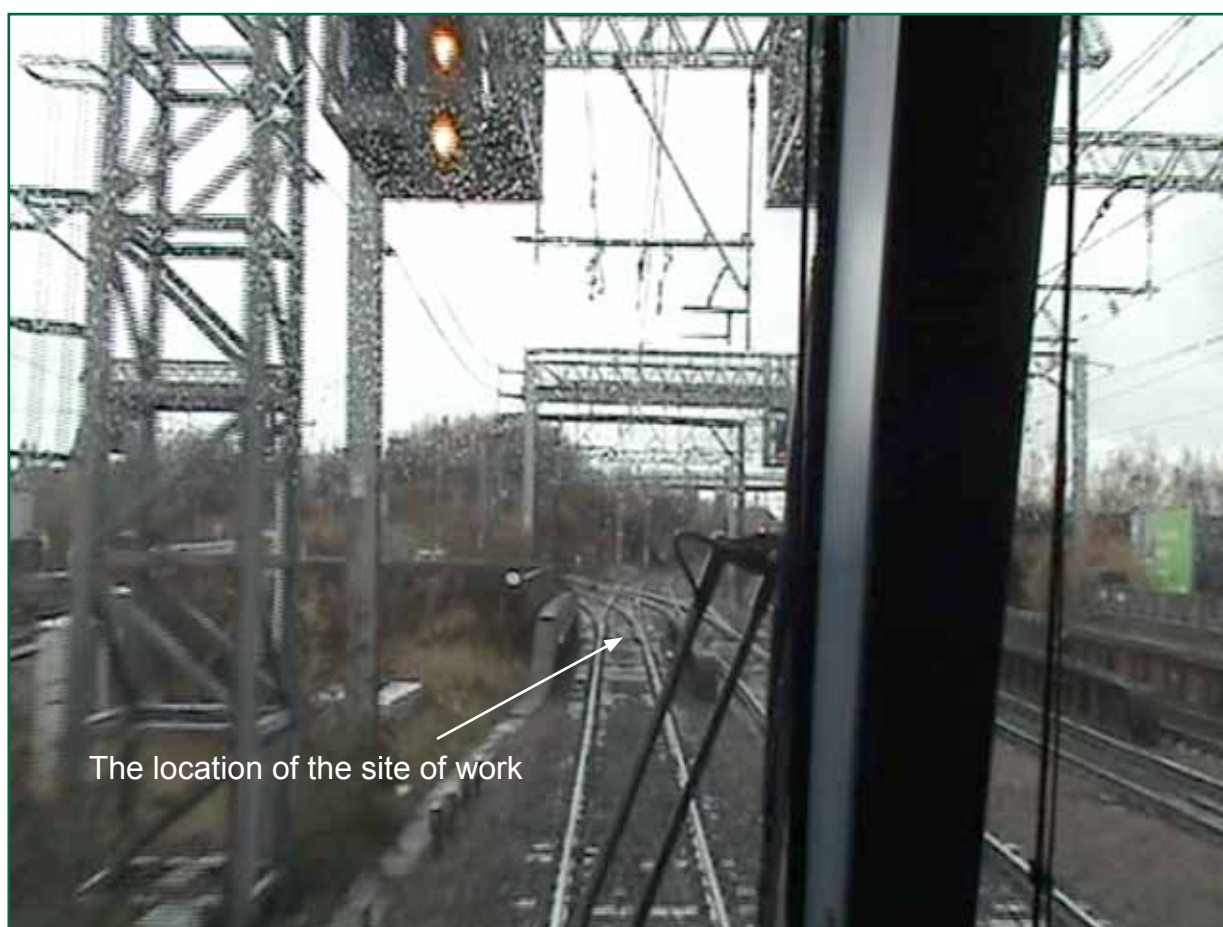
Figure 9: The driver's view on the approach to the site of work

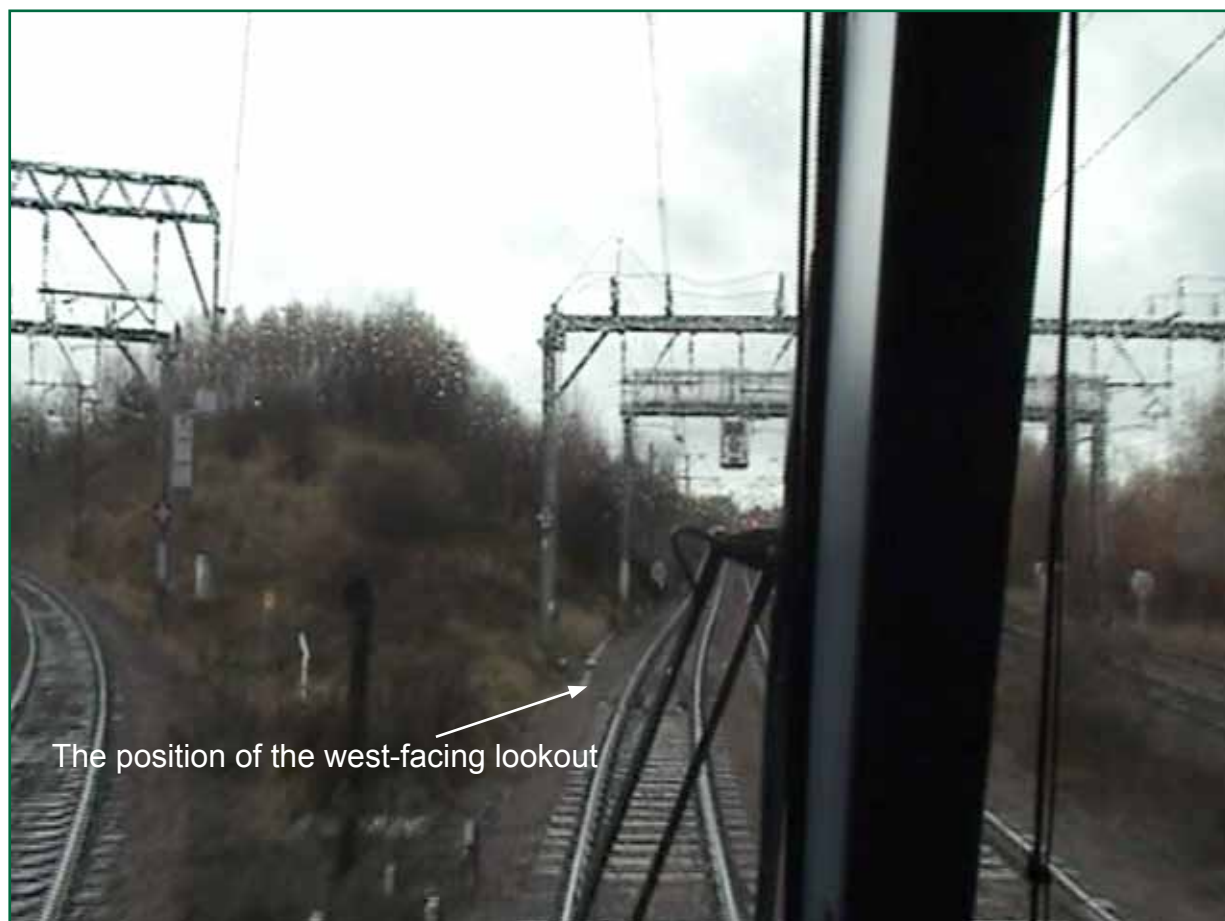
- 30 At 09:37:32 hrs the train was travelling at 24 mph (39 km/h) and was approximately 10 metres from the west-facing lookout when the trainee remarked that he looked close to the line; neither he nor the supervisor had time to react as the west-facing lookout was struck approximately a second later; the lookout faced west, away from the train and had not moved throughout its approach (figure 10).

Figure 10: The driver's view of the west-facing lookout

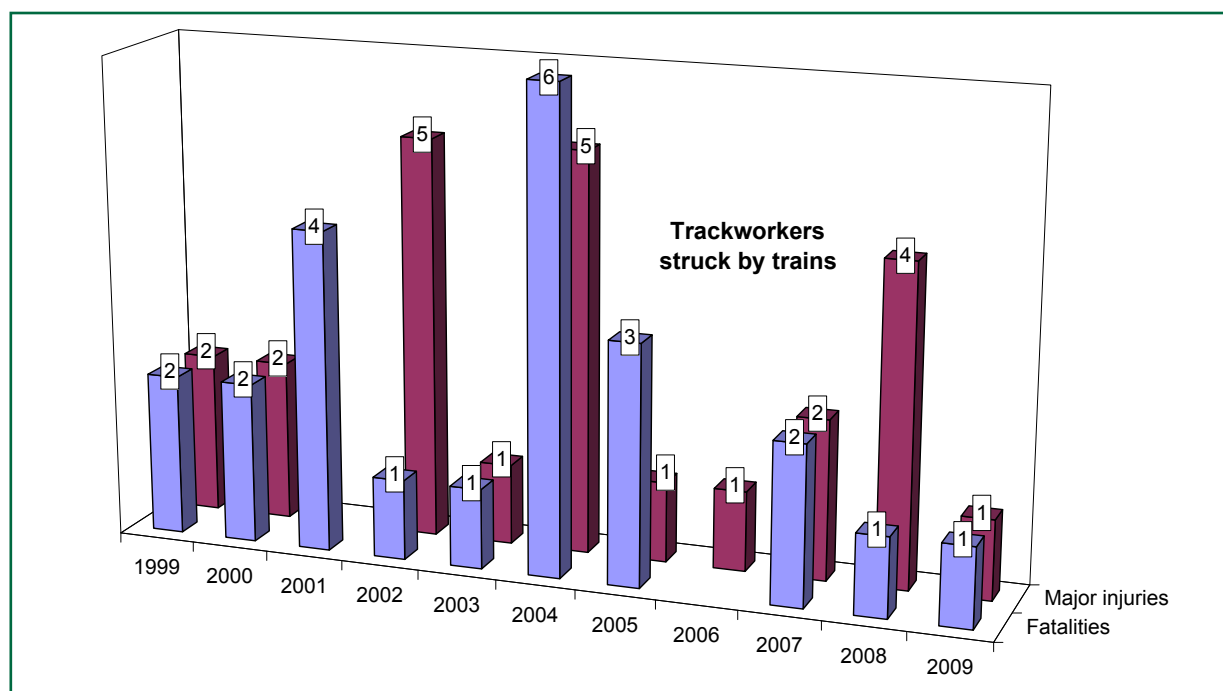
- 38 Figure 11 summarises the accidents in which trains struck track workers resulting in fatalities and major injuries in years 1999 to 2009. These accidents are described in RAIB report 30/2009 into the accident at Dalston junction and so they are not described again in this report. Figure 11 shows that in this period:

- Trains struck and killed 23 track workers, four of whom were acting as lookout at the time of the accident. These accidents happened on 10 October 2000 at Bradford Mill Lane, on 18 July 2001 at Purley Oaks, on 5 April 2005 at Newbridge and on 2 December 2009 at Whitehall West junction.

- Trains struck 24 track workers who sustained major injuries, one of whom was acting as a lookout. This accident happened at Dalston junction on 30 March 2009 and is the subject of RAIB report 30/2009.

Figure 11: Track worker fatalities and major injuries. Information courtesy of the Rail Safety and Standards Board

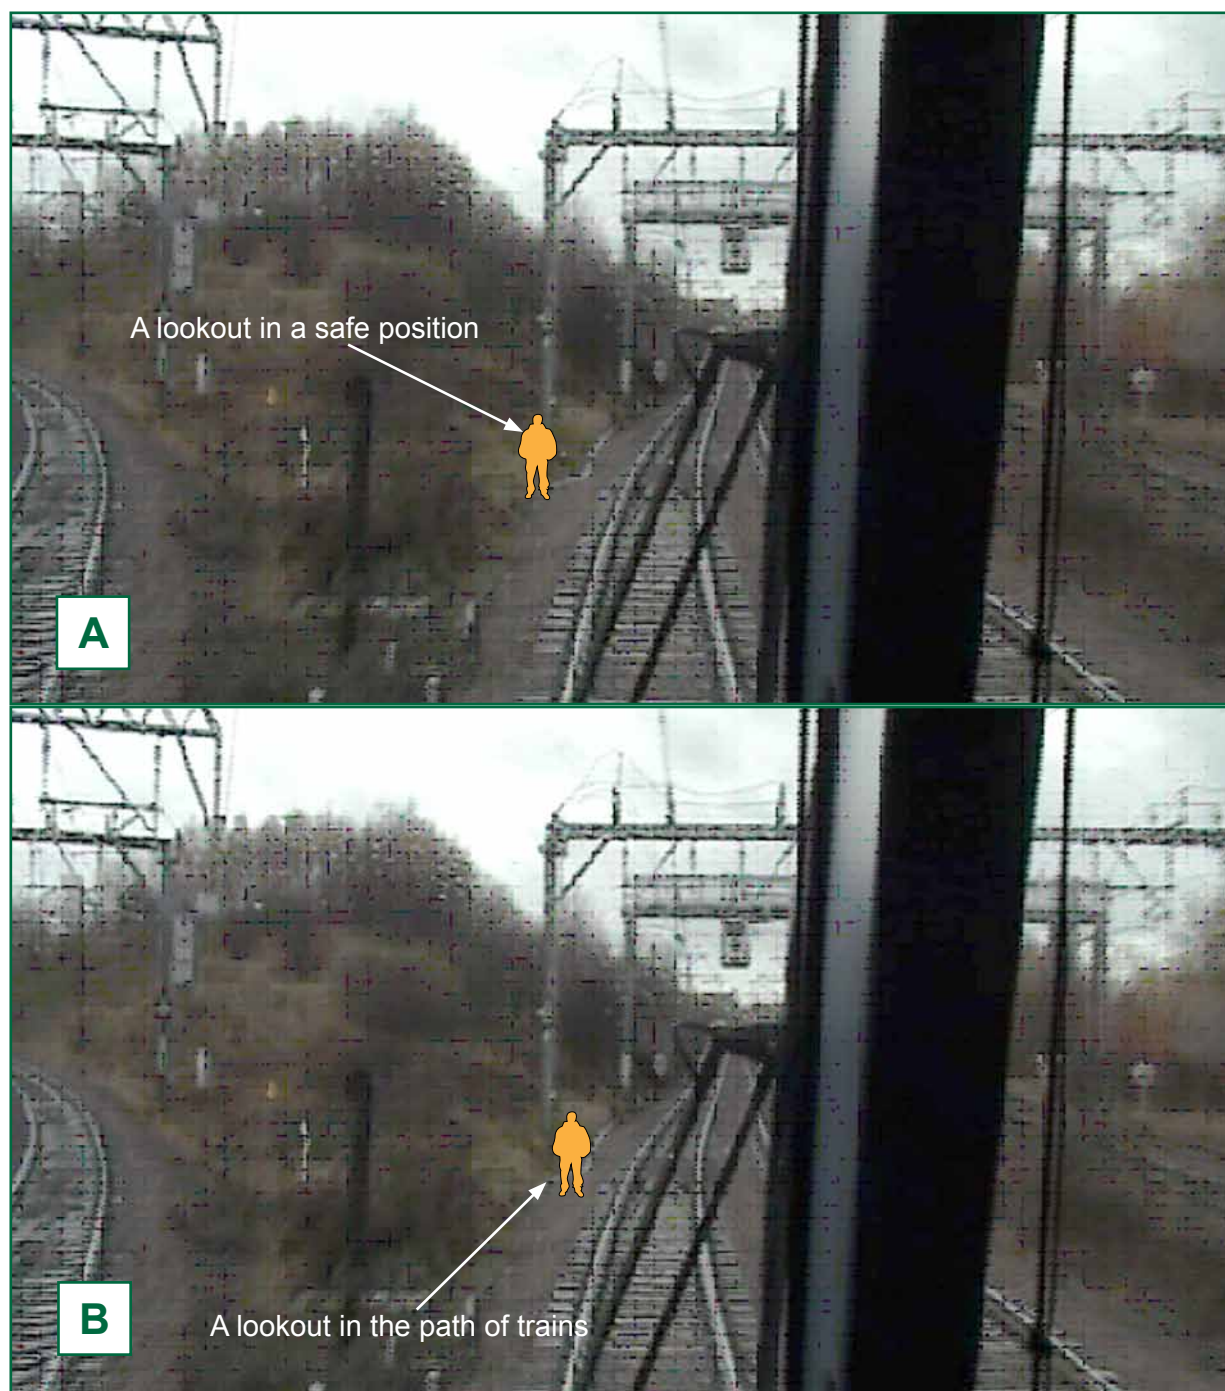
- 60 The train was approximately 10 metres from the west-facing lookout when the trainee remarked that he appeared to be close to the line. Figure 12 is a reconstruction of the trainee driver's view from the cab at this location. It shows, to scale, a figure representing a lookout in a safe position and another in the path of trains; both may appear to be safe positions because of the figures' nearness to curved track and overhead line equipment which is clear of passing trains.

Figure 12: The view from the cab showing a lookout in a safe position (A) and in the path of trains (B)
