# Rail Accident Report

**Fatal accident at Halkirk level crossing,  
Caithness  
29 September 2009**

# Fatal accident at Halkirk level crossing, Caithness, 29 September 2009

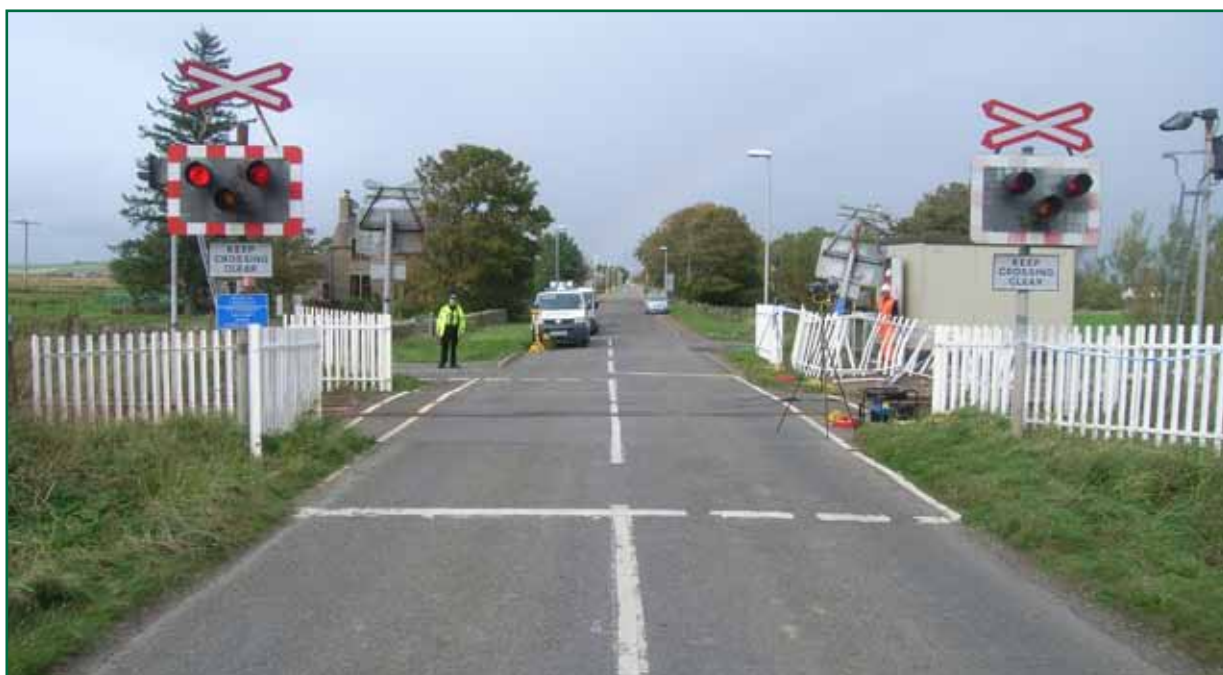
Figure 3: Halkirk level crossing from the south

- 33 The train hit the rear of the car leaving vertical indentations caused by the train's gangway on the nearside rear passenger door and roof. The impact caused the car to rotate in an anti-clockwise direction when viewed from above and be pushed into steel picket fencing and the post supporting the road traffic light signals at the north-east corner of the crossing (figure 3).

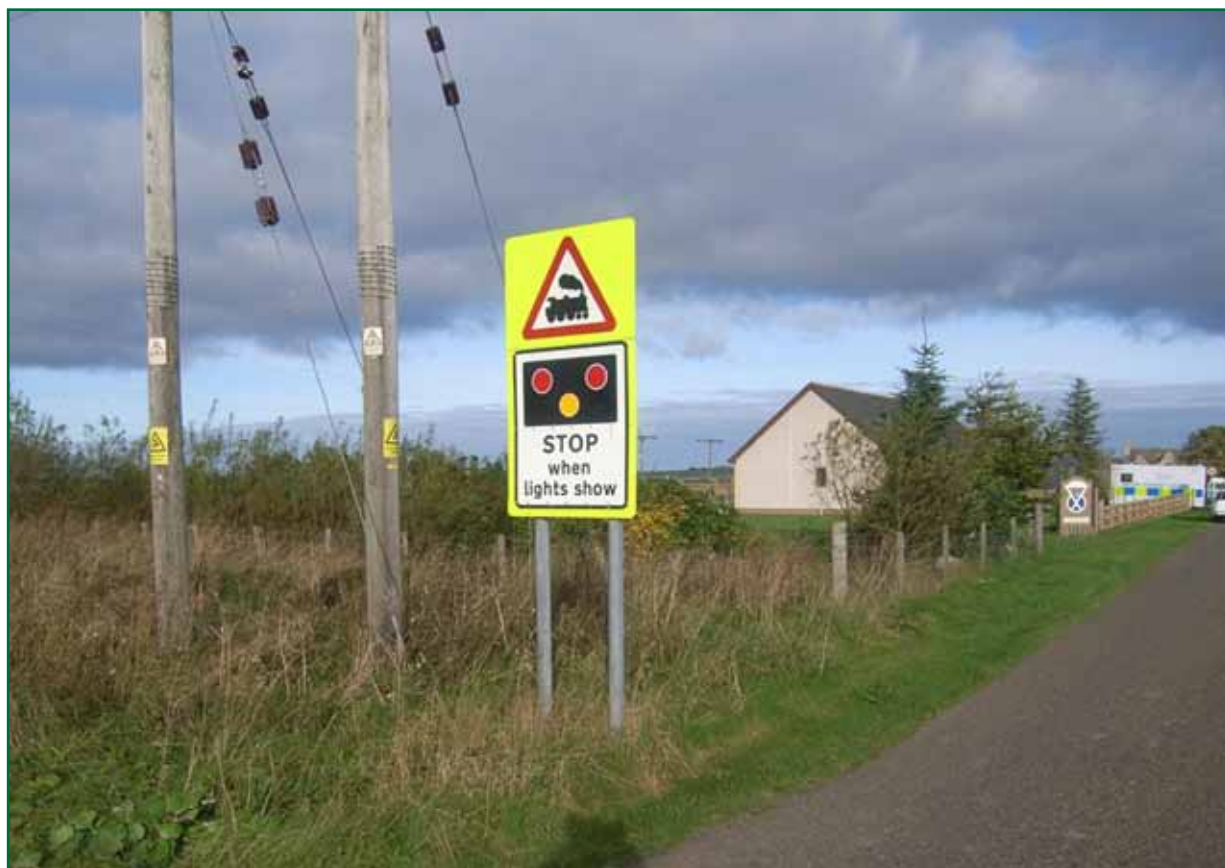
Figure 4: Signage on the approach to Halkirk level crossing

- 132 The optical tests (paragraph 41) found that with the sun position as it existed at the time of the accident, the standard hoods fitted to the red light units of the road traffic light signals (figure 4) were more effective than would have been the case had long hoods been fitted. With standard hoods, a high level of contrast was measured between the lit and unlit red light units with only a small area of each light unit affected by sunlight (figures 8a and 8b). This contrast would have been reduced with long hoods because the light from the sun in the position it was at the time of the accident would have struck a larger area of the lens, because a long hood has more open sides than a standard hood. Long hoods are therefore not more effective in mitigating the effect of sunlight falling on the road traffic light signals for all sun angles.

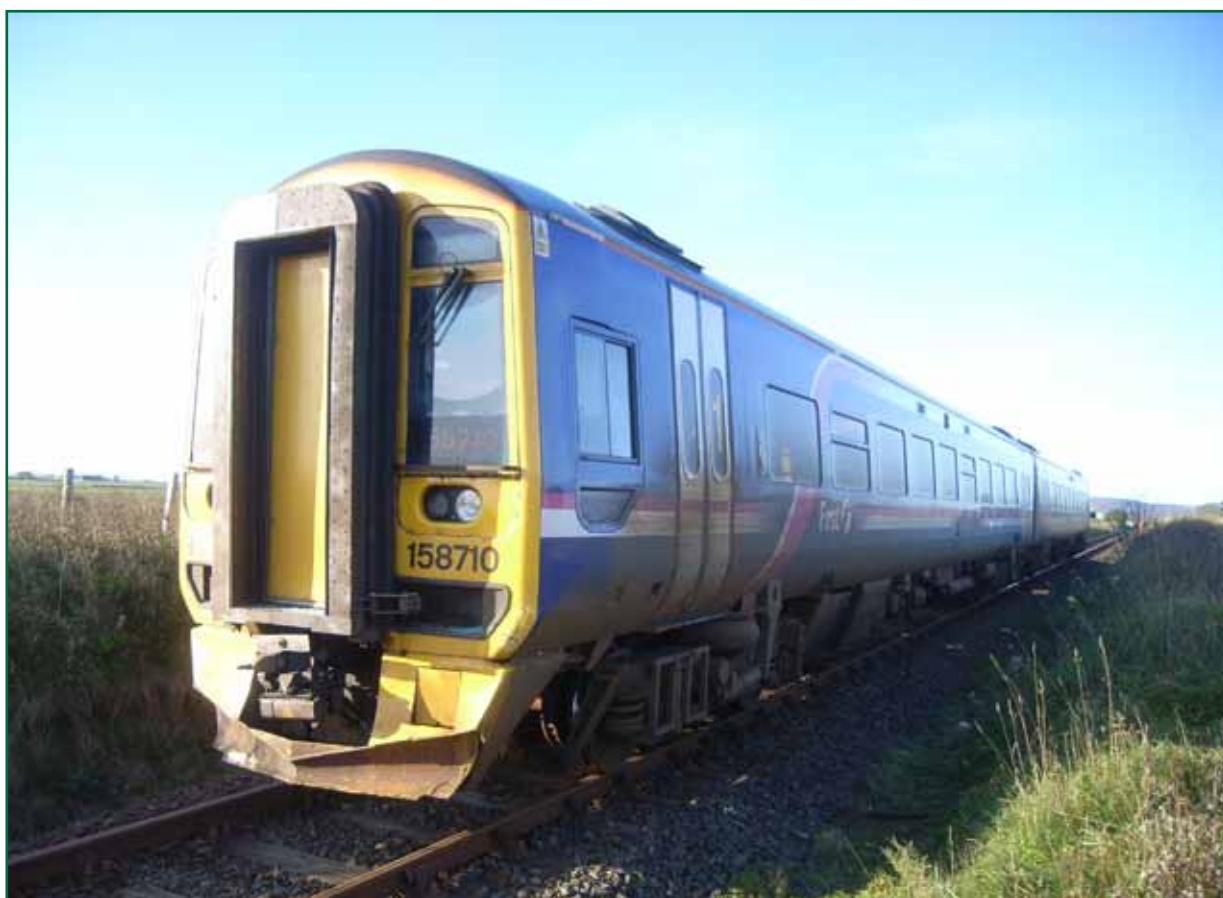
- 37 The three occupants of the car were fatally injured and the car was severely damaged on its nearside.
- 38 The train sustained minor damage to its front end, particularly the coupling. There was also some bodywork damage, the most serious of which was the hole in the left-hand side of the leading coach caused by the second impact with the car (figure 6).
- 39 Level crossing equipment on the north side of the crossing was damaged by the impact of the car.

Figure 6: The train involved in the collision at Halkirk level crossing

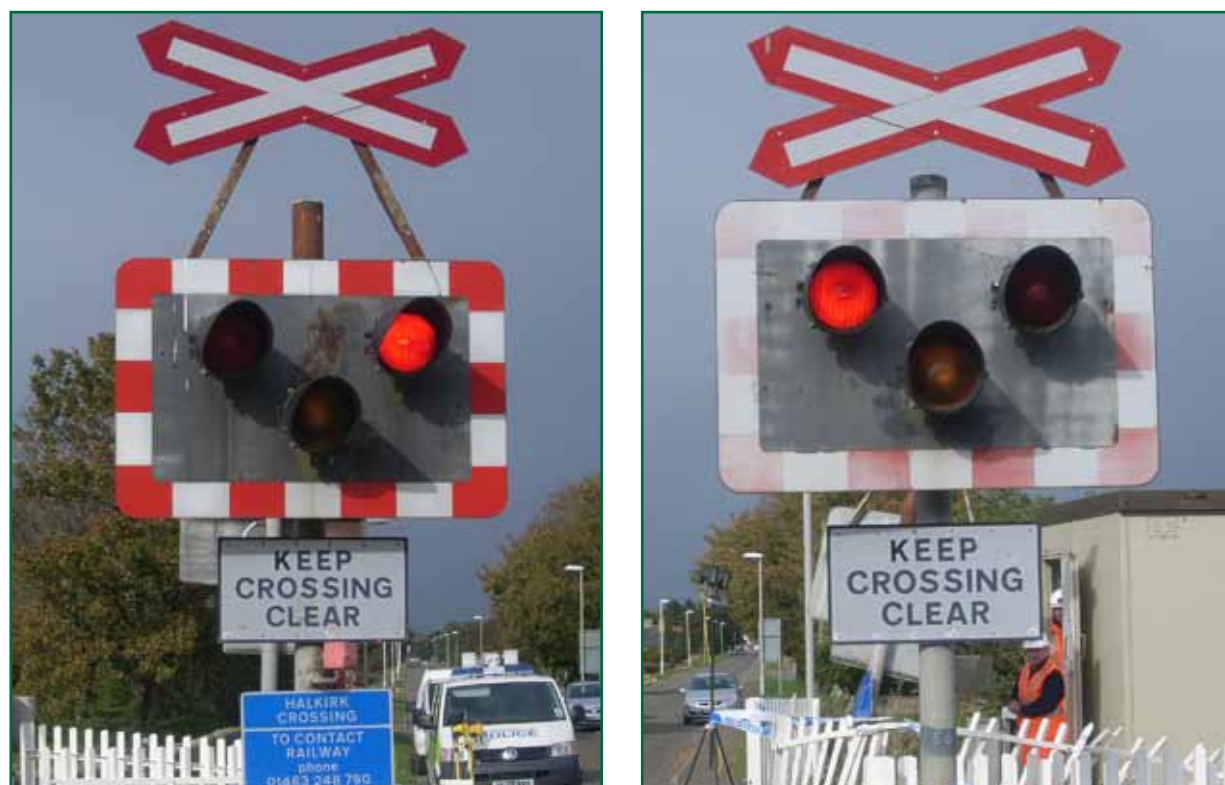
- 76 The matt black backboards and chequered surrounds (particularly the offside backboard) were faded and unable to prevent the reflection of sunlight (figure 7). The expert's view was that this would have been tolerable for a vehicle driver with normal eyesight.
- 77 The poor condition of the backboards, in combination with falling sunlight, reduced the conspicuity of the lights to any approaching road vehicle. Although unlikely to have significantly affected someone with standard eyesight, this was of particular significance to a road vehicle driver with sub-standard eyesight and a greater susceptibility to the effect of glare.

Figure 7: Condition of road traffic light signals, Halkirk crossing, south side

- 80 However, the optical tests found that the condition of the backboards was such as to reduce the amount of contrast between the lit red light units and the areas of the backboards, an effect that was more significant in the case of the right-hand backboard. This reduced the conspicuity of the lights.

- 81 Network Rail's routine inspection of 22 April 2009 (Appendix D, paragraph 27) noted that both the south side road traffic light signal chequered red and white borders were unsatisfactory: the nearside backboard was starting to rust and the off side backboard was faded. The defect was allocated a priority in accordance with Network Rail's procedures for the work to be completed within six months. A work arising form was completed on 24 April 2009 for action by the signal maintenance function. Remedial action was not taken before the next inspection, and the same defects were noted at the following inspections on 2 June and 21 July 2009. New work arising forms were completed duplicating the one that had been completed on 24 April 2009 and allocating the same priority for the work to be completed within six months.

- 1 *The intention of this recommendation is that Network Rail should maintain the backboards fitted to road traffic light signals at level crossings so as to maximise the contrast between the lit red light unit and the backboard.*

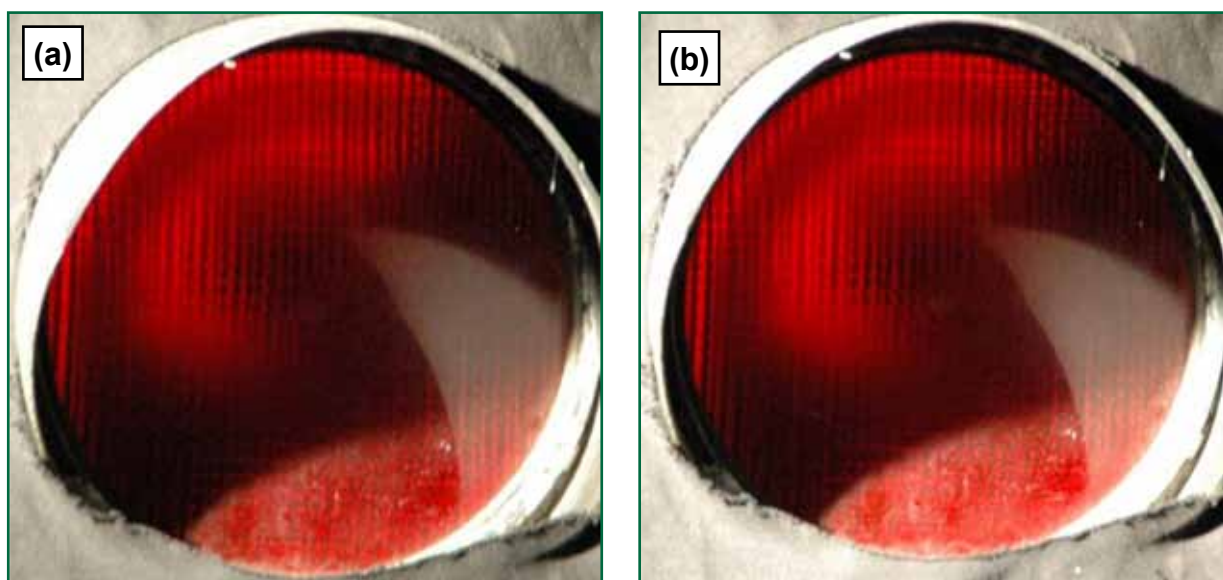
- 78 Figure 8 shows the effect of sunlight on the road traffic light signals, with the sun in the same position as it was at the time of the accident. This effect was investigated further with respect to the condition of the backboards and the amount of *contrast* between them and the lit red light units of the road traffic light signals. The difference long hoods would have made, had they been fitted, was also investigated.
- 79 The optical tests (paragraph 41) carried out found that only a small area of each lit red light unit would have been affected by sunlight at the angles associated with viewing the lights at the time of the accident (figure 8). These show a small crescent at the base of the lens and an arc shaped reflection from inside the hood. Therefore, the effect of sunlight swamping the red light units was not likely to have been a significant factor.

Figure 8: The effect of sunlight on the near side road traffic light signal red light units during tests from (a) 100 metres and (b) 50 metres

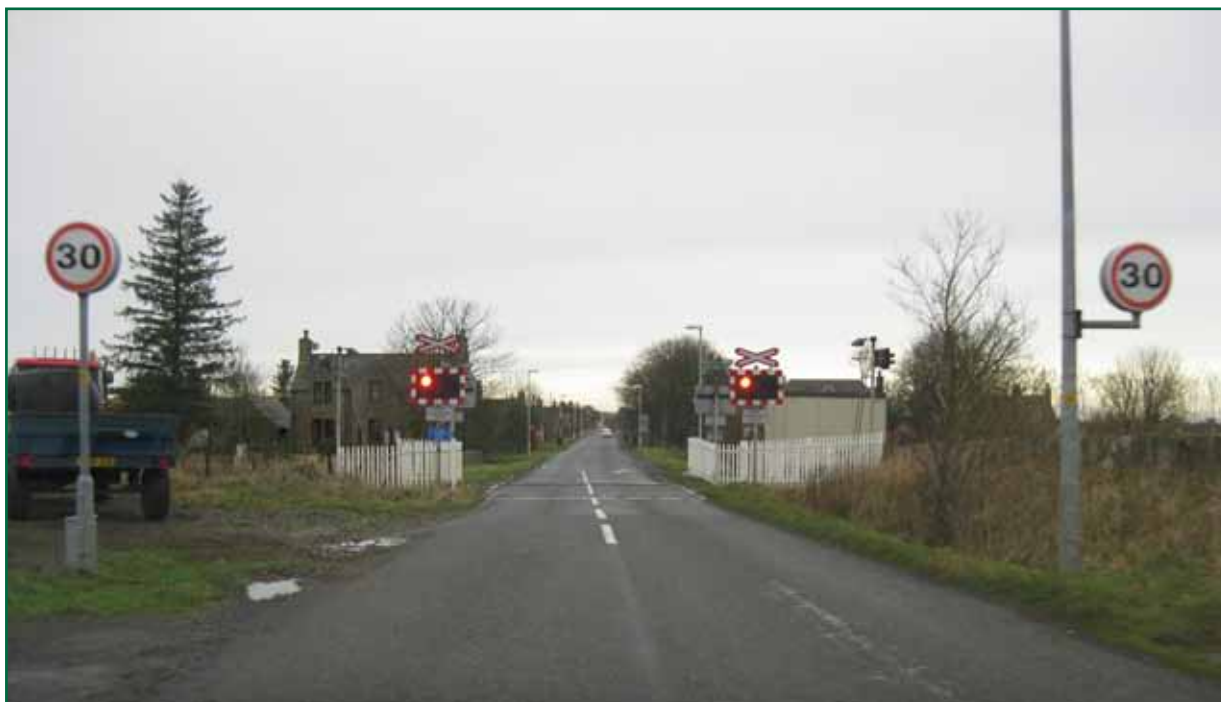
- 88 The specialist human factors consultant commissioned by the RAIB advised that the commencement of the 30 mph (48 km/h) speed limit close to the crossing on the south side (figure 9) could be a distraction to motorists approaching the crossing. This proximity of the speed limit signs to the crossing might reduce the attention given to the crossing, or remove attention away from it completely. The signs might also draw a car driver's attention to the vehicle speedometer to check vehicle speed and away from maintaining vision out of the vehicle's windscreen. Other signs in the vicinity of a level crossing that are not related to that crossing could also be a potential distraction.

Figure 9: the 30 mph signs at Halkirk crossing (taken after the accident and the renewal of the road lights to the LED type)

- 2 *The intention of this recommendation is that Network Rail should take into account the human factors issue of highway speed limit and other signs positioned close to level crossings while assessing the risk.*

Network Rail should consider amending the level crossing risk management toolkit to include the human factors issue and associated risk reduction measure relating to the potential distraction caused by highway speed limit signs and other signs positioned close to level crossings (paragraph 135c).
