Rail Accident Report

Failure of Bridge RDG1 48 (River Crane) between Whetton and Feltham 14 November 2009

Failure of Bridge RDG1 48 (River Crane) between Whitton and Feltham 14 November 2009

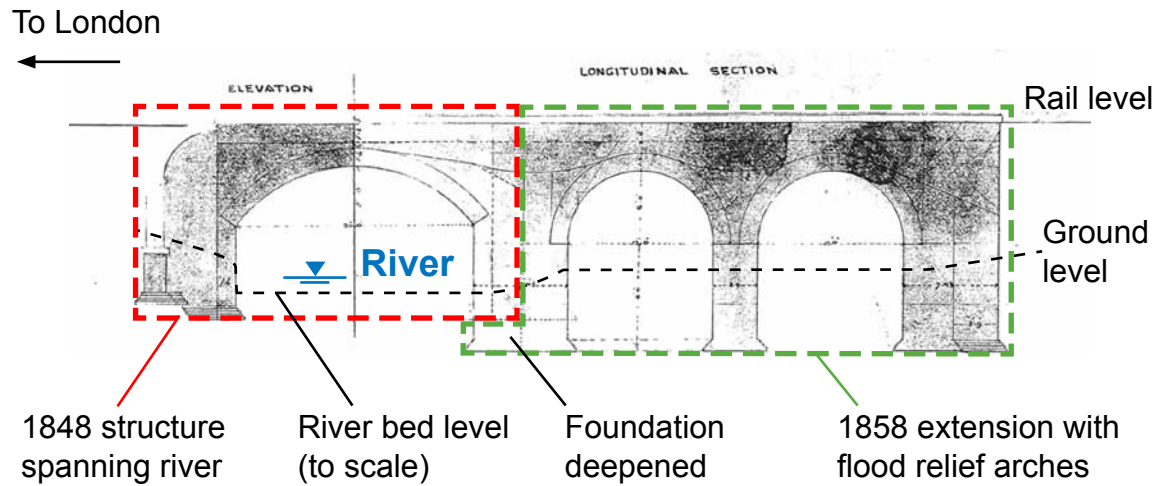
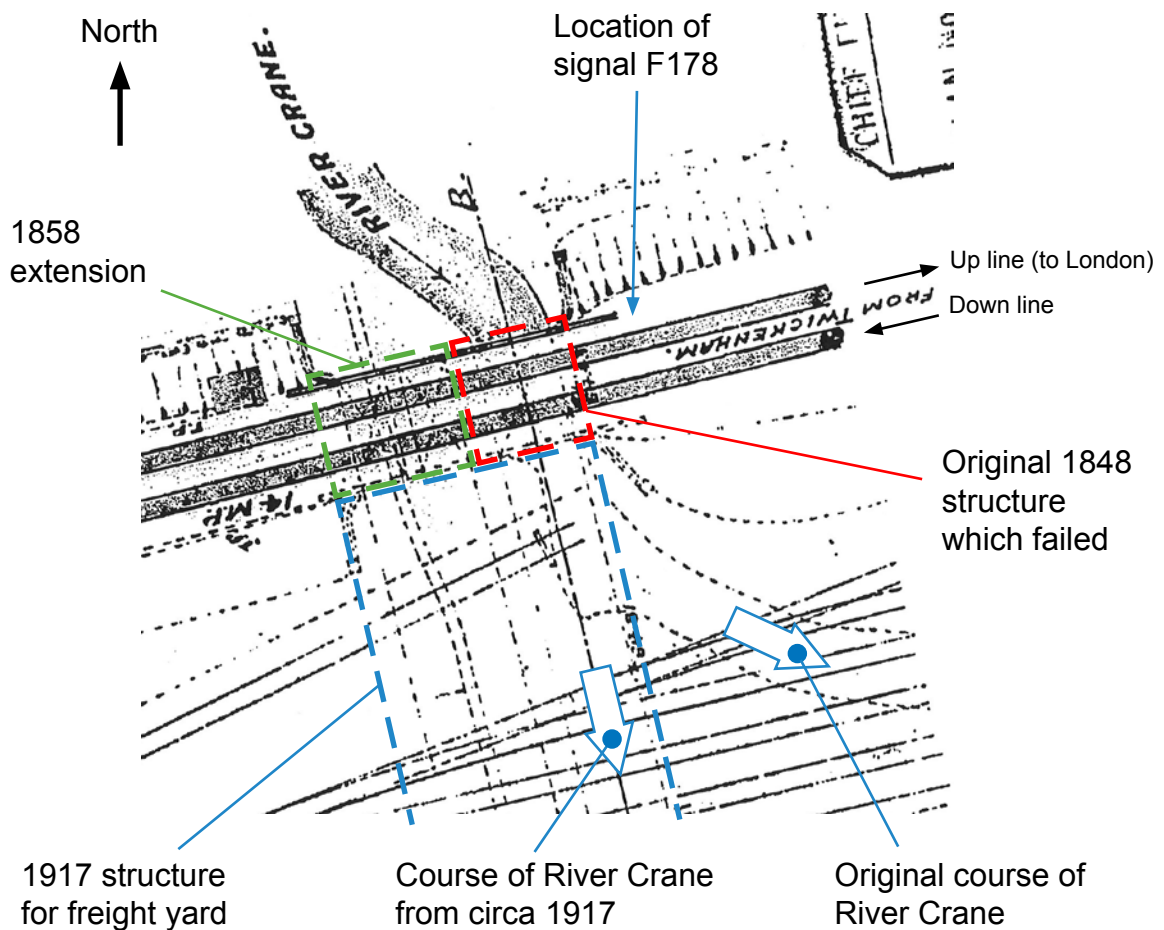
Figure 3: Extracts from historical drawings showing bridge 48 and later extensions

- 21 Network Rail record drawings indicate that the east abutment of the original 1848 structure retained its original foundations. A core hole drilled in 1991 recorded the depth of this foundation as 0.65 metres below river bed level. Record drawings indicate that the foundations of the west abutment were deepened to 1.5 metres below bed level when it was rebuilt in 1858. The 1917 widening was also constructed with deeper foundations.

- 22 The River Crane approaches the bridge from the north at a 10° angle, placing the east abutment on the outside of the bend (figure 3). The shape of the river channel directs the river flow towards this abutment, regardless of whether any obstruction is present.

a) 1858 drawing of the north (upstream) face of bridge 48 and extension incorporating twin flood relief arches

b) 1917 drawing showing widening of existing bridge for freight yard

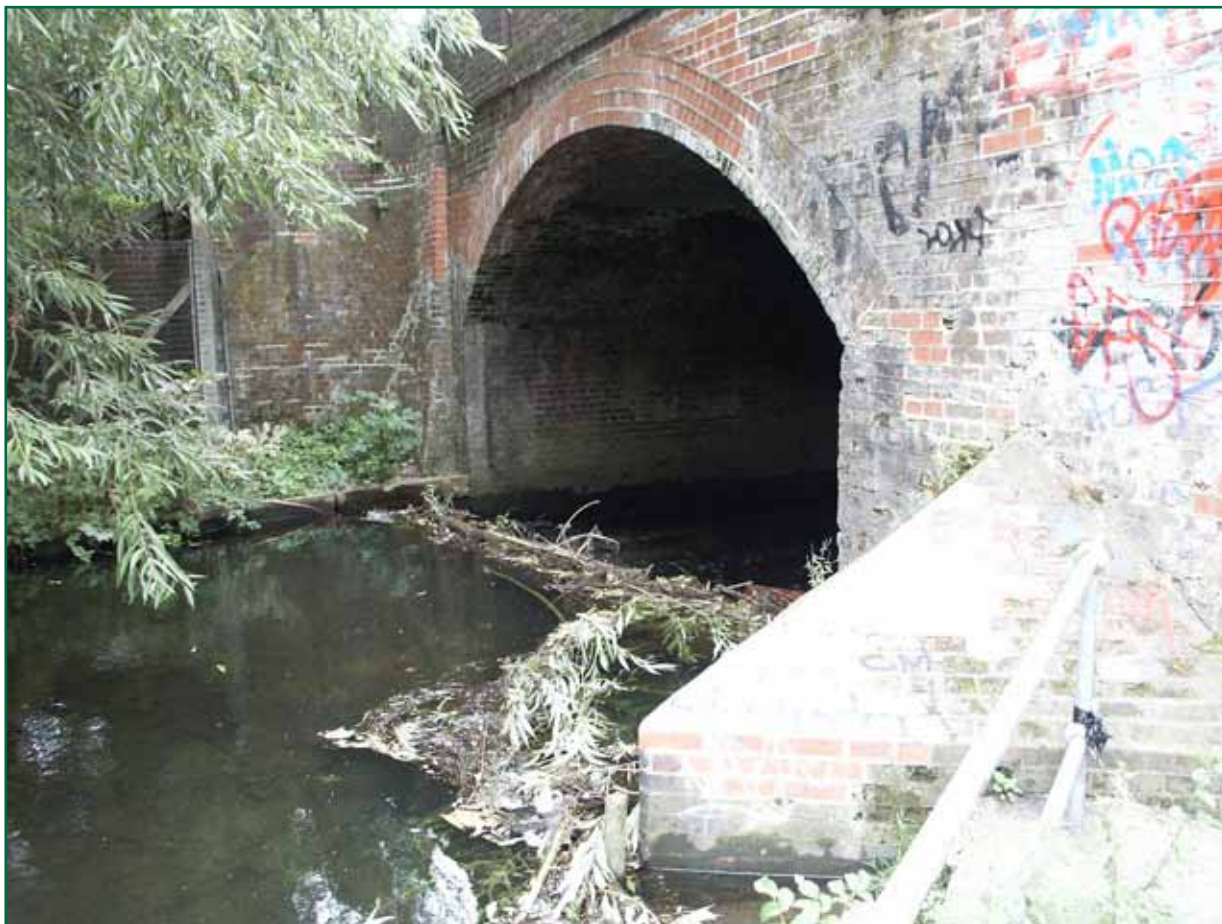
- 23 On 20 August 2009, a member of the public took a photograph of a recently cut willow branch positioned across the upstream face of bridge 48. The branch was sufficiently long to span the full width of the watercourse, constricting the flow (figure 4).

Figure 4: Branch across upstream face of bridge 48 on 20 August 2009 (photograph: N Banks)

- 24 Local fishermen were aware of an obstruction which raised the level of the river upstream of the bridge by an estimated 600 mm from the late summer.

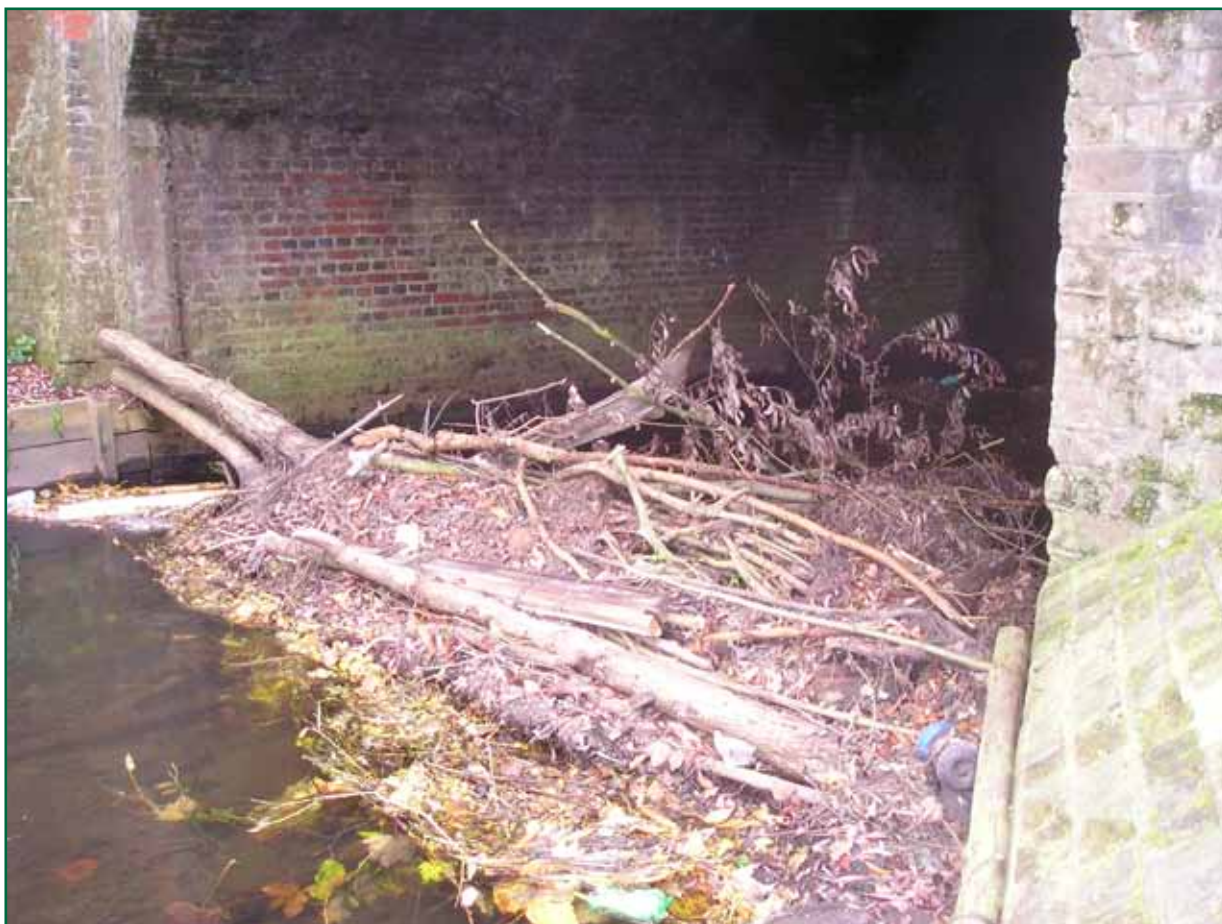
- 26 On 28 October 2009, an Asset Inspector employed by the Environment Agency (EA) observed a large obstruction at the upstream face of bridge 48 (figure 5) formed of logs, branches and other detritus. This constricted the flow and directed it towards the east abutment. The inspector did not report the obstruction to Network Rail.

Figure 5: Obstruction across upstream face of bridge 48 on 28 October 2009 (photograph: Environment Agency)

- 91 The EA's records show that obstructions were observed in the channel beneath bridge 48 in September 2008 and again during an internal inspection in December 2008. An EA Inspector also observed and photographed the large obstruction against the upstream face of the bridge by 28 October 2009, but he considered that the risk of flooding was low due to the size of the arch. The EA was considering removing the obstruction using its own resources and at its own expense, but no action had been taken prior to the failure occurring.

- 92 The EA did not notify Network Rail of any of the identified obstructions as the risk of upstream flooding was judged to be low and there was no visible damage to the structure. The scour risk was not recognised.

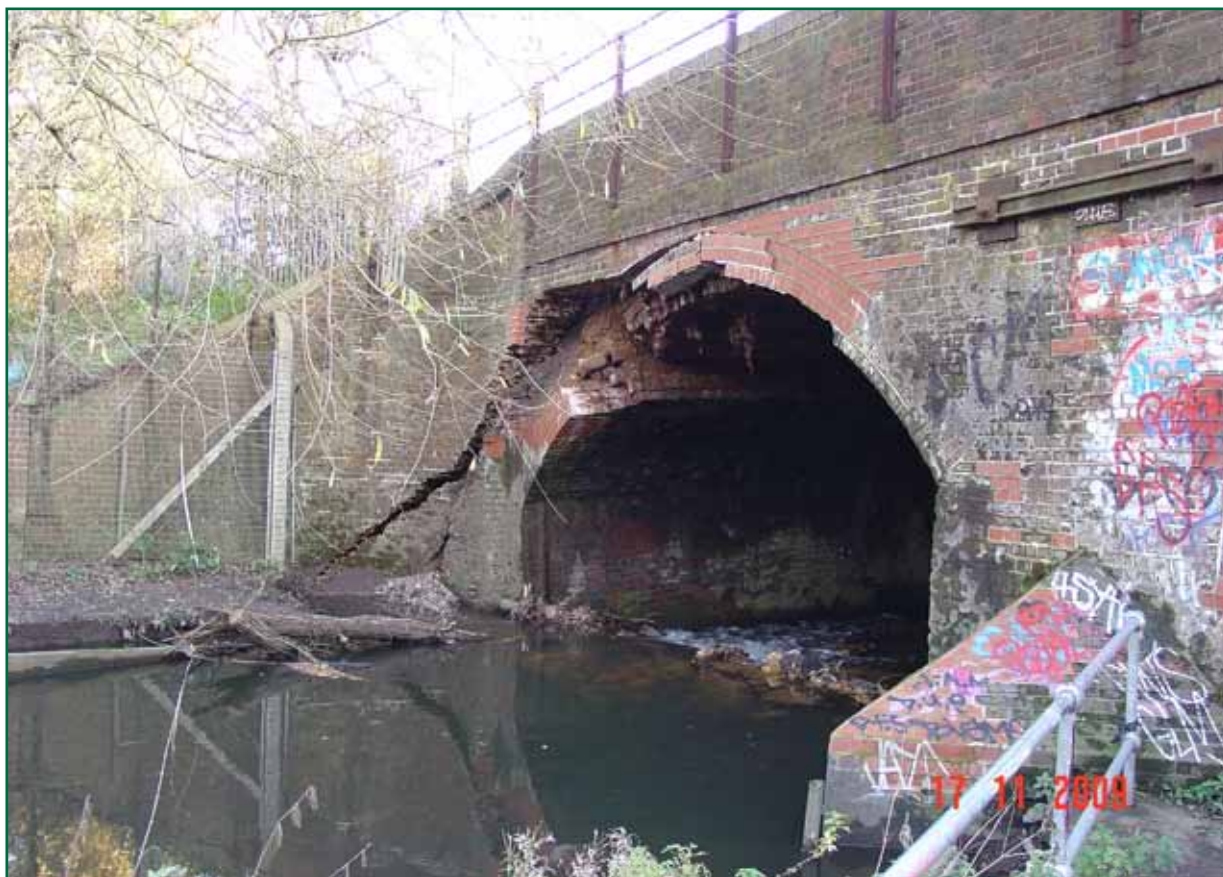
- 27 By the evening of 14 November 2009, the flowing water had *scoured* a void beneath the east abutment, leaving a 5.5 metre long section unsupported (65% of the abutment's width). The void extended beneath both the up and down lines.

- 29 During the six minute period between train 2C74 and the following train 2S74 crossing the bridge, the unsupported section of the east abutment subsided. This movement caused dislocation of the arch at the upstream face and resulted in a loss of track support to the up line (figure 6).

Figure 6: upstream face of bridge 48 following the incident showing failed arch

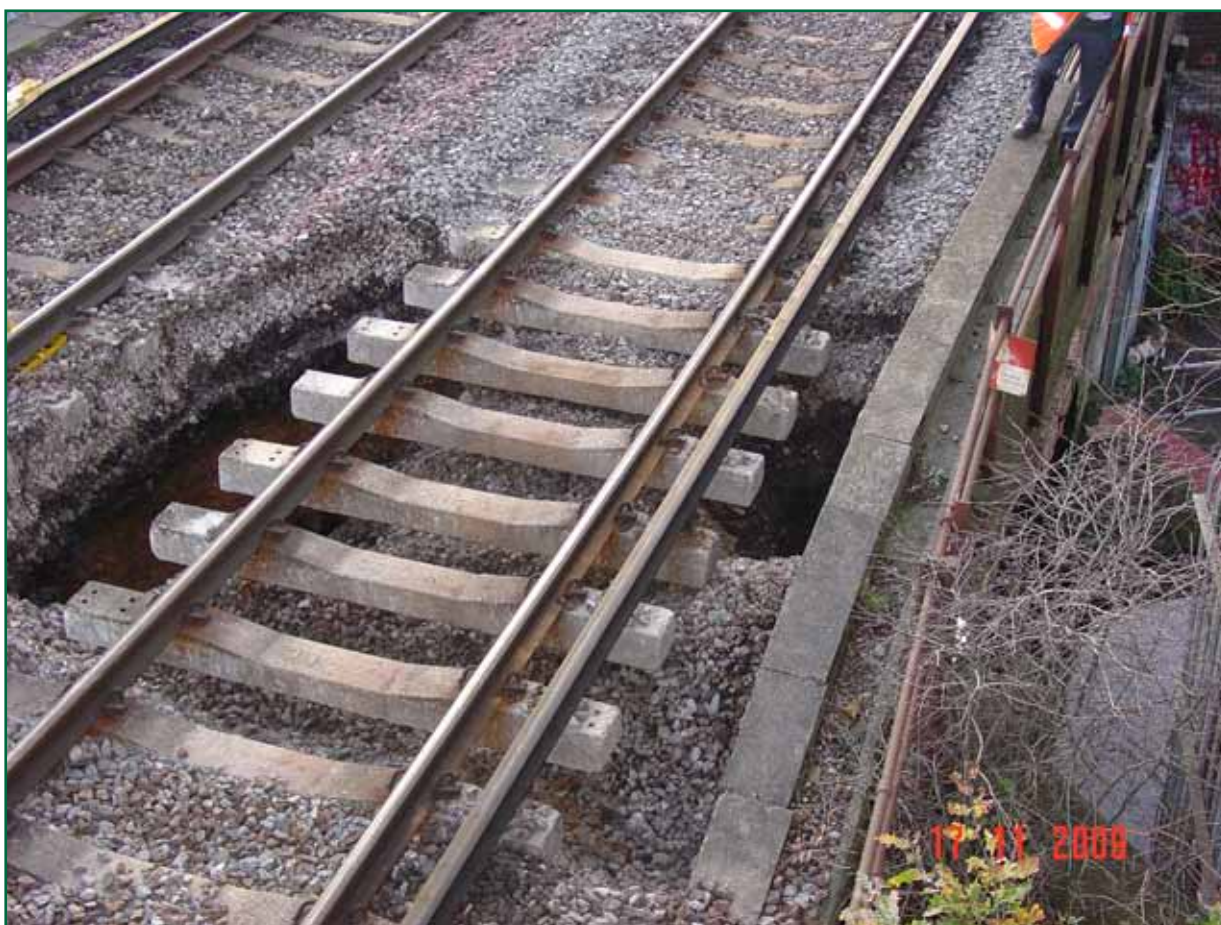
- 36 The on-call supervisor attended site, accompanied by six men with equipment to lift the track and consolidate the ballast. He arranged for the signaller to block the line while he examined the track, but was unable to find a dip at the reported location. He subsequently widened his search in both directions.
- 37 At 00:14 hrs on Sunday 15 November, the on-call supervisor contacted the signaller and instructed him to limit the speed of the next train, 5S80, an ECS movement standing at signal F178, to 5 mph (8 km/h) so that he could watch it pass. As it crossed bridge 48, he observed the rails dipping by an estimated 150 mm. On inspection, he found ballast missing around and beneath six sleepers and a hole between the up and down lines through which he could see the river (figures 7 and 8).

Figure 7: Overview of track showing loss of support to up line

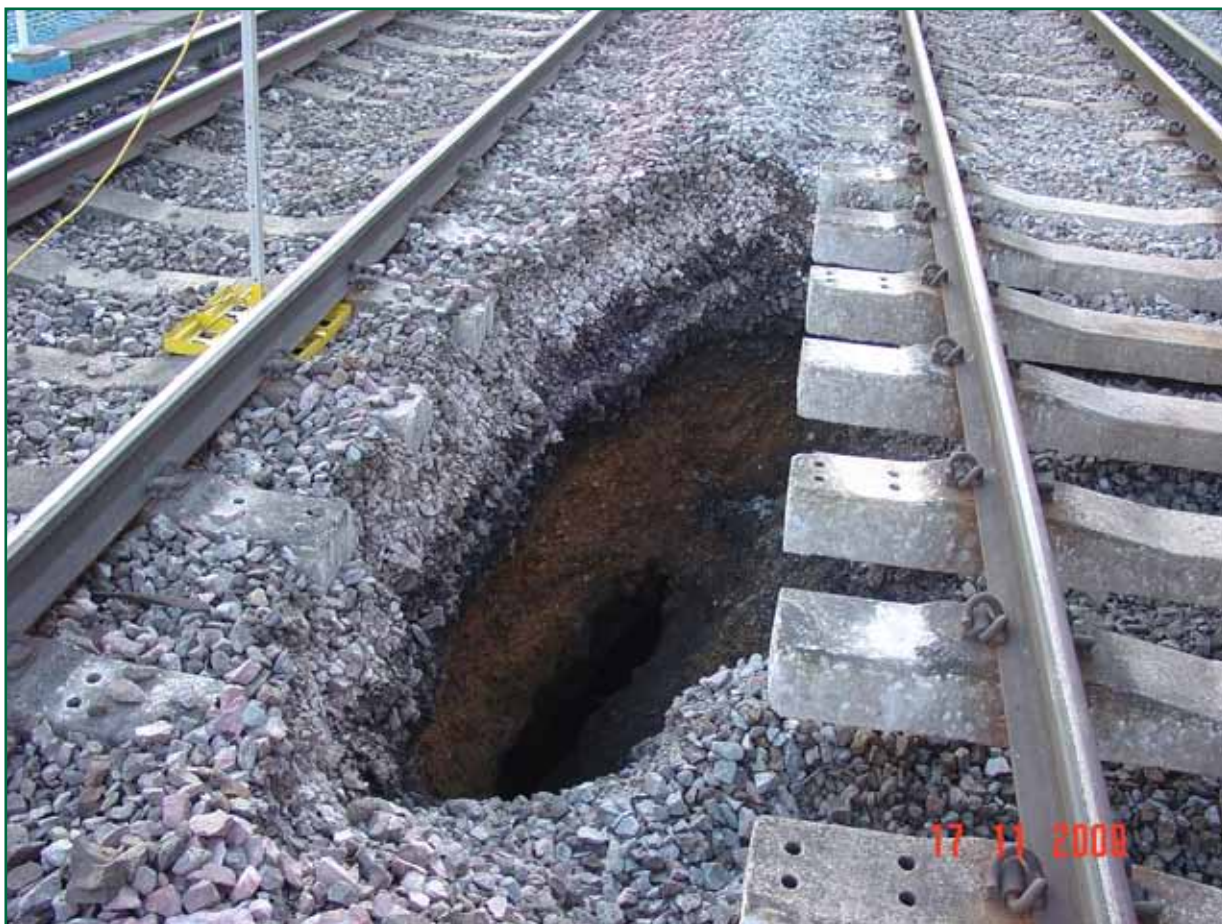
Figure 8: Void to river in six-foot between up and down lines

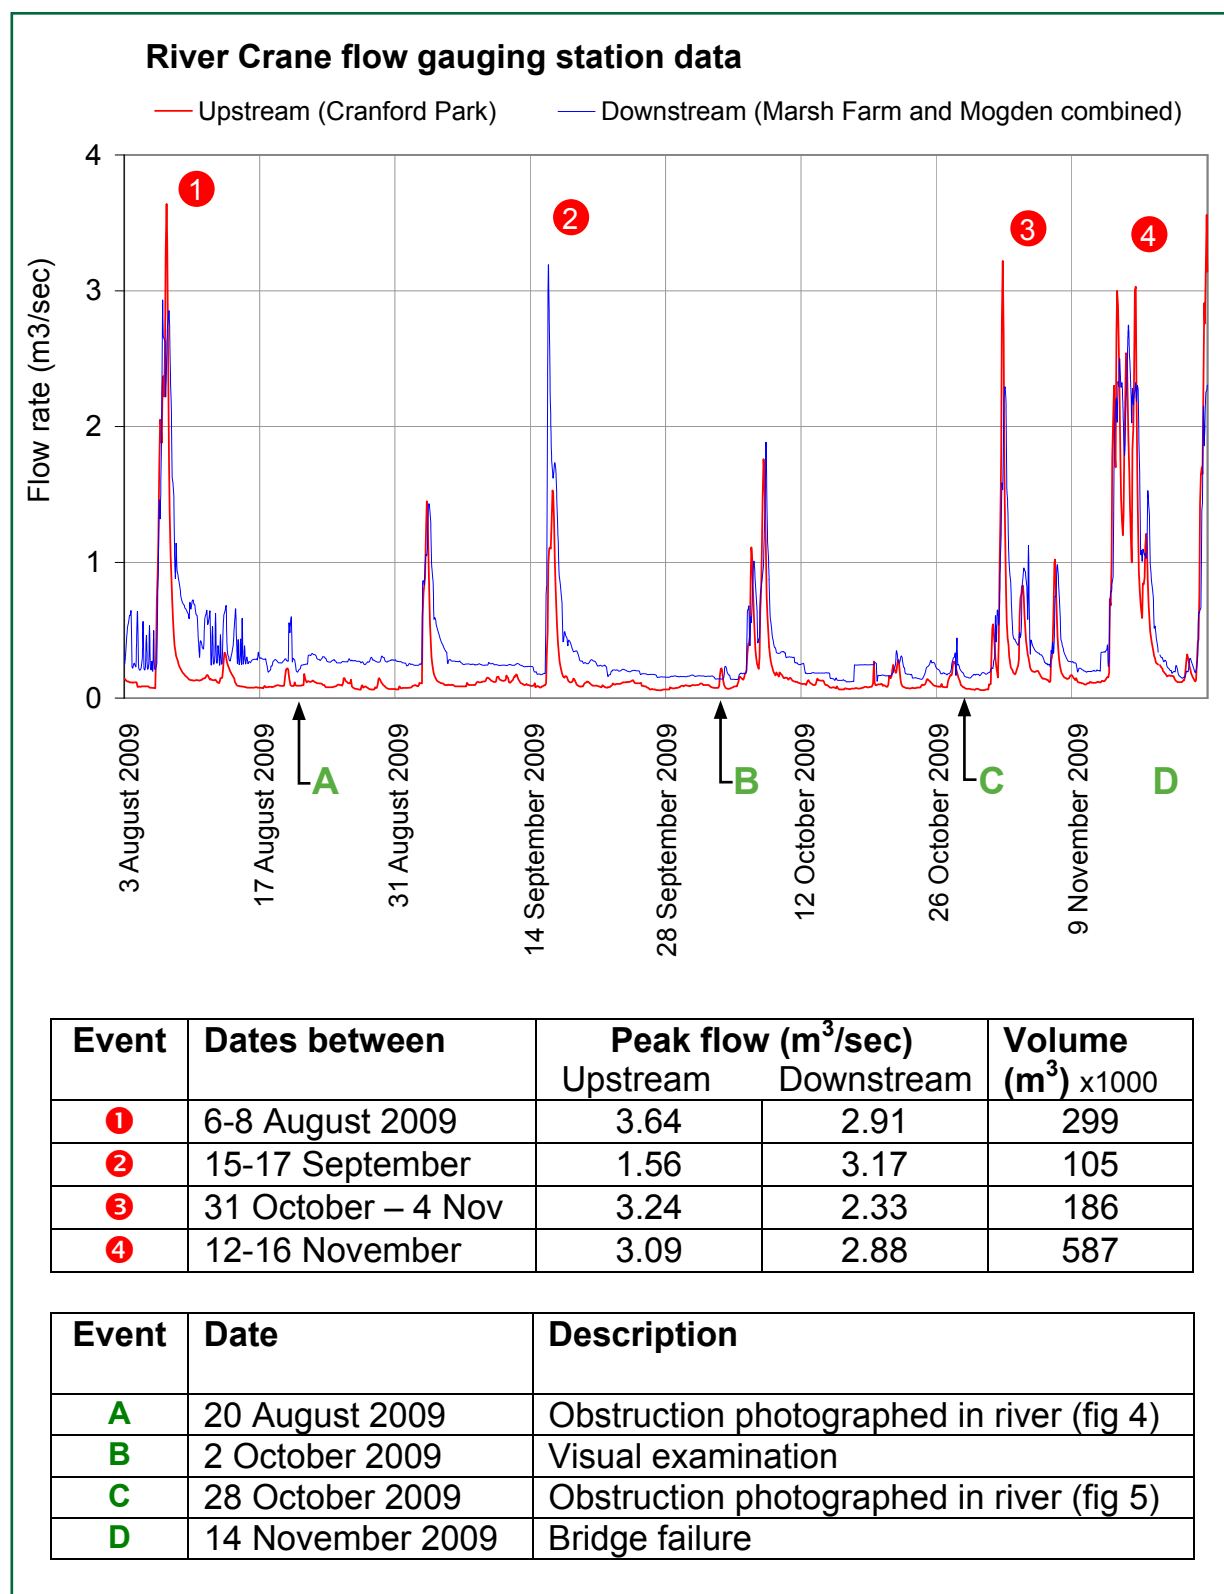
Figure 9: Flow data

- 48 Data for the River Crane upstream and downstream of bridge 48, recorded at *gauging stations* operated by the EA, indicates that the flow significantly increased on four occasions between August and November 2009. Flow levels were raised during the 48 hours prior to the incident (figure 9).

- 49 The data indicates that the flow rate, measured upstream of the bridge, averaged 0.21 m³/sec during the three months prior to the incident. Flow peaked at 3.02 m³/sec in the 48 hours prior to the incident (ie 14 times greater than the average flow). Although the increase in flow was significant, it was not exceptional and the depth of water, measured at the gauging stations, was not sufficient to trigger a flood alert.
