# Rail Accident Report

**Near-miss on Victory level crossing, near  
Taunton, Somerset  
19 December 2009**

# Near-miss on Victory level crossing, near Taunton, Somerset, 19 December 2009

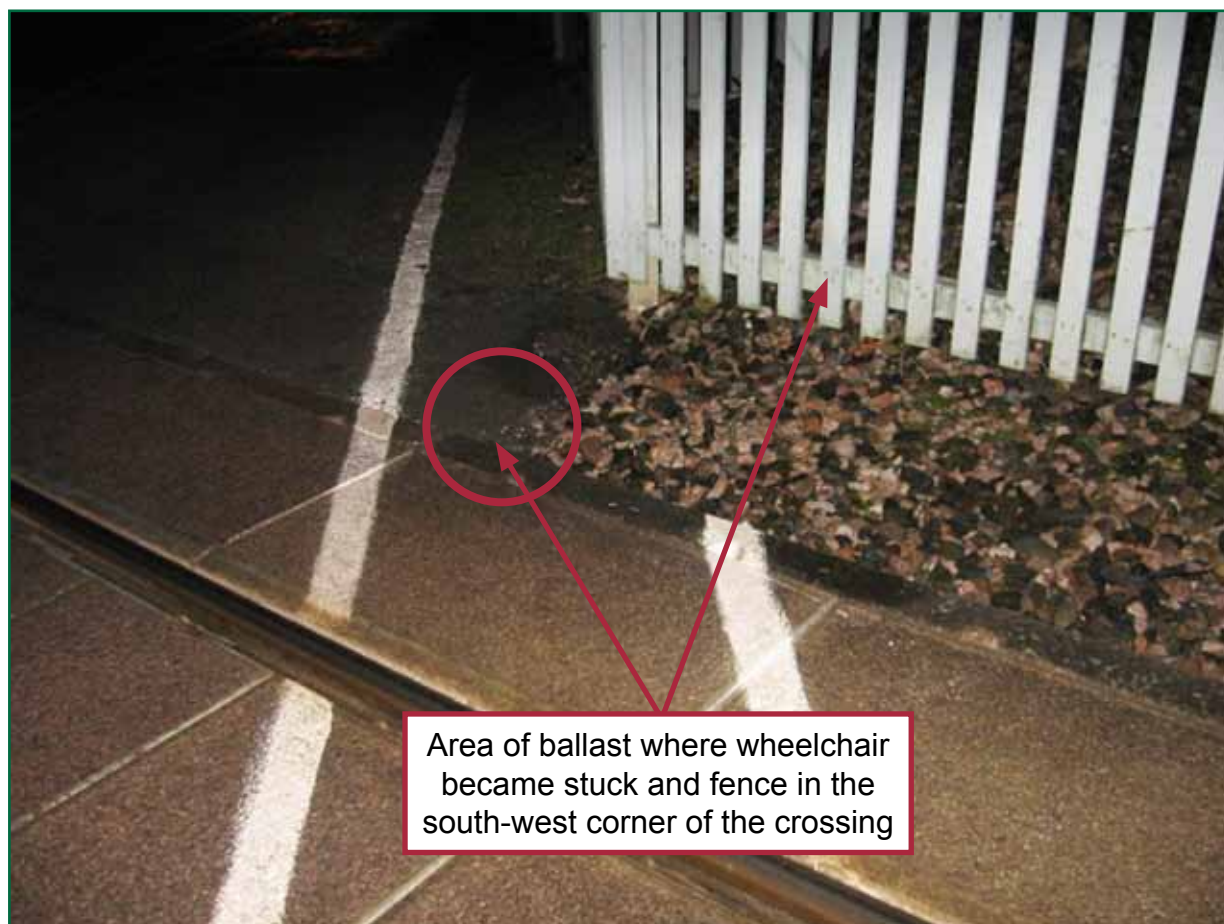
Figure 2: Area of ballast and fence in south-west corner of the crossing (photograph courtesy of Network Rail)

- 38 **One of the front wheels of the wheelchair became stuck in an area of ballast in the south-west corner of the crossing.**
- 39 Since March 2007, the crossing surface included an area of ballast approximately 1 metre wide and 2.4 metres long at the south-west corner (figures 2 and 3). The wheelchair user had used the crossing on most days since then. On this occasion, the course taken by the wheelchair user directed him towards it and he either misjudged his position or was distracted and his front wheels encountered the ballast.

- 47 The following week, on the night of 17/18 March 2007, the local Network Rail off-track gang fitted new crossing panels to recreate the down side section of the level crossing. The down line edge beams were also re-installed. A sub-contractor laid asphalt to the level of the crossing surface and adjoining road approach. Photographs taken by the HOTR department during the work (figure 10) indicate that the asphalt installed at this stage did not extend beyond the left-hand side of the carriageway (in the direction of travel) on the south side of the crossing and did not correspond with what had been present previously. A short section of ballast remained at the south-west corner of the crossing (figure 2).

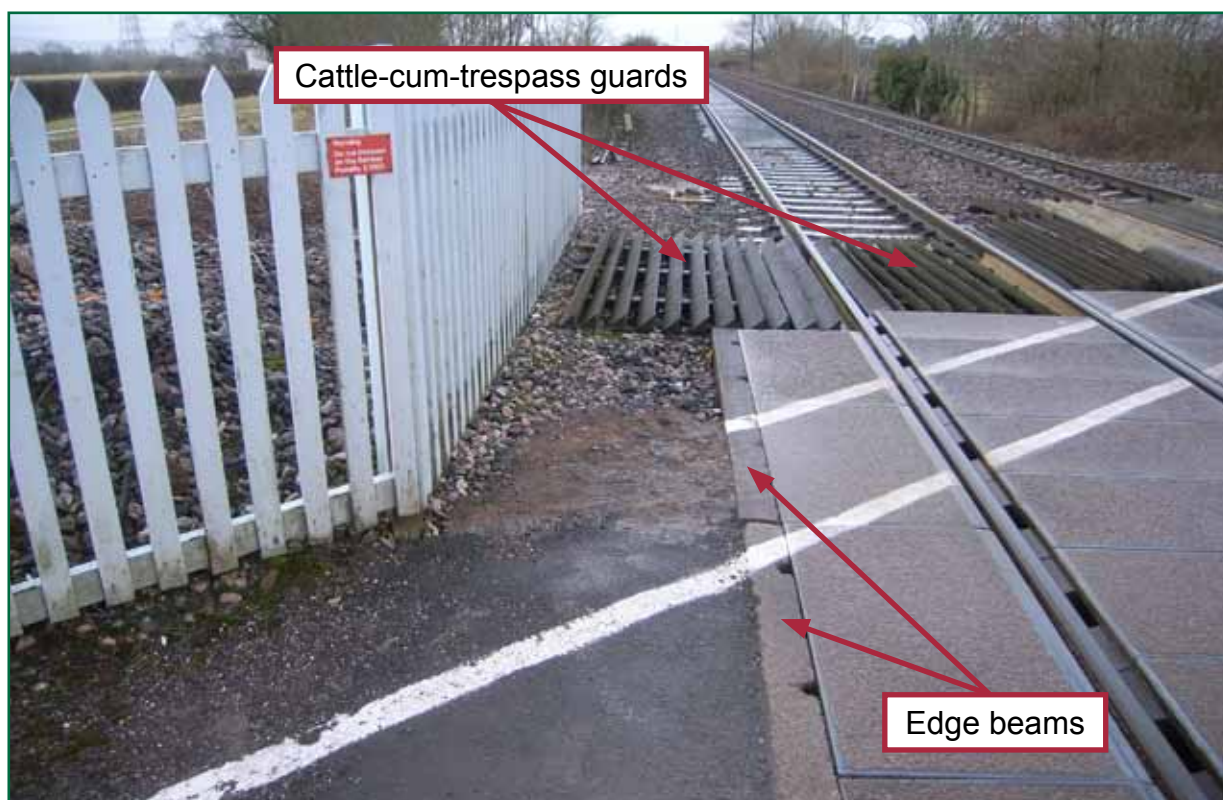
- 21 At Victory level crossing the flangeway gaps were measured to vary between 55 and 62 mm.
- 22 Edge beams (figure 4) are installed on the north and south sides of the crossing to secure the outer crossing panels and to provide an edge for the asphalt section that is used to fill the gap between the crossing panels and the road approaches.

- 23 A footway for pedestrians is marked out over the level crossing surface to provide a walking area clear of the road carriageway. Cattle-cum-trespass guards (figure 4) are installed along the east and west sides of the crossing panels to deter animals and trespassers from gaining access to the railway lines.

Figure 4: Position of edge beams and cattle-cum-trespass guards

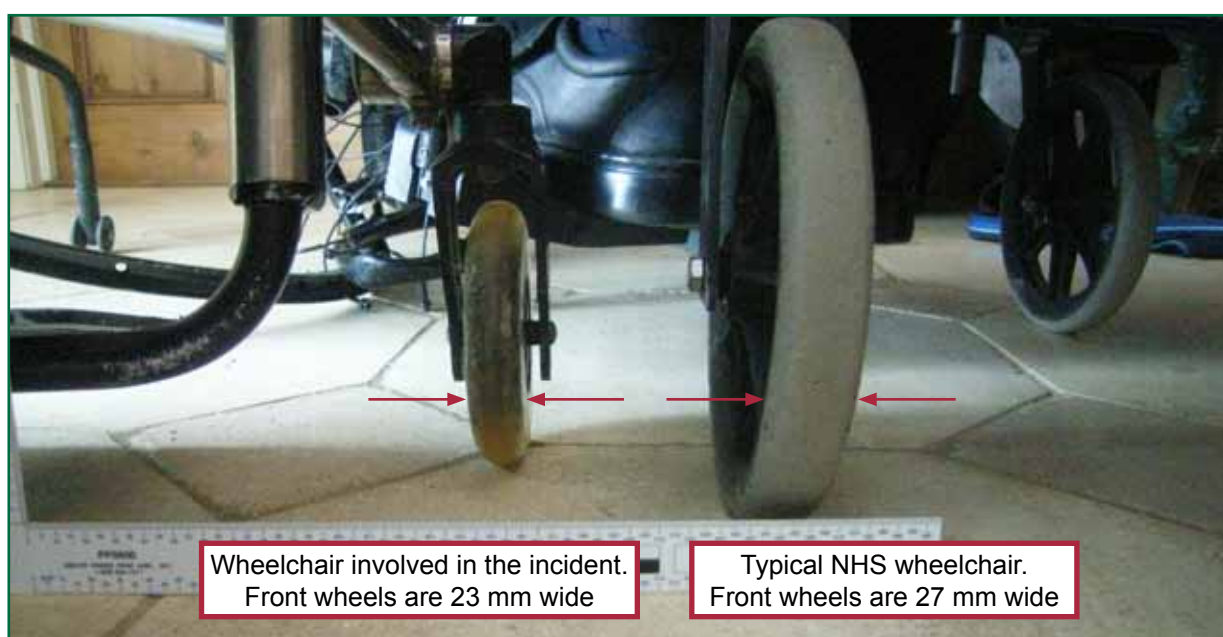
- 24 There is no lighting and no footpath on either road approach to the level crossing, and no lighting on the level crossing itself.
- 25 The wheelchair that was struck by the train was a specialist light-weight wheelchair of titanium construction. The front wheels are free to swivel through 360°. The front wheels are smaller than a typical National Health Service (NHS) wheelchair, and are approximately 23 mm wide (figure 5). Typically, the front wheels of a NHS wheelchair are approximately 27 mm wide and are also free to swivel through 360°.

Figure 5: Wheels of wheelchair involved in incident (left) and standard NHS wheelchair (right)

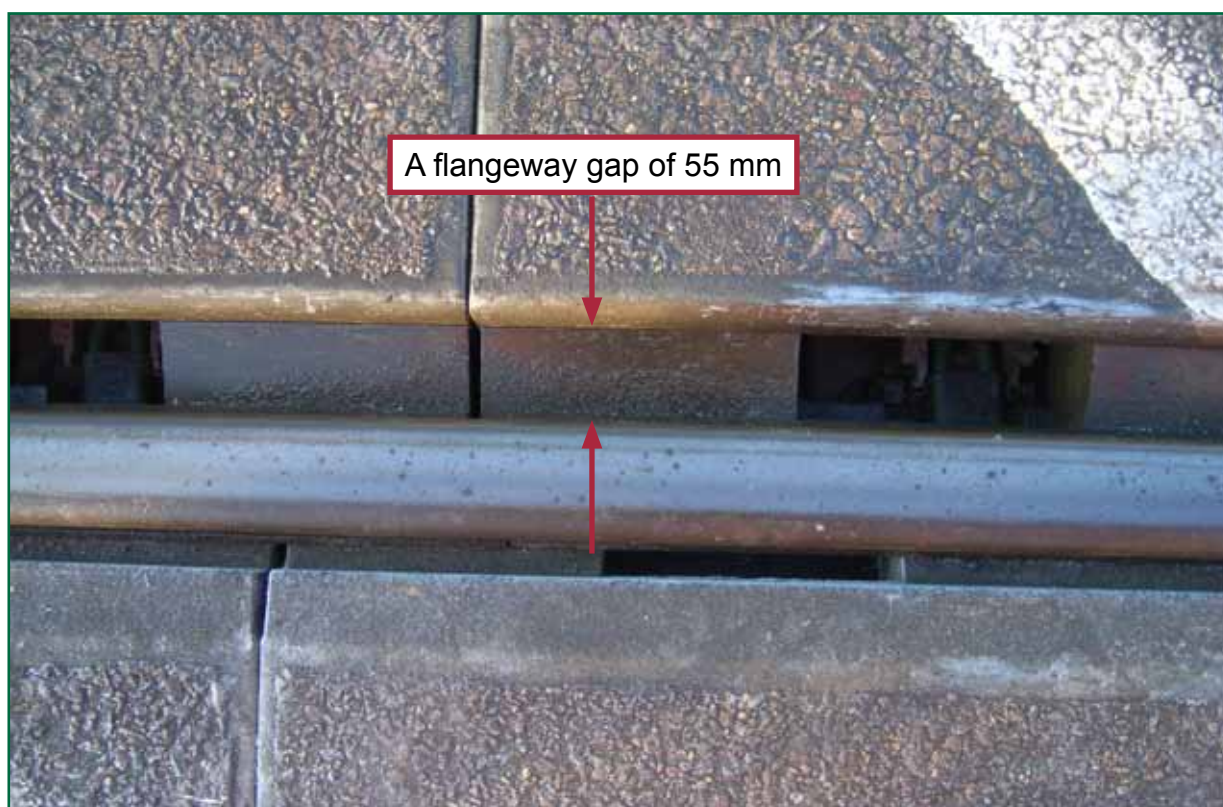
- 19 The RAIB checked the operation of Victory level crossing and found that it complied with its design specification.
- 20 The level crossing surface comprises pre-fabricated rubber panels. The railway lines pass through gaps between panels. The flanges of rail vehicle wheels pass through gaps between the rails and adjacent panels, referred to as *flangeway gaps*. Network Rail standard NR/SP/SIG/19608 (later re-numbered to NR/L2/SIG/19608 and referred to as such in the remainder of this report) states that the flangeway gap shall not be less than 55 mm wide to allow for the safe passage of train wheels (figure 6). If the flangeway gap is too small the wheels of passing trains could contact the edge of the crossing surface and damage it creating a derailment risk and a hazard to crossing users.

Figure 6: Example of the flangeway gap at Victory level crossing

Network Rail should, taking account of research in this country and developments overseas (paragraph 83), review methods for minimising the hazards from the flangeway gap at level crossings, particularly those that are skewed relative to the roadway or path, to users with small-wheeled equipment, such as wheelchairs and pushchairs, with a view to evaluating the costs and benefits of options for improving the safety of users of level crossings (paragraph 95d).

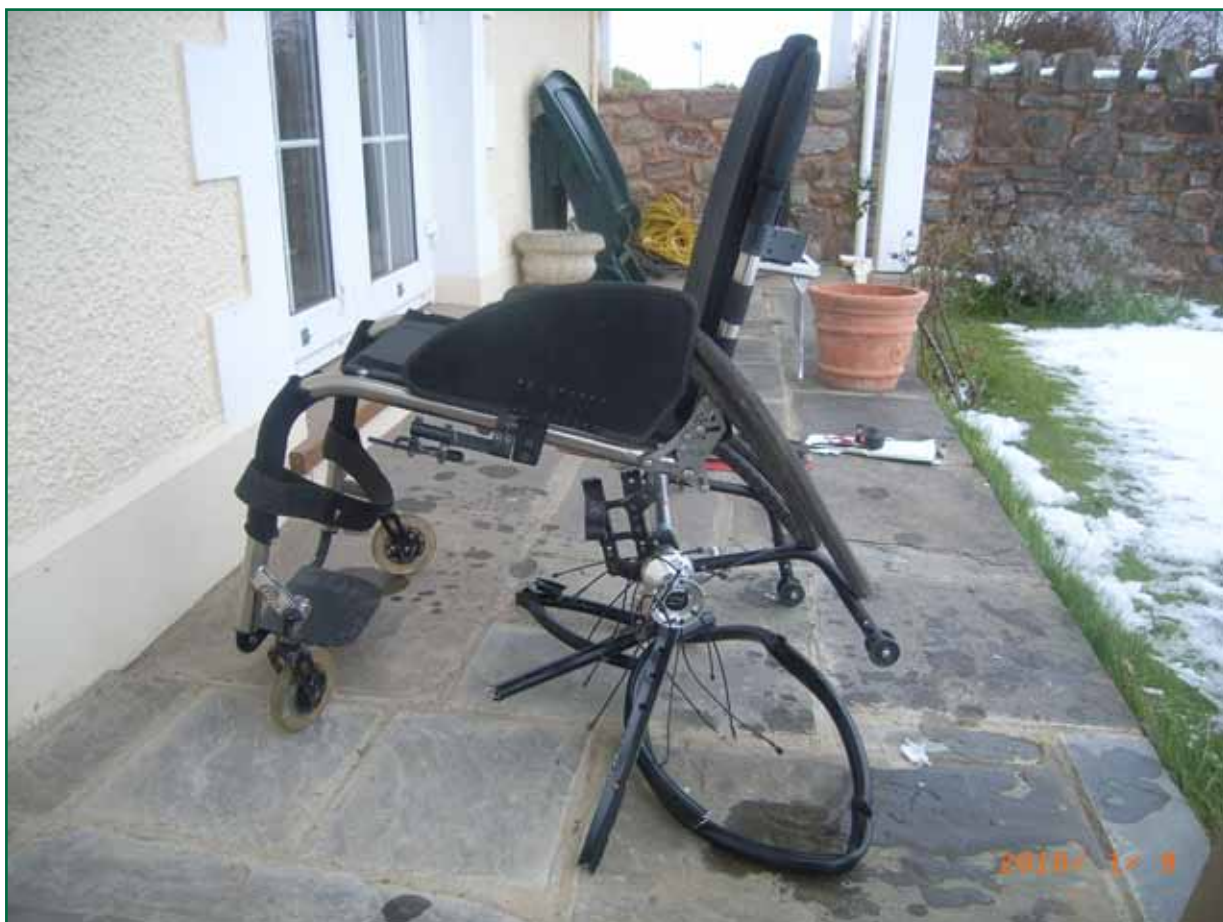
- 31 The wheelchair suffered significant damage (figure 7). The wheelchair user suffered some bruising to his right leg when he pulled himself from the wheelchair and was left shocked by the incident.

Figure 7: The damaged wheelchair

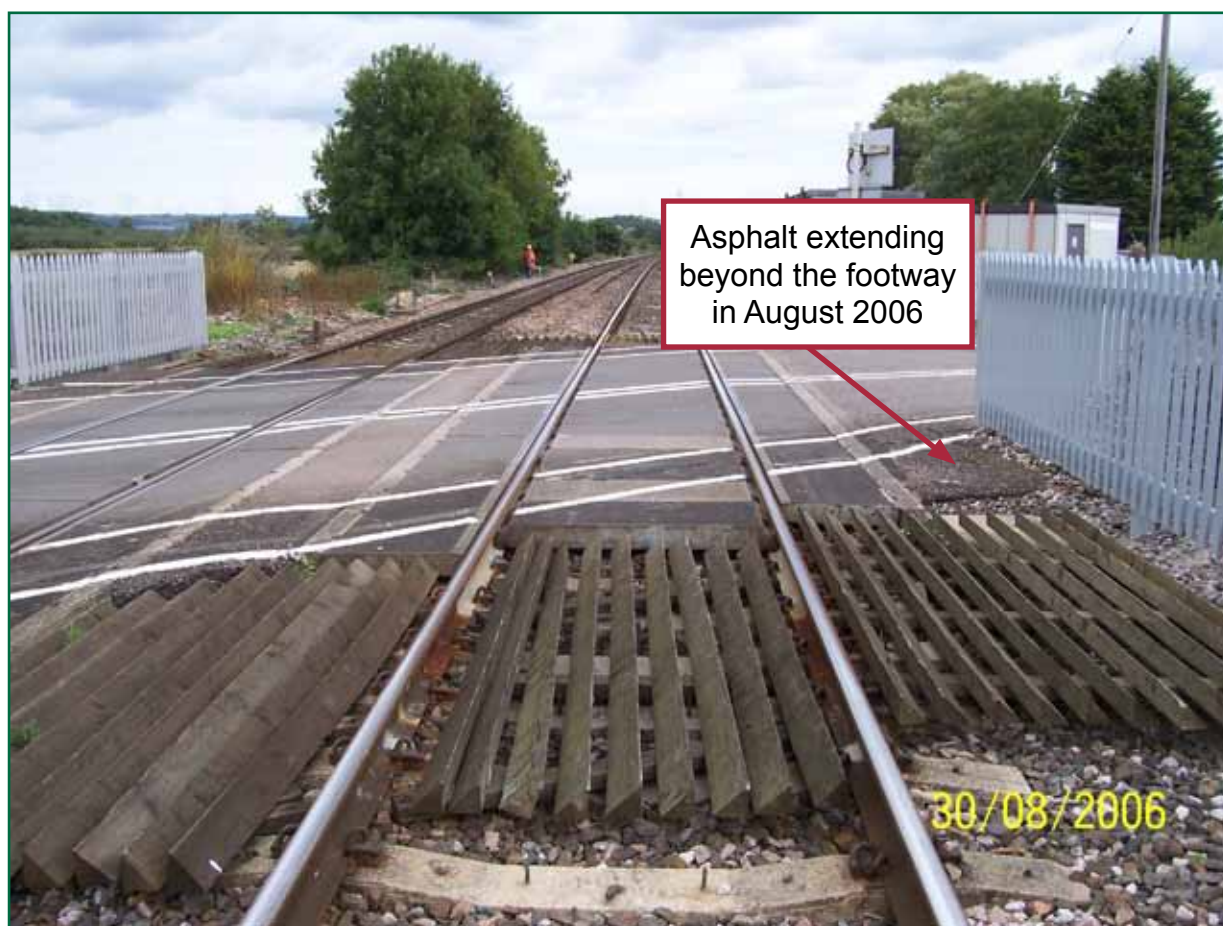
- 43 Photographic evidence from August 2006 shows the condition of the crossing before this work took place. It indicates that the asphalt that filled the gap between the level crossing surface and the road highway originally extended beyond the corner fence post towards the end of the edge beam on the south side (figure 9).

Figure 9: The asphalt section in August 2006 (photograph courtesy of Network Rail)

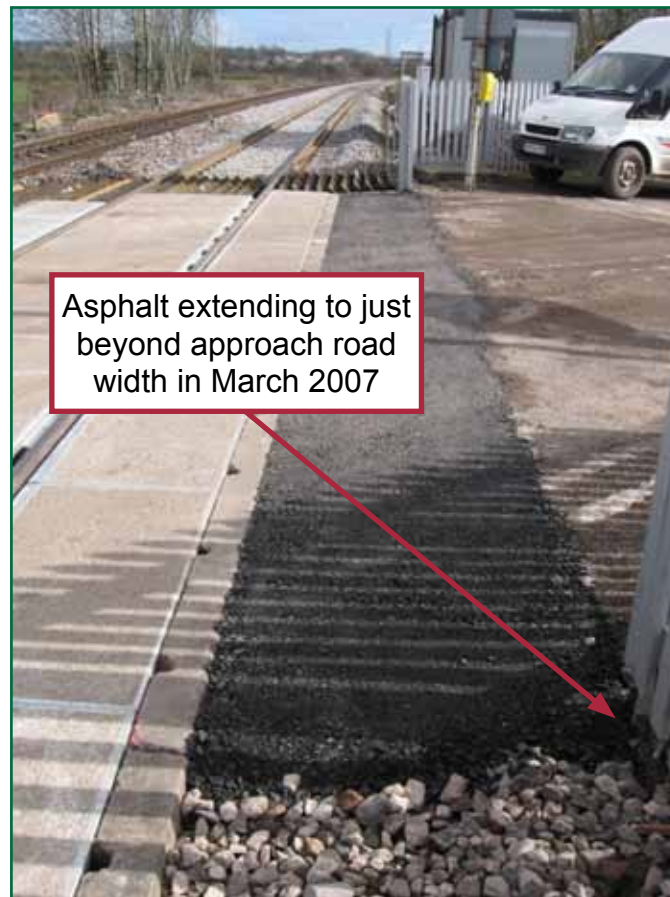
- 40 **When the down line through Victory level crossing was re-laid in March 2007, the asphalt strip on the south side of the crossing was not replaced along the full length of the crossing. A section of ballast was left in the south-west corner. The non-application of asphalt to the full length of the south side of the crossing is a causal factor in this incident.**

Figure 10: The asphalt section following the work in March 2007 (photograph courtesy of Network Rail)

- 63 **After the work undertaken on 17/18 March 2007, the crossing was left in a suboptimal condition with an uneven interface in the south-west corner between the crossing surface, asphalt and ballast. The uneven interface was not identified during a number of crossing inspections that took place between March 2007 and December 2009 and no remedial action was taken. This was a causal factor in the incident.**
