Rail Accident Investigation Branch

Rail Accident Report

Derailment near Gillingham tunnel, Dorset 28 November 2009

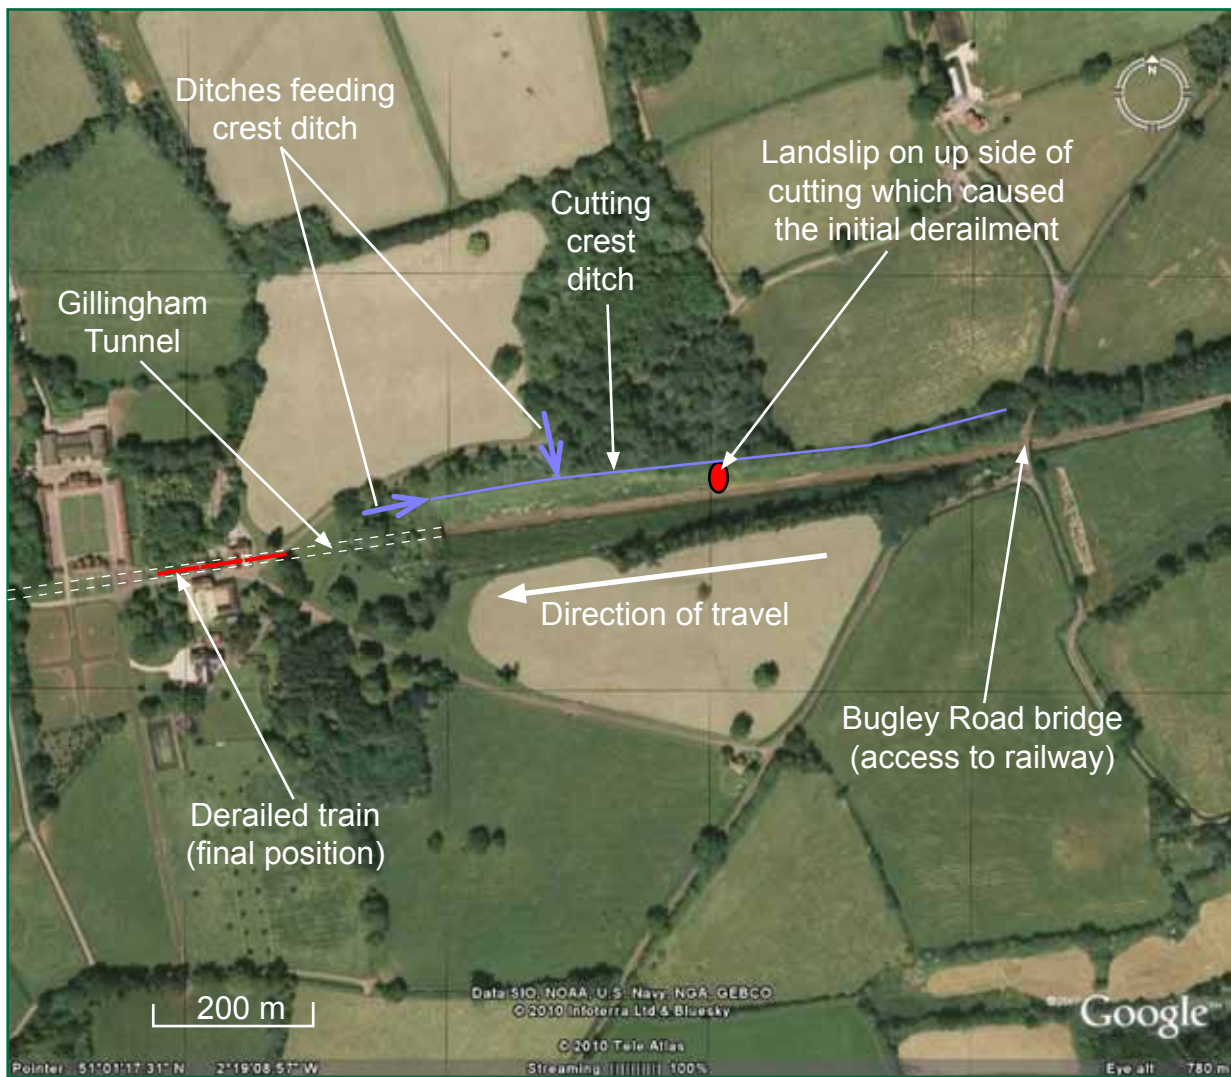
Figure 2: Accident overview (image courtesy of Google Earth)

- 18 The derailment took place in a cutting which is 8 metres deep at the site of the landslip which caused the derailment. A ditch along the northern cutting crest is intended to intercept water from adjacent farmland and woodland to prevent it running down the cutting slope (figure 2). This ditch crosses the Network Rail boundary at several places and is outside the boundary at the location of the landslip (figure 4).
- 19 The railway runs through the incident area in a straight line with a maximum permitted speed of 85 mph (137 km/h). It was constructed as a double track railway in the mid nineteenth century. In 1967, it was reduced to a single track running along the middle of the area formerly occupied by the two tracks. This resulted in a wide cess along the both sides of the single track (figure 3).

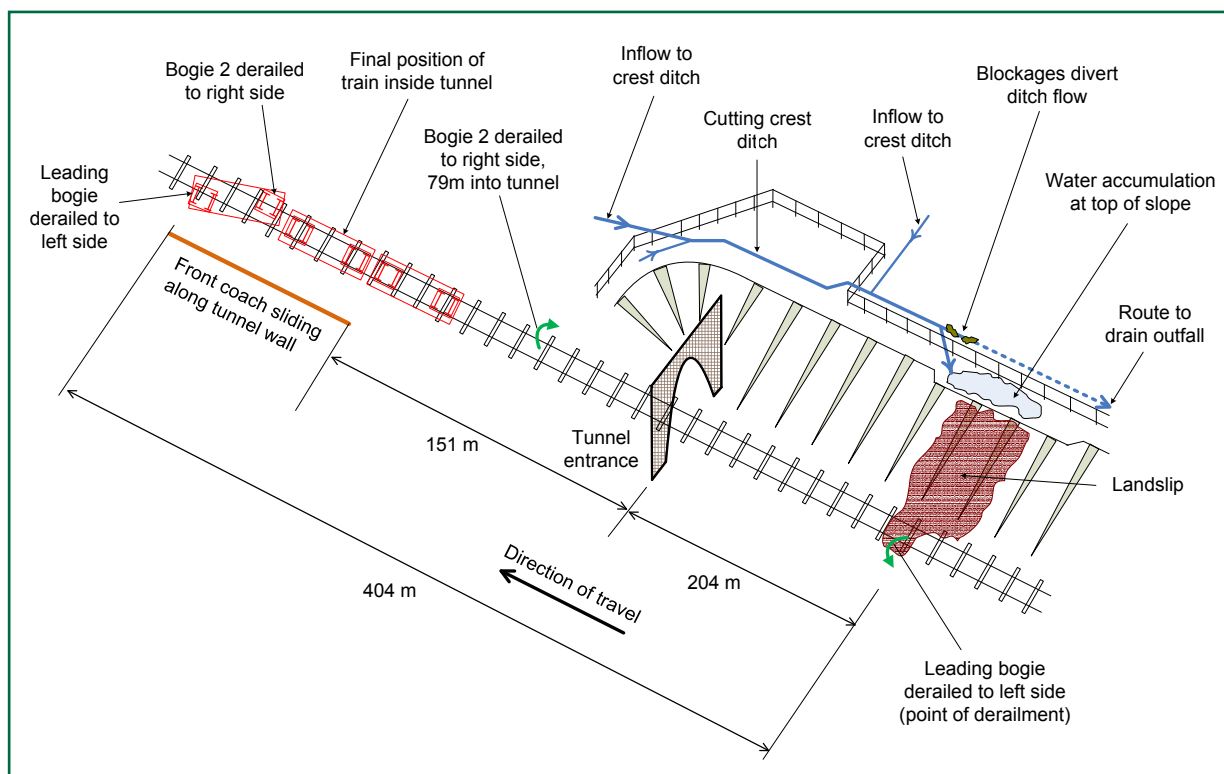
Figure 4: Plan of accident site (not to scale)

- 25 Network Rail had taken over maintenance of the crest ditch in the months leading up to the accident even though parts of this ditch were just outside the Network Rail boundary (figure 4). Land owners are normally responsible for maintaining ditches on their own land but it can be difficult to establish the extent of these obligations and, even if they are known, it can be difficult to force a neighbour to undertake the work. Rather than addressing these complex issues, Network Rail sometimes decide to maintain ditches on neighbouring land if the neighbour permits access. This approach had been adopted at Gillingham.

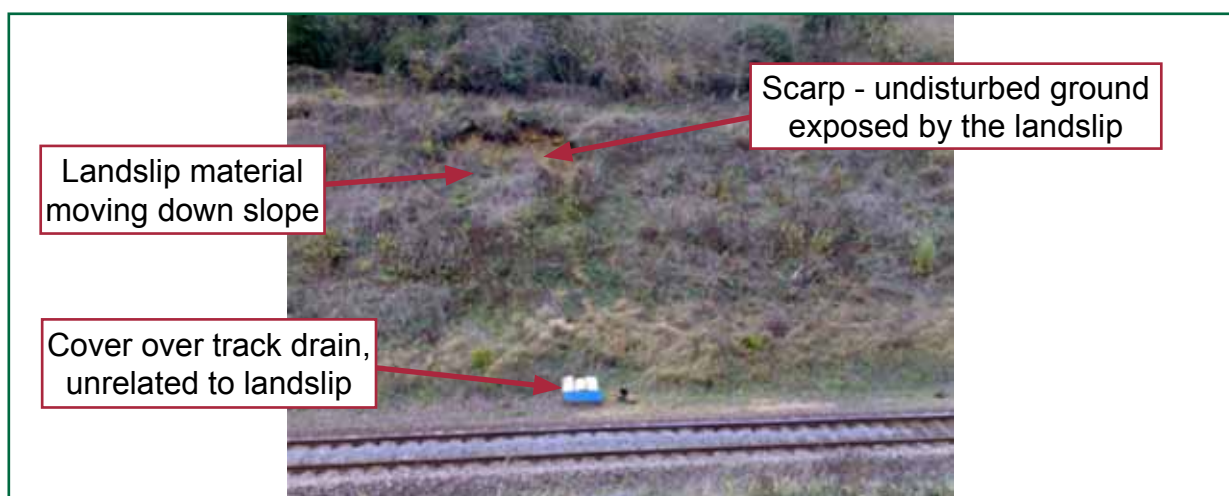
Figure 5: Landslip which occurred shortly before 17 December 2008 (image courtesy of Network Rail)

¹¹ Landslips not affecting the track can take several forms; an example is shown in figure 5.

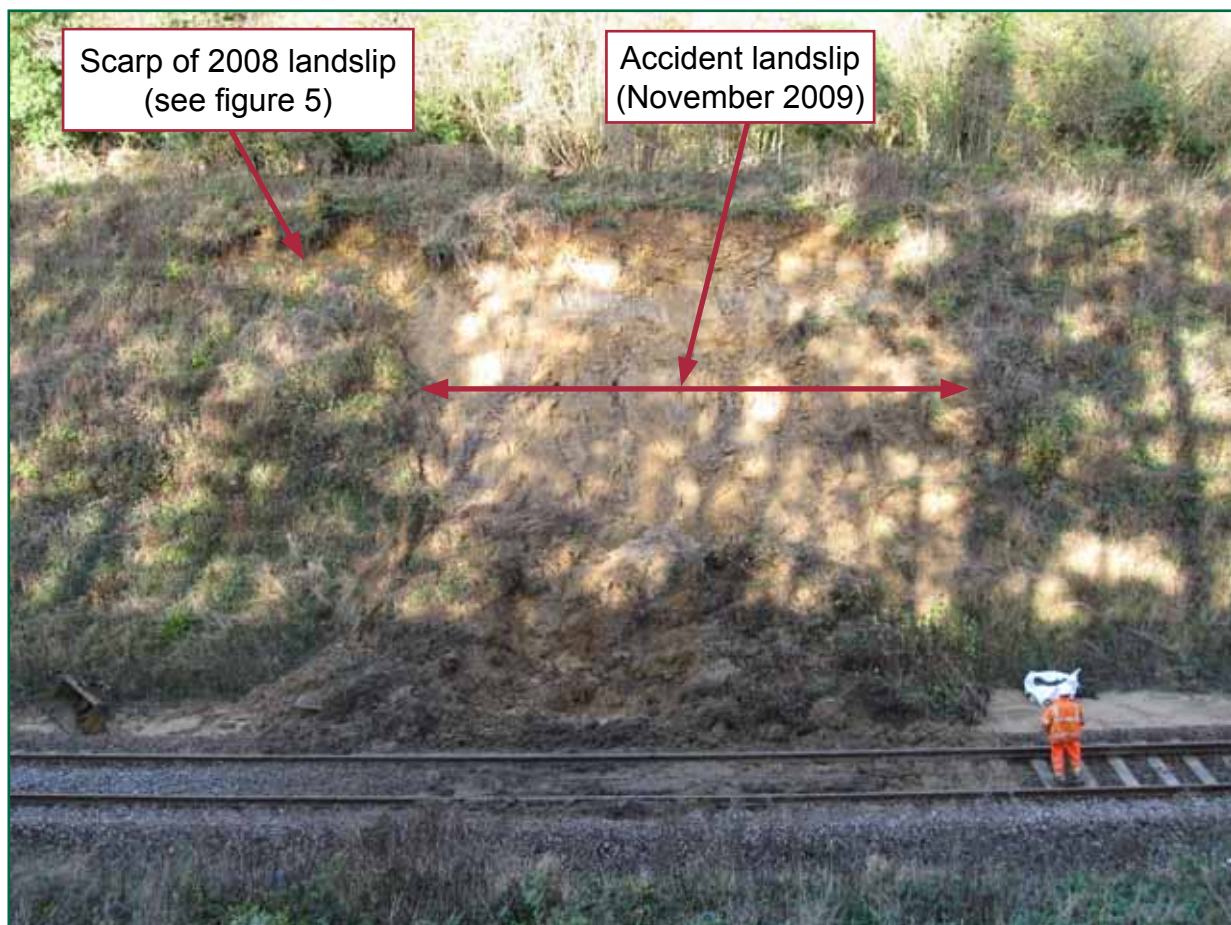
- 50 On 28 November 2009 a train travelling towards London passed the accident site in darkness and without incident at about 18:40 hrs; approximately 40 minutes before the accident. After this train passed, debris from a landslip caused by an overflowing drainage ditch blocked the line at 107 miles 34 chains. There were no witnesses to this event, which took place adjacent to the landslip reported in December 2008 (figure 6).

Figure 6: Accident and December 2008 landslips (Image courtesy of Network Rail)

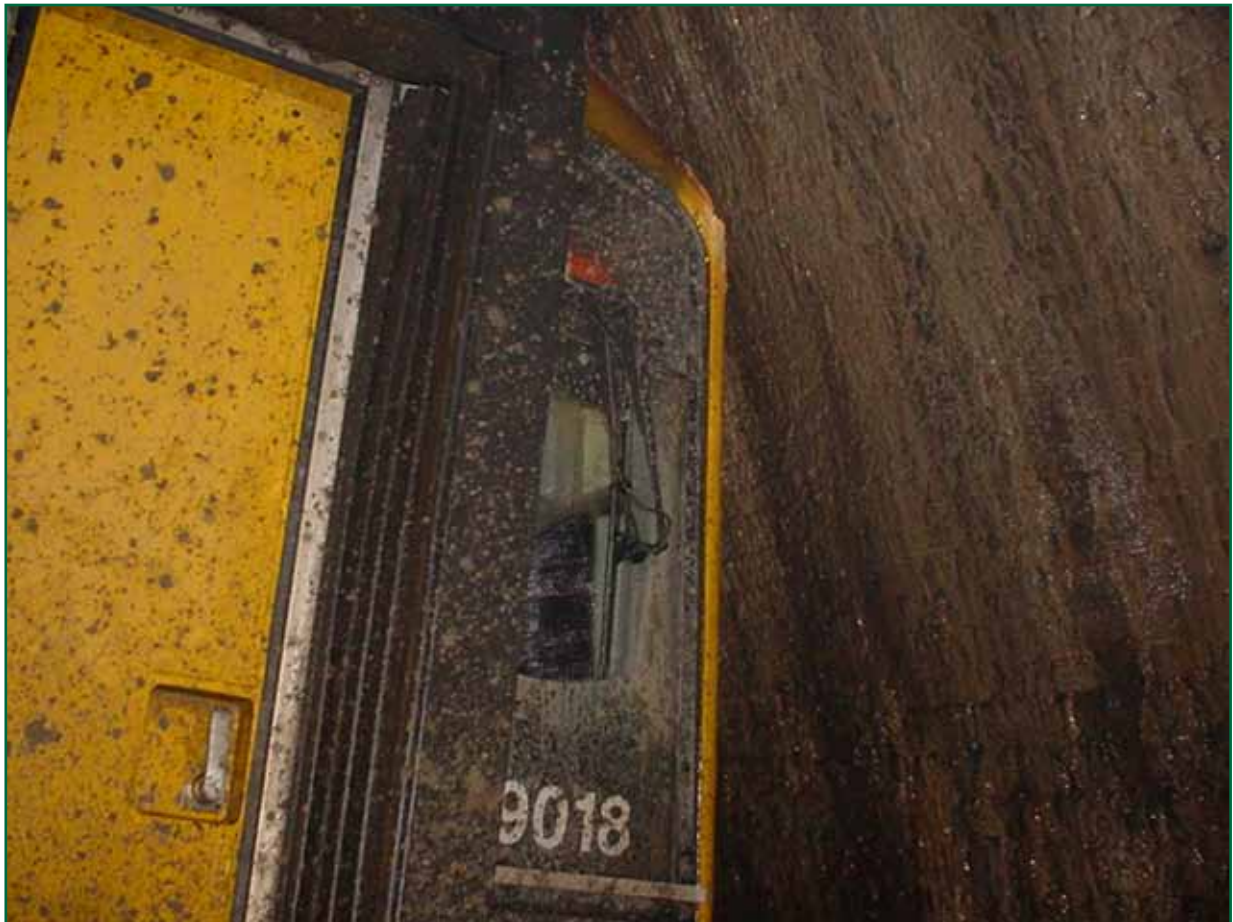
- 53 The rear bogie of the front coach derailed when it was 79 metres inside the tunnel. The front coach leant towards the left until the front left corner of this coach struck the tunnel wall 151 metres from the tunnel entrance. This coach slid along the tunnel wall until, 27 seconds after the initial derailment, the train stopped with its leading end 200 metres inside the tunnel (figure 7).

Figure 7: Train leaning against tunnel wall after the accident

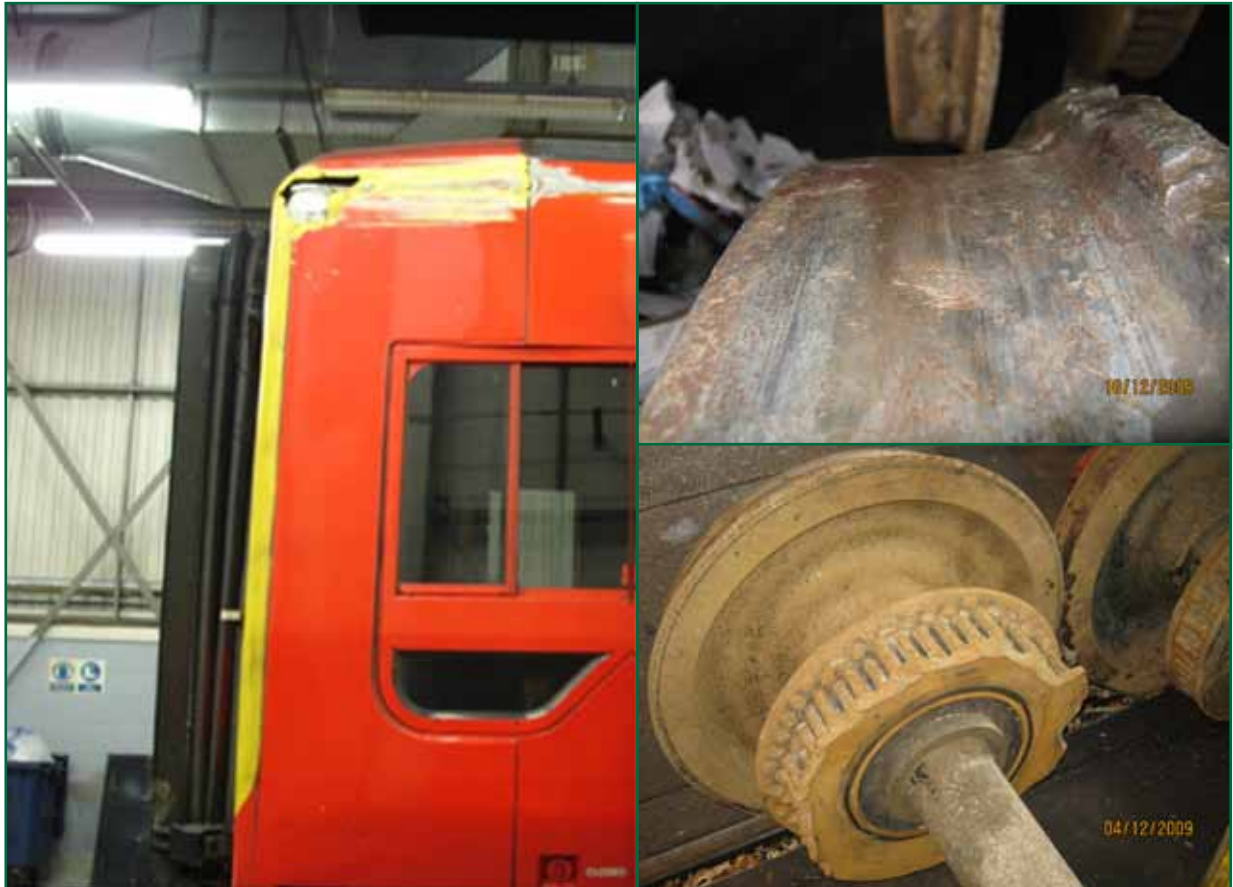
- 54 Two passengers reported minor injuries. The leading coach sustained damage to the bodywork and components including wheels, brakes and the engine (figure 8).
- 55 Approximately 450 metres of track required repair. The line remained closed for five days until 04:52 hrs on 3 December 2009.

Figure 8: Body and wheelset damage (Images courtesy of South West Trains and Railcare)

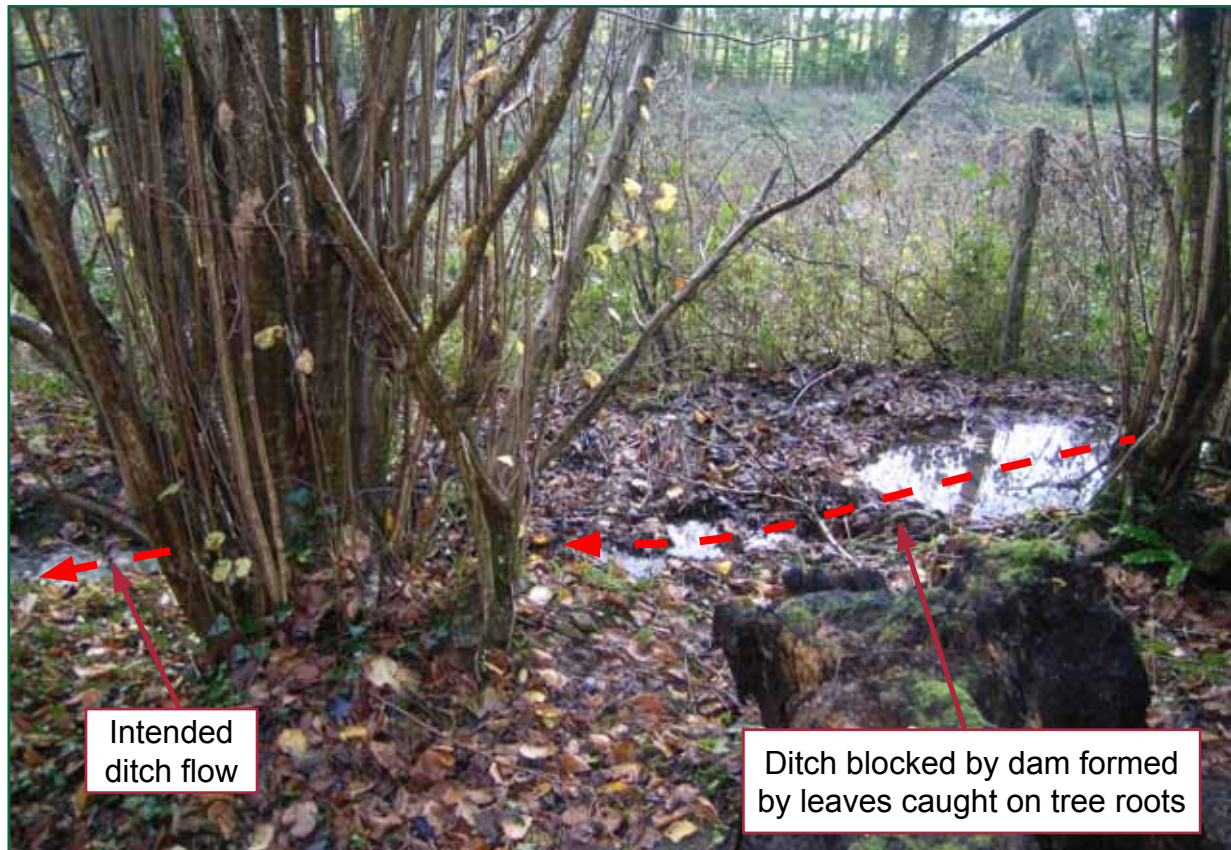
- 60 **The immediate cause of the accident was a landslide triggered by water overflowing from a blocked ditch.**
- 61 Inspection of the site after the accident showed that leaves had blocked the crest ditch causing water to overflow and accumulate at the top of the cutting slope (figure 9). This would have made a landslide more likely because:

- 66 **The ditch, at least in the area where tree roots caused the blockage, was not dug out to an adequate size during maintenance work. There is no evidence that, in the absence of obstructions, the ditch capacity would have been inadequate. It is uncertain whether the ditch size was sufficient to deal with the leaves, branches and twigs expected to fall from the surrounding vegetation. It is certain that the roots caused leaves and twigs to accumulate and block the ditch. The presence of roots is a causal factor and the ditch size is a possible causal factor.**

- 67 The ditch overflowed due to a blockage caused by leaves and twigs being trapped in tree roots which partially obstructed the ditch (figure 9). These roots would have been present when the ditch was maintained in July 2009, and had not been removed. Neither the volume of water nor the leaf fall were exceptional so it can be concluded that the roots were, at least in part, the reason why the ditch overflowed.

Figure 9: Blocked cutting crest ditch (railway boundary fence and cutting in background)

- 68 The Wessex drainage team had not removed the roots as it was impractical to do this with the hand tools they normally carried. There is no record of how they dealt with the roots but it is likely that they followed their normal practice and widened the ditch by an amount they judged to be sufficient to compensate for the blocking effect of the roots.

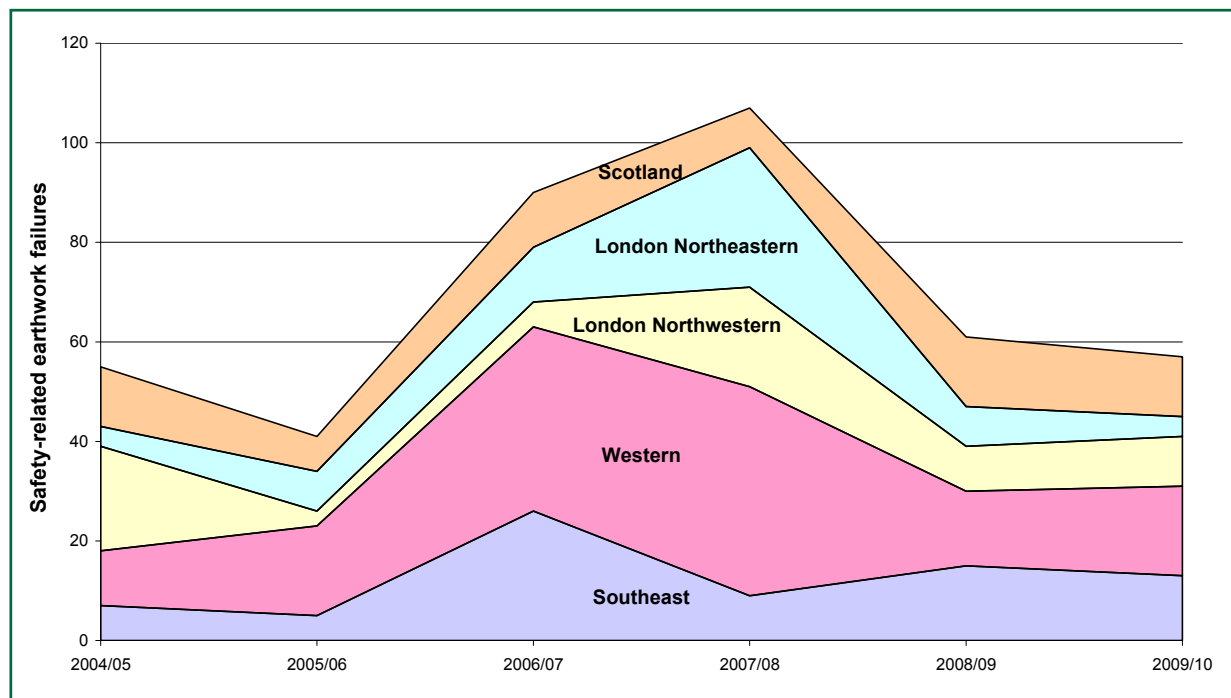
107 As weather conditions have a large effect on earthwork performance, a significant part of the annual variation in earthwork failures may be a consequence of annual differences in weather conditions. In addition, improved reporting of events may have contributed to the increasing number of failures recorded in early years. These factors mean there is insufficient information to draw firm conclusions about trends in earthwork performance.

Figure 11: Earthwork failures 2004 to 2010 by Network Rail territory
