Rail Accident Report

**Incident at Romford station,
4 February 2010**

Report 20/2010
December 2010

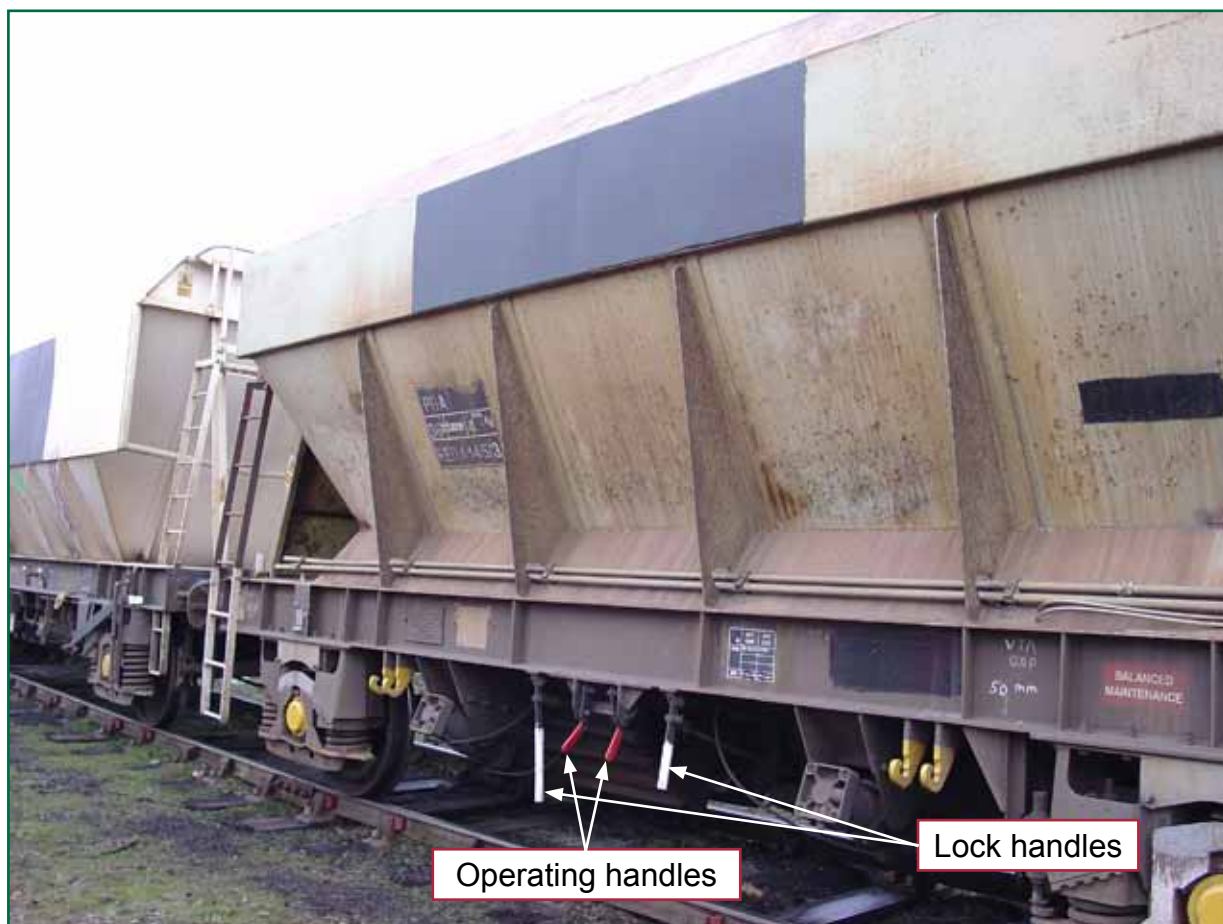
- 16 PGA wagons are air-braked four-wheeled vehicles, which carry mineral or aggregate material in two hoppers, each with a set of power-operated bottom doors which can be controlled by a person standing on the ground alongside the wagon (figure 4).

Figure 4: Wagon 14513, showing door control and locking handles

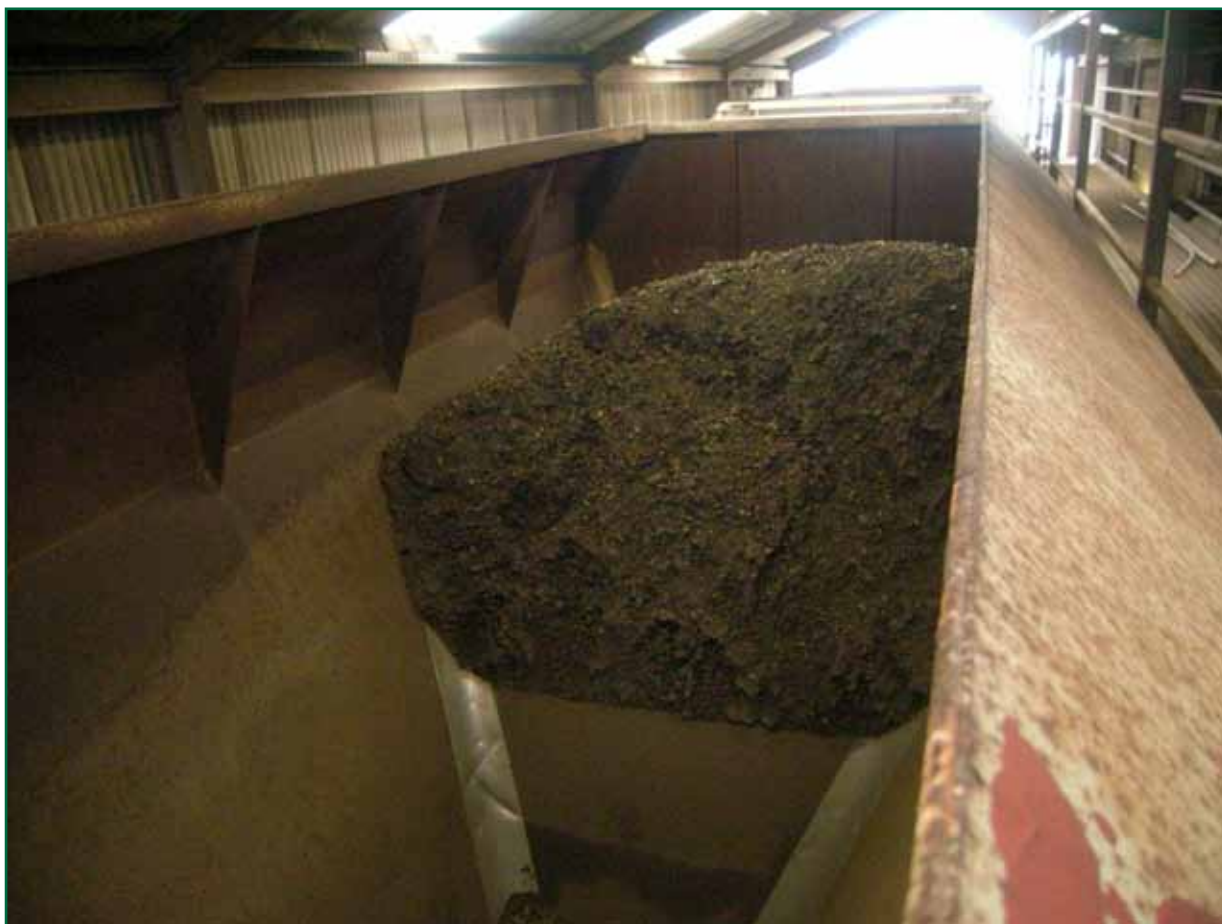
Figure 5: Remaining load in wagon 14513, after the incident

- 40 While the wagon was stationary in Acton yard, from 4 January to 3 February, most of the load is likely to have stuck in the wagon even though one set of doors was open: initially because the load was frozen, and latterly for the reasons discussed in paragraph 36. However, when the wagon was moved some of the load did come out, and several tonnes were found on the tracks in the yard where the wagon was shunted on 3 February. This suggests that a wagon door was open on or after 4 January when the wagon arrived at Acton.
- 41 After the incident, when the RAIB examined the train at Ipswich, the leading pair of doors on wagon 14513 was found to be open, and the other pair, although closed, was not fully locked. One of the two hoppers was empty, and the other was almost full (figure 5).

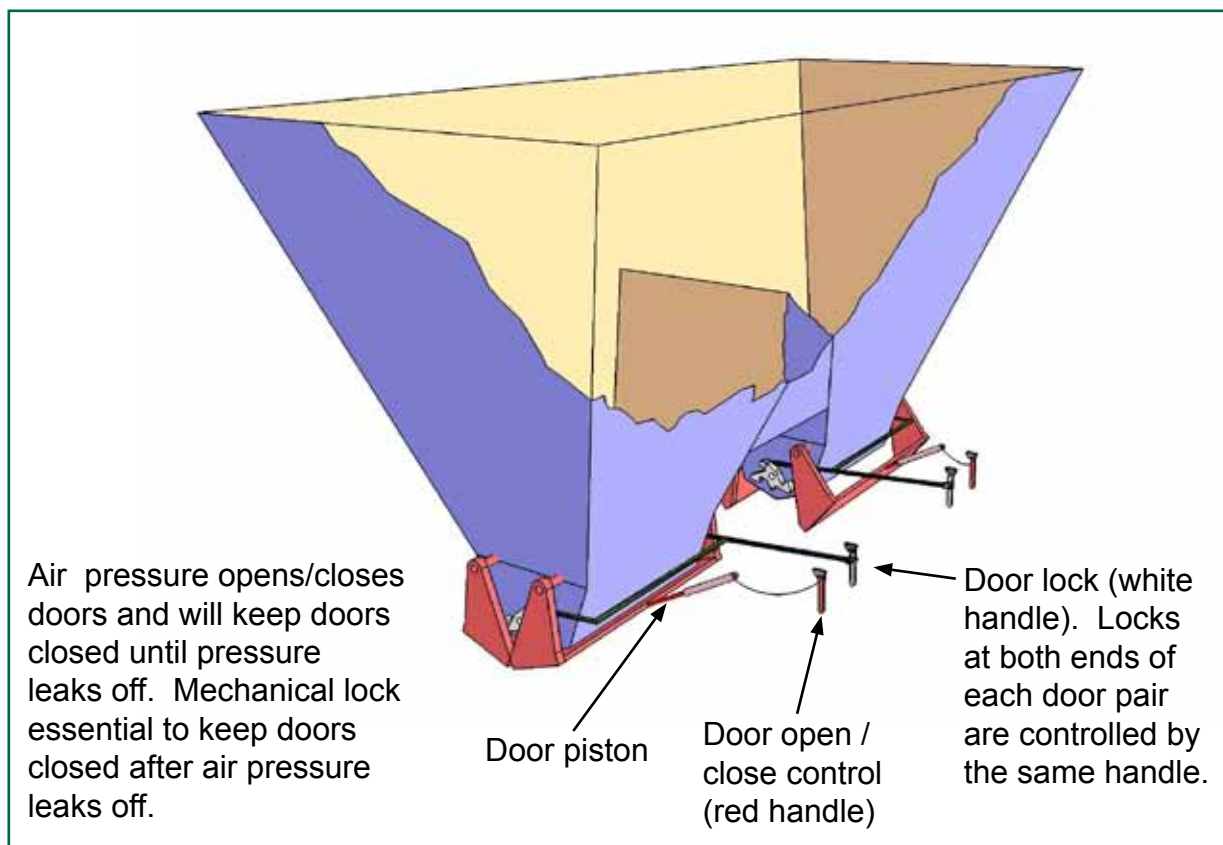
- 43 The hopper doors on PGA wagons are power-operated, and are opened and closed by air cylinders (figure 6). These are controlled by red-painted handles below the *solebar* of each wagon. There is a separate lock mechanism which acts on both ends of each pair of doors, and is operated mechanically by white-painted handles below the solebars⁴.

Figure 6: Door arrangements on PGA wagons

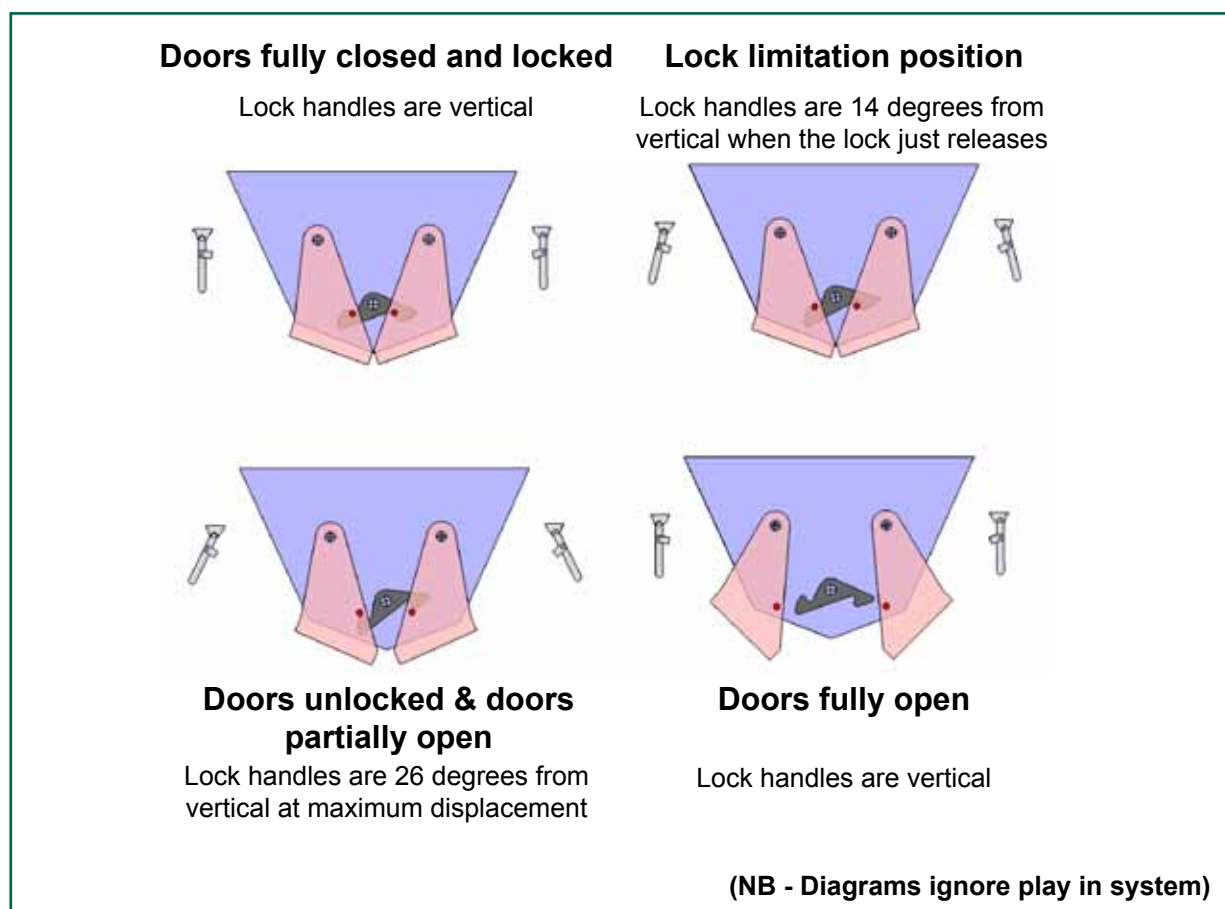
- 44 The lock mechanism uses a hooked cam which engages with a pin on each door (figure 7). Closing the doors should cause the lock to engage, but friction in the linkages and obstruction by stones may mean that the lock is not fully secure until the white handles have been forcibly operated by the person unloading the wagon. Witness evidence suggests that staff were in the habit of kicking the white handles to secure the locks. Once the doors are locked, the design of the mechanism means that it is not possible for them to be unlocked without deliberate action by an operator.

Figure 7: Door locking handles

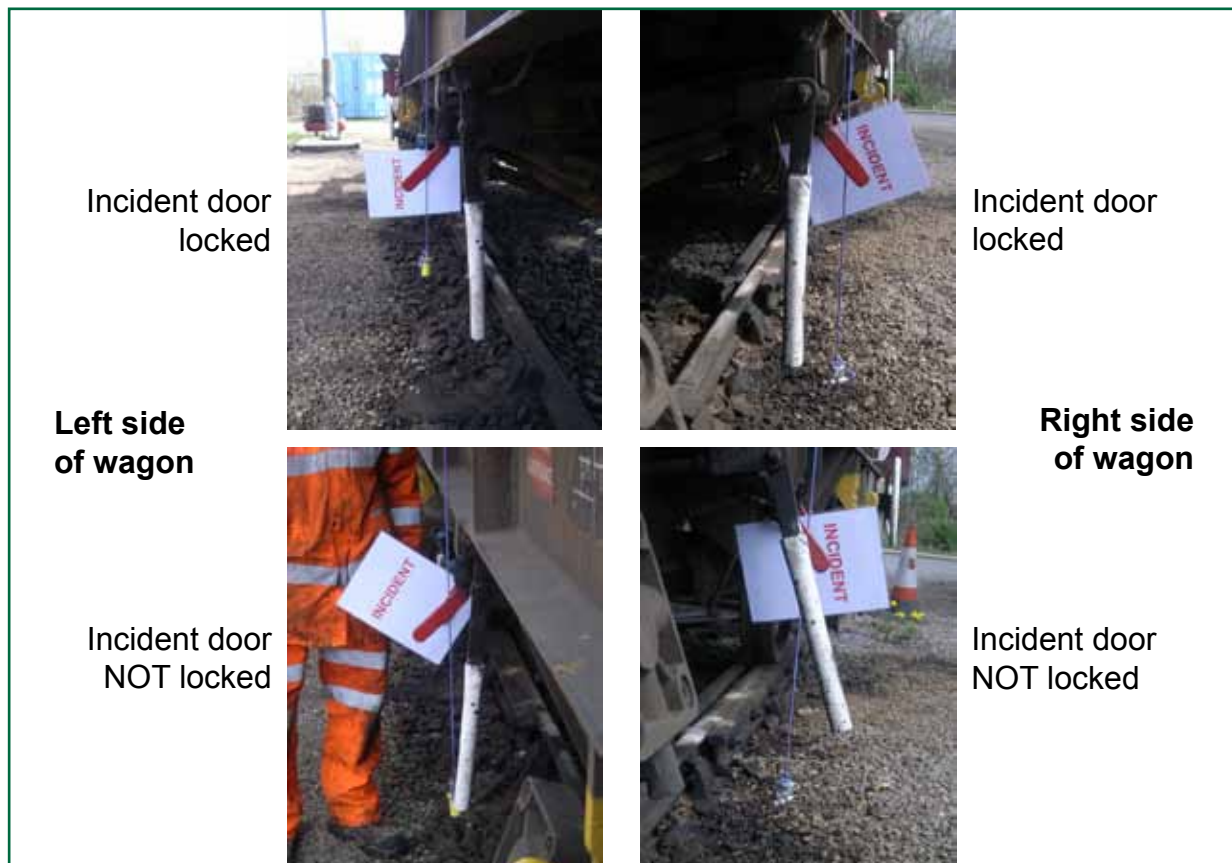
42 The position of the lock handles on the PGA wagon can lead staff to believe that the doors are closed and locked when the doors are actually partially or fully open. The design of the mechanism permits this condition to exist. This was a causal factor.

- 45 The lock handles are designed to be nominally vertical when the lock is engaged and secure, and to stick out at an angle if it is not. However, the RAIB's tests found that, because of the design of the cam, and wear and distortion in the rodding linking the handles to the cam, the variation in the position of the handles was very small, and could not be relied on to indicate the state of the lock (figure 8). Handles could appear to be vertical with the doors both locked and unlocked. This is a probable causal factor, because witness evidence indicates that staff making visual checks relied on the position of the handles to indicate the condition of the doors.

Figure 8: Variations in handle position between doors locked and unlocked

- 1 *The intention of this recommendation is that the PGA wagon fleet should be modified to enable wagon discharge operators to have a clear indication of the state of the doors.*

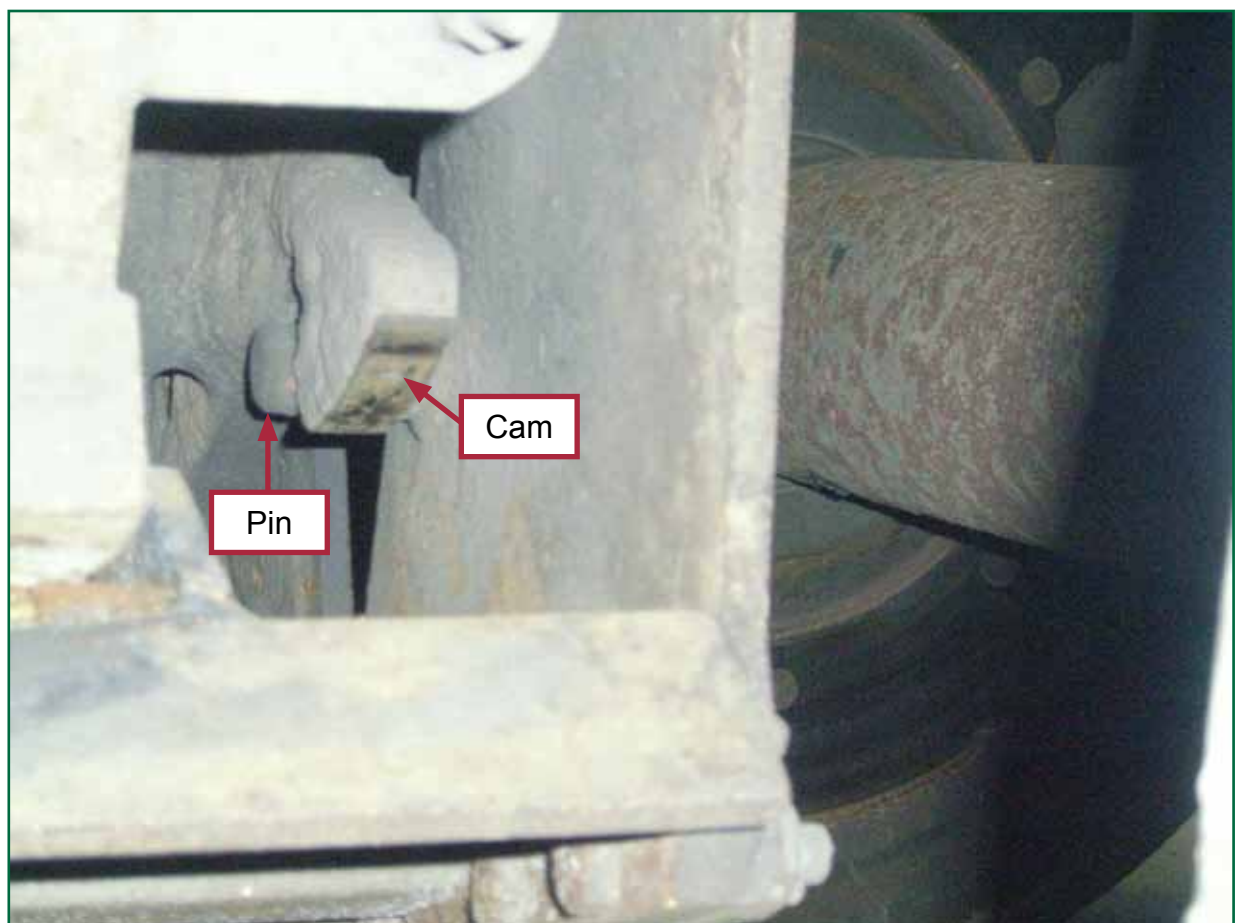
Figure 9: View of lock mechanism, between doors and hopper, showing cam not fully engaged with pin

- 47 The only way to be certain that the lock is secure is to confirm that the cam has engaged with the door pin by looking through the gap between the ends of the doors and the hopper (figure 9). This is not easy to do: it is awkward and time-consuming, and requires a torch, sometimes even in daylight.
