Rail Accident Report

**Fatal accident at Moreton-on-Lugg,
near Hereford,
16 January 2010**

Fatal accident at Moreton-on-Lugg, near Hereford, 16 January 2010

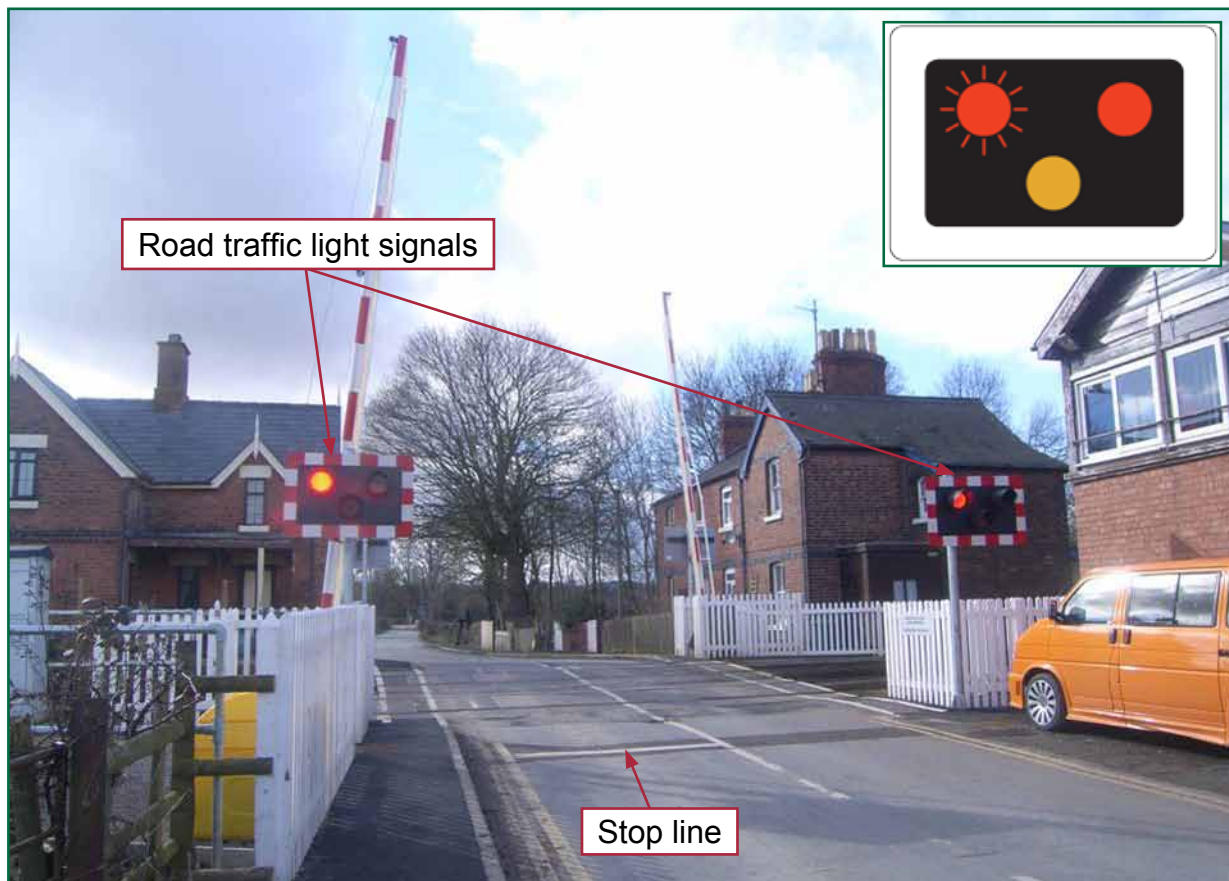
Figure 5: Moreton-on-Lugg level crossing from the east (inset: road traffic light signal from Highway Code)

- 23 The level crossing at Moreton-on-Lugg (figure 5) has two *BR 843 Mk 2 barrier units*, one on each side of the railway. When lowered, the barriers extend across the full width of both the road and adjacent footways. There are two sets of road traffic light signals in front of each barrier, one on each side of the road. The traffic light signals have *light emitting diode* (LED) light units. Stop lines, on the approach side of the road, are marked 2 metres in front of each pair of traffic light signals. There is an audible warning for pedestrian users. Figure 6 is a plan view of the crossing.

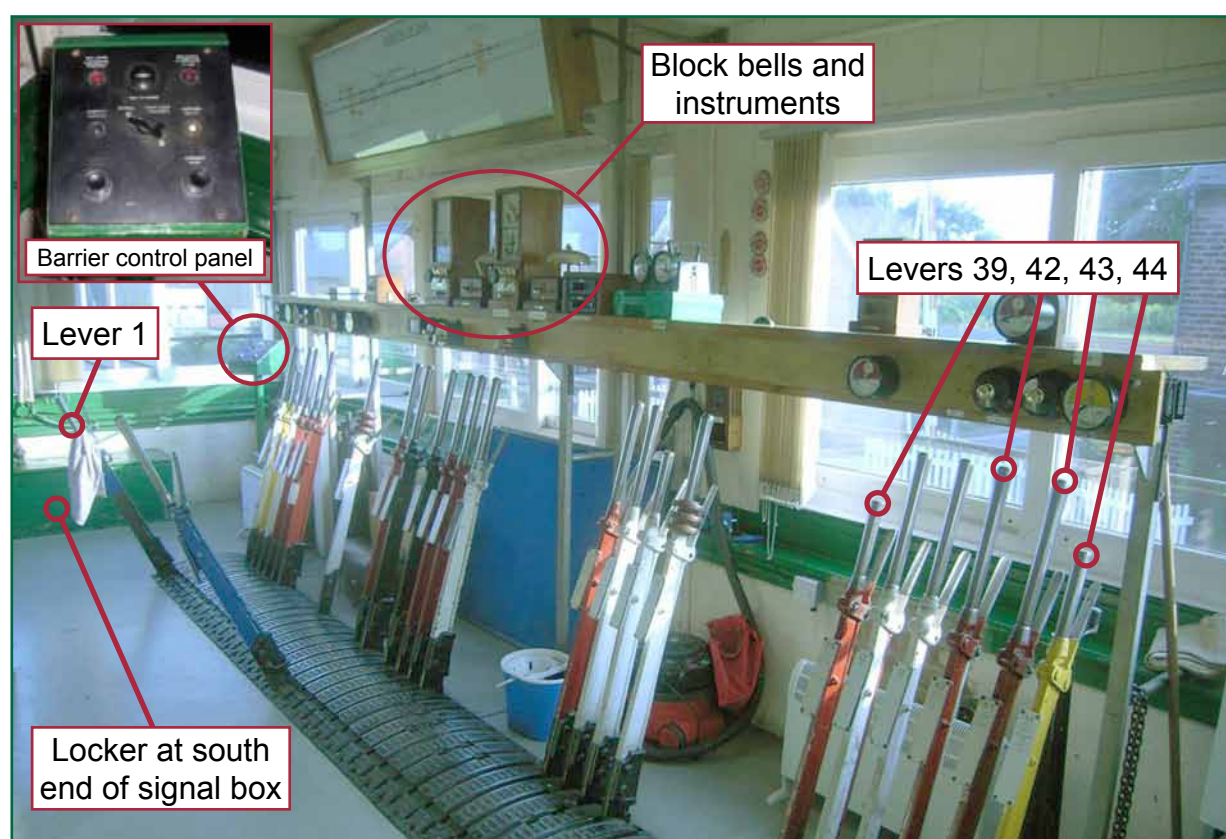
Figure 7: Signalling and level crossing controls in Moreton-on-Lugg signal box

- 30 The signaller controls the signals and *points* from a *lever frame*; there are 15 levers currently in use. The barrier control panel (paragraph 26) is located to the south side of the frame, between the road and lever 1. Lever 1 provides the interlocking between the railway signals and the barrier controls. The signaller pulls it so that, via the electrical interface (paragraph 26), the barrier control panel is made active. The signaller can only push lever 1 back (*replacing* it in the frame) if the barriers are fully down. There are *block instruments* on a shelf over the frame for *offering* and *accepting* trains to and from Hereford and Leominster (paragraph 15). The controls are shown in figure 7.

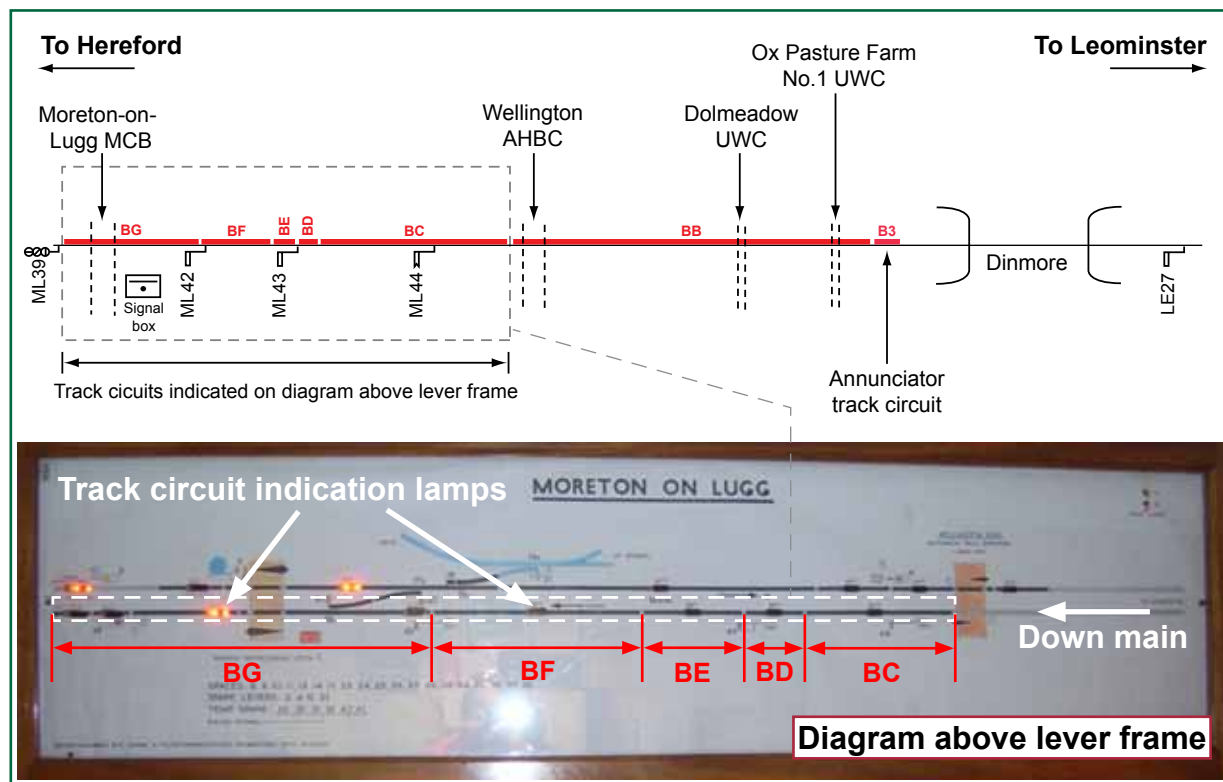
Figure 9: Signalling on the down main approaching Moreton-on-Lugg (not to scale)

- 34 Figure 9 shows the layout of the signalling on the down main between Leominster and Moreton-on-Lugg, the line on which train 1V75 was approaching. It also shows the location of the track circuits and their indication on the diagram in the signal box (paragraph 31).

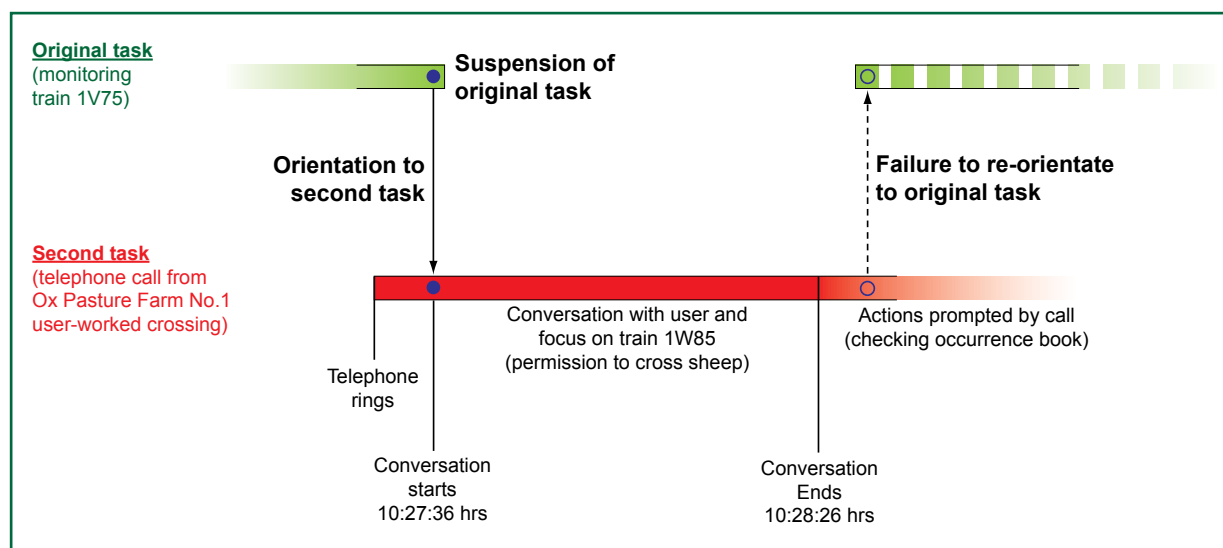
Figure 11: Interruption resulting from the second call from Ox Pasture Farm No.1 user-worked crossing

Figure 11 is a simplified diagram of the interruption caused by the second call from Ox Pasture Farm No.1 user-worked crossing.

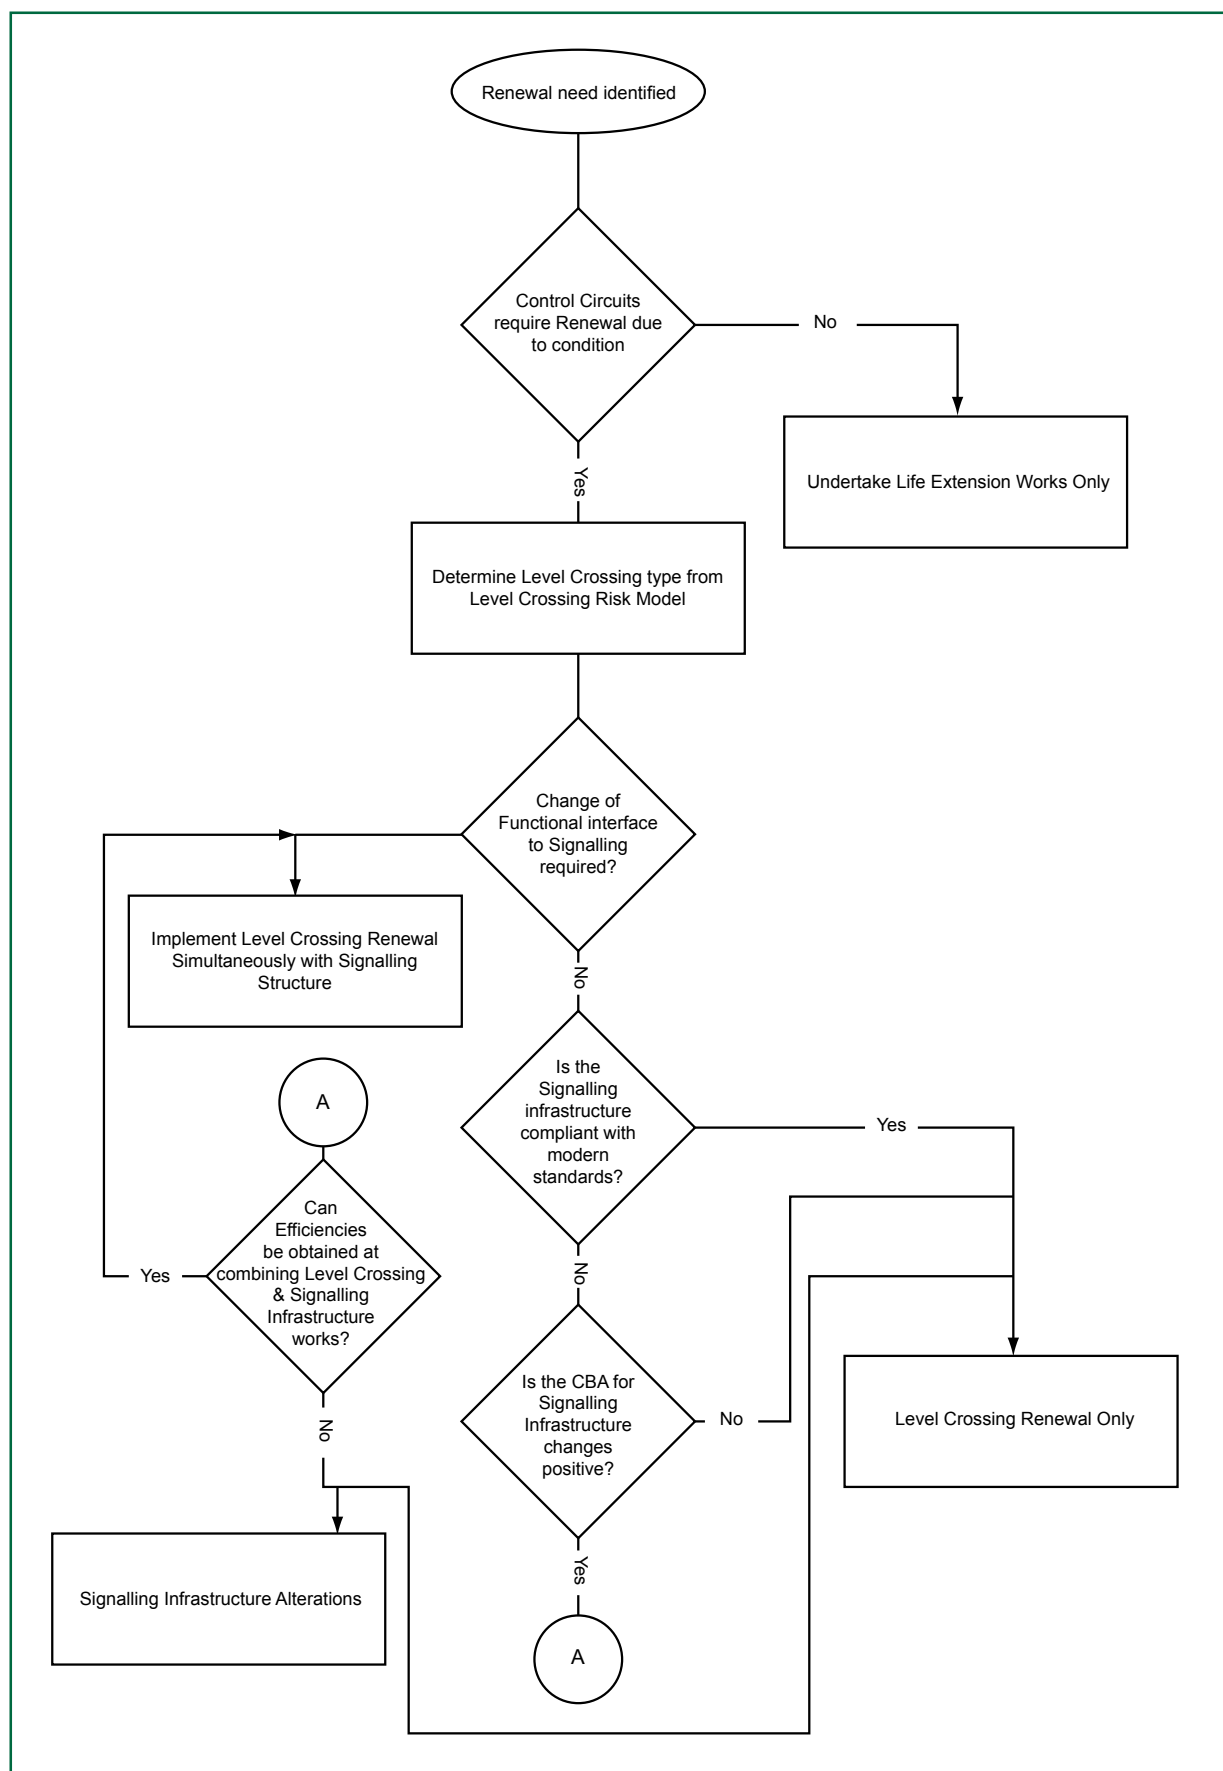
Figure 12: Level Crossing renewal flowchart produced by Network Rail for discussion in 2007 (note: the term 'life extension works' is used instead of partial renewal)

- 146 The decision to carry out a partial renewal, as a strategy to improve value for money, limited the signalling renewal work at Moreton-on-Lugg to like-for-like equipment replacement. This contributed to there being no industry requirement to do a risk assessment to consider the safety benefit of an upgrade to bring the wider signalling system into compliance with current engineering standards.
