Rail Accident Investigation Branch

Rail Accident Report

Runaway of an engineering train from Highgate 13 August 2010

13 August 2010

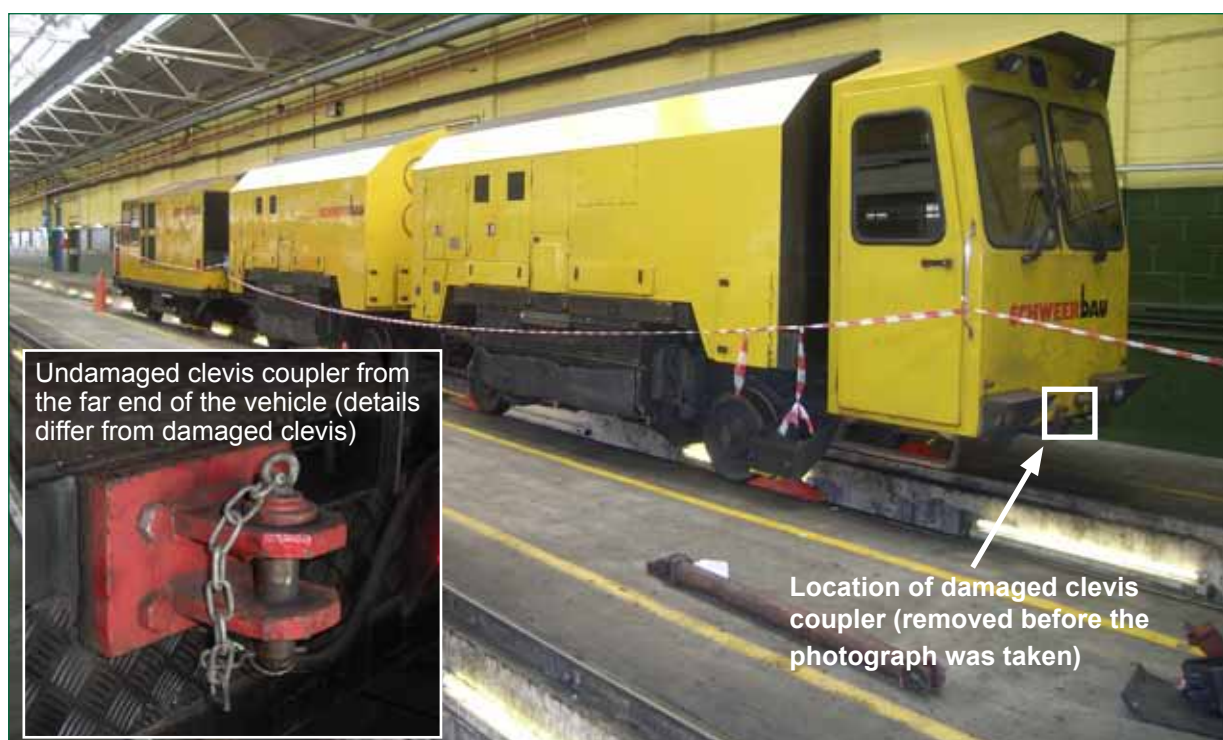
Figure 3: Rail grinding unit showing vehicle end which collided with passenger train.

- 23 The RGU is a self-propelled three-car diesel powered on-track grinding machine weighing about 37 tonnes (figure 3). It is equipped with grindstones which are used to maintain the shape of the railhead to give trains a safe and reasonably smooth ride. The train was built in 2001 and moves between various European railway and tramway systems. It was first used on LUL infrastructure in 2002. The RGU can be used in tunnels provided special ventilation arrangements are made to control exhaust emissions. The emergency coupler used with the RGU is described in paragraph 121. The defect which necessitated towing the RGU, and the absence of effective brakes during this activity are discussed in paragraph 68.

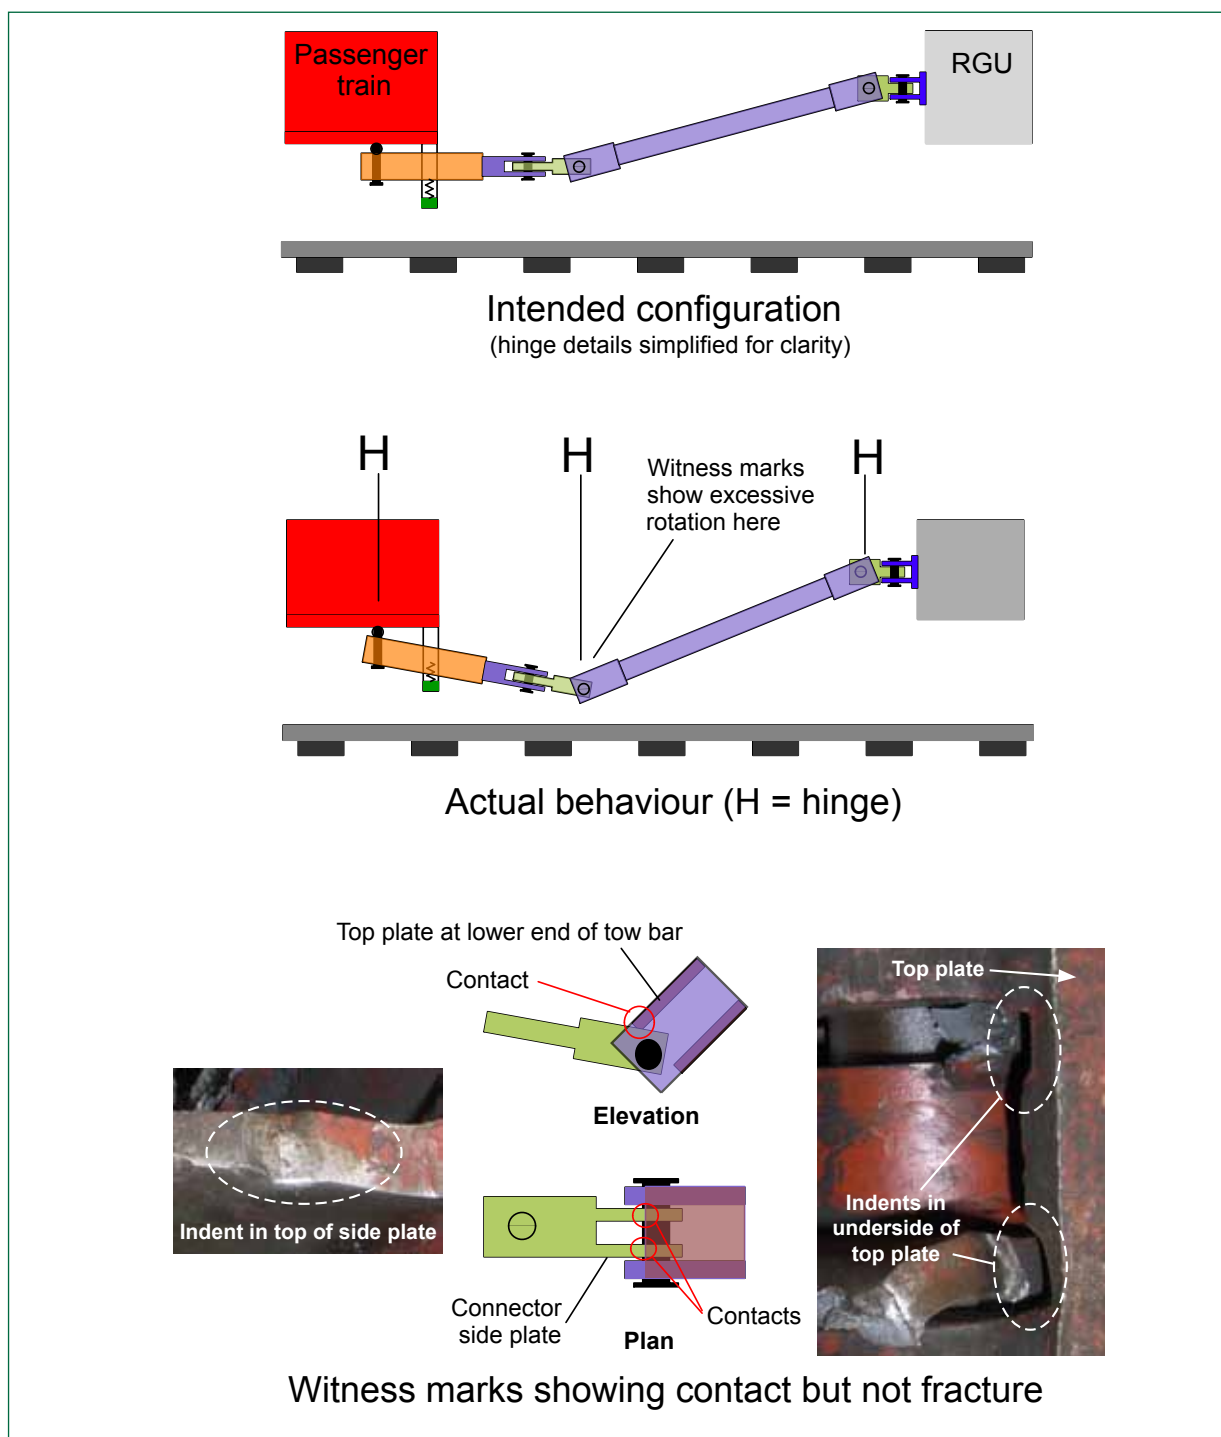
Figure 13: Vertical coupling deflection (phase 1 of breakage).

- 125 The excessive downward deflection of the coupling in phase 1 was due to the presence of three hinges allowing vertical rotation at the top of the tow bar, the lower end of the tow bar and the wedglock/car body fixing (figure 13). The nature, but not the maximum extent, of this deflection is illustrated by the still images extracted from a video made by Tube Lines during testing after the July 2010 incident (figure 14). This type of deflection was also described by witnesses to the attempted push recovery during the July 2010 incident and was seen during tests by the RAIB after the Highgate incident. The extent of this movement is evidenced by marks on the metal plate which extends over the pin at the lower end of the tow bar (figure 13).

126 The RAIB has calculated that the maximum vertical deflection was probably just sufficient for the lower end of the tow bar to have touched the *negative rail* (centre rail) as reported by staff who observed the attempted push recovery during the July 2010 incident. There were no marks indicating that the coupler struck the negative rail at Highgate. Contact may have occurred without leaving marks, as the area of tow bar likely to touch the rail had been wrapped with an insulating mat intended to prevent an electrical hazard if the coupler touched the negative rail (paragraph 167). Alternatively, the lateral deflection of phase 2 may have meant that the relevant part of the tow bar was not directly above the negative rail.

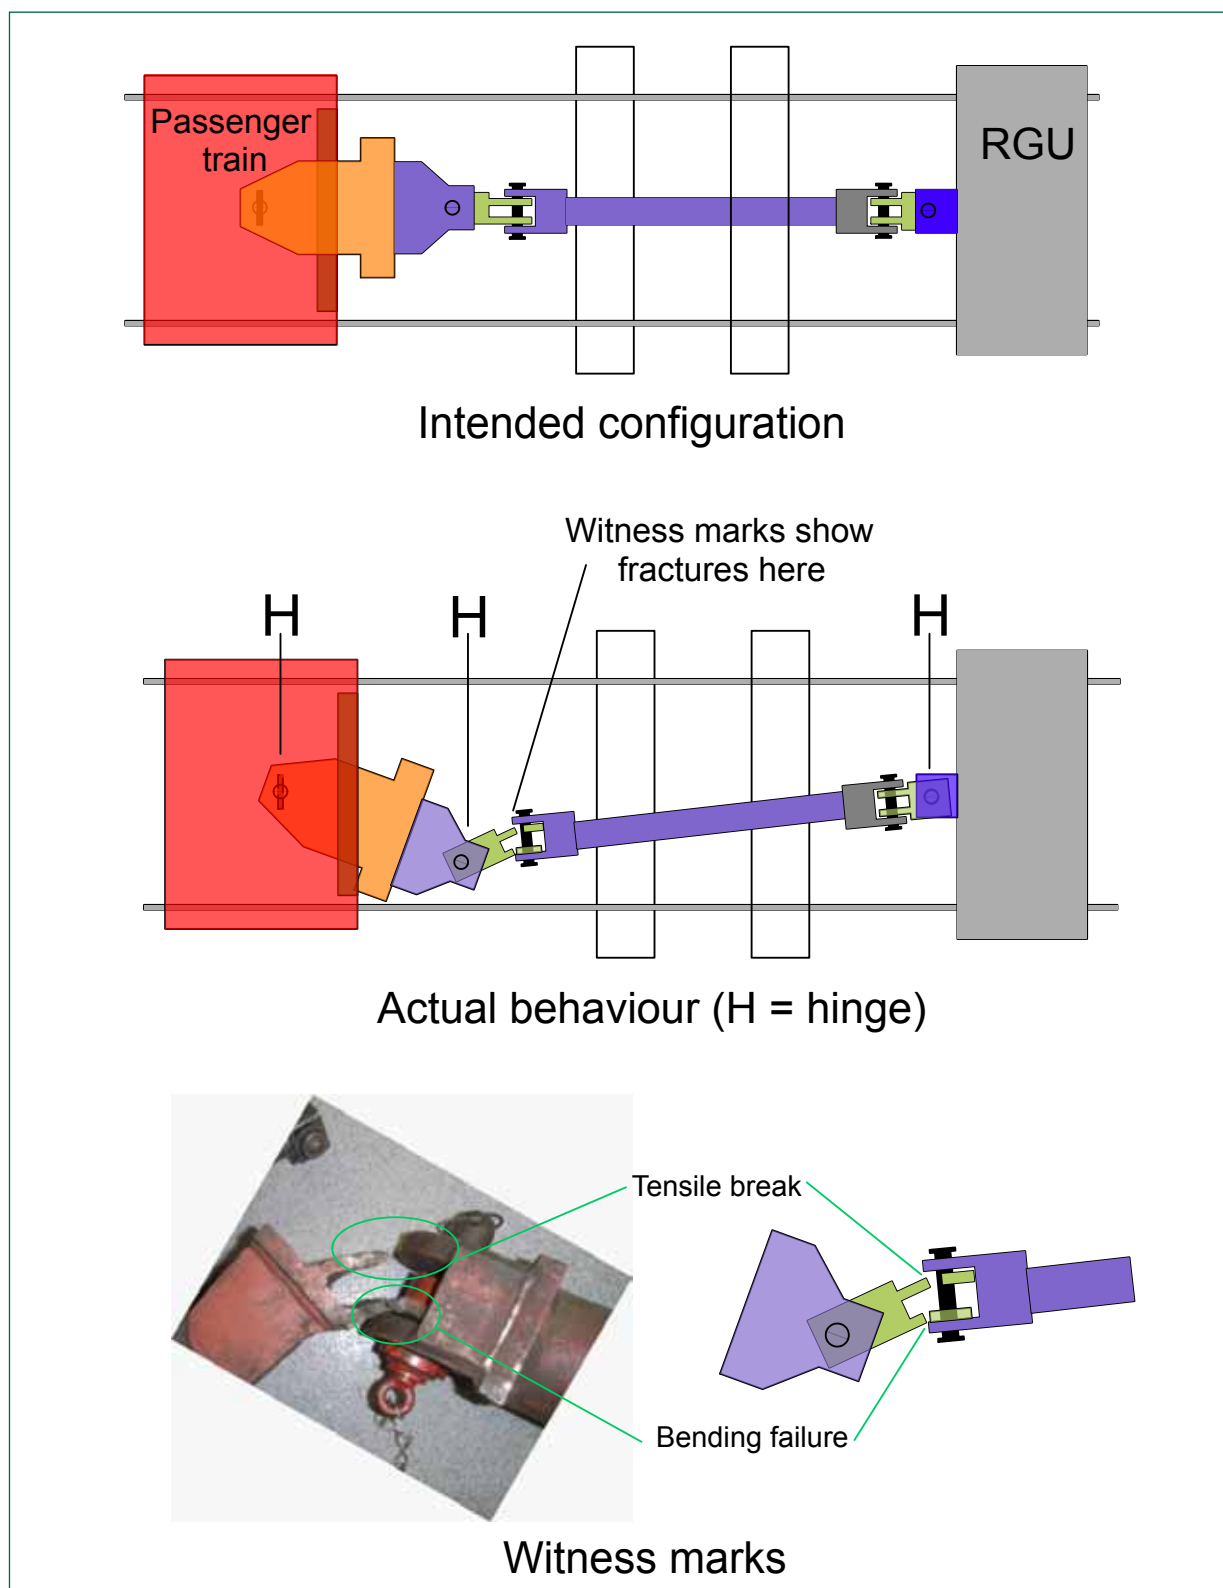
Figure 15: Lateral coupling deflection (phase 2 of breakage).

127 The excessive lateral deflection of the coupling in phase 2 is again due to the presence of three hinges. These allow lateral rotation at the clevis pin, at the adaptor box/tow bar connection and at the wedgelock/car body fixing (figure 15). This movement was observed during the push recovery in July 2010 and in the RAIB testing (figure 16). It is also evidenced by the way in which the two plates at the lower end of the tow bar fractured during the Highgate incident (figure 15).

- 128 The RAIB inspected the fracture faces shortly after the incident and concluded that the fracture was caused by a sudden overload event. There were no indications of fatigue failure and no significant manufacturing defects could be seen. RAIB has calculated that, during the emergency brake application, the coupling was subject to a compressive load of about 5.7 tonnes; significantly more than the 3.5 tonnes at which the coupler would be expected to fail in the deflected phase 2 configuration.

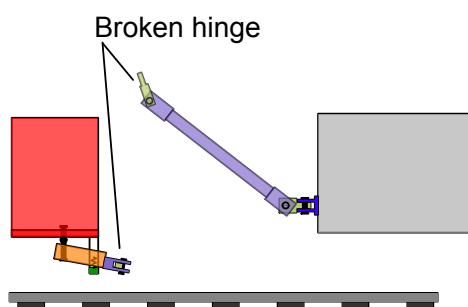
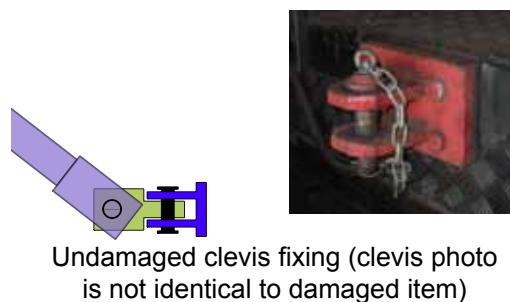
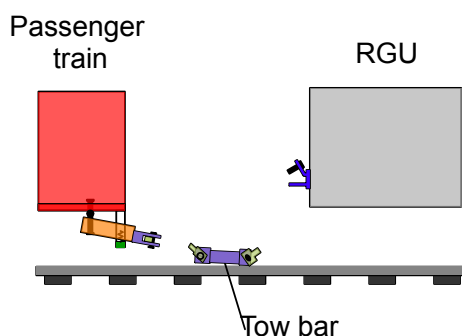
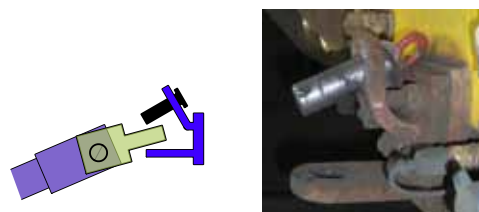
Figure 17: Upward tow bar movement (phase 3 of breakage).

- 129 Phase 3 included the rapid upward movement of the tow bar and a collision between the RGU and the assisting train. The upward movement was observed by staff at Highgate; the collision is evidenced by the marks on the trains shown on figure 17. The upper RGU clevis plate deformed during the collision and allowed the tow bar to fall onto the track (figure 17). RAIB has not attempted to model phase 3 in detail.

Energy stored in compressed coupling components causes tow bar to flip upwards

Collision - the upper clevis plate is initially horizontal (witness marks 3 & 4), and is pushed upwards during the collision (witness marks 1 & 2)

Tow bar falls onto track (may occur during phase 3B); RGU rolls backwards

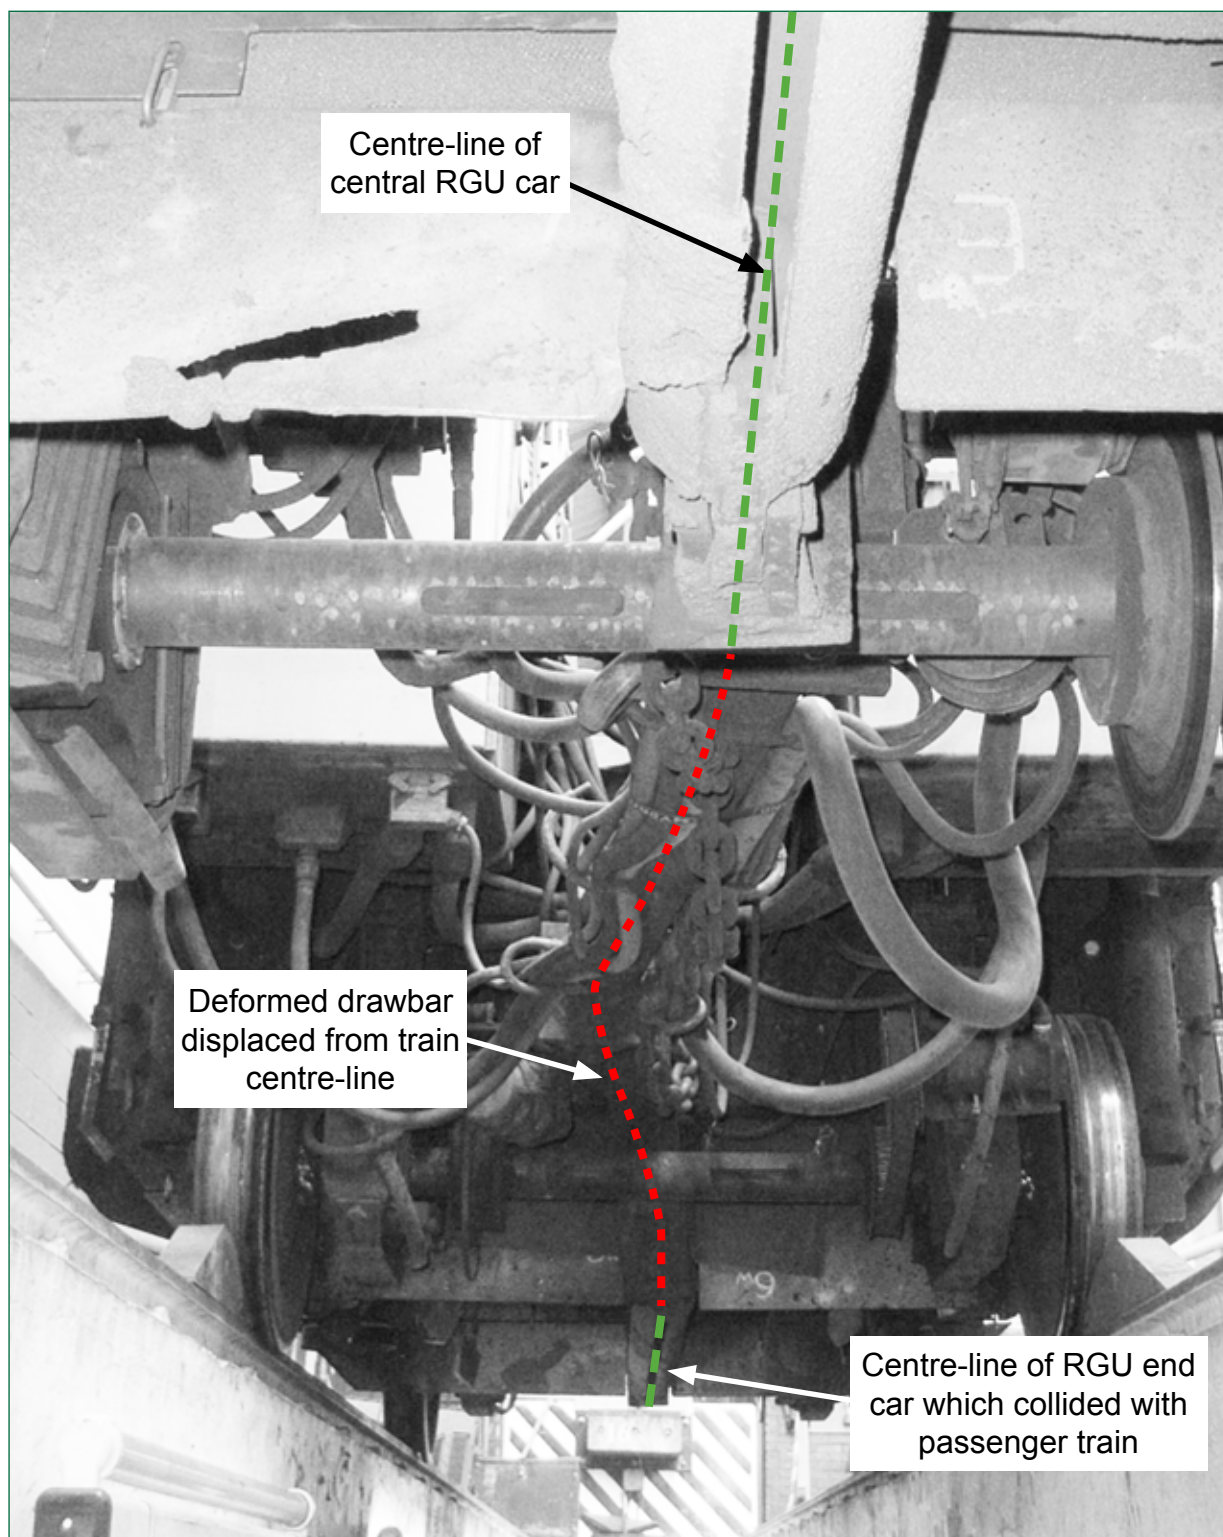
Figure 18: Deformed drawbar on RGU.

- 131 After the incident, significant deformation was found in the drawbar linking two of the RGU cars (figure 18). The drawbar damage may have been caused during the incident. It is not likely that the damage existed before the incident because it would probably have been detected during the daily inspection of the RGU. Even if the damage existed before the coupling broke, it would not have played any part in the emergency coupler failure.
