# Rail Accident Report

**Train passed over Lydney level crossing with  
crossing barriers raised  
23 March 2011**

# **Train passed over Lydney level crossing with crossing barriers raised, 23 March 2011**

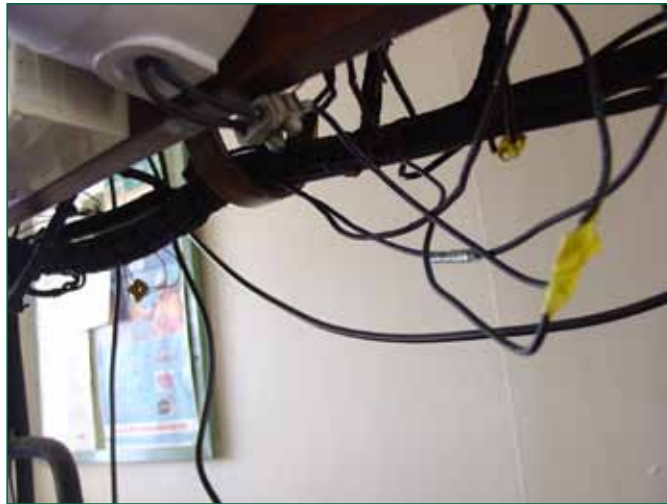
- 52 Network Rail undertook full functional testing of the crossing after the incident. This testing was undertaken after the defective contacts on the barrier pedestal were replaced, and before RAIB attended site (RAIB did not attend immediately after the incident because, although a serious incident<sup>9</sup>, Network Rail did not report it to RAIB until the following day). Network Rail's testing did not reveal a fault which would explain why the annunciator failed to sound when expected. Possible reasons include a temporary high resistance electrical contact (ie a dirty electrical contact), or poor connections in the disorganised wiring seen beneath the instrument shelf (figure 8).

*Figure 8: Disorganised wiring beneath the instrument shelf on 7 April 2011*

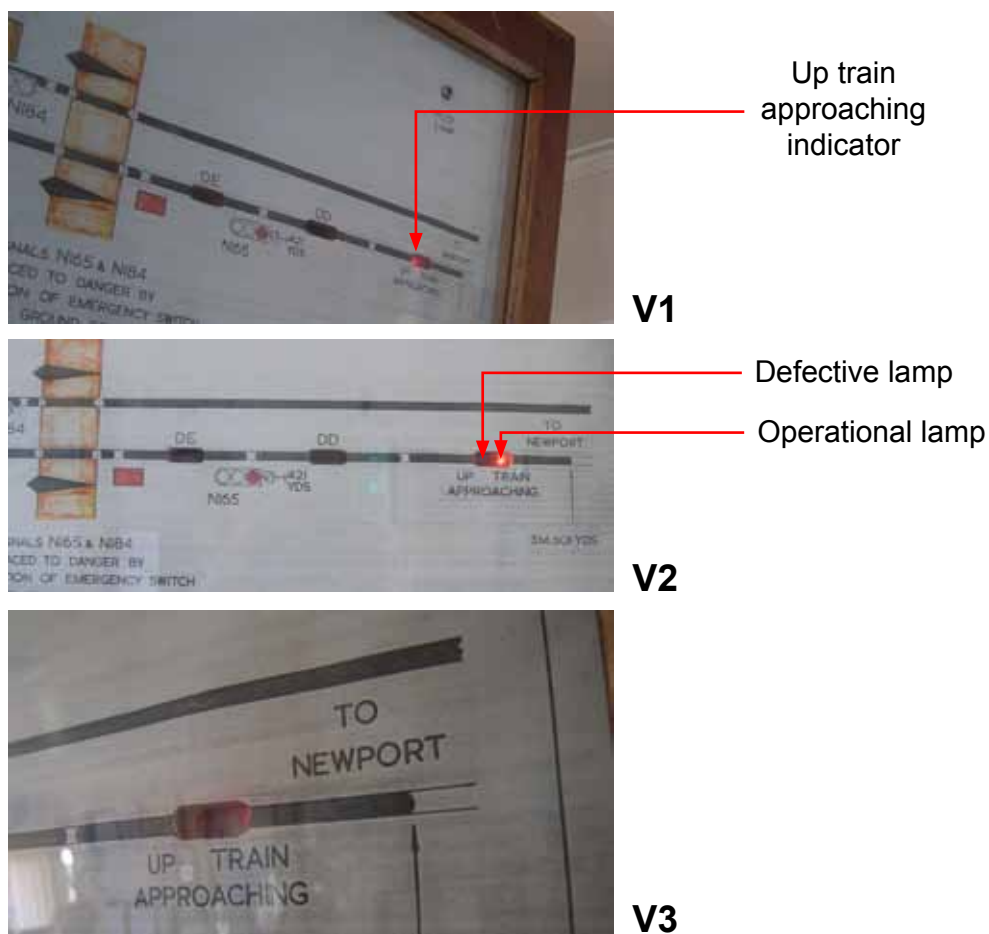
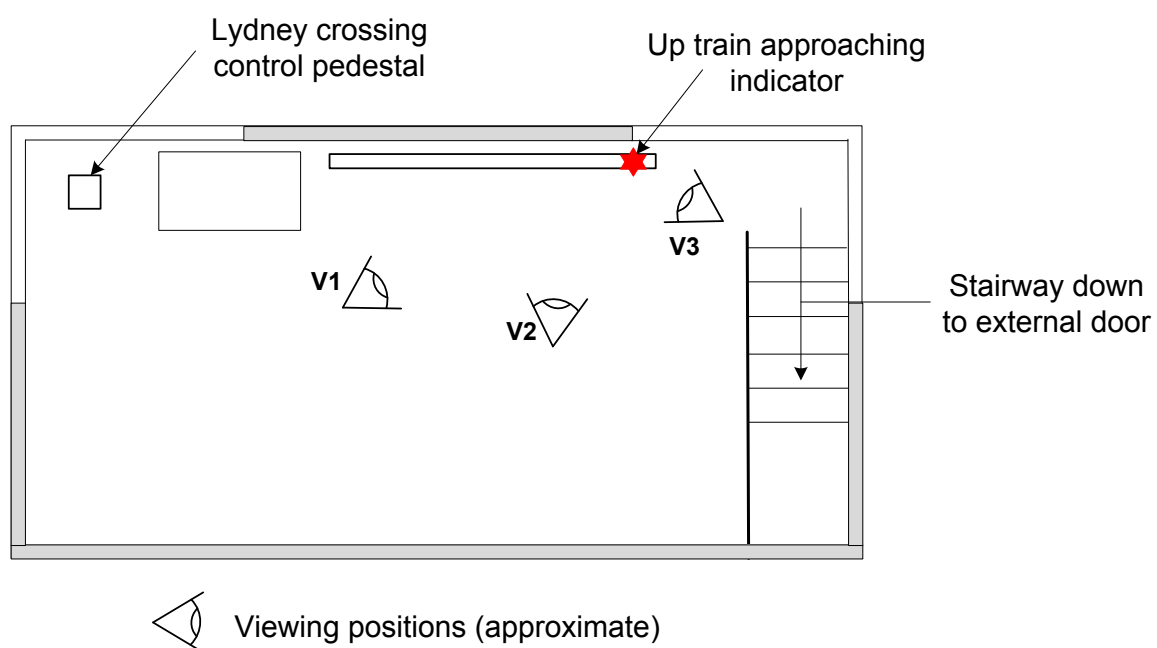
Figure 9: Visibility of up train approaching indicator

- the crossing keeper did not properly examine the diagram.
- 58 Post-incident examination by the RAIB showed that one of the two lamps in the up train approaching indicator was defective (figure 9) and the surface layer of the diagram was detached from the backboard around this indicator.

- 59 When the crossing keeper was deciding whether to raise the barriers manually, train 1M68 was occupying track circuit 1137 and this would have illuminated the up train approaching indicator. Post-incident testing by RAIB showed that, when viewed from directly in front, this indication was easily seen although the left-hand lamp was defective (figure 9, view V2). Viewed from the left (view V1), conspicuity of the indication was poor because the detached surface layer partially obscured the illuminated lamp. Viewed from the right (view V3), the defective lamp and the detached surface layer meant that it was difficult to see that the indicator was illuminated.

- 60 The crossing keeper was standing at the control pedestal when the barriers did not respond to the raise button. He then moved towards the stairway in order to leave the box and raise the barriers manually. It is possible that, while doing this, he viewed the diagram and, due to the diagram and indicator defects, gained the impression that the indicator was not lit.

- 151 RAIB wrote to Network Rail, on 18 April 2011, giving the preliminary findings of the RAIB's investigation. On 12 May 2011, following a further visit to Lydney, the RAIB advised Network Rail that the Lydney diagram was defective.
