# Rail Accident Report

## Two incidents involving track workers between Clapham Junction and Earlsfield 8 March 2011

# Two incidents involving track workers between Clapham Junction and Earlsfield, 8 March 2011

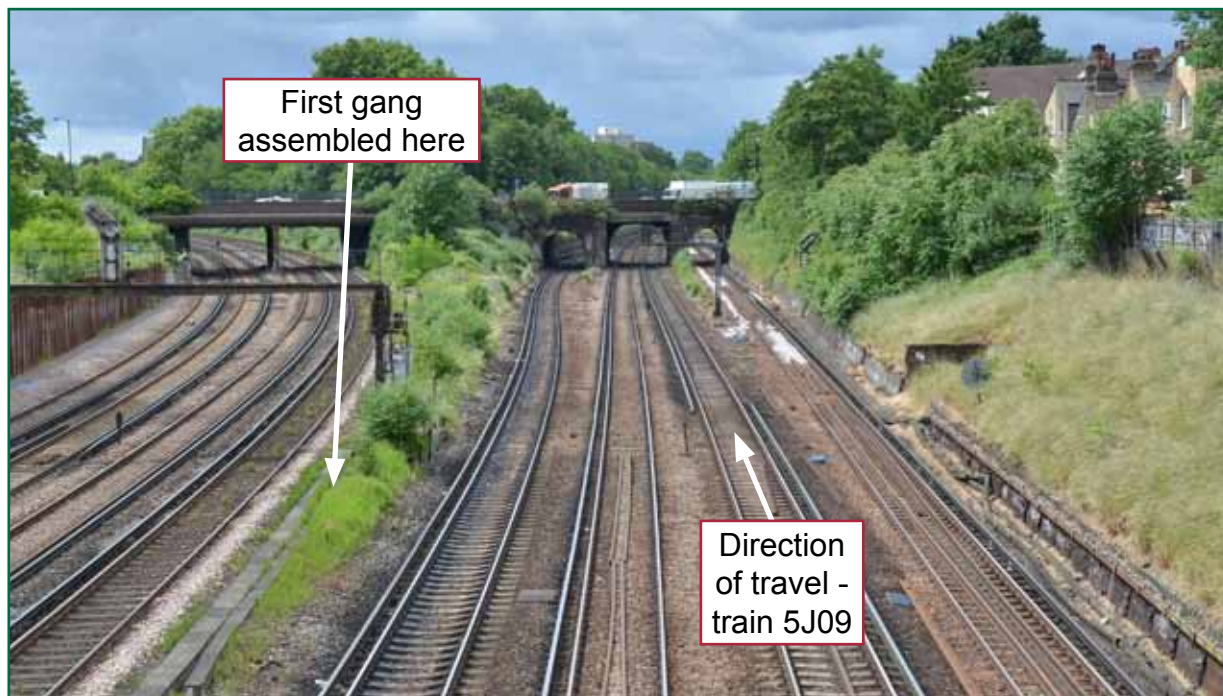
Figure 2: View of Wessex lines at 4 miles 14 chains, showing where the first gang assembled after the first incident at 05:46 hrs

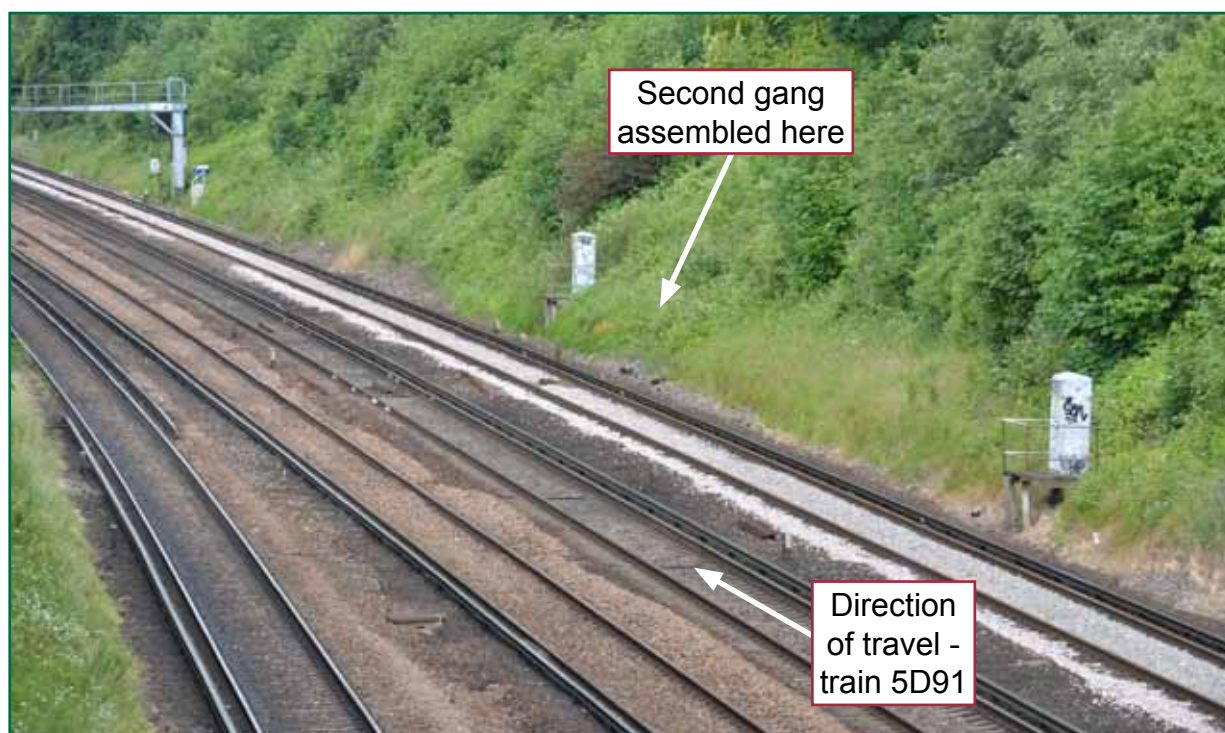
Figure 3: View of Wessex lines at 4 miles 76 chains, showing where the second gang assembled after their near-miss incident at 06:10 hrs

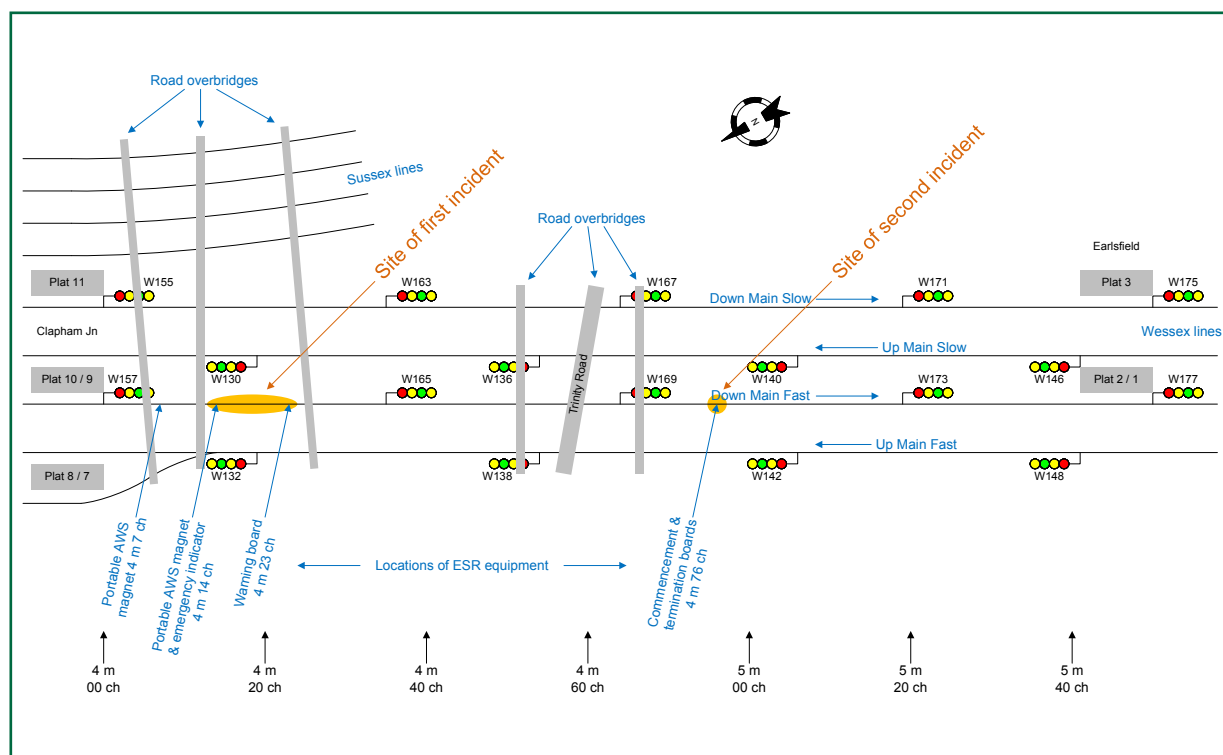
Figure 5b: Layout of the ESR equipment installed on the Down Main Fast line on 8 March 2011

- 119 The driver of train 5D91 received the warnings triggered by the portable AWS magnets and observed the emergency indicator shown in figure 5b; the warning board was probably not visible as it had fallen over (paragraph 39). He did not immediately tell the signaller about the missing warning board as required by module SP of the Rule Book (if necessary stopping his train specially). He had been accelerating as he passed the ESR equipment, using step 2 of the traction controller<sup>14</sup>. About 350 metres further on, just before he passed signal number W165, he increased his traction demand to step 4, and continued until he observed COSS B's gang about 670 metres later (paragraph 44).
