Rail Accident Investigation Branch

Rail Accident Report

Boiler incident on the Kirklees Light Railway 3 July 2011

3 July 2011

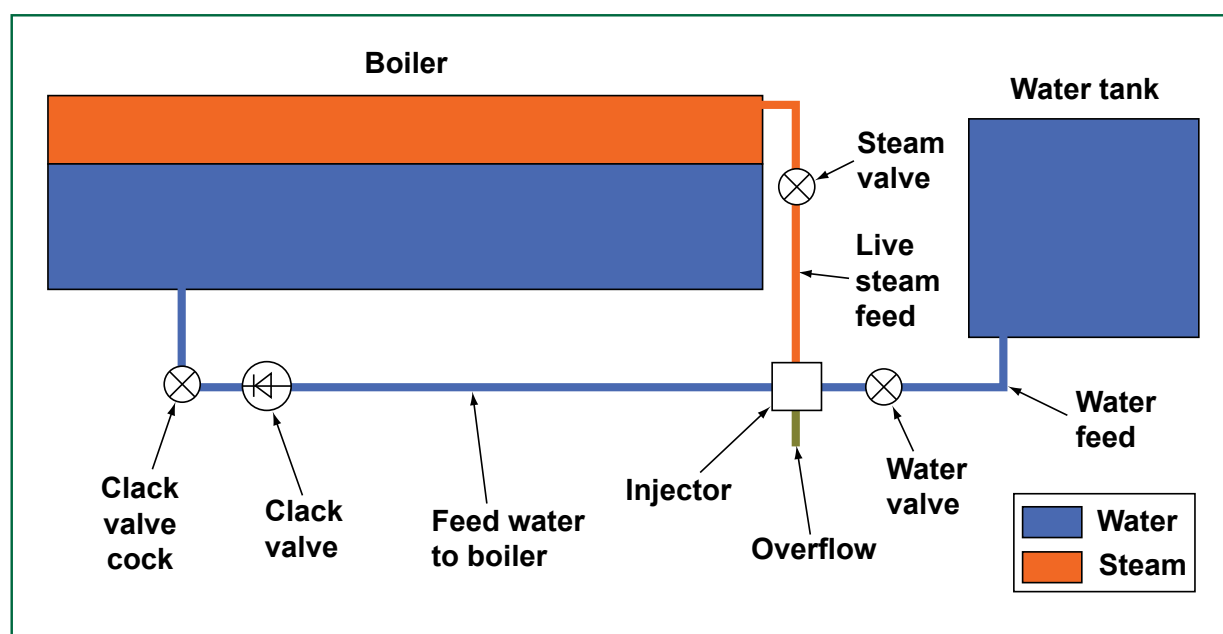
Figure 3: Schematic diagram of the water feed arrangements

- 52 When examined by the KLR's responsible officer after the incident, the valve between the clack valve and the boiler was found to be open by only 1 ½ turns (paragraph 33). Following the incident, the RAIB tested an identical valve on another KLR locomotive and found that the injector worked with the valve open by any amount beyond ¼ turn. After locomotive Hawk's boiler had been repaired and the locomotive had been reconstructed, the RAIB conducted a test using the original large injector valve, refitted to locomotive Hawk. The test measured the rate of fill of the injector with the valve open by various amounts. The results showed that the injector started to work when open by ¼ turn and that the rate of fill was the same with the valve opened ¼ turn, 1 ½ turns and 12 turns (fully open). The limited opening of the valve on the day of the incident would therefore not have affected the rate at which the injector filled the boiler.

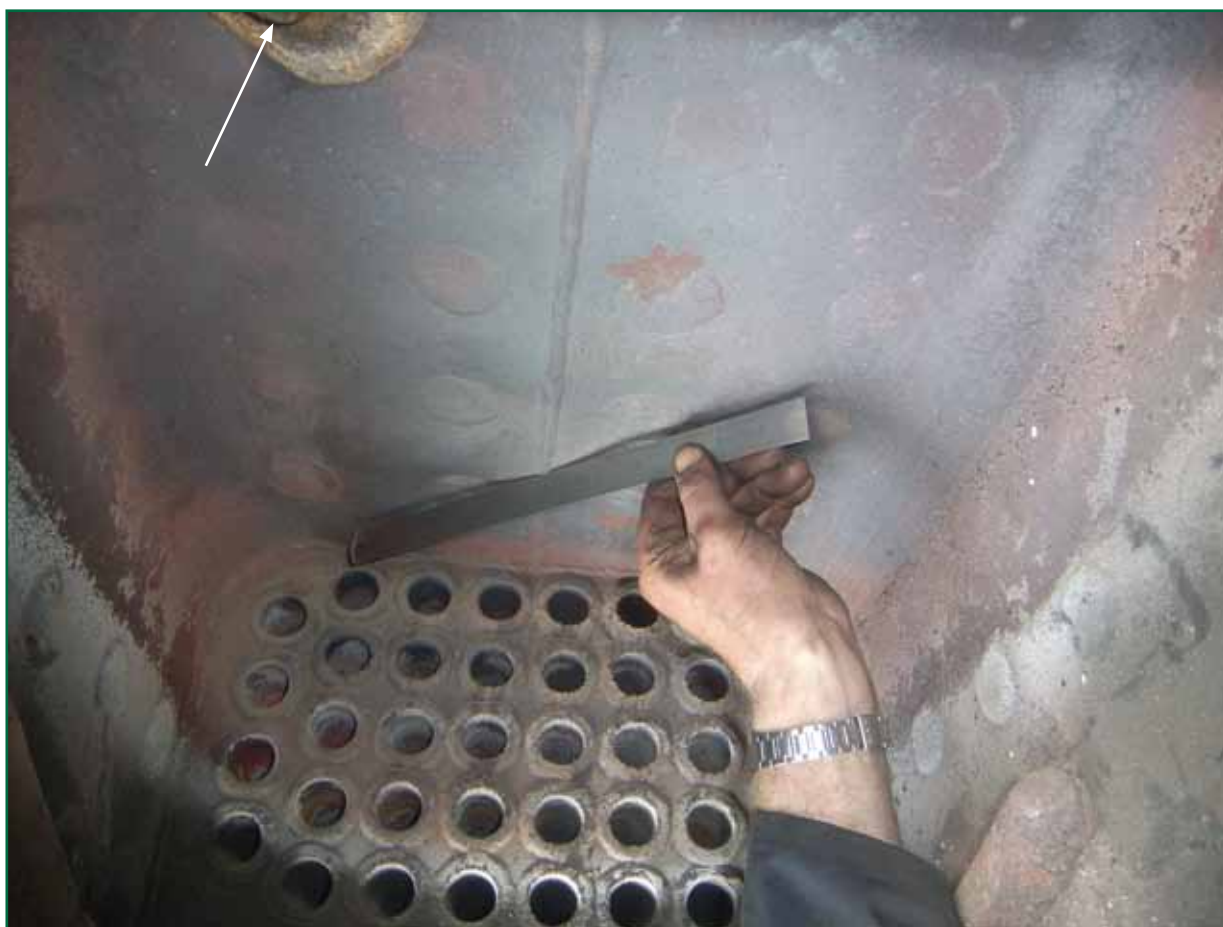
Staff involved

Figure 7: Interior of firebox showing scorch marks and quilting of the crown (location of fusible plug arrowed)

50 The water level in the boiler was allowed to fall so low that the fusible plug melted and the firebox crown sheet was damaged. This was a causal factor in this incident.
