Rail Accident Report

Partial failure of Bridge 94, near Bromsgrove, 6 April 2011

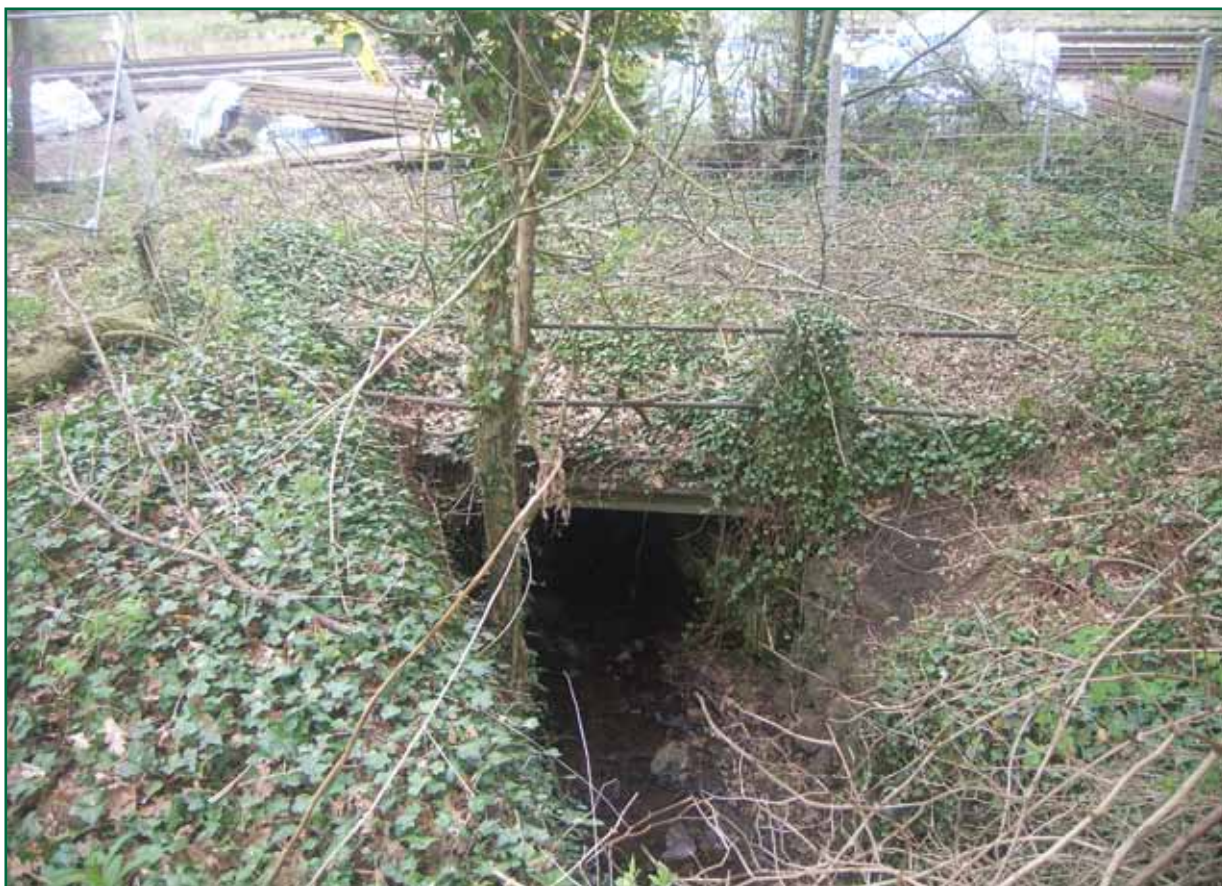
Figure 5: Upstream headwall with railway in background

- 20 Bridge 94's upstream headwall is located outside the railway boundary on the down (east) side of the railway in woodland (figure 5). The downstream end lies beneath a modern housing development (paragraph 17) and does not have a headwall.
- 21 Deck E, which partially failed on 6 April 2011, supports the down goods loop, the down main line and part of the up main line. It is a brick arch, 0.4 metres thick comprising 3 rings of brickwork. The crown of the arch is recorded as being 0.97 metres below track level.

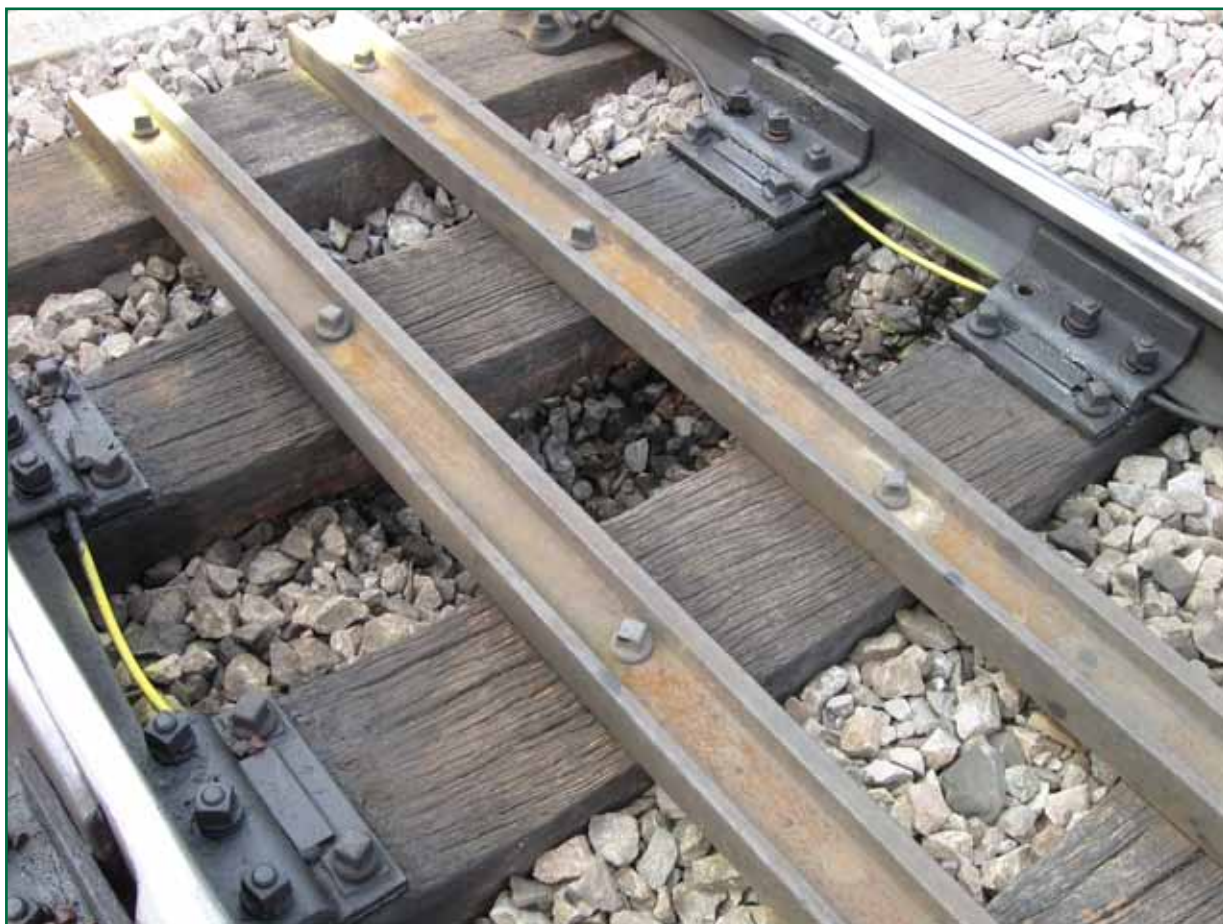
- 29 The next basic visual track inspection took place on Tuesday 29 March 2011. Patroller A, who on this occasion was being mentored by the ATSM, observed a lack of ballast in the four-foot (ie the space between the running rails) beneath the same adjustment switch. He made a record on his patroller's report. The ATSM instructed the patroller to replenish the ballast, which he did. Despite having visited this site many times, neither member of staff was aware that there was a bridge beneath the track at this location.

- 30 On Tuesday 5 April 2011, during the following week's inspection, a different patroller (Patroller B) found that ballast was missing beneath the adjustment switch. He contacted the ATSM who instructed him to top up the ballast again. The ATSM also arranged to make a special inspection himself the following morning.

- 31 On Wednesday 6 April 2011, the ATSM observed that the void had reappeared, but saw no evidence of track movement when trains passed over the site. He examined the site, looking for manhole covers which might indicate the presence of a cross-track drainage pipe. He located the upstream headwall of Bridge 94 in the undergrowth on the east side of the railway (figure 5), and became concerned that the structure could be collapsing. He stayed on site to monitor the situation during the day, and arranged for a further inspection by Patroller B that evening. As there was no evidence of rail movement, he did not consider that a speed restriction was necessary at this time.

- 32 At 19:00 hrs that evening, Patroller B attended site with a colleague specifically to inspect the defect. They measured a depression 350 mm deep below bottom of sleeper level (figure 6) and one member of staff entered the structure and observed ballast in the watercourse (figure 7). Patroller B was concerned and contacted the Gloucester ATME and requested his attendance. The ATME was not on-call, but agreed to attend site and advised Patroller B to inform Network Rail's fault control and request a structures examiner.

Figure 6: Ballast loss beneath sleepers at adjustment switch (photograph courtesy of Network Rail)

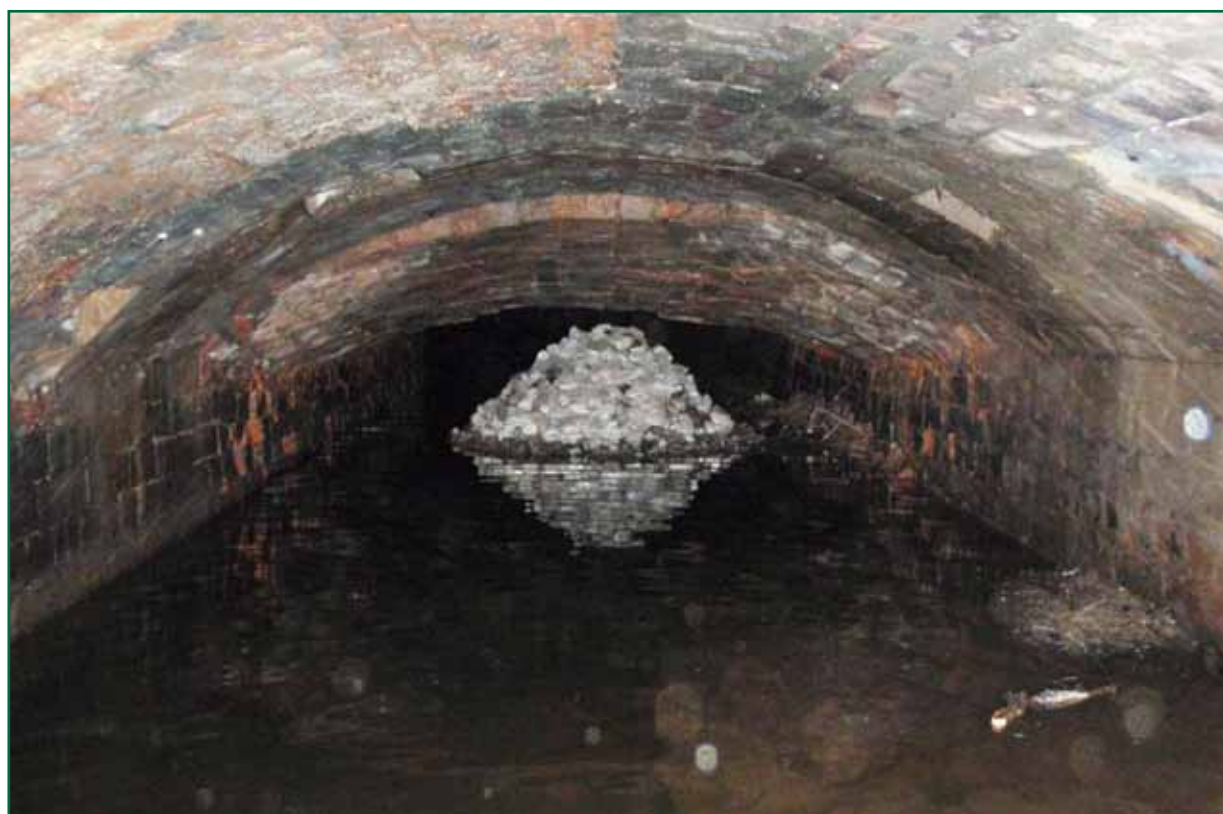
Figure 7: View from within structure showing distortion of arch beneath down main line and ballast lost into watercourse (photograph courtesy of Amey)

- 34 When the ATME was informed of ballast in the watercourse, he entered the structure and observed ballast falling into the water as a train passed above. He lowered the speed limit on the down main line again to 20 mph (32 km/h) for all trains pending the arrival of the structures examiner. Initially, this required signallers to caution all trains from Blackwell because of the steep gradient¹ immediately north of Bromsgrove station which could have made it more difficult for drivers to slow their trains sufficiently for the speed restriction at Bridge 94.

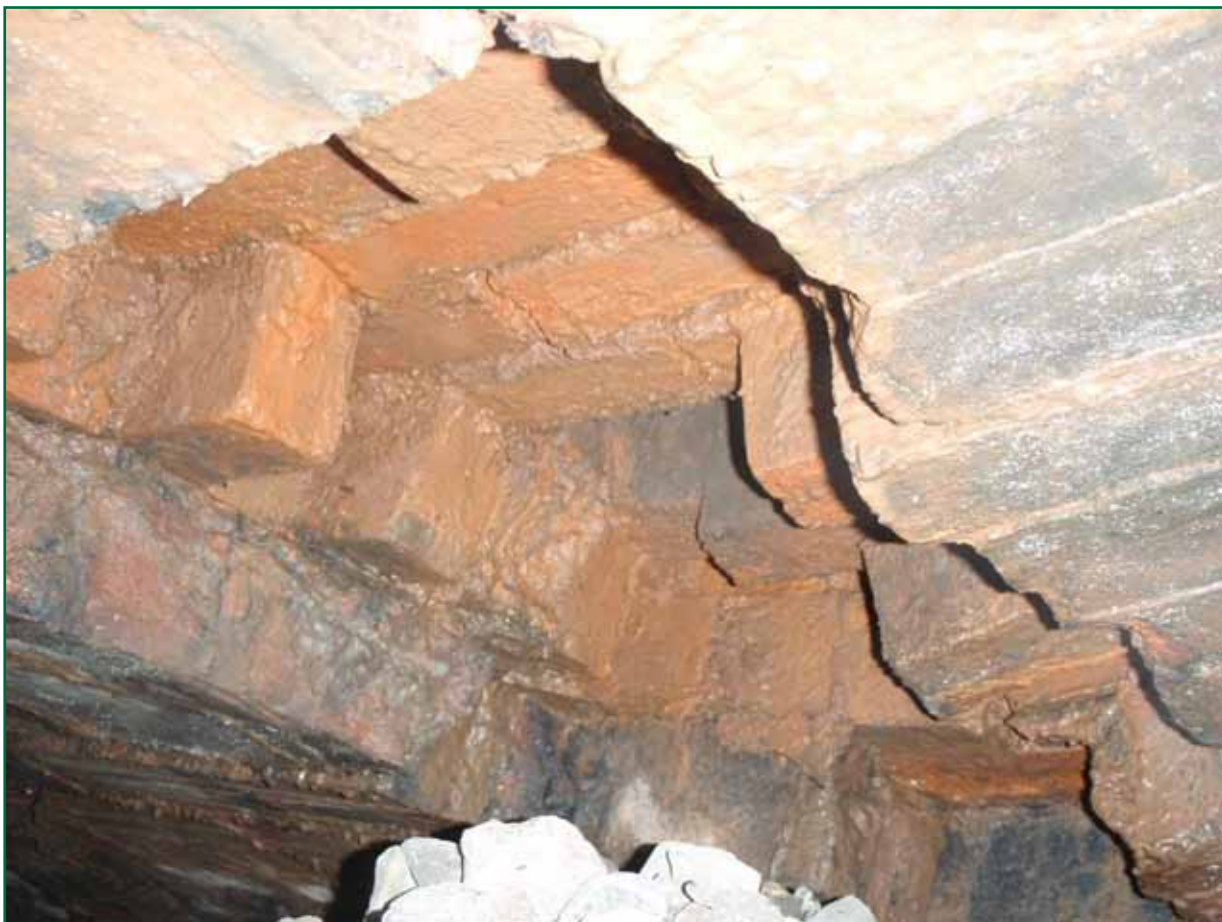
- 36 At 22:00 hrs, the ATME and structures examiner took part in a telephone conference with Network Rail structures engineers and operations staff. The structures examiner advised that a 600 mm square section of brick arch had failed. The conference supported the ATME's decision to block the down main line.

Figure 8: Loss of brickwork at location of failure (photograph courtesy of Amey)

- The loss of shape and reduction in the compressive force allowed a section of the brickwork to fall out (figure 8).
- 55 At the time that the partial failure was discovered, the structure was substantially weakened and complete failure was probably imminent.

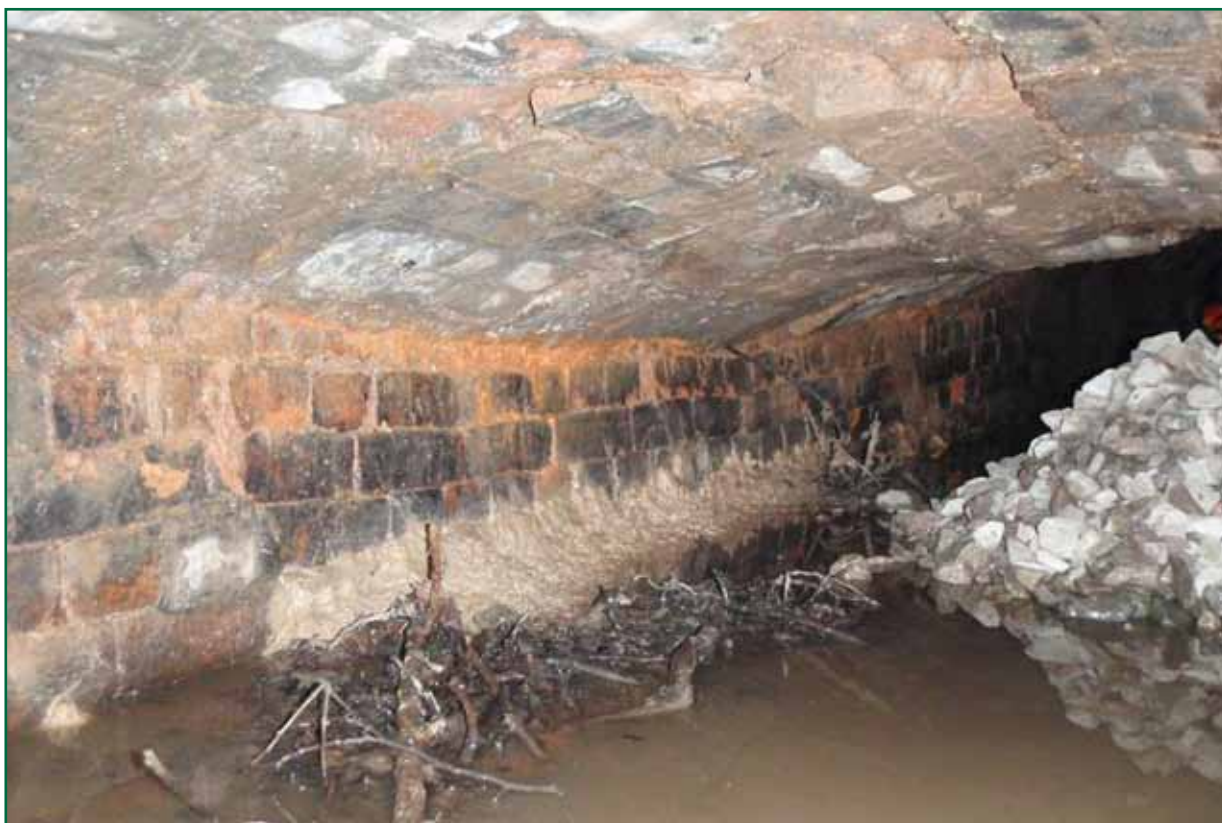
- 39 At 05:47 hrs, the examiner advised that the damage appeared more widespread from below and was likely to affect the up main and down goods lines. He reported that the lower two of the three rings of brickwork forming the arch structure had separated from the upper ring (figure 8), that surrounding brickwork exhibited significant deformation to the arch profile suggesting possible widespread failure, and that the north abutment was leaning away from the watercourse (figure 9). A hole in the roof was allowing ballast to drop through.

Figure 9: Deformation to roof of deck E and leaning north abutment looking upstream (photograph courtesy of Amey)

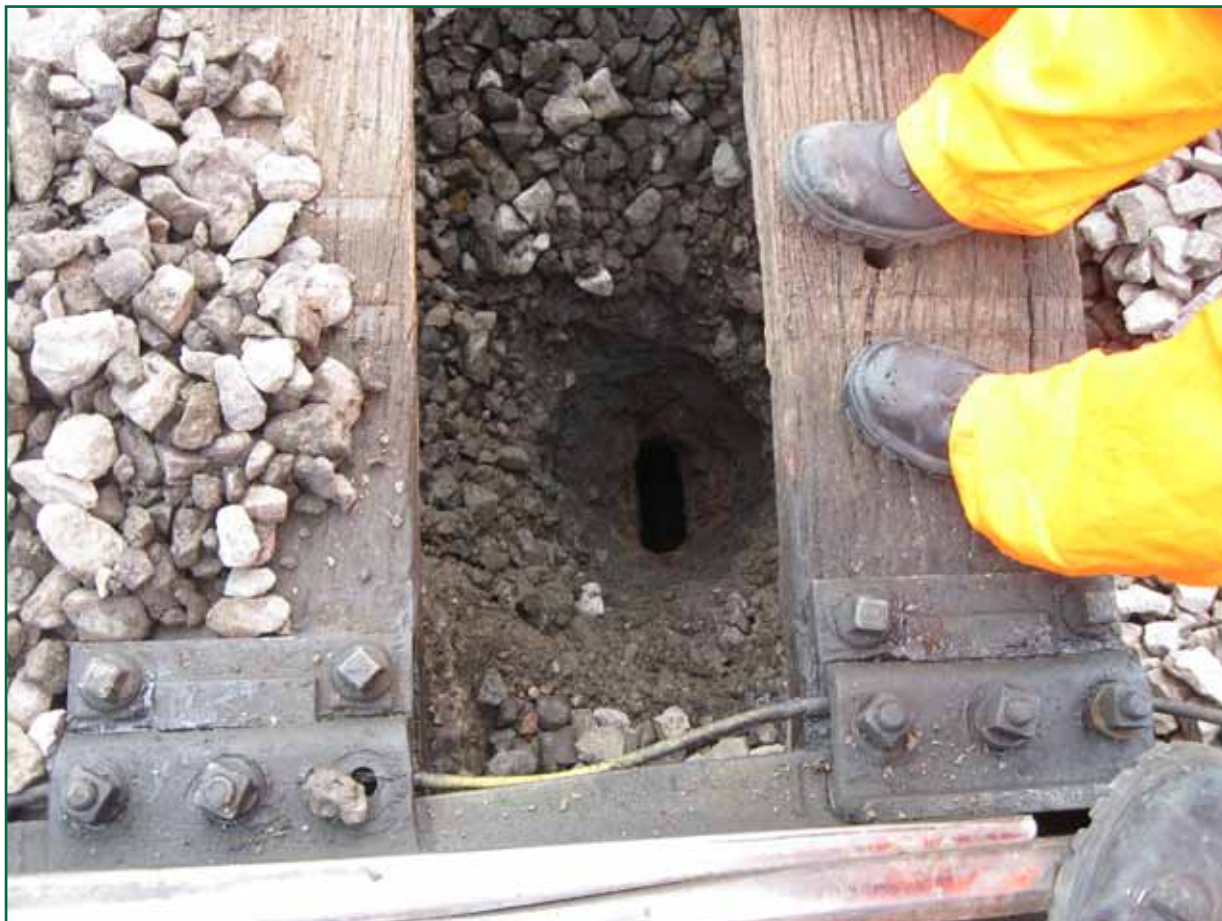
Figure 10: View into structure from track level following partial clearance of ballast (photograph courtesy of Network Rail)

- 40 Work commenced immediately to excavate the structure from above to confirm the exact location of the affected arch and adjacent unaffected decks relative to each track (figure 10). Following a review of the damage, the up goods loop was reopened to traffic at 08:28 hrs. The down loop was found to be only marginally affected, and a decision was taken to temporarily reinforce the track by screwing additional lengths of rail to sleepers. This allowed the down loop to reopen for passenger traffic at 16:50 hrs, with a 20 mph (32 km/h) emergency speed limit in place.

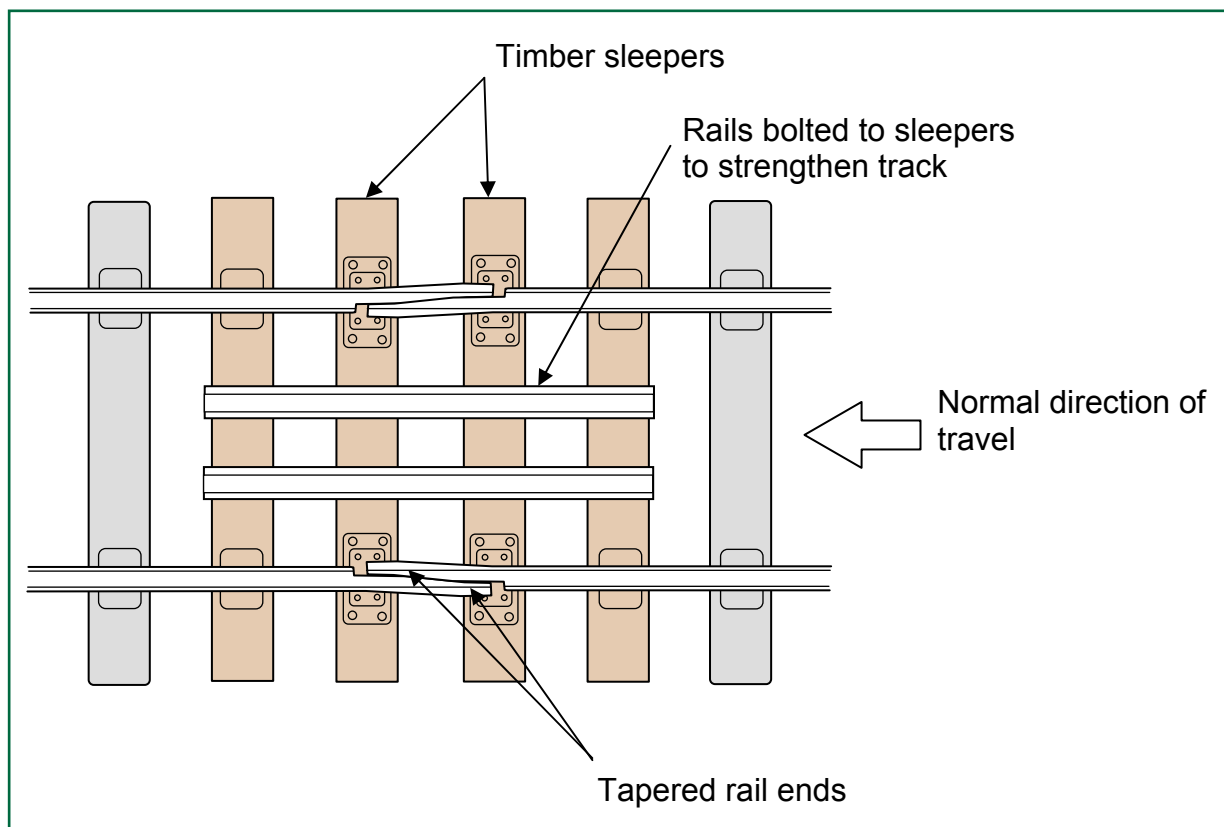
Figure 11: Diagram of an adjustment switch

- 17 Bridge 94 is a single span *underbridge* carrying the railway over Bromsgrove Stream. The span between abutments varies between 1.76 metres and 1.9 metres, with an internal height above the surface of the water of between 1 metre and 1.4 metres. The width of the deck (ie length over watercourse) has not been accurately measured, but exceeds 47 metres, before connecting directly into a storm drain system beneath a modern housing estate on the west side of the railway. Network Rail considers the structure to be a bridge rather than a culvert because it has non-brickwork spanning elements and directly supports the track.

- 46 **The roof of the structure was damaged by impact loading originating from train wheels passing over an adjustment switch which had been installed above, creating a minor, but recurring dip in the track. This was a causal factor.**

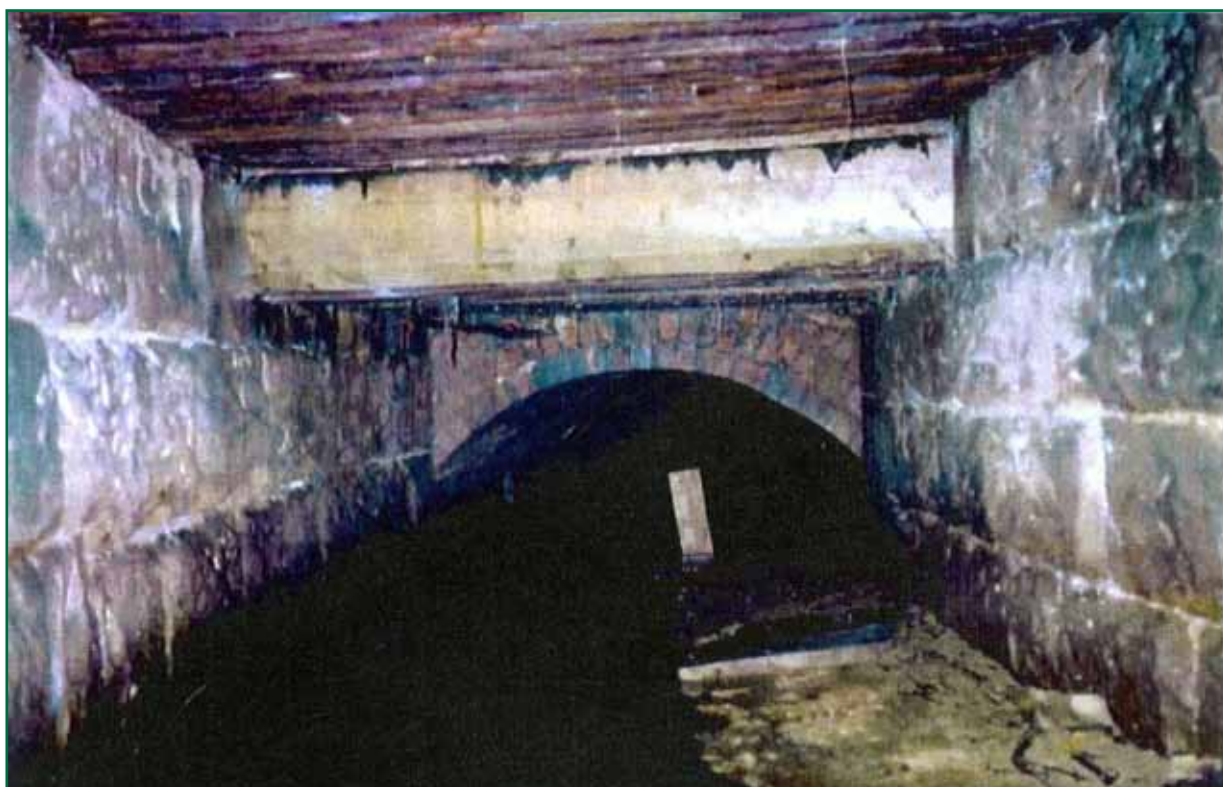
- 85 Bridge 94 was inspected in November 2001 by staff trained and equipped to enter confined spaces (figure 12). Railtrack received the inspection report, which included photographs of the structure, in January 2002. The corresponding assessment report was delivered in August 2003, and confirmed that the structure was in 'fair condition' and sufficiently strong to carry the loads imposed by rail traffic. Deck E was found to have an acceptable arch shape, but the report recorded a 5 mm wide longitudinal crack from abutment to abutment and damp staining indicating that the waterproofing had broken down.

Figure 12: Internal photograph (November 2001) showing decks C, D and E (photograph courtesy of Network Rail)

- 86 The assessment report confirmed that the structure was sufficiently strong to carry the imposed loads from rail traffic, but recommended re-waterproofing the deck, monitoring and repointing of 5 mm cracks in the brick arch sections, replacing small areas of damaged brickwork and removing obstructions to water flow.
- 87 A Network Rail structures assessment engineer (SAE) reviewed the assessment report, and visited site in November 2004 to resolve anomalies he had observed on a drawing. He subsequently hand-amended the general arrangement drawing to put the tracks in the correct order.
