Rail Accident Investigation Branch

Rail Accident Report

Collision between a train and a tractor, White House Farm User Worked Crossing 25 September 2011

25 September 2011

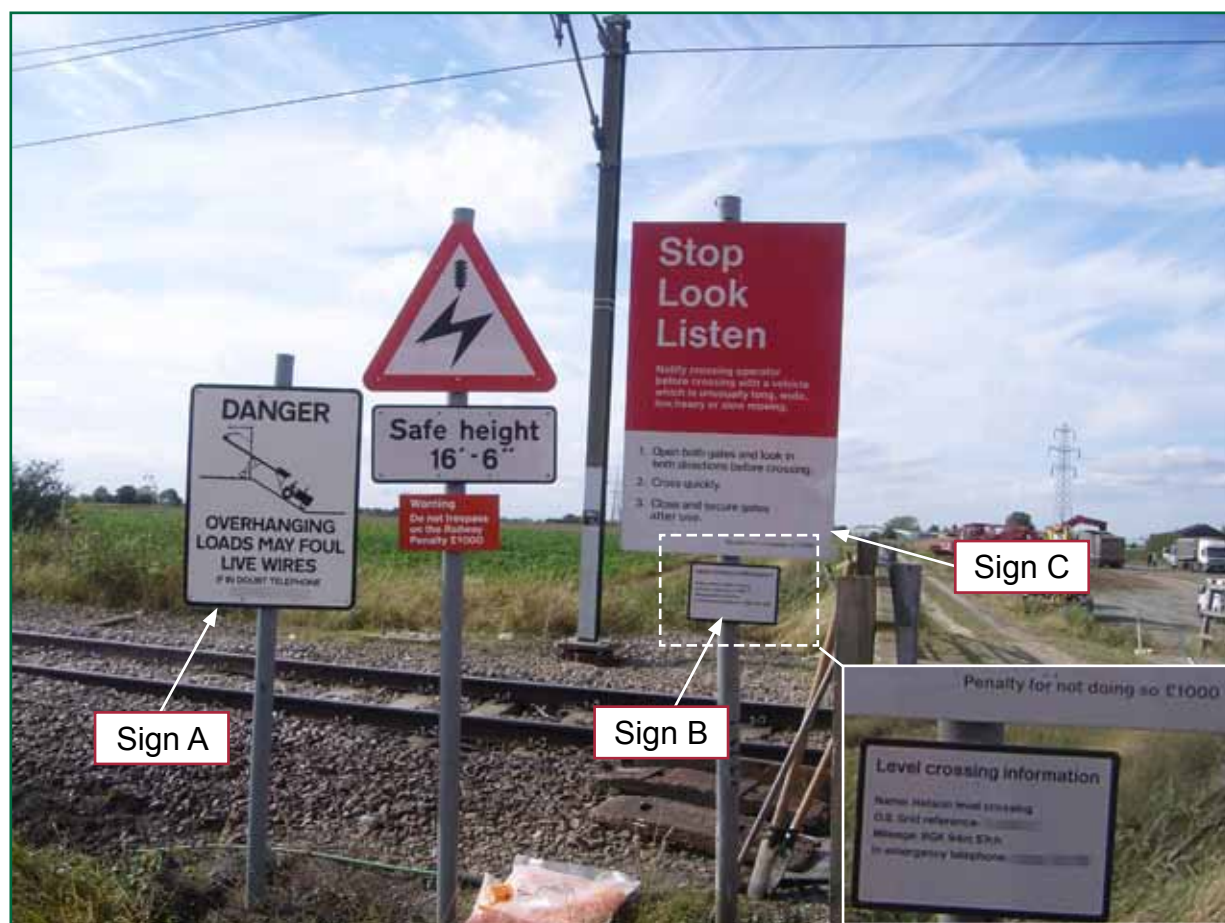
- 7 Signs at the crossing included two telephone numbers. One was for drivers of vehicles with overhanging loads who were required to call if they were in doubt as to whether their load might foul the overhead lines (sign A in figure 3). This telephone number connected the user with Network Rail's control centre for the Kings Lynn route. The other telephone number was for emergency use and connected the user with the signaller at Kings Lynn (sign B in figure 3). Drivers of vehicles that were unusually long, wide, slow, heavy or slow-moving were required to 'contact the operator' (sign C in figure 3), although there was no indication of which of the two telephone numbers was the right one to use.

Figure 3: Signs at White House Farm UWC

- 50 Five different signs were provided at the crossing (figure 6). Two different phone numbers were also provided, but a user could not tell from the signs who would respond. There was a reference to contacting the operator for drivers of designated vehicles (paragraph 7), without any indication of which phone number to use.

- 51 The number of signs is confusing and the signs lack useful information. The Rail Safety and Standards Board is currently undertaking a research project, 'T983 - Research into signs at private level crossings'. The scope of the research includes determining the instructions, messages and/or warnings that should be conveyed to users of level crossings on private roads, and on private land, to ensure that they carry out the required actions correctly and safely.

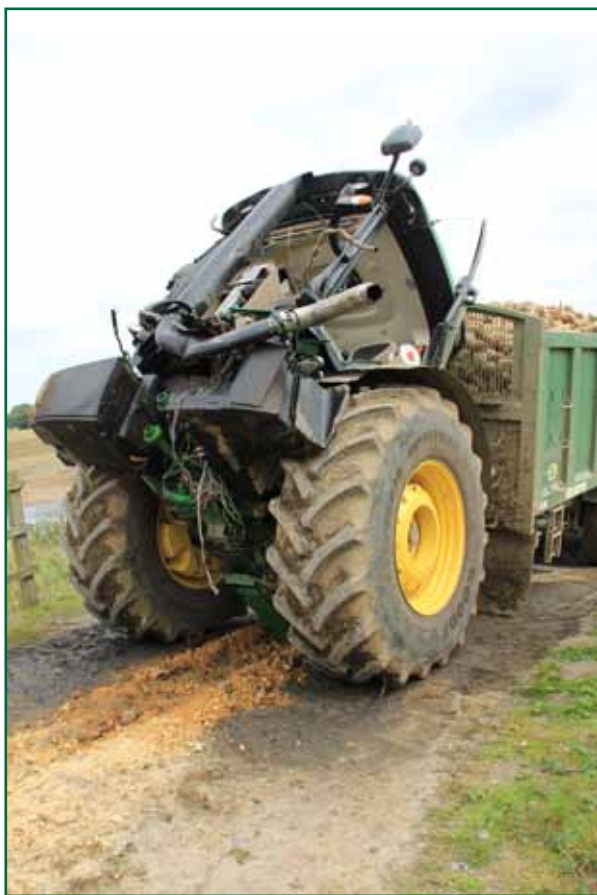
- 17 The driver of the train vacated the cab shortly before the train struck the tractor. The impact between the train and the tractor caused the front of the tractor to be separated from the driving cab (figure 4). The tractor driver remained in the cab of the tractor, but suffered a broken collarbone, lacerations and bruising.

Figure 4: The cab section of the tractor (trailer still attached)

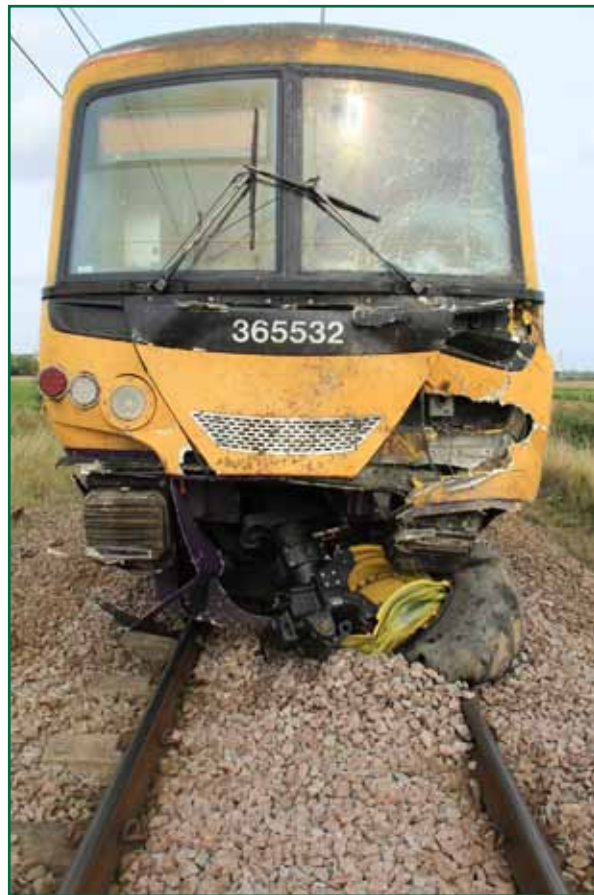
- 18 Debris from the front half of the tractor became lodged under the train (figure 5). In the aftermath of the collision, the second wheelset on the train was derailed, but the train remained upright and in line, stopping approximately 320 metres from the crossing. There were 41 passengers and a Revenue Protection Inspector on the train. None were injured.

Figure 5: Debris under the front of train 1T60

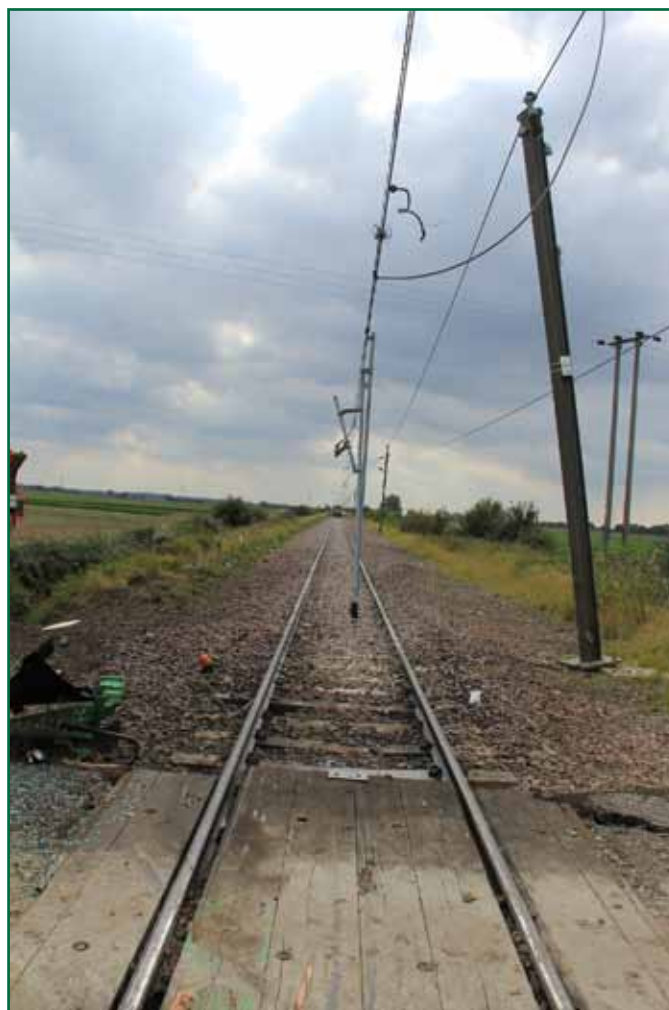
- 20 A solid metal counterweight (weighing approximately 1100 kilograms) on the front of the tractor was detached in the collision and it struck and dislodged a stanchion supporting the overhead line equipment which supplies traction current to trains. The power lines were left hanging near the track (figure 6). It was necessary for the equipment to be isolated and earthed before passengers could be evacuated from the train. The evacuation did not start until approximately 13:00 hrs.

Figure 6: Damage to overhead line stanchion and equipment caused by counterweight from tractor

- 39 There was a need to earth the dislodged overhead line equipment (paragraph 18) before evacuation could commence. The nearest staff competent to undertake earthing were at Cheshunt, almost 100 miles, and around two hours' drive, away. By the time that they had been deployed, travelled to Kings Lynn and applied the earthing equipment, almost three hours had elapsed since the accident.

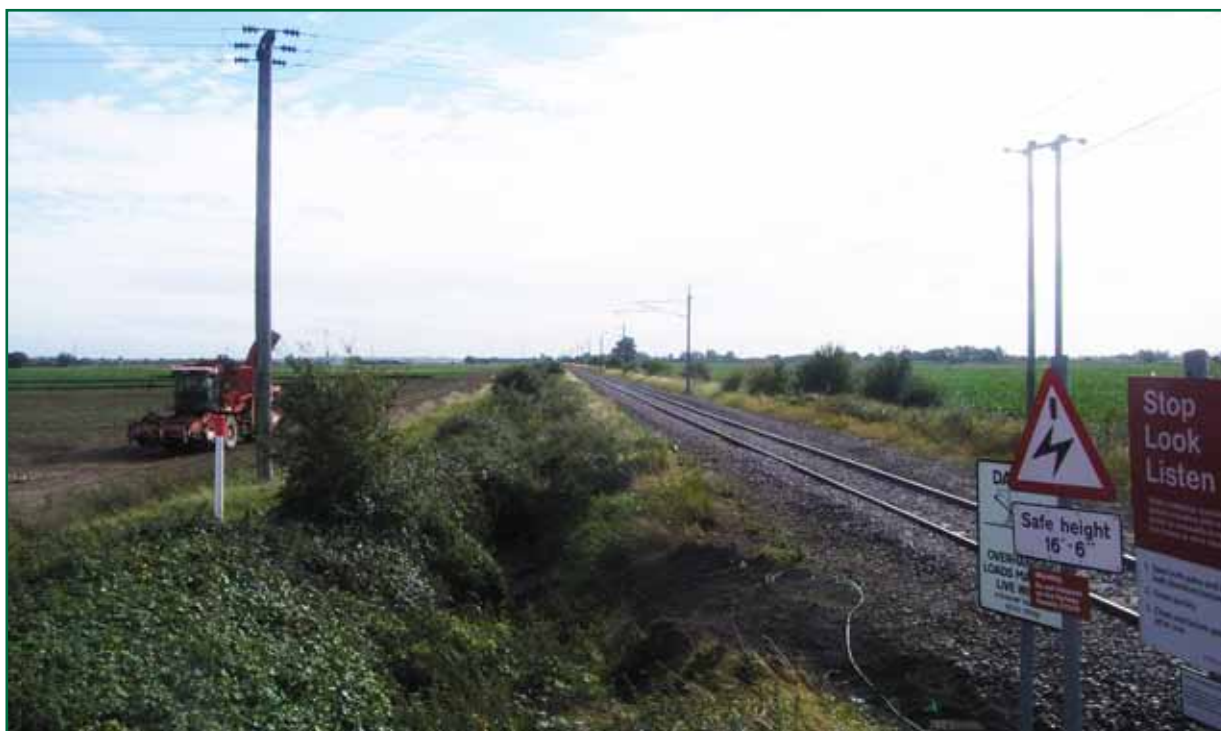
- 47 This makes a significant difference to sighting distances (figure 7). The crossing gate and signage are located 2.6 metres from the nearer rail on the up (east) side of the crossing. Network Rail had estimated the sighting distance towards Watlington to be 1388 metres from this point¹². The RAIB observed that the sighting distance changed significantly if measured from a point further back from the crossing, for example:

- 475 metres when viewed from a position 3.2 metres from the sign/gate (5.8 metres from the nearer rail); and
 - 317 metres when viewed from a position 5 metres from the sign/gate (7.6 metres from the nearer rail).

- 48 The front of a tractor similar to the one involved in the accident on 25 September 2011 is approximately 3.7 metres from the driver's position. For the purposes of illustration, if the tractor driver were to stop with the front of the tractor approximately two metres from the nearer rail (as is likely if the driver is looking for trains), the sighting distance towards Watlington would be around 500 metres; equivalent to a sighting time of around 12 seconds for a train approaching at 90 mph (145 km/h).

Figure 7: Sighting from White House Farm UWC towards Watlington at 5.8 metres from the nearer rail on the east side of the crossing from a height similar to that of a person sitting in a tractor. Sighting from a point further back would be significantly impaired by the vegetation to the left of the line.

- Re-assessed sighting distances at White House Farm UWC and found that they are not compliant. Network Rail intends to install telephones at the crossing to provide users with a direct means of communication with the signaller before they cross (paragraph 64a).
- Restored the telephone number which had previously been out of use (paragraph 64d).
- Updated its records regarding the authorised user at White House Farm UWC (paragraph 64e).
