# Rail Accident Report

## **Safety incident between Dock Junction and Kentish Town 26 May 2011**

# Safety incident between Dock Junction and Kentish Town, 26 May 2011

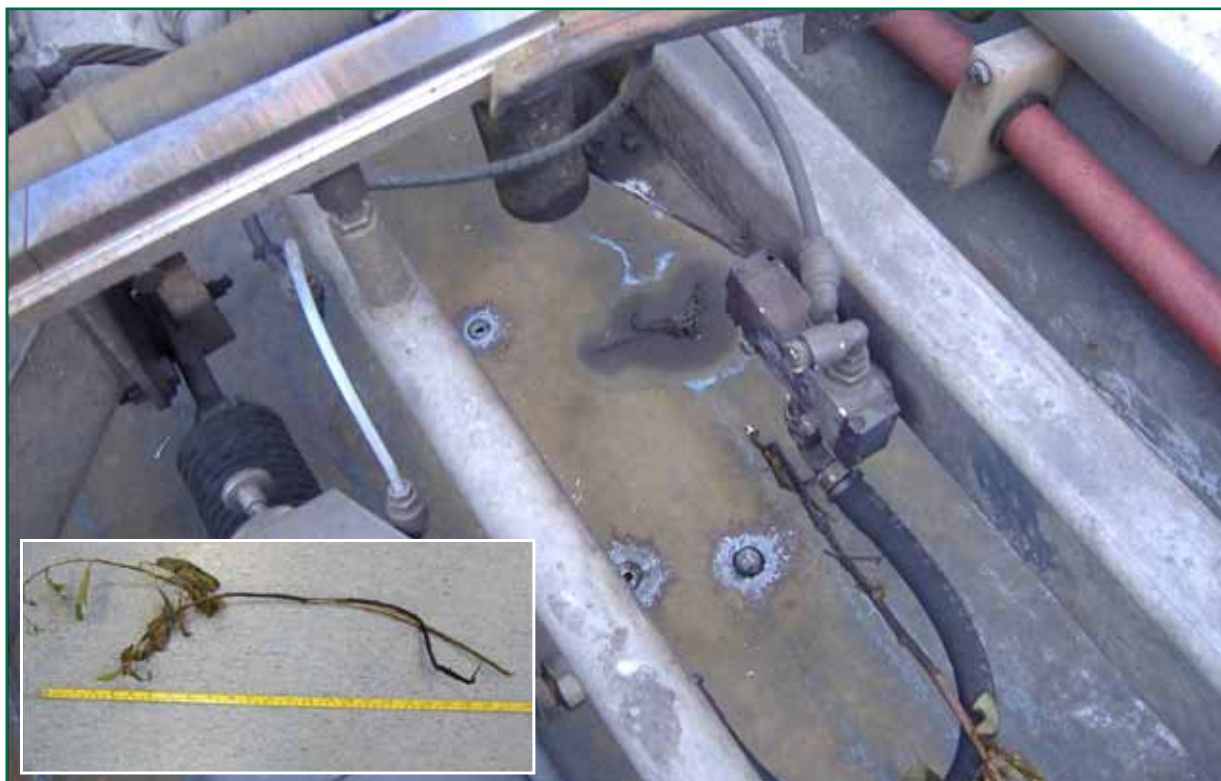
Figure 5: Damaged pantograph with foliage

- 50 **Foliage had become lodged around the rear pantograph of train 1W95 at some point while the pantograph was not in use, which caused electrical tripping after the train left Farringdon with the pantograph raised and the subsequent immobilisation of the train at Dock Junction. This was a causal factor in the incident.**

- 53 Because the driver was unaware of the foliage at the rear of the train, the sequence of events caused him to believe that there was now a problem taking power through the front pantograph. As the incident started to escalate, the number of demands placed on the driver (primarily communication with the passengers, with the signaller and with the fitters at Cauldwell depot) increased. This reduced his ability to diagnose via the train management system the possible causes of the tripping that had occurred after the train left St. Pancras. The driver, having discussed the matter with the signaller, declared the train a failure and was instructed by the signaller to isolate the front pantograph leaving the train without power. The presence of the foliage was not identified until the train reached the depot later in the evening.

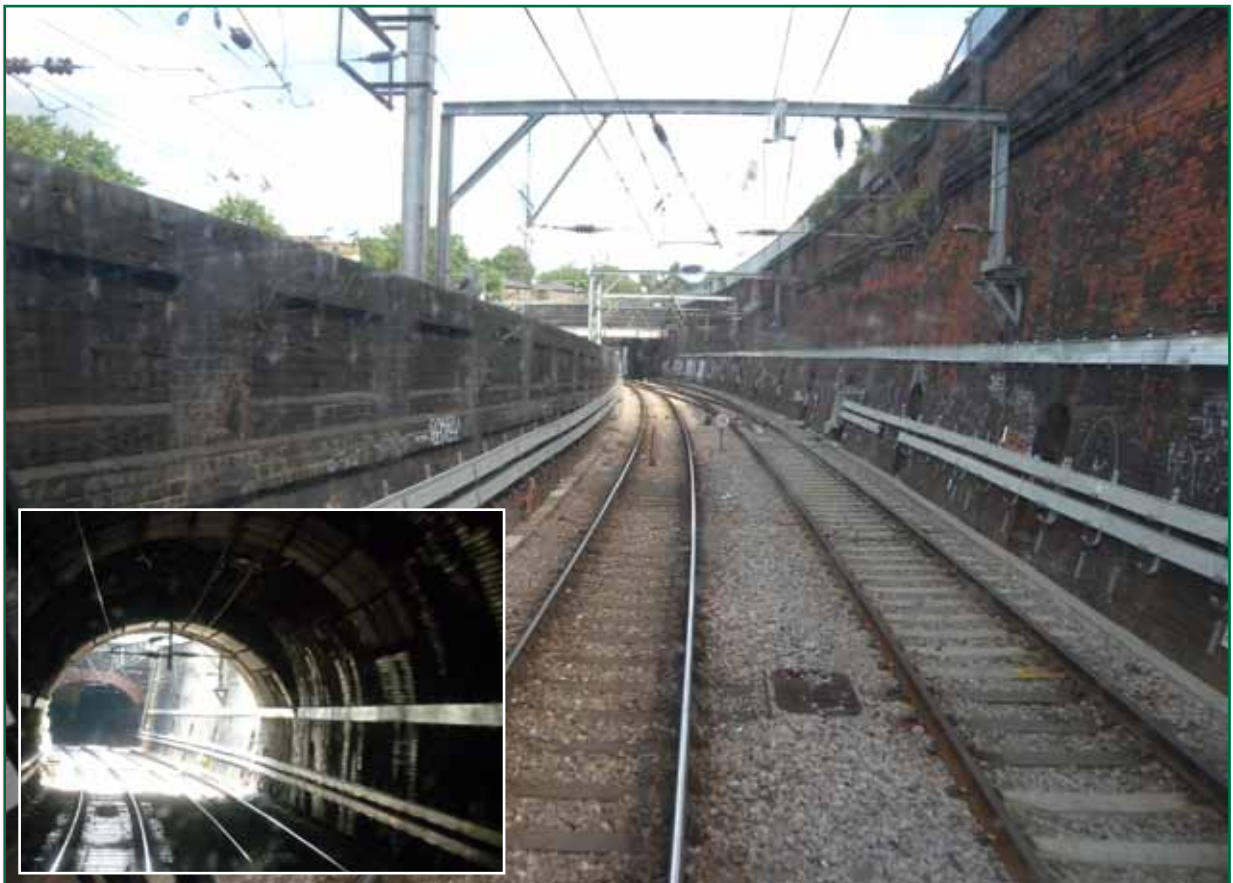
- 32 Shortly before 18:26 hrs, the OHLE tripped again and the train stopped near to Dock Junction (figure 7). The electrical control room operator decided not to reset the OHLE again in order to prevent damage occurring. Although the driver had not reported that the train had failed, the signaller advised him that a FCC depot technician would be in contact as both the signaller and FCC controller believed that the problem was a technical fault on the train. The driver made a further announcement to the passengers to update them on the situation.

Figure 7: Down Moorgate line near Dock Junction North

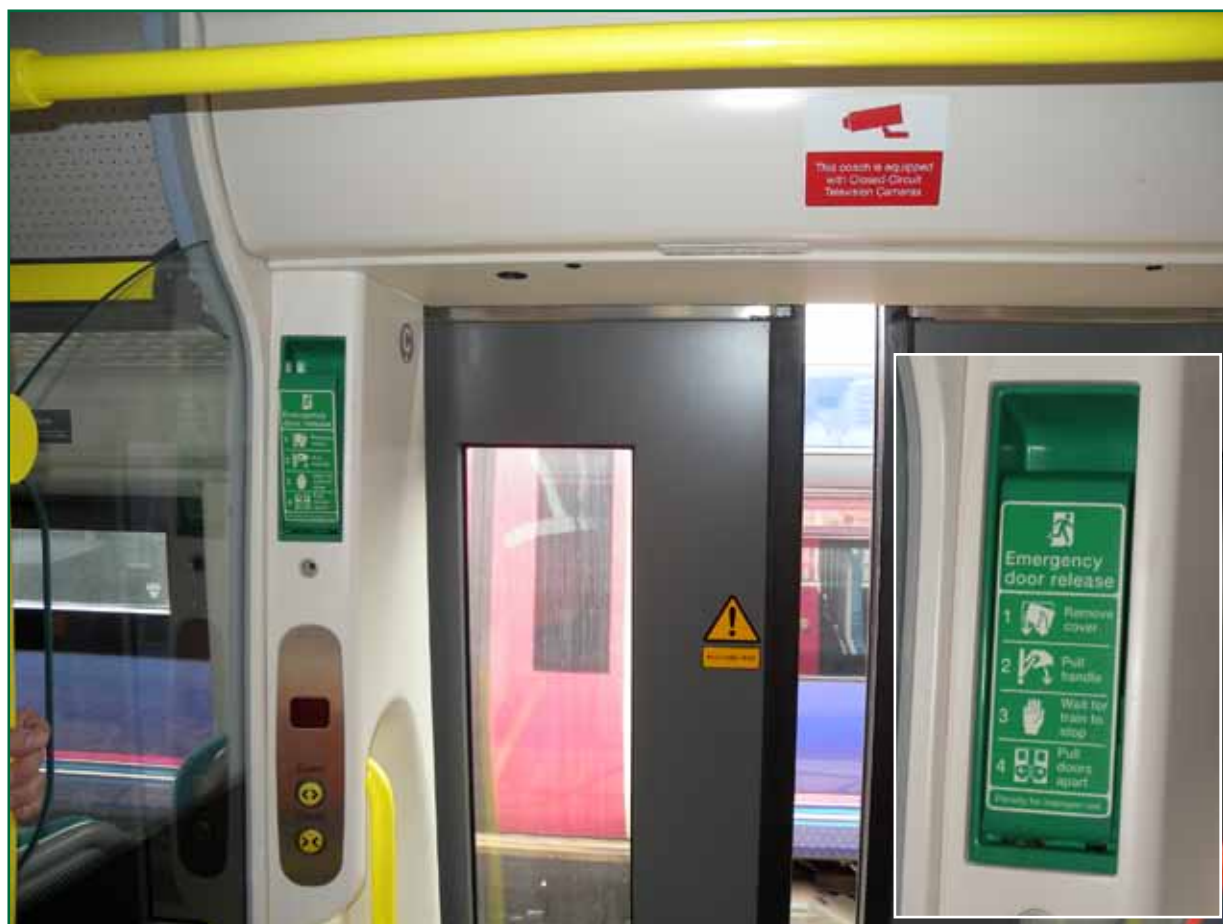
Figure 9: Door egress handle allowing partial opening of the train door after egress handle is pulled down (inset - egress alarm in its normal state)

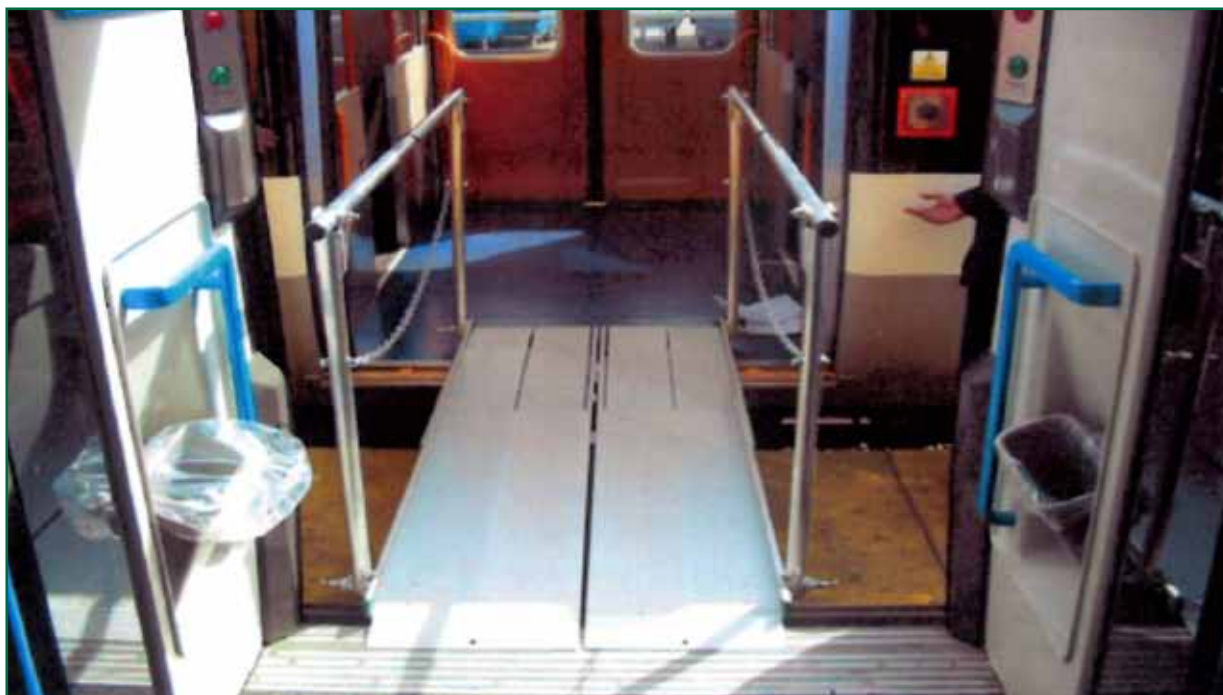
- 65 *Transboardment bridges* (figure 12) could have been used to transfer passengers from the failed train to another train drawn up alongside<sup>6</sup>. FCC's procedure for dealing with stranded trains (paragraph 62) included this option. Although the document had been authorised as a company procedure in January 2011, it had only been loaded onto FCC's intranet system on 17 May 2011, a week before the incident. The intranet system was the source of information for control room staff on FCC's company procedures.
- 66 An audit undertaken after the incident confirmed that some key staff (including those in the control room) were not aware of the contents of the procedure because the briefing program had lapsed. Control room staff were therefore unaware of the existence of transboardment bridges and the option was not considered

Figure 12: Transboardment bridge (image courtesy of FCC and Southern Railways)

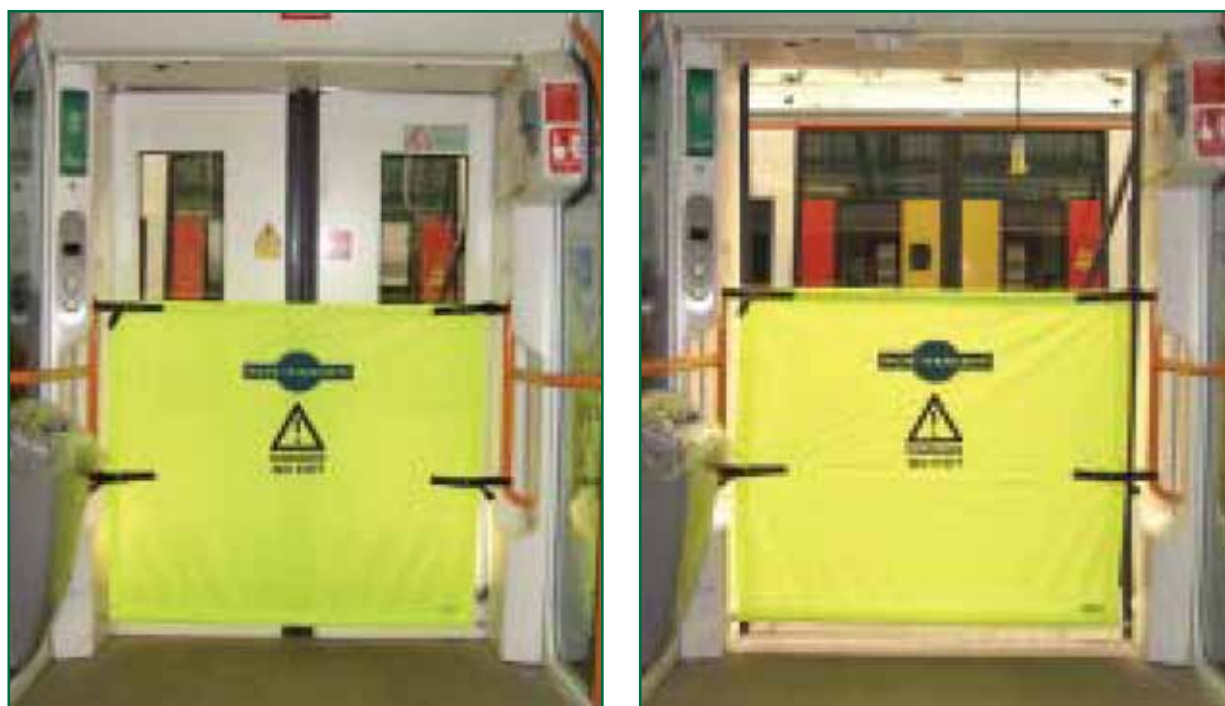
- 87 Following this incident, a formal investigation was completed by Railtrack and a number of recommendations were made including the provision of door screens (figure 13) to enable some doors to be opened without compromising passenger safety.

Figure 13: Emergency door screen equipment (images courtesy of FCC and Southern Railways)

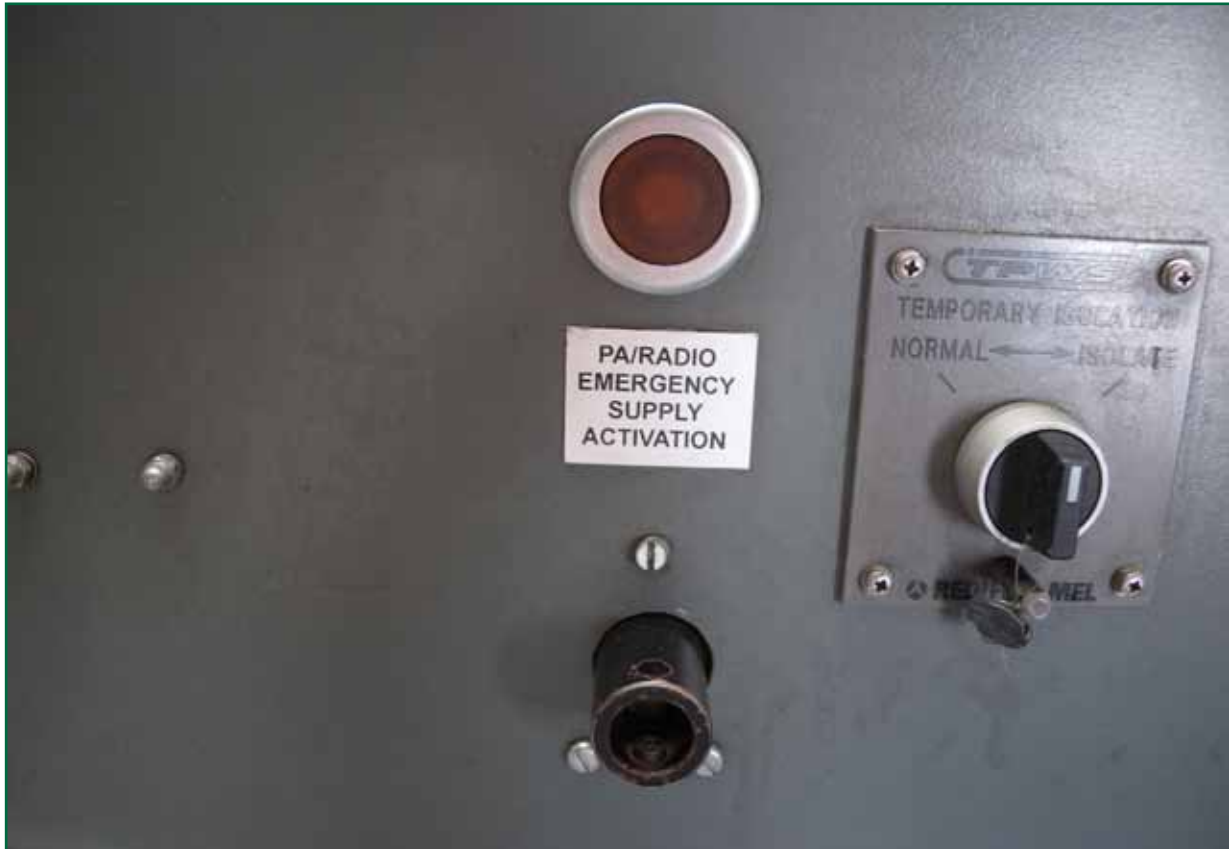
- 94 The class 319 units that had operated most services on Thameslink routes before the introduction of the class 377/5 units were equipped with an auxiliary battery button which allowed drivers to continue to use the public address system when power had been lost. The class 377/5 units were not equipped with such a button, but it was established after the incident on 26 May 2011 that drivers can obtain power for the public address system for up to five discrete periods of around seven minutes each by re-setting the auxiliaries. However, FCC was unaware of this (the seven minute cycle is mentioned in FCC training material but does not specifically mention that it will enable the public address system to be used) and its use had not therefore been briefed to drivers.

Figure 14: Auxiliary battery button on the class 319 train

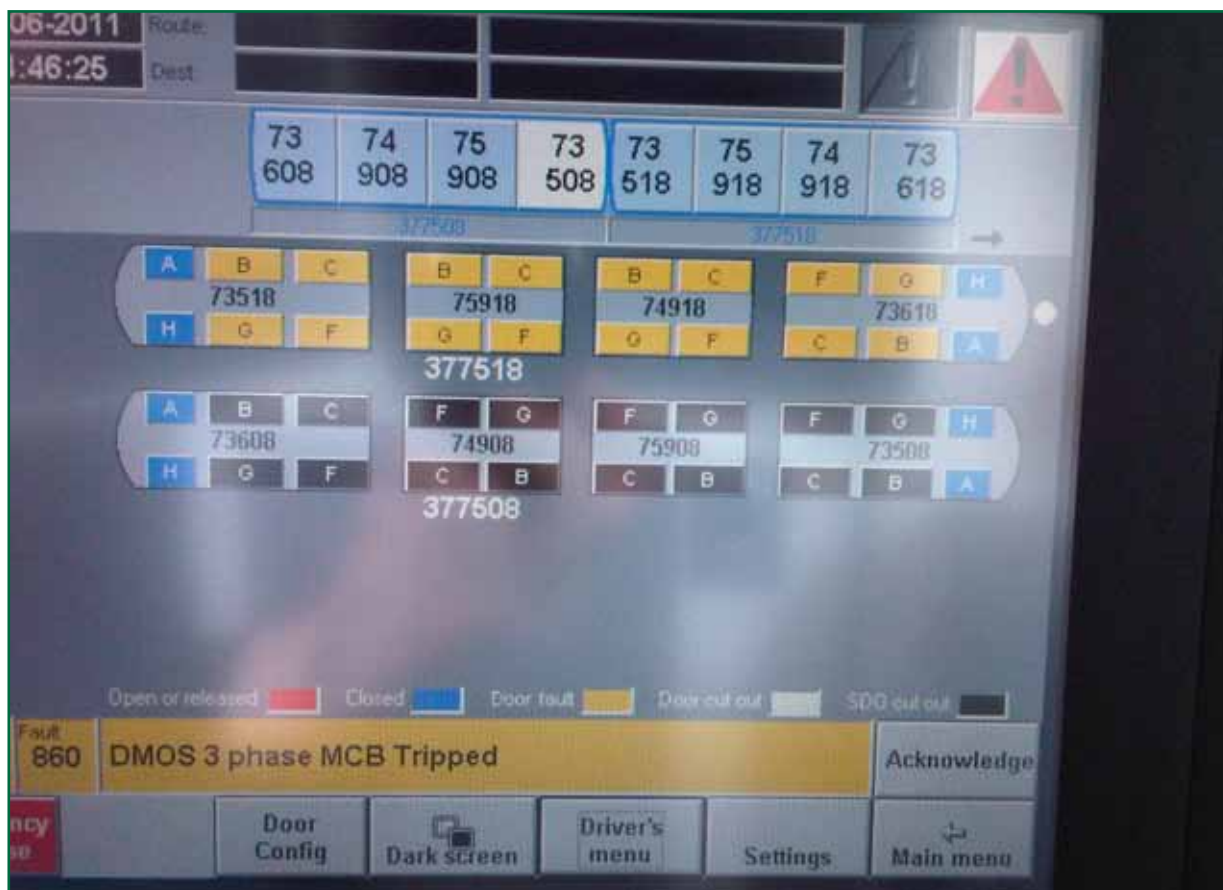
Figure 16: Image showing (yellow) door fault indication on the driver's in-cab display

- 104 The driver's display screen showed the status of all doors on the rear eight coaches as 'door fault' (yellow). This meant that the status of the doors was unknown; it did not necessarily mean that they were open.

- 105 The door fault indication is interlocked with the train's traction power system, which meant that the driver would not be able to take power (to move the train) unless the fault could either be resolved or overridden. As the status of the doors on the failed portion of the train was unknown the mobile operations manager, OHLE engineer and the fitter were dispatched to check the doors and close them as necessary (paragraph 98), but the fault indication persisted.
