Rail Accident Report

Fatal accident at Piccadilly Gardens, Manchester, 5 June 2011

This report is published by the Rail Accident Investigation Branch, Department for Transport.

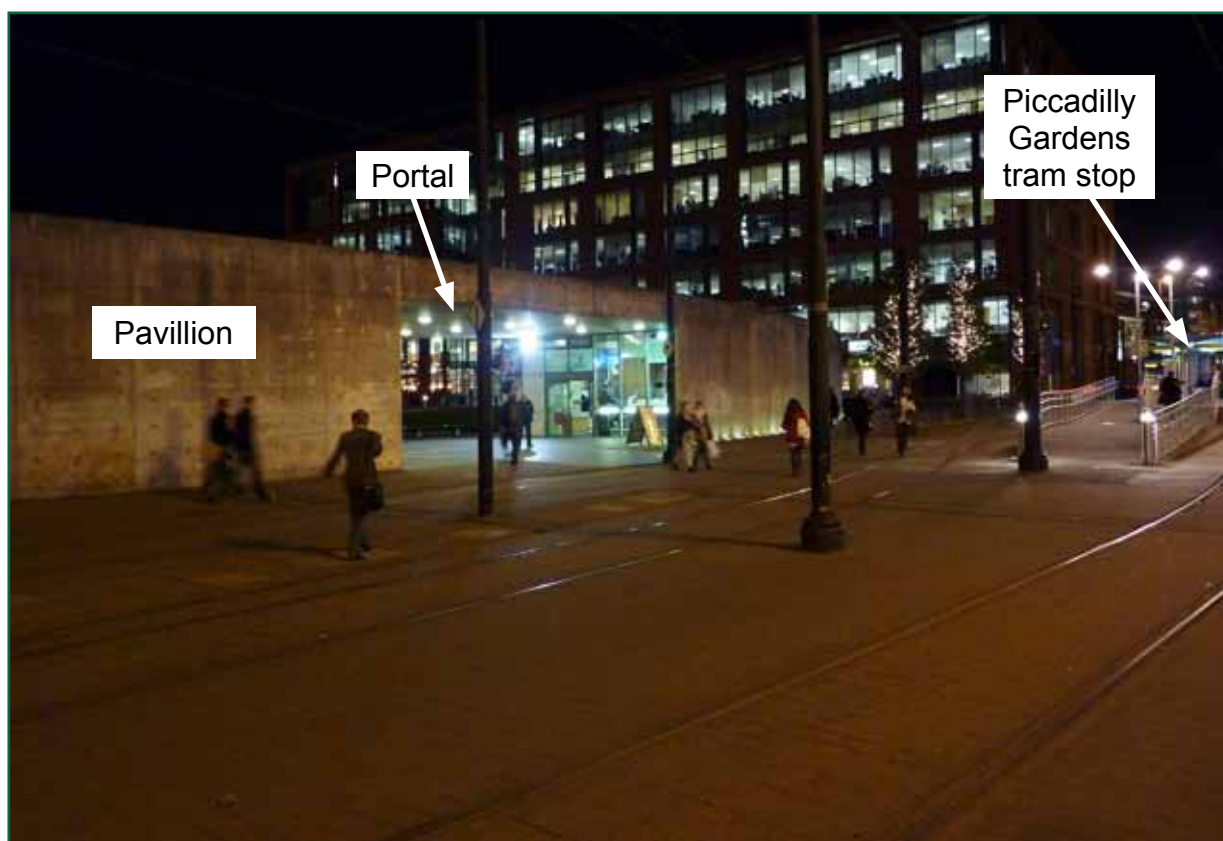
Figure 2: The Pavillion showing the portal entrance leading to/from Piccadilly Gardens

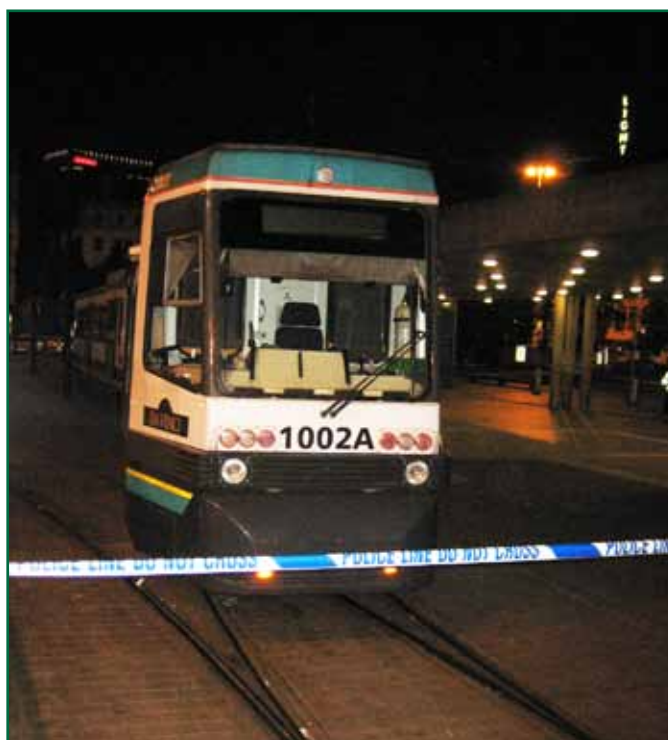
- 11 The tram involved in the accident was a T68 type, number 1002 (figure 3). This was one of the fleet of 32 T68 trams, built by Ansaldo, Italy, first introduced in 1992. It was travelling from Bury to Piccadilly Gardens tram stop.

Figure 3: The 'A'-end of tram 1002 at the accident site

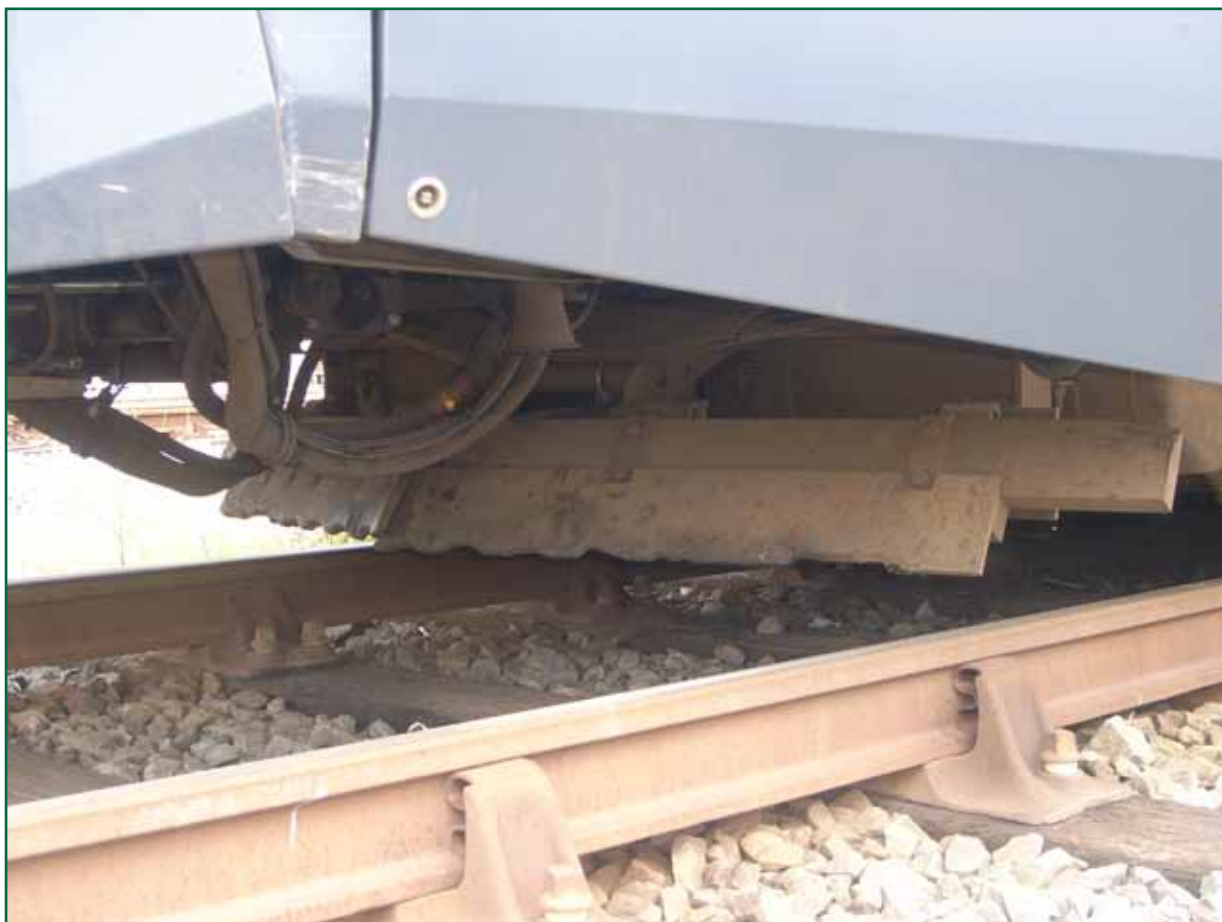
- 17 The under-run protector on the leading end of the tram was mounted on the bogie frame (the metal frame equipped with the wheelsets), 1.4 metres back from the front of the tram. It consisted of two wooden sections fixed to metal support brackets and it spanned the full width of the bogie. On the leading end of tram 1002, the clearance between the lower edge of the wooden section and the road surface was 115 mm. Metrolink's design and maintenance instructions specify that this clearance should be 115 mm, with a tolerance of +/- 5 mm. Some clearance (ground clearance) is necessary between the underside of the protector and the paved highway to prevent contact between the protector and the rails and road surface when the tram meets changes in vertical curvature in the track.

- 18 On the lower edges of the wooden sections were 10 mm thick rubber strips. The rubber strips projected below the wooden sections giving a clearance of 80 mm between their lower edges and the road surface when on level track.

Figure 4: The under-run protector on the 'A'-end of tram 1002 (not at accident site); the notches in the rubber edge are caused by occasional contact with rail heads

- 77 For the under-run protector to make contact with the chest, the protector had to be able to pass over the arm and shoulder.

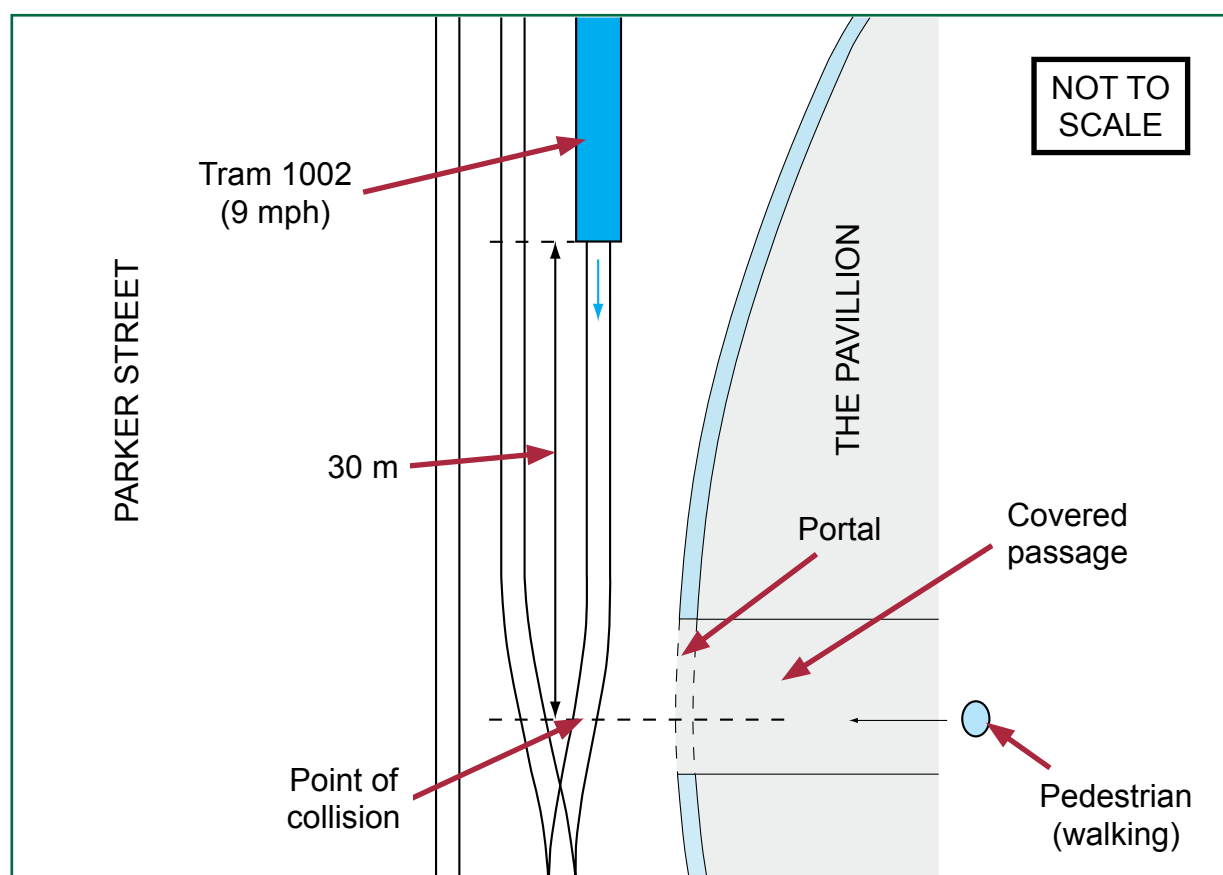
- 28 The pedestrian walked into the covered passage of the Pavillion 8 to 9 seconds prior to the accident. He was within the central half of the passage's width. At this time the tram had turned into Parker Street and was about 30 metres from the point of collision (figure 5).

Figure 5: Positions of tram and pedestrian 8 to 9 seconds before the accident

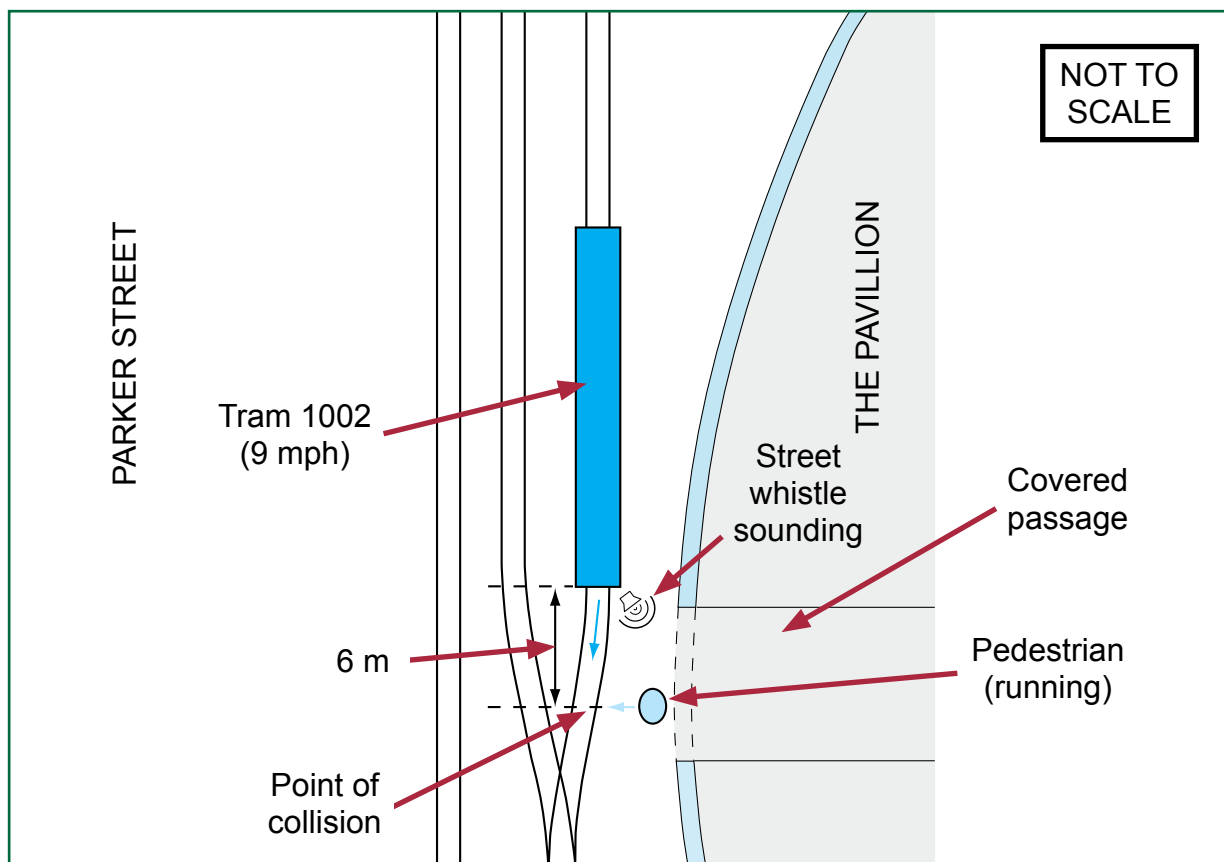
- 30 The data recorder shows that the driver sounded his street whistle between 1.5 and 2 seconds before the collision, when the tram was approximately 6 metres away (figure 6).

Figure 6: Positions of tram and pedestrian 1.5 to 2 seconds before the accident

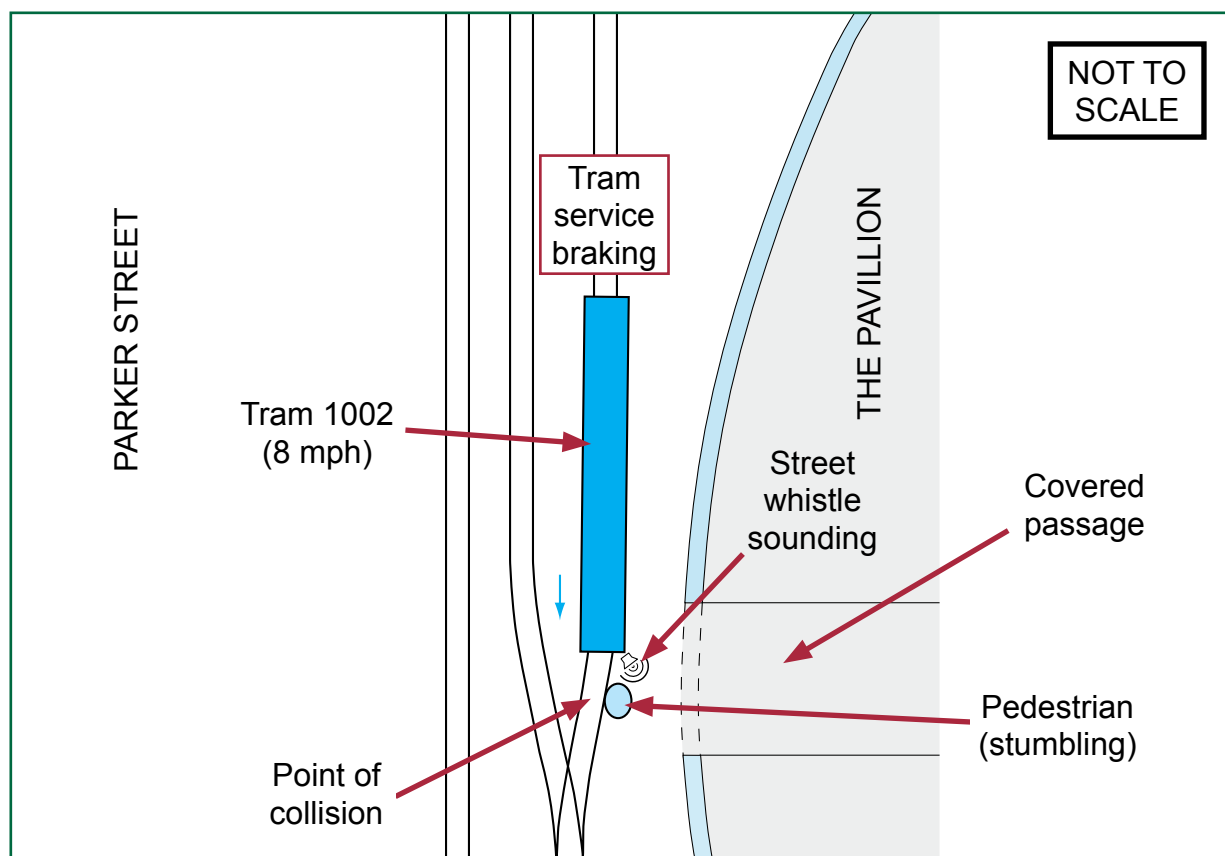
- 32 The CCTV footage shows the pedestrian attempting to stop immediately before crossing in front of the tram then stumbling (figure 7). The tram at this time was continuing to brake and sound its street whistle. The data recorder indicates that the speed of the tram was 8 mph (13 km/h) when the pedestrian was struck.

Figure 7: Positions of tram and pedestrian approximately 1 second before the accident

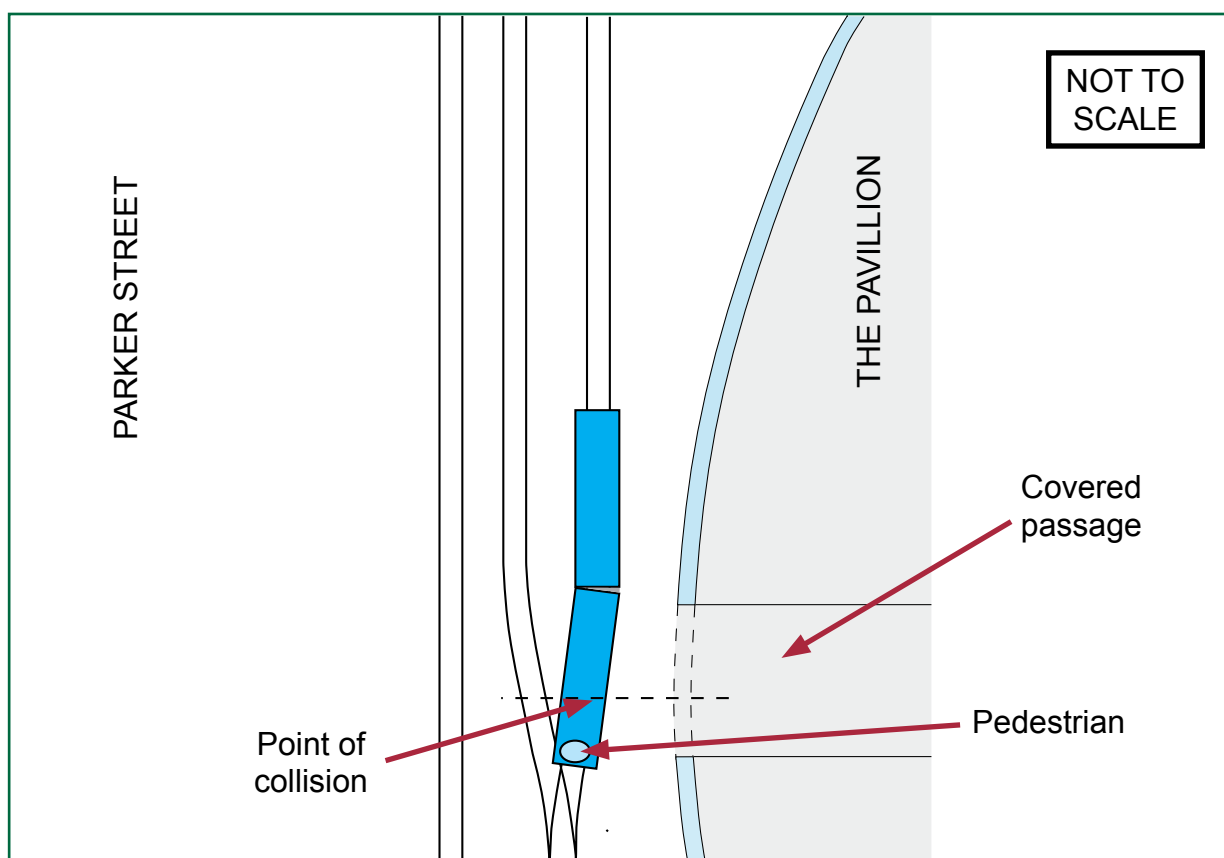
- 33 The driver stopped sounding the tram whistle and applied the hazard brake (figure 8). This was within 2 seconds after the collision and when the tram was travelling at 7 mph (11 km/h).

Figure 8: Positions of tram and pedestrian following the accident

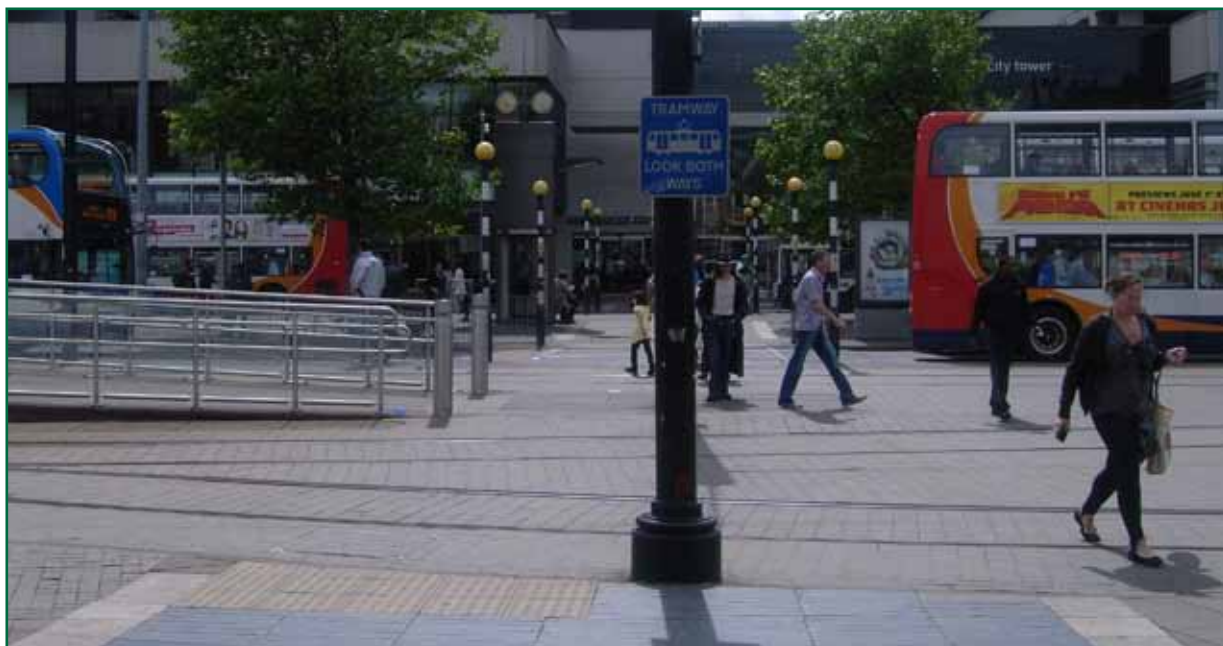
Figure 9: The approach to the tram lines from the covered passage

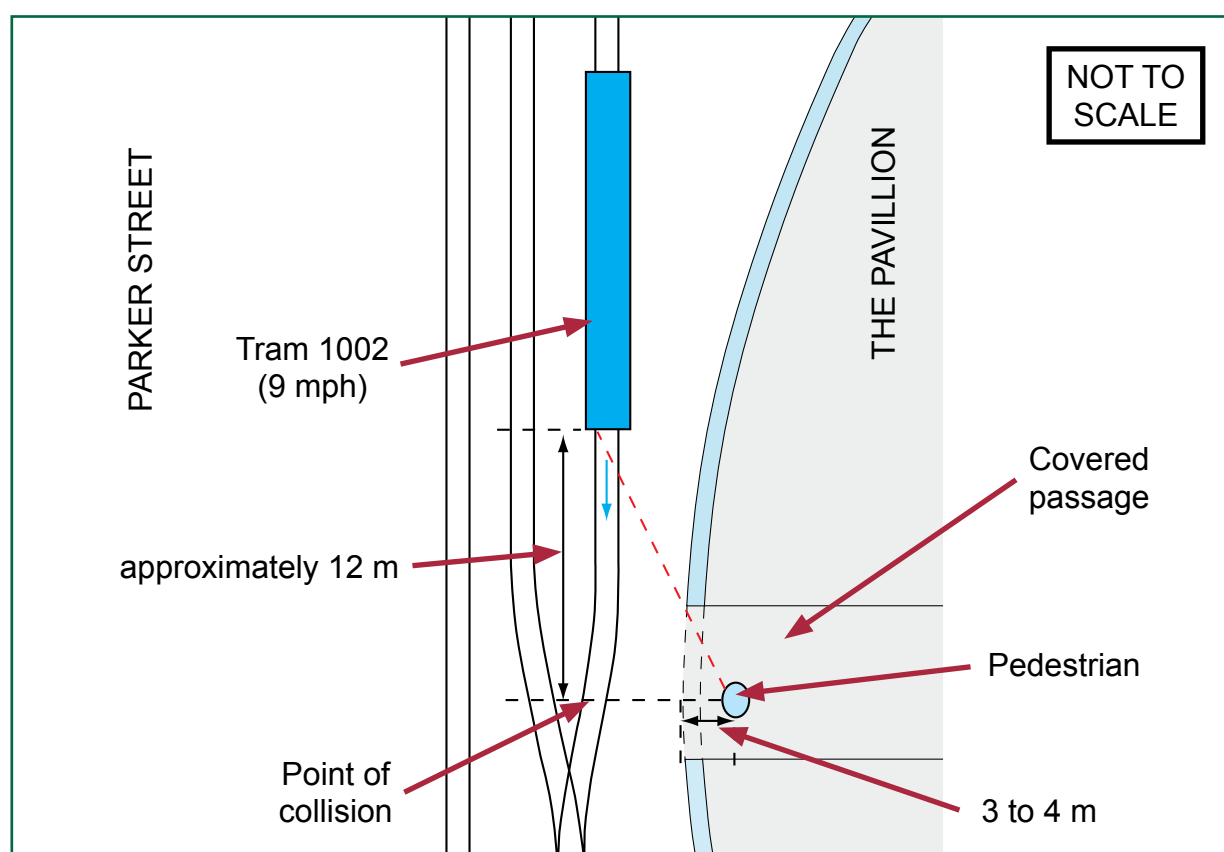
- 53 From analysis of the positions of the tram and the pedestrian, based upon the CCTV footage, the tram would have been visible to the pedestrian when he was 6 to 7 metres from the nearest running rail. At this point the pedestrian was 3 to 4 metres from leaving the covered passage and corresponds to a time when the tram was approximately 12 metres from the crossing. For the running pedestrian, based upon his approximate speed measured from the CCTV footage, this was about 3 seconds before reaching the tram lines (figure 10).

Figure 10: Relative positions of tram 1002 and pedestrian when the tram was visible
