Rail Accident Report

**Person trapped in doors and pulled along
platform at King's Cross station, London
10 October 2011**

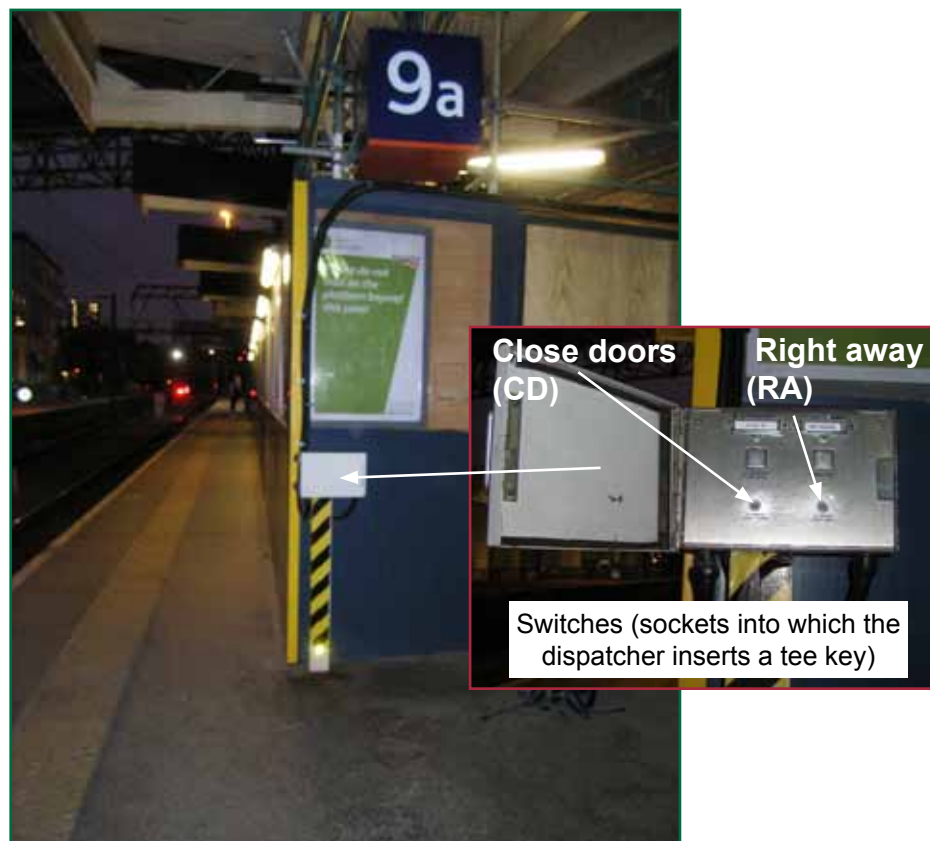
Figure 2: Dispatch point with CD/RA controls mid-way along platform 9

- 23 The dispatcher was standing at the dispatch point midway along platform 9, about 60 metres from the incident door and about 2 metres from the platform edge (figure 2). The distance to the incident door was significantly less than the 160 metres maximum viewing distance advised in RSSB publication RIS-3703-TOM⁵. Although there were few people on the platform, the group of people not intending to board the train were between the dispatch point and the incident door. This meant that the dispatcher did not have a clear view of passenger A and the incident door (figure 3). If the group had not been present, it is possible that the position of passenger A's body would still have prevented the dispatcher seeing her trapped hand.

- instructing dispatchers to position themselves, and move where necessary, so that they can get an unobstructed view of the whole side of the train;
- moving CD/RA control positions to a location with an improved view of the side of the train, or providing a wireless hand set for operation of these indicators;
- using public address systems to ask passengers to move away from the train; and
- use of closed circuit television (CCTV) or mirrors to assist dispatchers.

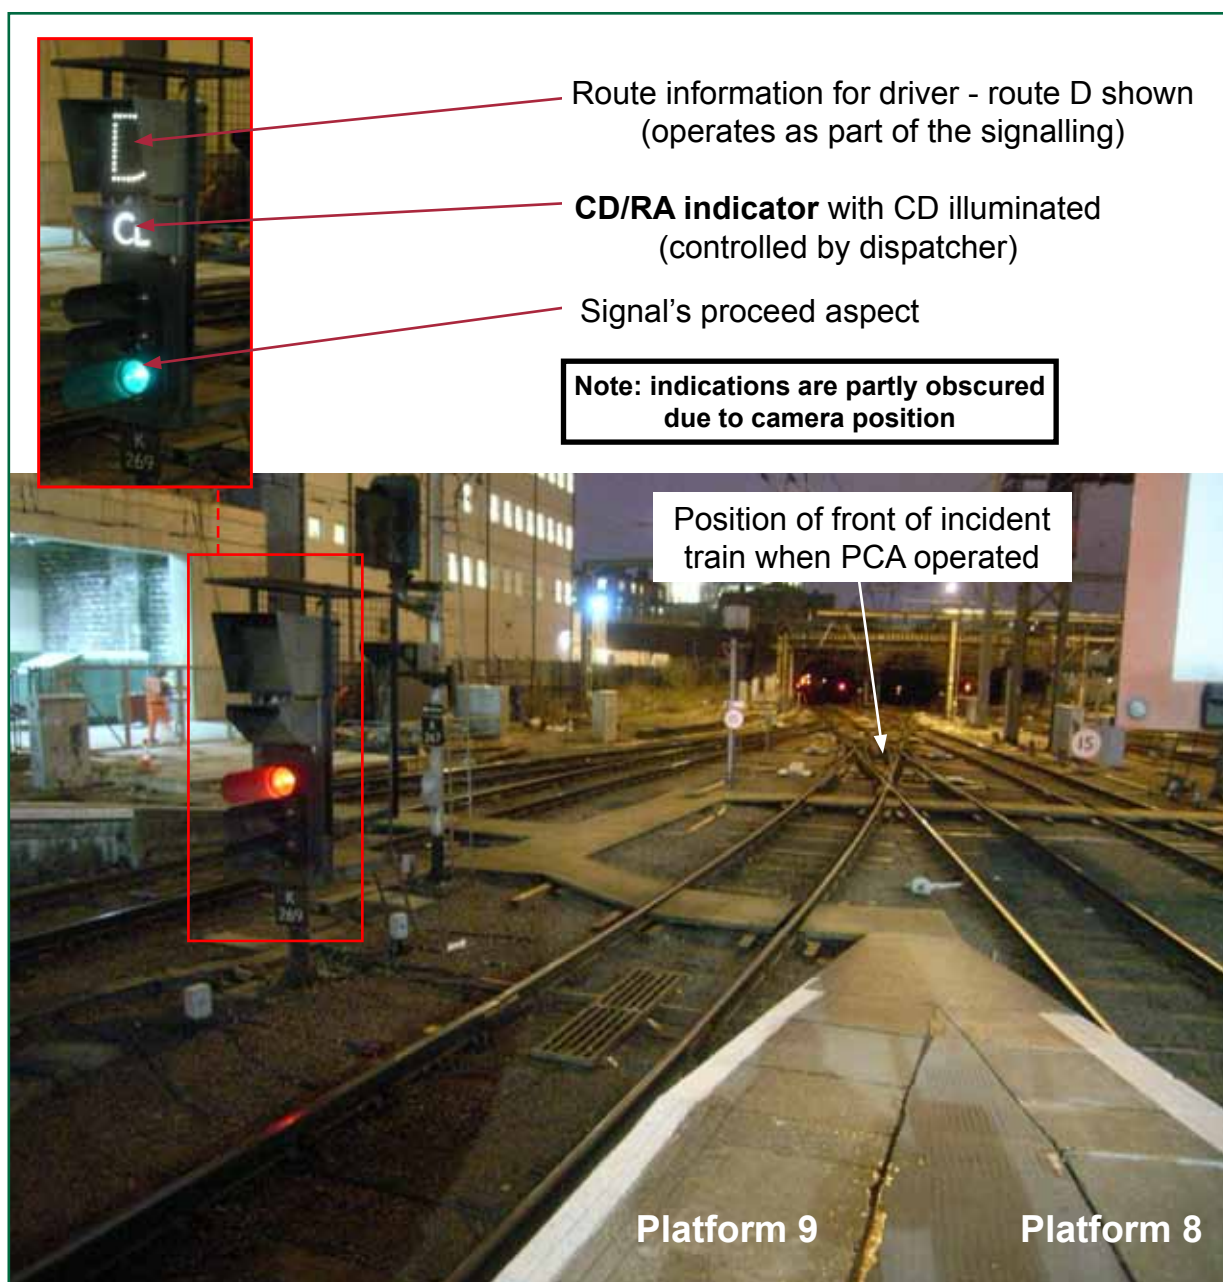
Figure 4: CD/RA indicator and trackwork used by trains leaving platform 9

- 46 When the PCA was operated, the front of the train had left the platform and was running on to the points at the exit from King's Cross station (figure 4). The driver assumed that there was a problem inside the train. He decided that an immediate brake application was inappropriate because this would delay evening peak services, and because the train would have stopped over points, a location where, according to his training, it would be difficult to provide assistance to passengers.

Trains must be stopped immediately if the passenger communication alarm is activated while any part of the train is in, or has just left, a station.
