Rail Accident Report

**Fatal accident at Mexico footpath crossing (near
Penzance)
3 October 2011**

Fatal accident at Mexico footpath crossing (near Penzance), 3 October 2011

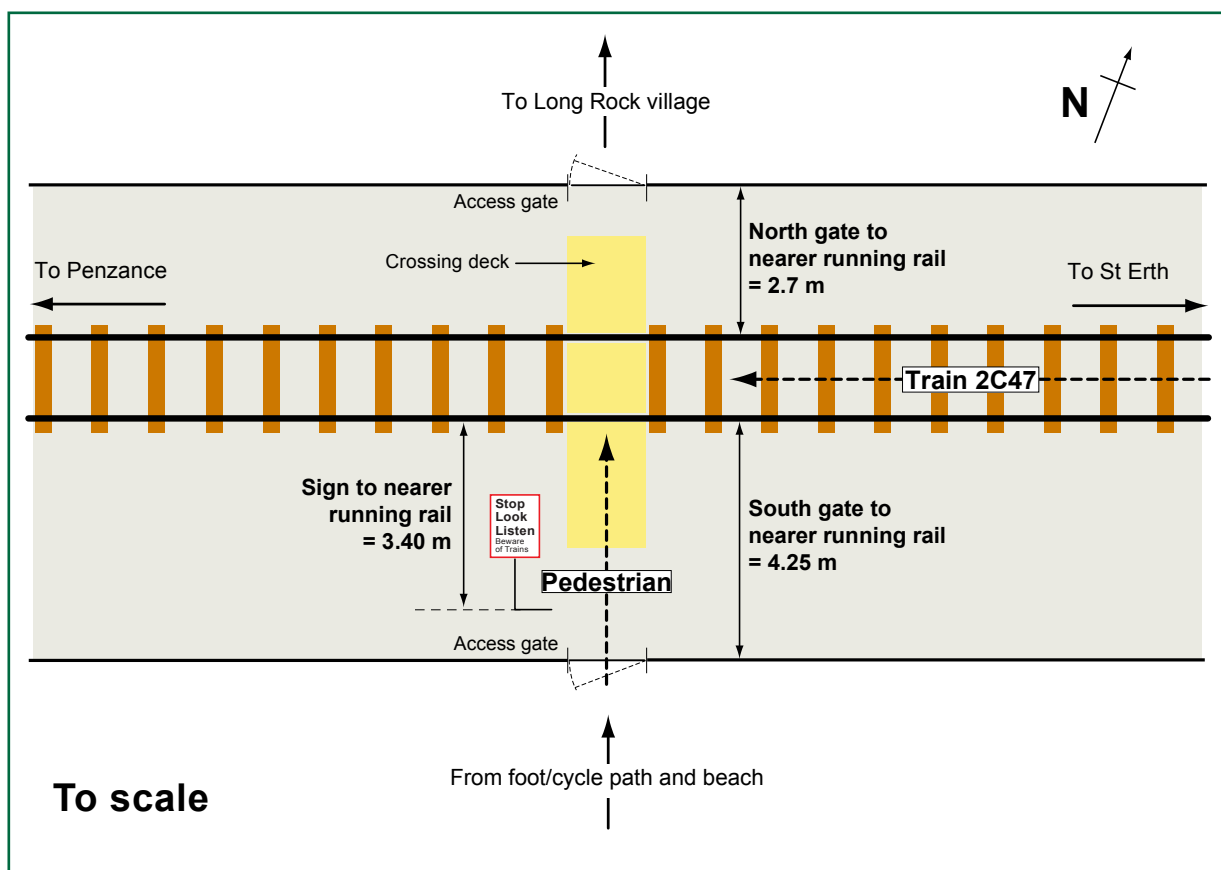
Figure 3: Layout of Mexico footpath crossing

- 7 The general layout at the crossing and key dimensions are given in figure 3. The crossing is on a stretch of single line, which is used by trains in both directions. The railway runs approximately east to west at this location and the footpath crossing, which crosses the railway at right angles, is referred to in the remainder of this report as being on a north/south axis.
- 8 Immediately to the south of the crossing is a footpath and cycle track with access to the beach. To the north of the crossing is a track leading to the main road and the village of Long Rock; see figure 4. There is a low bank which separates the railway from the coastal path to the east and west of the crossing. A pedestrian's approach to the crossing from the south cuts through the bank, which restricts their view to the east.

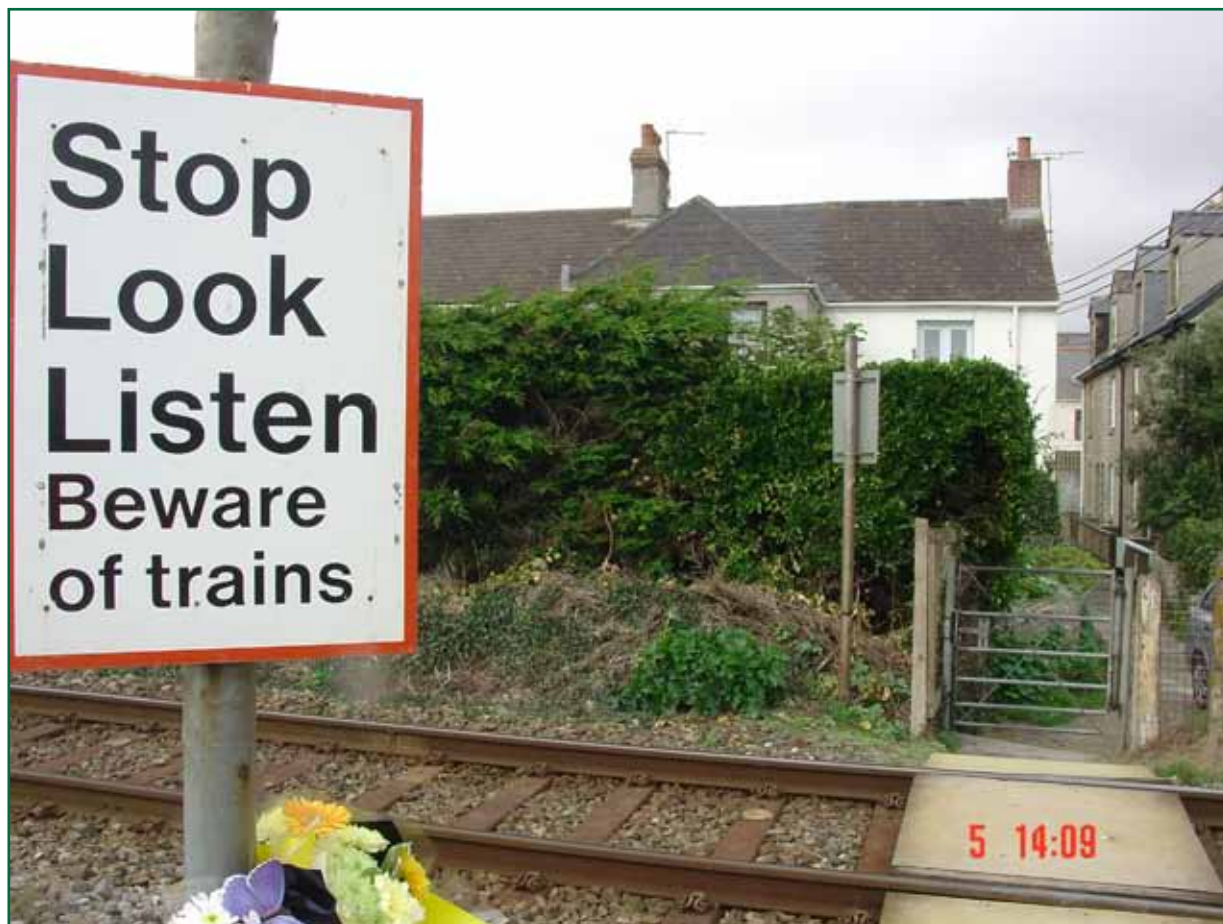
Figure 5: Signage at the crossing (view taken from south side)

- 14 The crossing is equipped with self-closing metal gates on the north and south sides and signs which instruct users to stop, look and listen and beware of trains; see figure 5. The signs correspond with the template for non-vehicular crossings contained in the Private Crossings (Signs and Barriers) Regulations 1996.

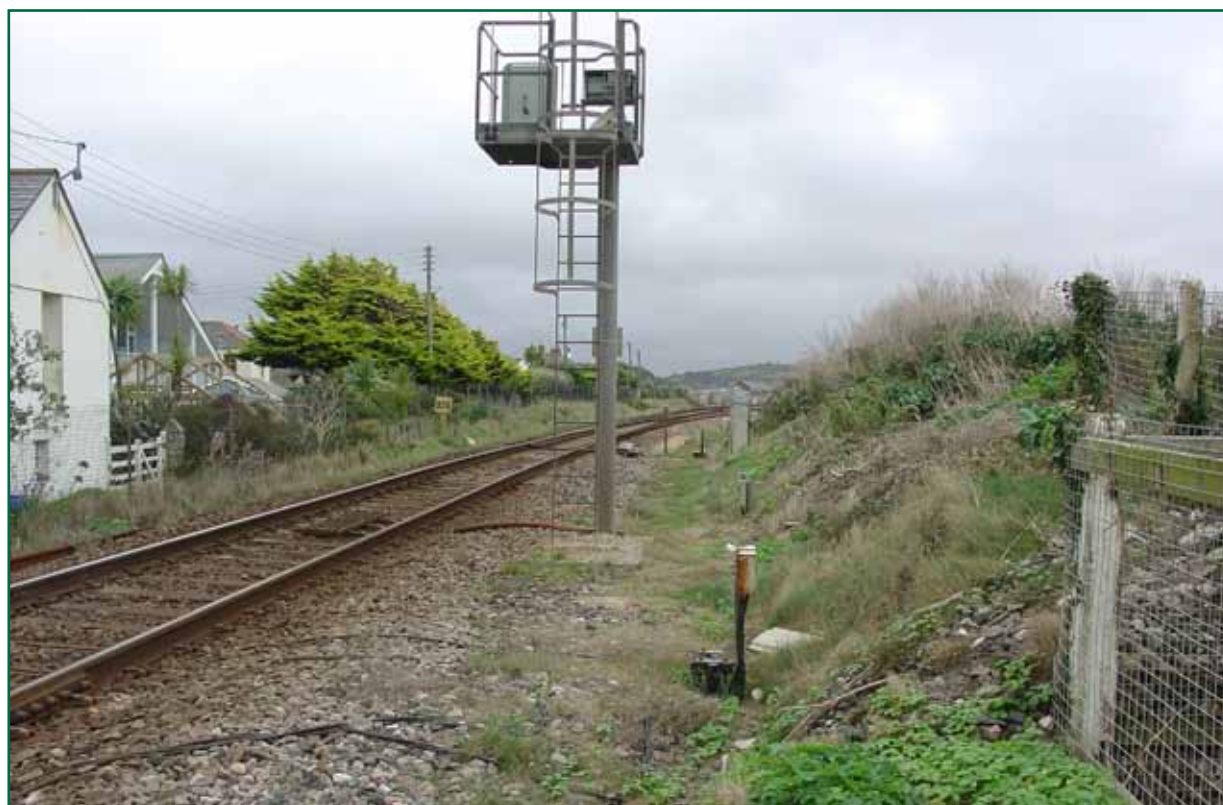
Figure 7: View east from a position alongside the sign on the south side of the crossing (3.40 metres from the nearer rail)

- 32 The sign which instructs users how to cross safely was located between the gate and the track at a distance of 3.40 metres from the nearer rail. At this location, the view to the east for a user is marginally better than that from the gate; see figure 7.

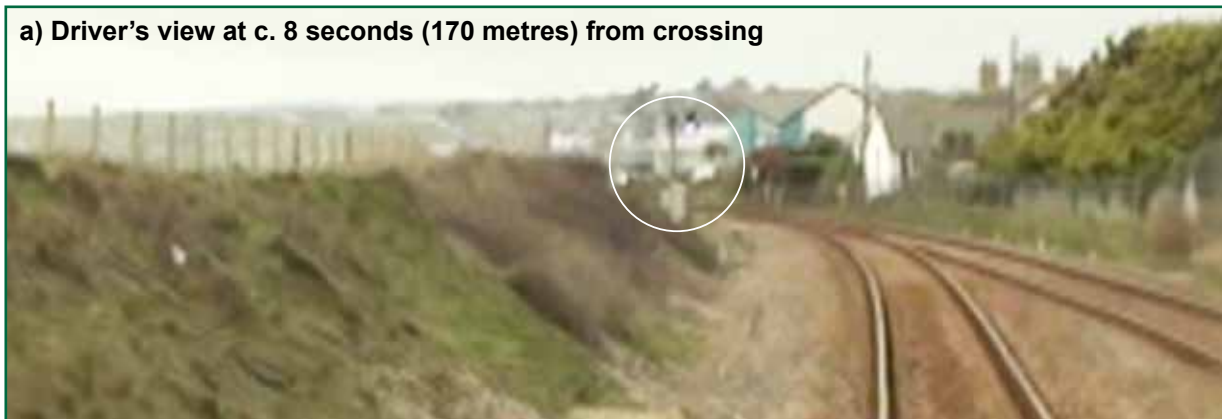
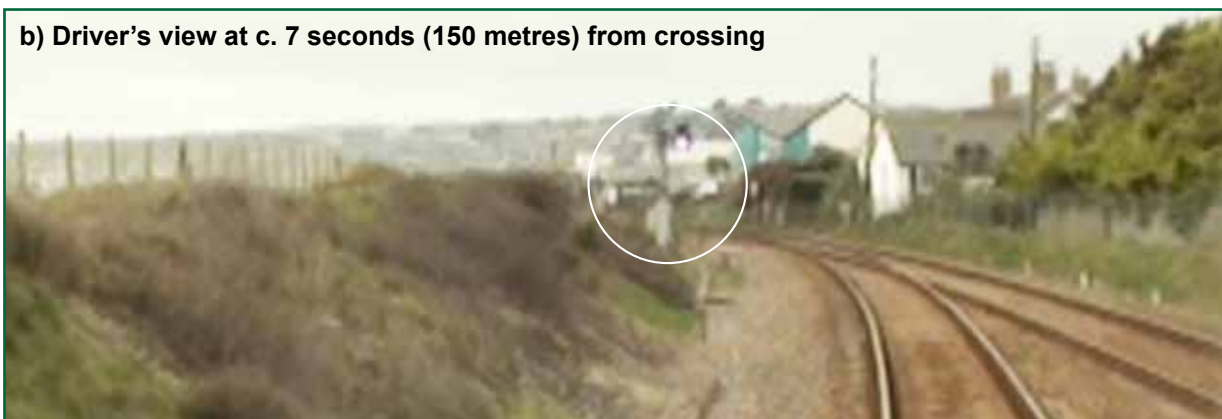
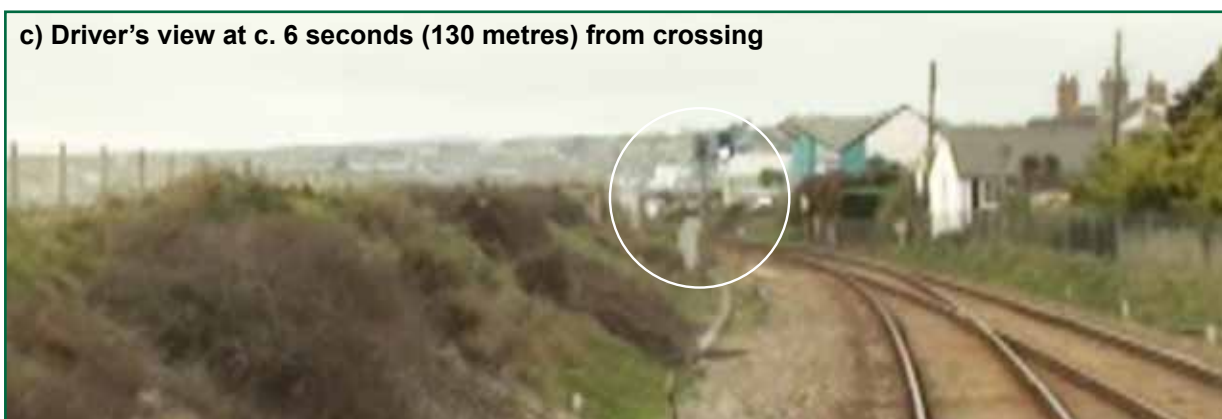
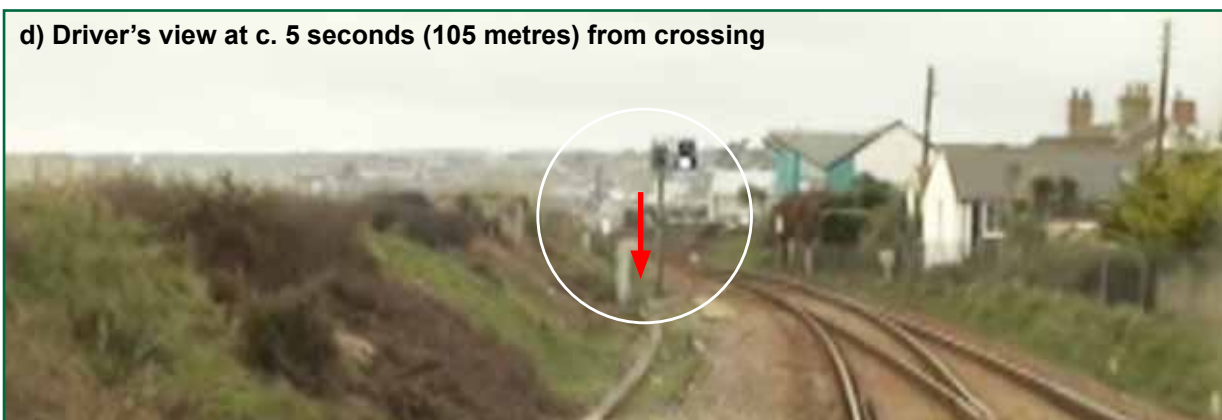
Figures 9a to 9d: The train driver's view approaching Mexico footpath crossing. It can be seen that the driver's view of the area (circled) immediately to the left of the crossing (the location where Mrs Nicholls was most likely to have been standing and arrowed in figure 9d) was initially obscured by the signal and the equipment cases, and it is not until the train is approximately five seconds from the crossing that the relevant area becomes visible to the driver. Note that the green signal that can be seen clearly in the photograph is mounted to the right of the post that comprises part of the obstruction to the driver's view.

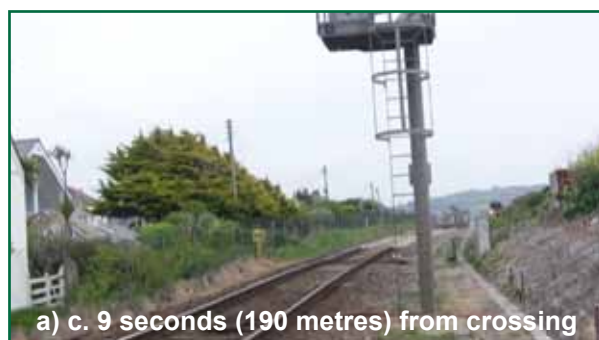
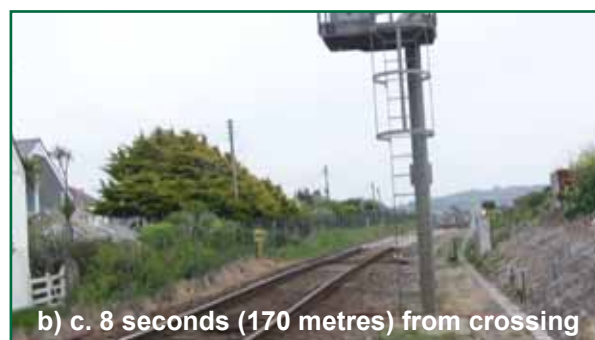
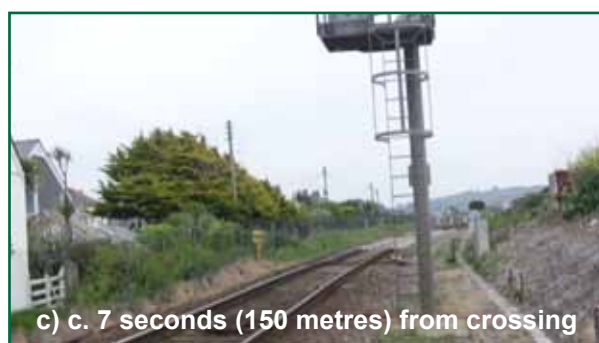
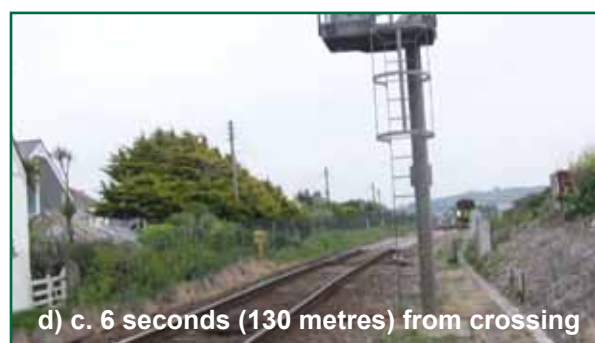
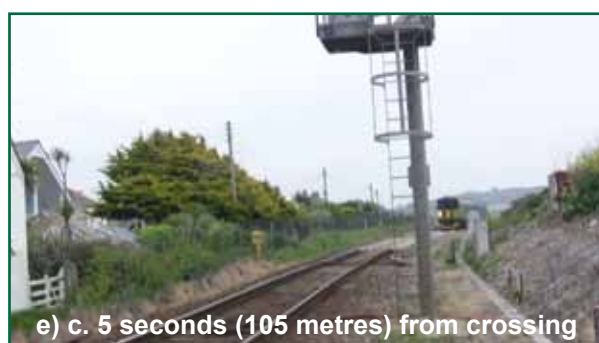
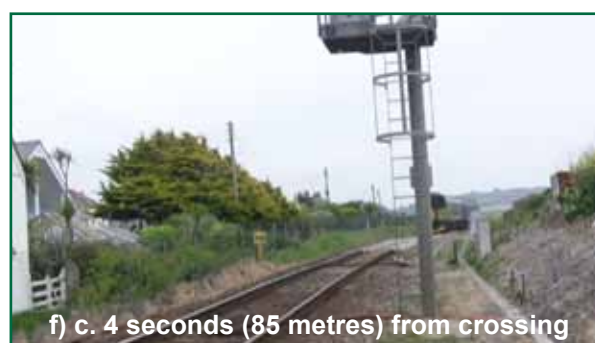
- 65 Figures 10a to 10f show that although the train is visible when it is around nine seconds running time from the crossing, the lower half of the train is obscured by two equipment cases for a period of around one second as it moves towards the crossing. The marker light which helps a pedestrian to distinguish the train as it approaches is obscured at this point, although the upper half of the front of the train and the side of the train are still visible. These findings are valid for someone looking from a position of 1.45 metres above ground. The RAIB noted that when the same train is viewed from 1.6 metres above ground (current Network Rail practice), the period of time over which the marker light disappears is shorter. This is because the roof of the equipment case is pitched and the higher the viewpoint, the narrower the obstruction to the user's view of the marker light (for a tall person, there would probably be no obstruction at all). The signal post also obscures the marker light, but at this point the train is closer and the period over which the marker light disappears is shorter.

Figures 10a to 10f: Views from the south side of Mexico footpath crossing towards a train approaching from the east taken at 1.45 metres above ground level and at 2 metres from the nearer rail. The images show that although part of the train is always in view, the distinctive marker light at the front of the train is temporarily hidden by the equipment cases at 7 seconds from the crossing and by the signal post at 4 seconds from the crossing.

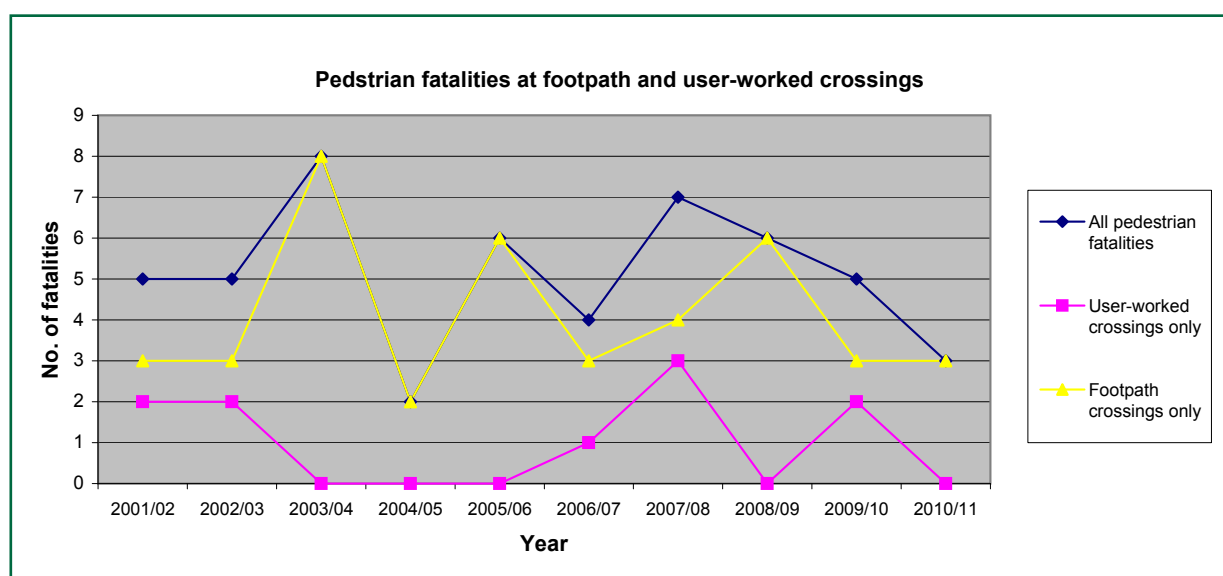
Figure 11: Fatal accidents to pedestrians on footpath and user-worked crossings, 2001-2011

- 91 The data in figure 11 relates to pedestrian fatalities on both 'active' and 'passive' crossings. On active crossings, a positive indication is given to users of the approach of a train (eg miniature stop light or barriers which close automatically as a train approaches), whereas on passive crossings (such as Mexico footpath crossing), there is no such indication. With regard to near-miss incidents, figure 12 shows that while there has been an increase in the number of near-miss incidents on passive crossings since 2007, the number was increasing throughout the period from 2001 to 2011 and the rate of increase did not change significantly after 2007.

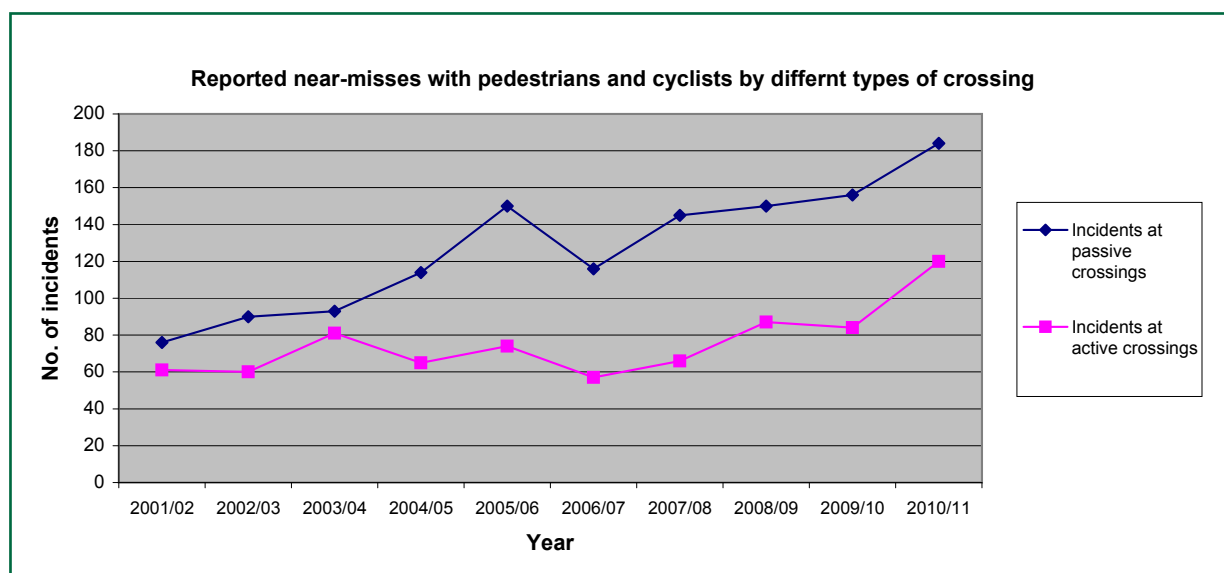
Figure 12: Near-miss incidents on active and passive crossings, 2001-2011

- 92 Not all passive crossings are equipped with whistle boards. The data reflected in figure 12 does not allow any determination of whether trends at whistle board crossings in the period from 2001 to 2011 are different from those at crossings without whistle boards. In order to determine if the change to sounding only the low tone at whistle boards is a significant factor in the increase in near-miss incidents since 2007, it would be necessary to separate the passive crossing data into crossings with and without whistle boards.
